Case Study: Common Design and Workmanship Issues Related to Brick Veneer Masonry of a Modern Mid-rise Building

Warren R. French, PE, RRC, RWC, FRCI, CMRS
French Engineering, Inc.
Houston, Texas

This paper will present the findings of a forensic investigation conducted on a 12-story, multi-family residential building recently constructed in New Orleans, Louisiana. We were retained by the owner's representatives to assist in determining a cause for the interior water infiltration being experienced, as well as to develop a plan for cladding system remediation and renovation.

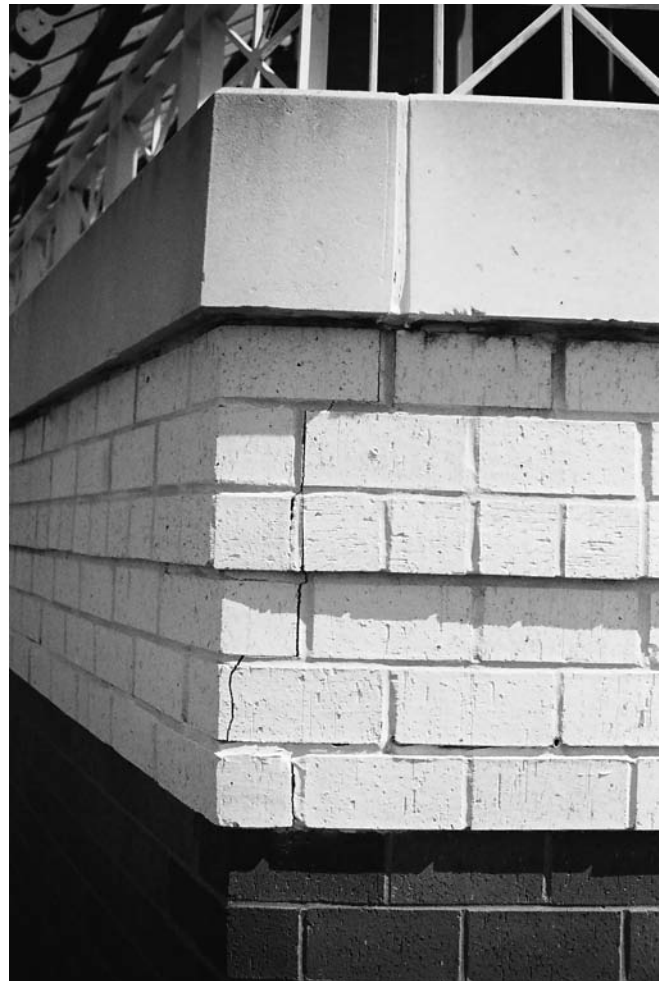
Figure 2 – Cracks in brick veneer at corner.

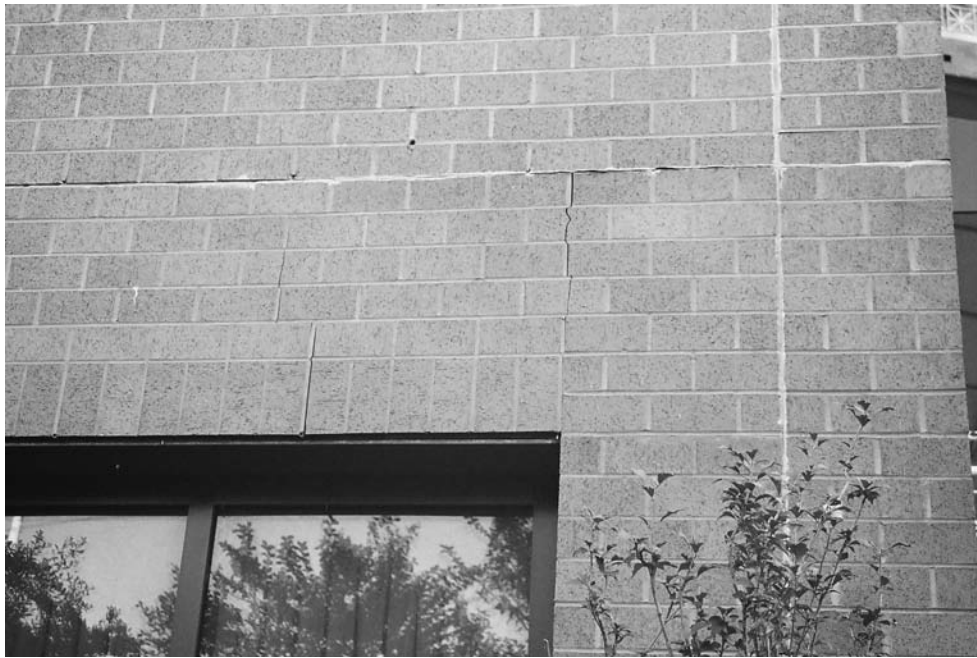
Figure 3 – Cracks in brick veneer above window.

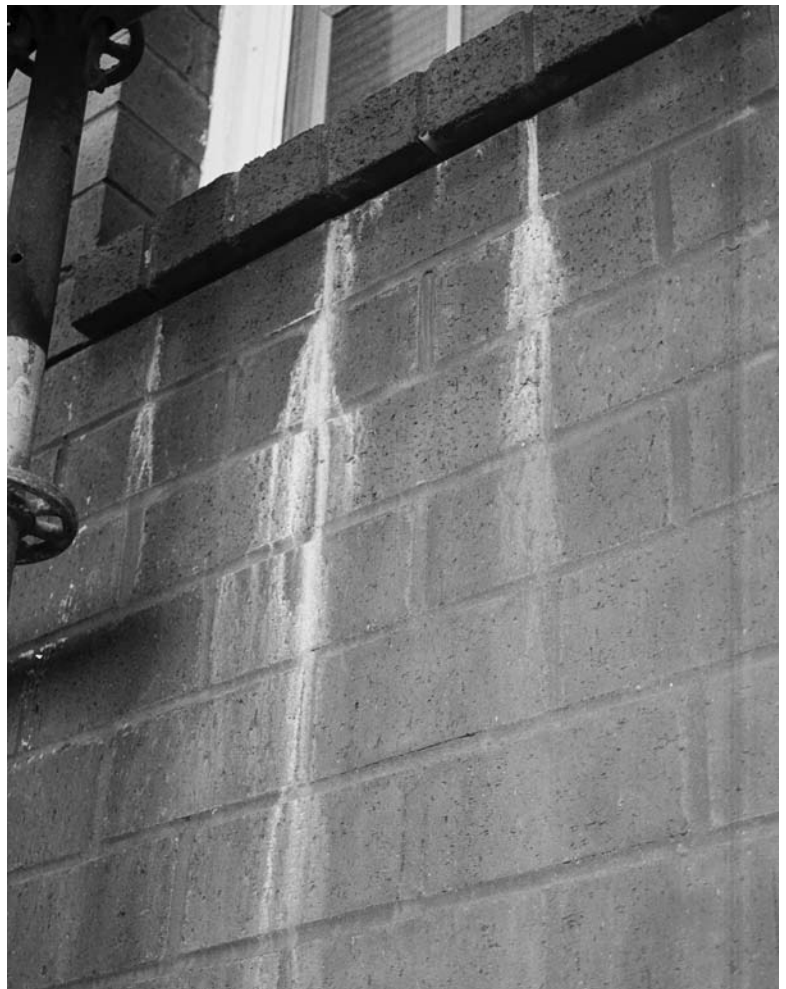
Our firm observed widespread efflorescence stains on the face of masonry units throughout each elevation of the building. Efflorescence is normally attributed to faulty design and construction practices. In addition, our firm observed that the horizontal joints in the masonry at the steel shelf angles were approximately 3/8-in wide and there is no space between the shelf angle and the masonry veneer occurring below. This orientation does not allow an effective means for accommodating vertical movement due to thermal expansion within the cladding assembly or due to deflections and racking of the structure. The horizontal masonry joint at the steel shelf angle was completely filled in with sealant and the through-wall flashing was not visible. Above this masonry joint were hollow plastic tubes for weeps. However, at several locations, the weeps were spaced greater than 16 inches on center. Since the membrane stops short of the exterior plane of the wall, since the horizontal joints were filled with

Figure 4 – Efflorescence and water stains below brick sill.

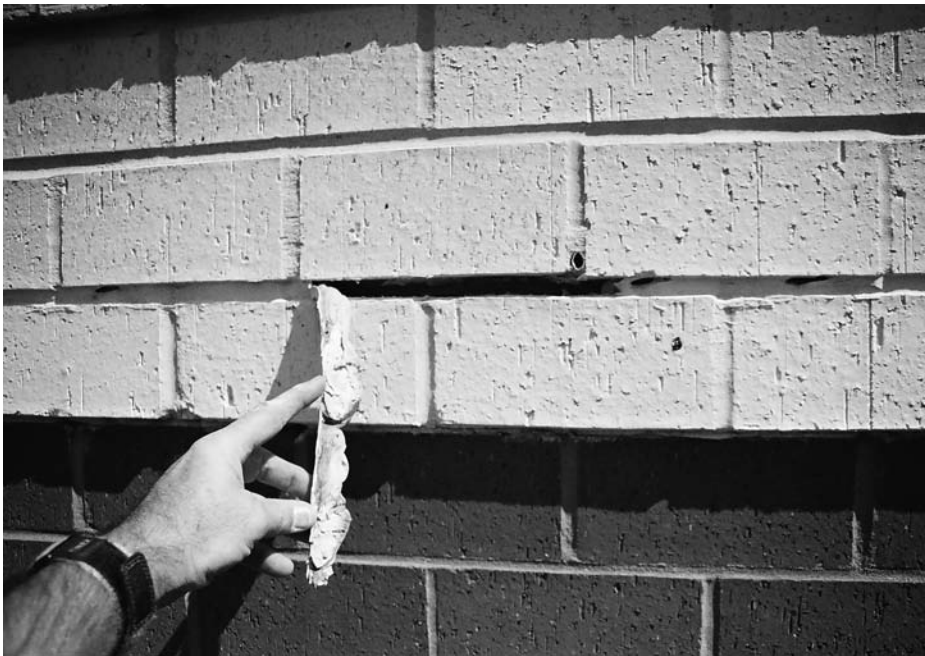
Figure 5 – Sealant installed with no backer rod.

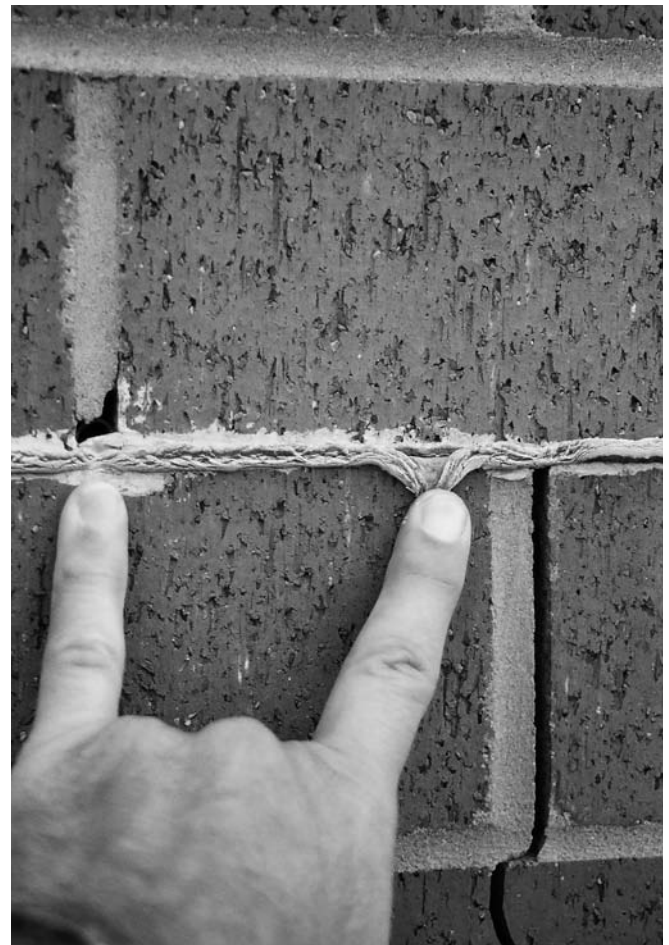
Figure 6 – Sealants failing in compression: masonry cracks.

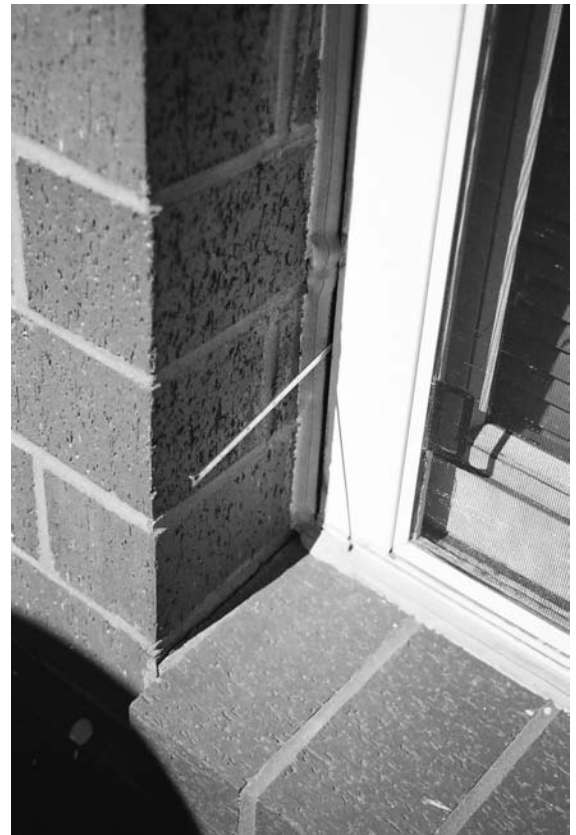
Figure 7 – Adhesive sealant failure at window jamb.

firm observed several locations where adhesion of the sealant along the jambs and sills of the window frame had failed, forming voids that were a source for moisture intrusion.

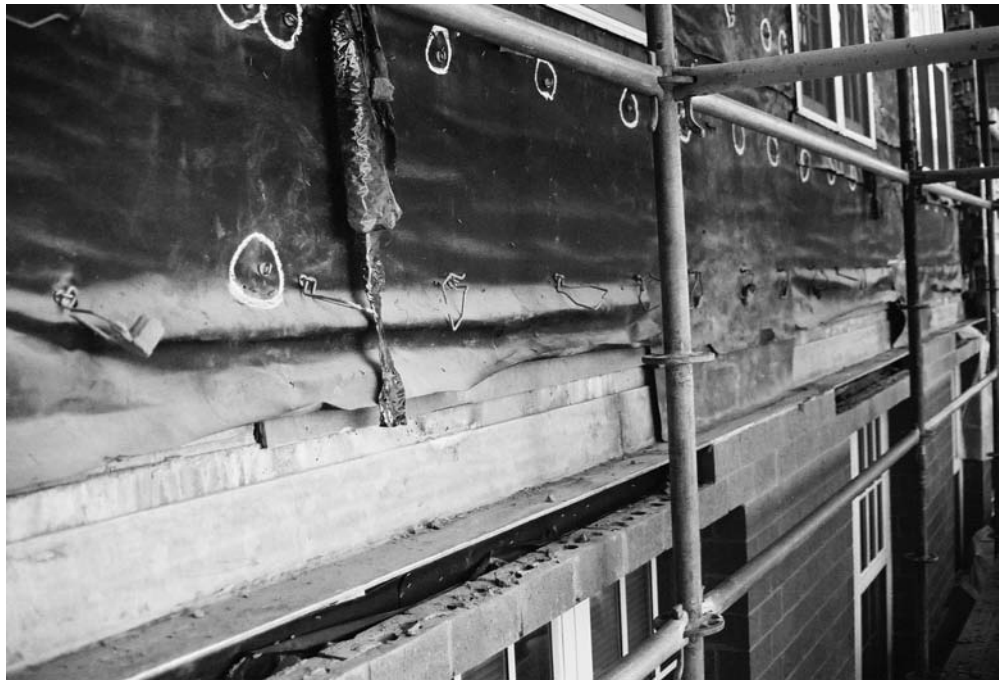
Figure 8 – Weather-resistant barrier not integrated with shelf angle; missing wall ties.

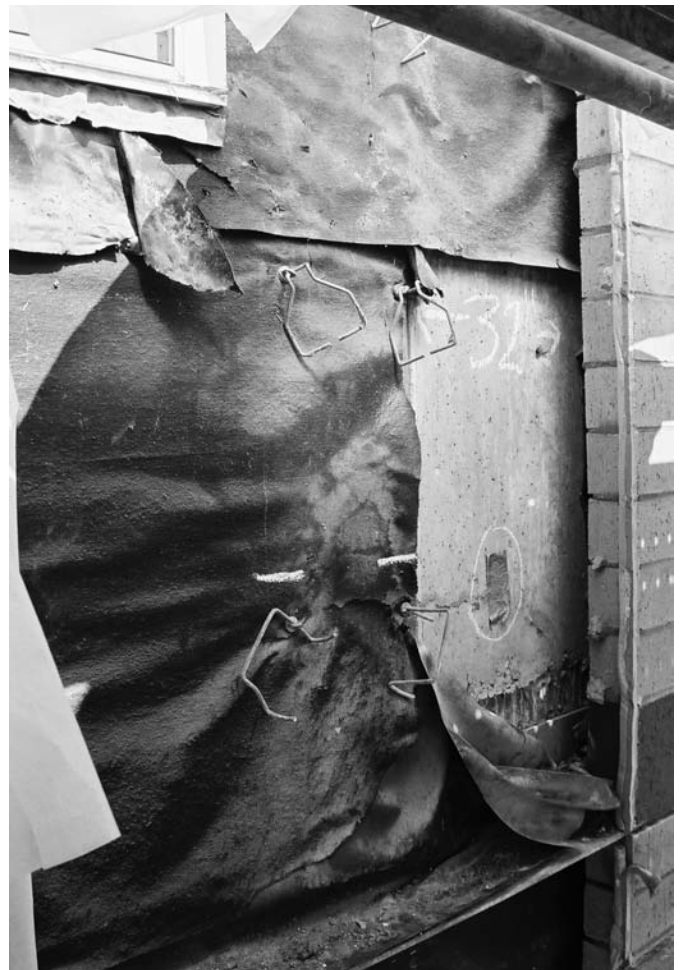
er barrier was generally poorly installed at the termination of the stud wall. We observed terminations of the weather barrier at these locations that were unsealed and were typically discontinuous across the concrete or CMU portion of the wall, leaving exposed cut edges of the sheathing without any protection against water absorption from the brick cavity.

Figure 9 – Weather-resistant barrier stops short of column; not sealed at terminations.

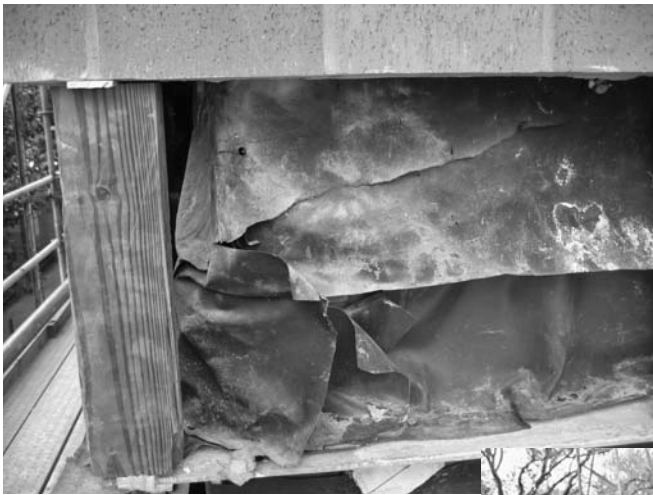
Figure 10 – Improper weather-resistant barrier at corner.

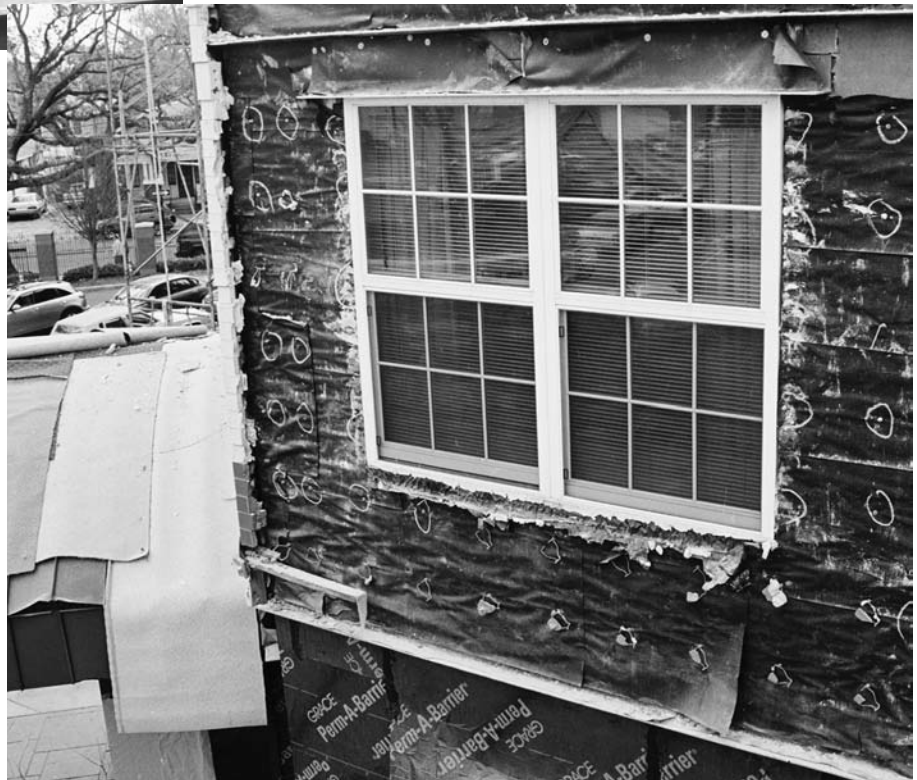
During the renovation demolition, we observed widespread periodic omission of specified wall ties or improper installation of wall ties. In certain locations, the original installation exhibits one or two missing wall ties of the six to eight anchor locations visible, while at other locations, the installation exhibits six missing wall ties of the 12 anchor locations visible. Accordingly, lateral support of the brick veneer in at least some wall areas is completely absent, and in other wall areas is questionable.

Figure 11 – Missing wall ties at one section of wall.

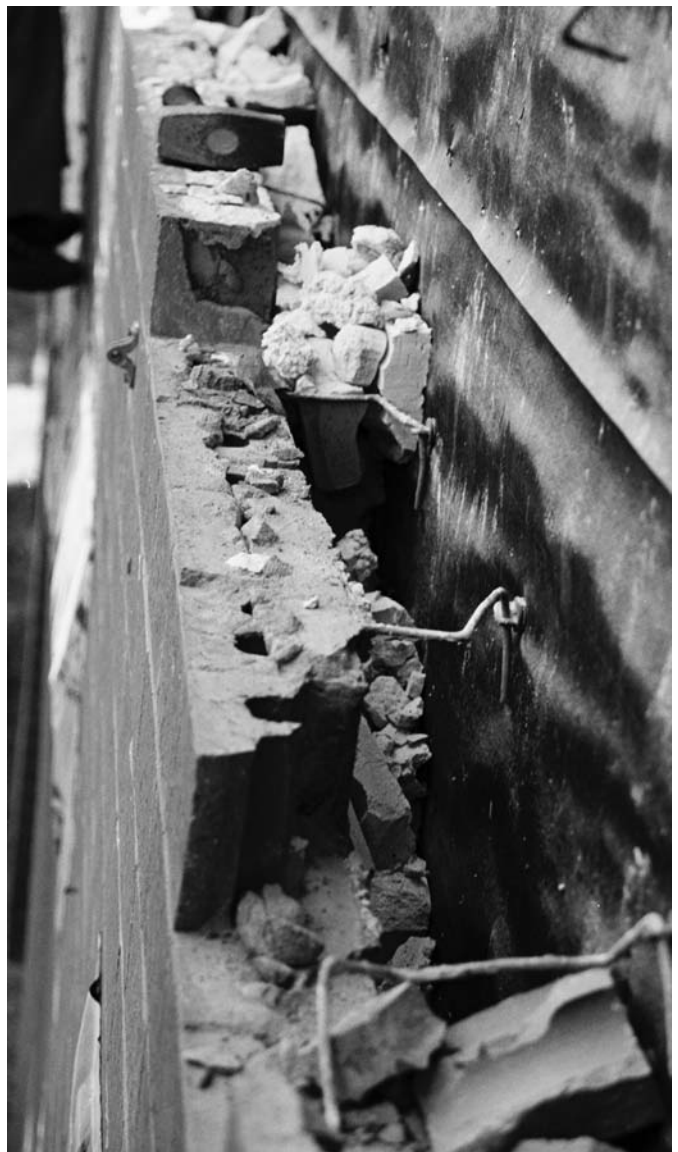
The most frequently observed improper tie/anchor assembly installed was a particular type of adjustable tie installed into a self-drilling screw anchor base (incompatible mating pieces). The adjustable wall tie product specified for use is designed for CMU or double-wythe masonry applications and utilizes a dual eyehook anchor to secure the tie. In most of the improperly installed locations, a single prong of the tie was inserted into the two-eyed anchor base, which does not provide adequate lateral support for the masonry.

Figure 12 (above) – Wall ties improperly installed with one leg engaged.

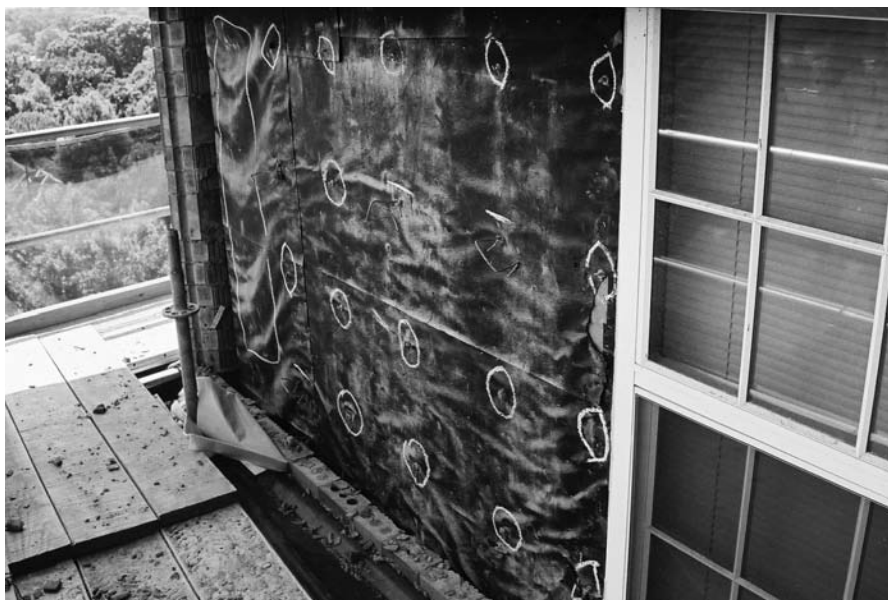
Figure 13 – Missing wall ties at one section of wall.

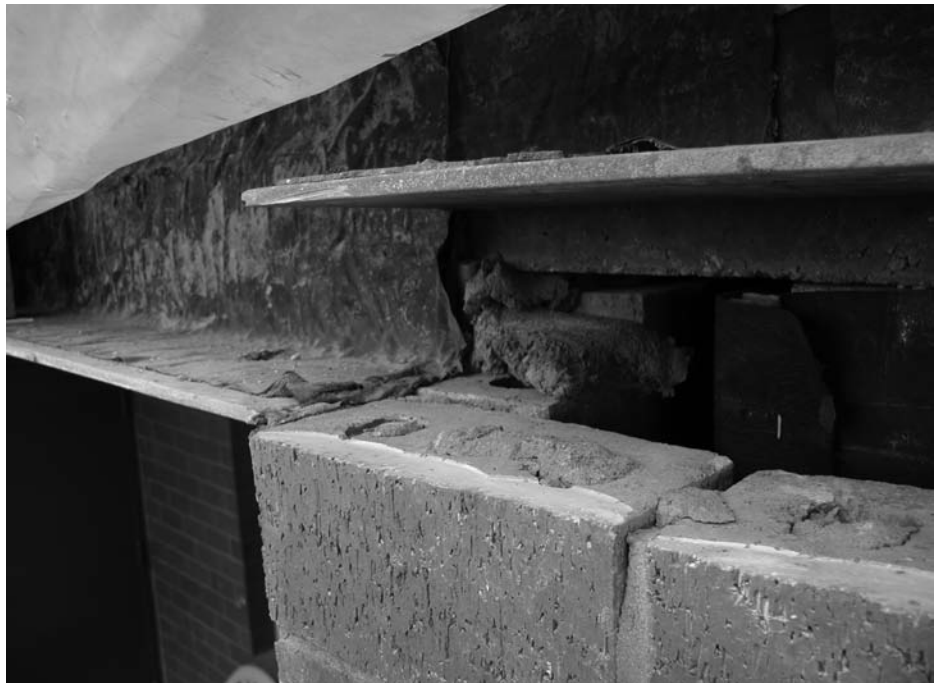
At a number of locations, steel shelf angles were offset vertically at locations below scuppers at recessed balcony areas along the east elevation. Selective demolition performed at the fourth floor below a balcony of one unit revealed the through-wall flashing to be discontinuous, not lapped properly, and not extended over the wythe of the masonry.

Figure 14 – Shelf angle offset in elevation; no end dam at membrane flashing.

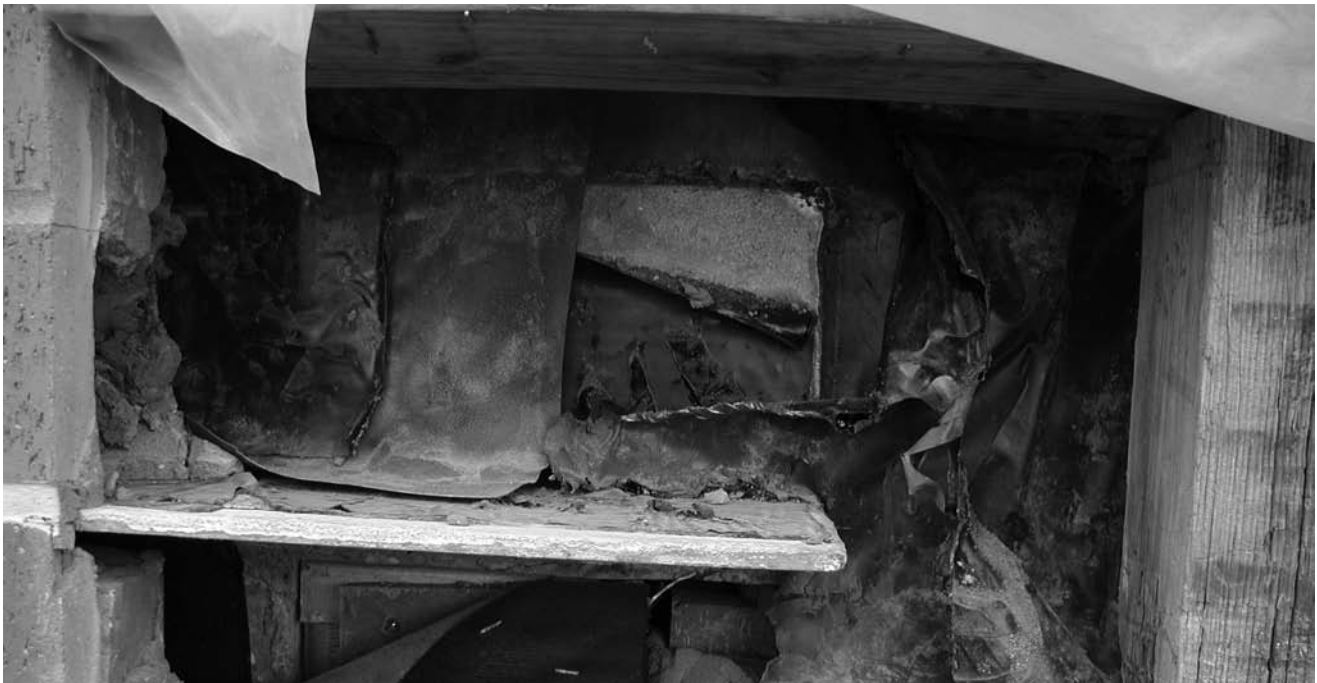
Figure 15 – Shelf angle offset in elevation; no end dam at membrane flashing.

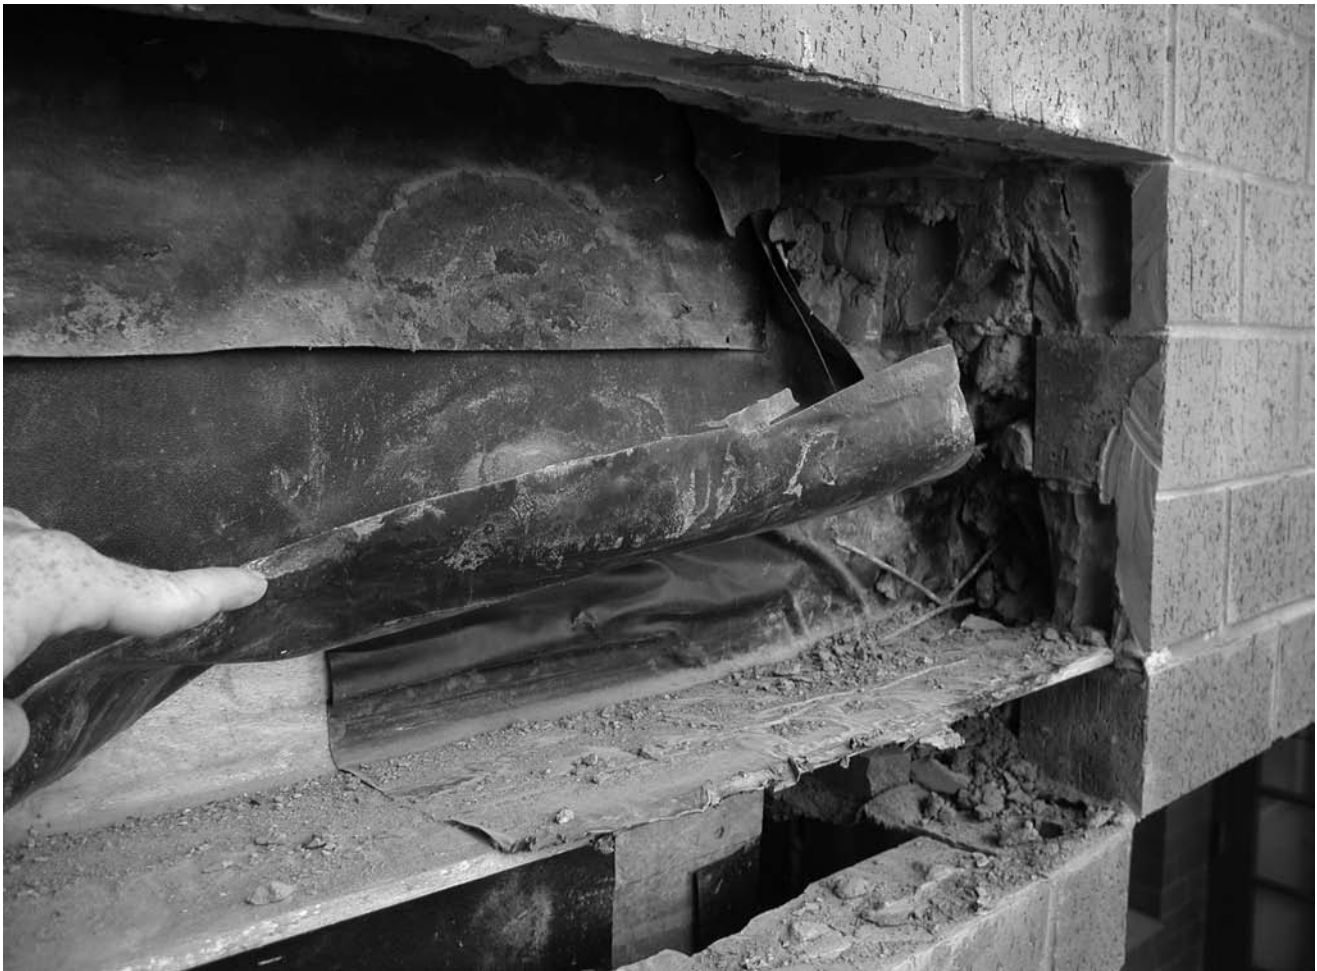
Selective demolition at the second floor terrace along the west elevation revealed that the PVC through-wall flashing material was dry set onto the steel shelf angle, the lap joints were not sealed with mastic, and the flashing did not extend to the outer plane of the brick veneer. In addition, the through-wall flashing was not integrated with the waterproofing membrane installed at the juncture between the concrete curb and the terrace deck. Mortar droppings were also measured to be eight inches high and plugging the plastic weeps.

Figure 16 – PVC flashing lap set “dry.”

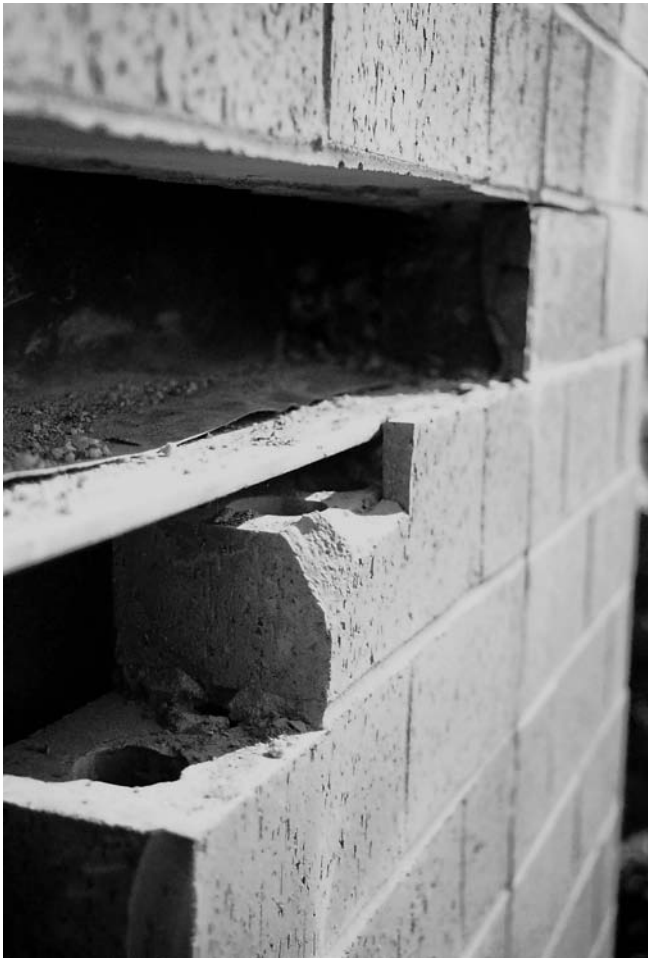
At a few areas, we observed that coursing of the brick veneer was not properly coordinated with installation of the steel shelf angle such that, rather than properly installing these cladding components, the masonry subcontractor simply saw-cut the back of each brick to allow the toe of the shelf angle to be let-in to the back of the veneer. However, since the shelf angle did not support the brick and there were hard mortar joints above and below this brick course, there was no proper relief of the brick expansion and contraction at these shelf angle locations.

Figure 17 – Coordination error in shelf angle placement; back of brick saw-cut.

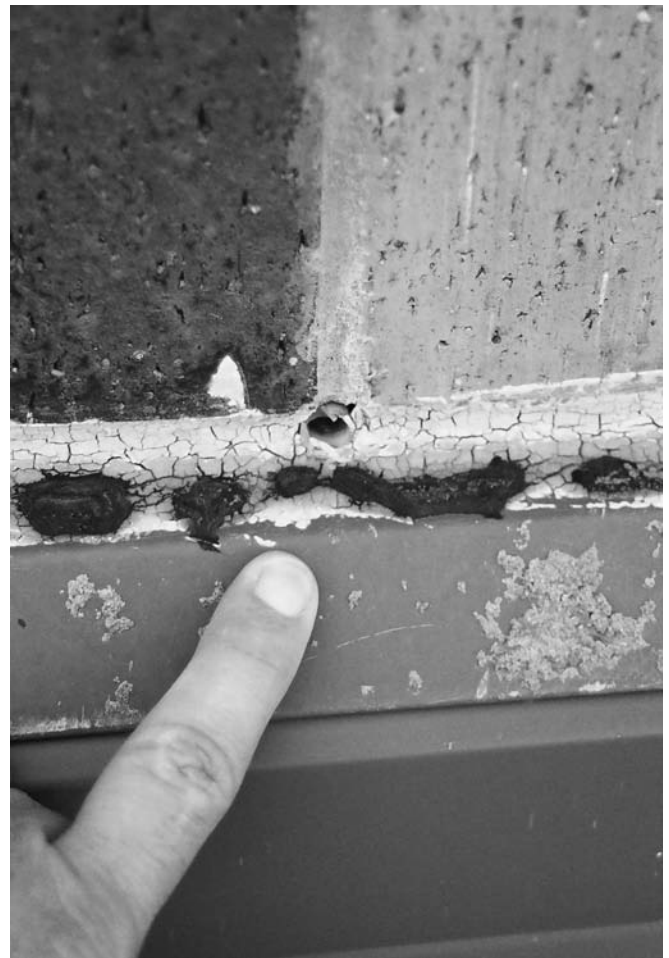
Figure 18 – Flashings oozing; weep tube clogged.

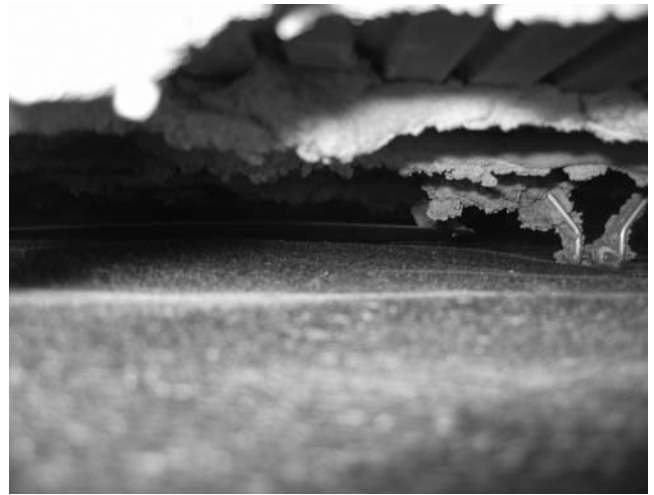
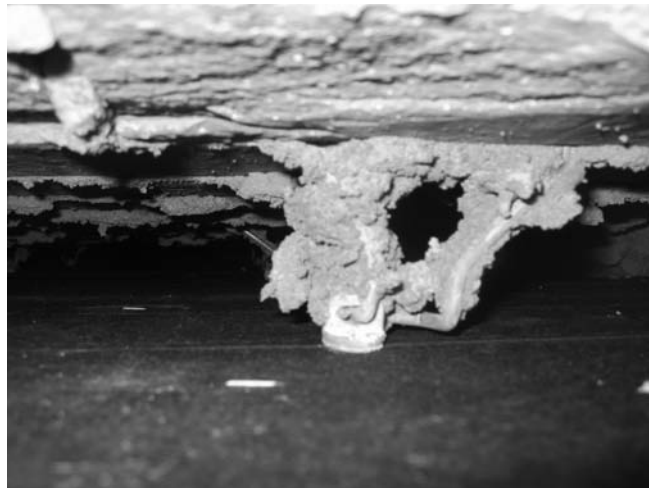
Figure 19 – Mortar bridging at wall tie.

Figure 20 – Mortar bridging at wall tie.

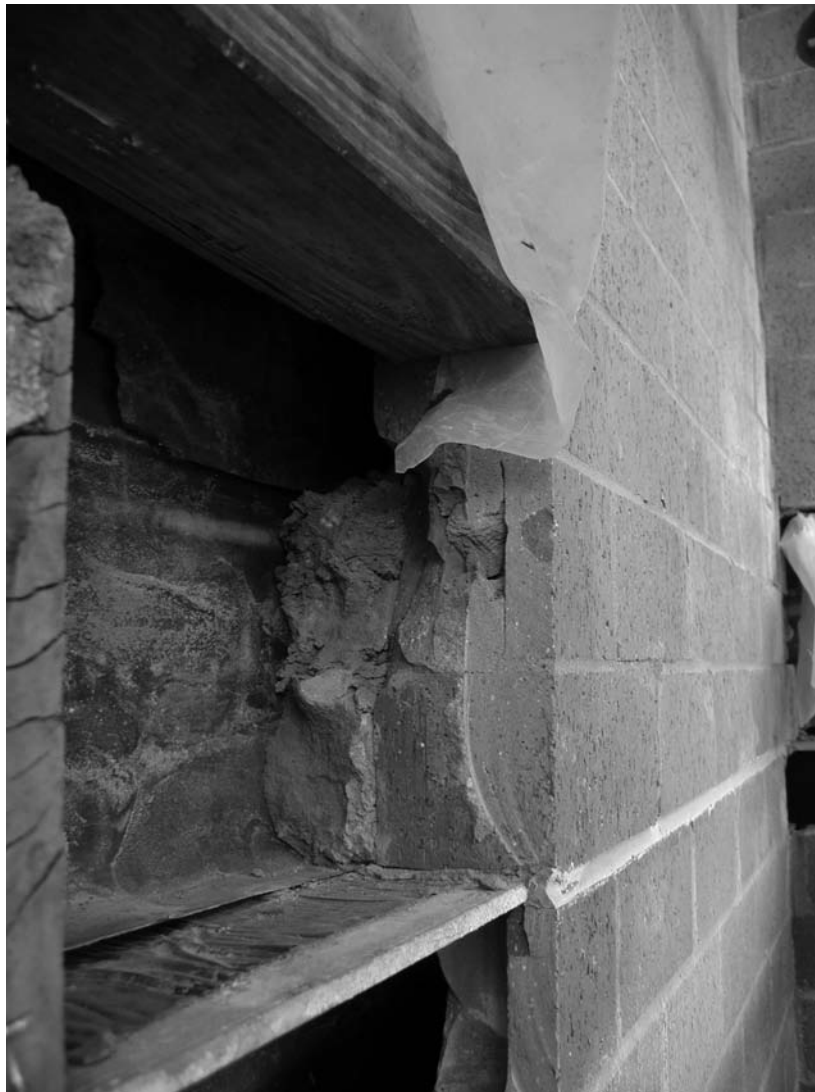
that self-adhering, through-wall flashing was installed below the topping slab and the lateral joints were improperly adhered, allowing openings. The top of the self-adhering membrane was also pulled down by excess mortar droppings that were measured to be ten inches high and plugging up the plastic tube weeps.

Figure 21 – Excessive mortar droppings in drainage cavity.

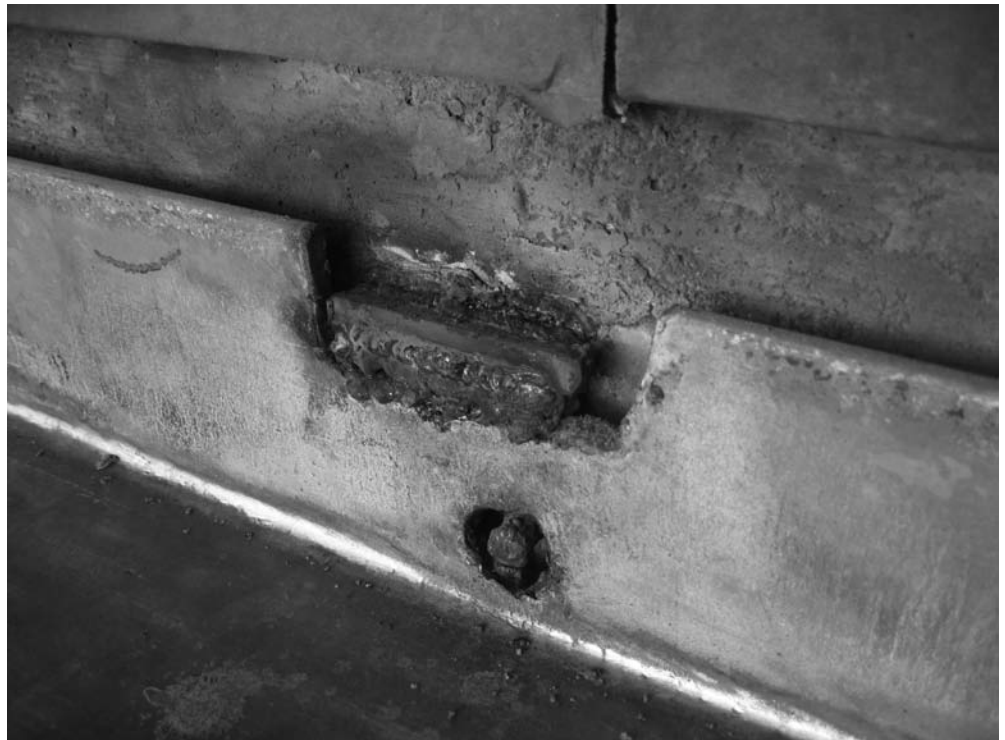
Our firm has observed numerous anomalies associated with the attachment and orientation of the steel shelf angles as originally installed at this project. The welding of the shelf angles was in poor condition considering the age of the building. A number of broken welds have been observed, as well as severely corroded welds and welds that projected more than one-half inch away from the slab.

Figure 22 – Improper weld between shelf angle and embed.

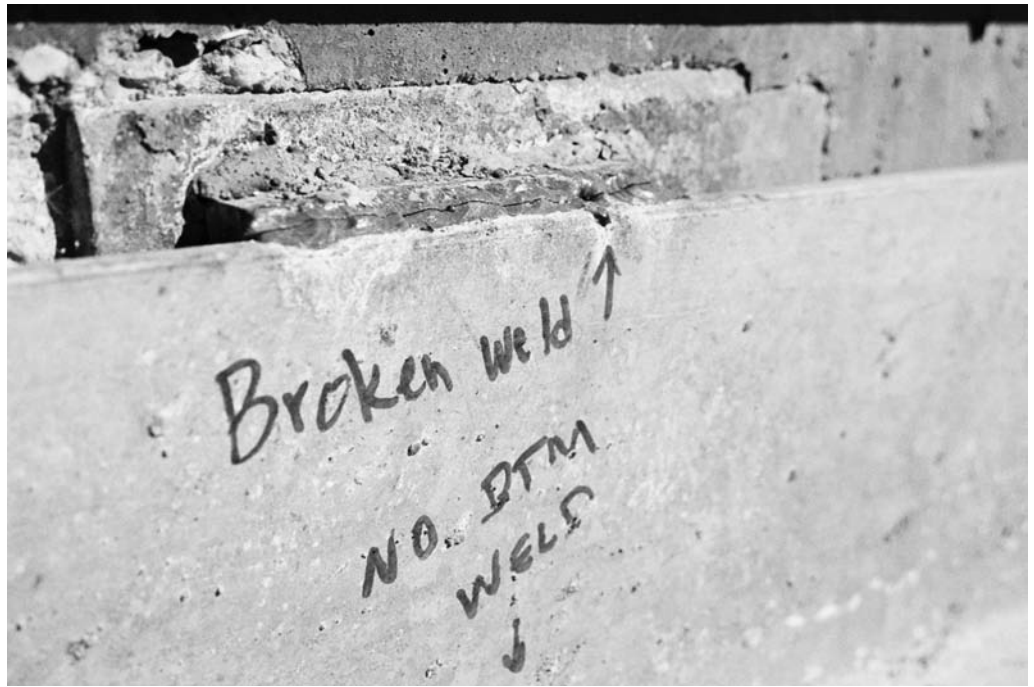
Figure 23 – Broken weld at shelf angle attachment.
