## **EL PASO ENERGY – BUILDING ENVELOPE SOLUTIONS FOR 1960S VINTAGE CONSTRUCTION**

**JERRY L. ABENDROTH, RRC, RVC, REWC, RRO, CDT**

*BUILDING EXTERIOR SOLUTIONS, LLC*

# EL PASO ENERGY – BUILDING ENVELOPE SOLUTIONS FOR 1960S VINTAGE CONSTRUCTION

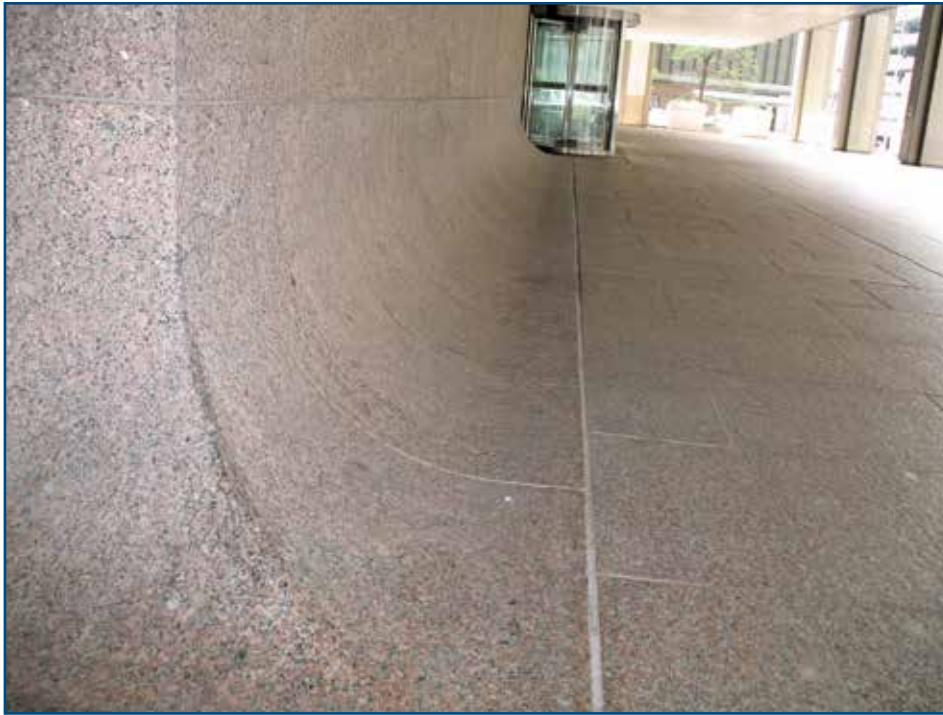
**Figure 3 – Granite paving at original plaza.**

The plaza of the El Paso building is clad with Texas pink granite and sweeping curved stones at horizontal/vertical transitions to the walls of the building (*Figure 3*). There are two ramps in the plaza—a down ramp and an up ramp, which provide access to and from the basement for delivery vehicles. An active fountain system was included in the revamped design in 1984. With the exoskeleton design, the plaza

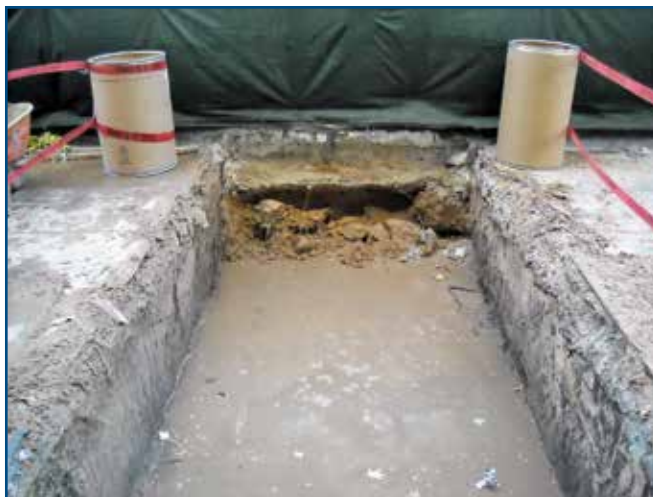
Figure 4 – Concrete “catch basins” at street.

From observations and from electronic level readings made during the several plaza and basement walk-throughs, a drainage plan was developed that added effective drainage to the plaza by locating new plaza drains in strategic areas that had previous evidence of deck deflection and ponding water. Several areas of the basement were included in the renovation design, and this facilitated installation of supplemental drainage lines to critical areas. For instance, the new plaza design included large planter areas with lengthy trench drains. Draining an area this large to the street would have overwhelmed the

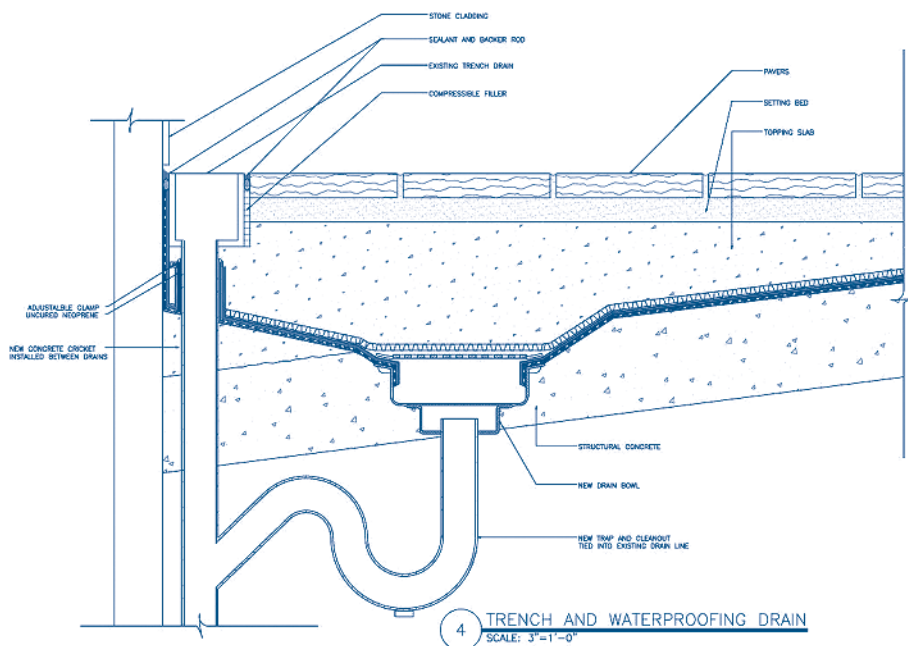
Figure 5 – Drain configuration at planter walls.

drainage mat for the waterproofing system. Additional drains were installed on both sides of the new planter walls to evacuate drainage water more efficiently (Figure 5).

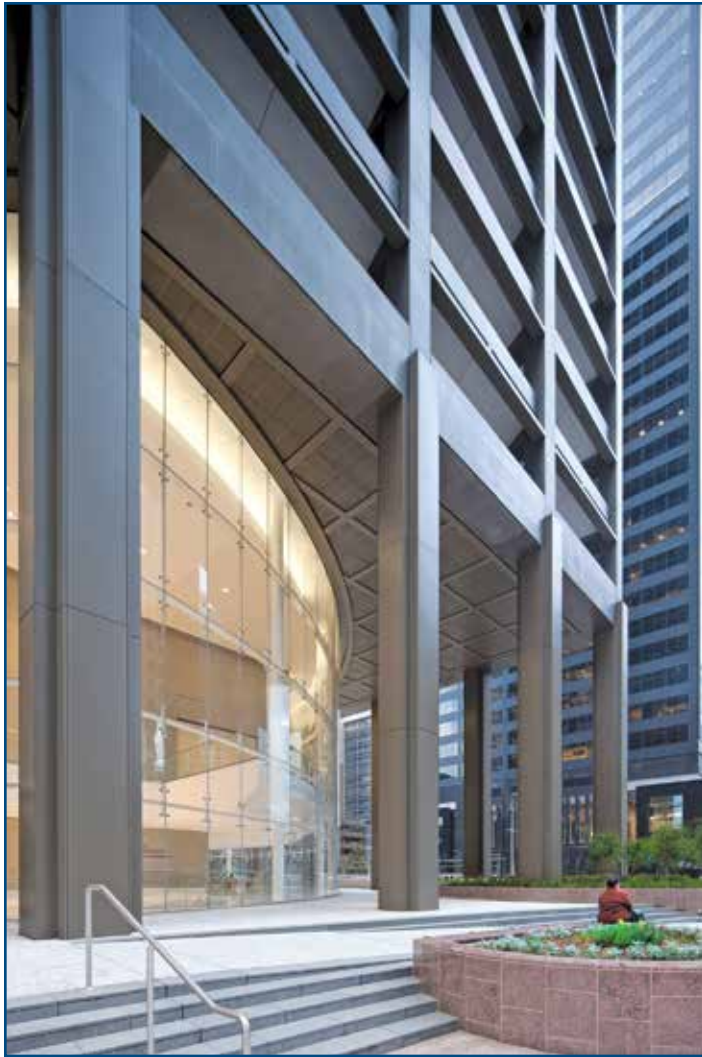
**Figure 6 – Redesigned plaza incorporating old and new cladding.**

A new paving cladding system was selected to be set in a mortar bed over the waterproofing and concrete layers. At several locations, existing cladding was to be integrated into the new design. After lengthy discussions about waterproofing tie-ins, it was decided that the existing cladding would be removed and reused at selected areas. The final design was not chosen until demolition was significantly in progress in

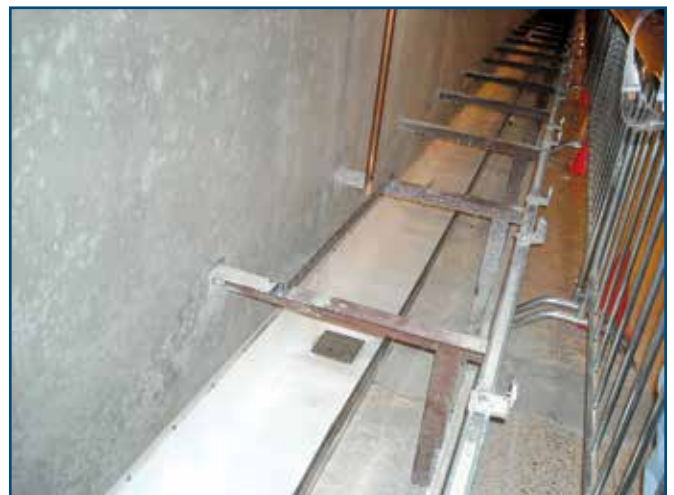
**Figure 7 – Tunnel gutter.**

First, a thermoplastic-lined gutter system was designed to be installed at the base of the wall that ran the entire length of the tunnel. The gutter was specifically designed to accept incidental water that seeped through the tunnel’s walls (Figure 7). At the lowest end of the gutter system, workers installed a drain that was routed to an open stormwater drain. The existing construction of the tunnel provided for slight slope; however, there were areas of ponding water in the drain area during testing of the system. Water was added to determine the extent of ponding water throughout the length of the gutter drain.

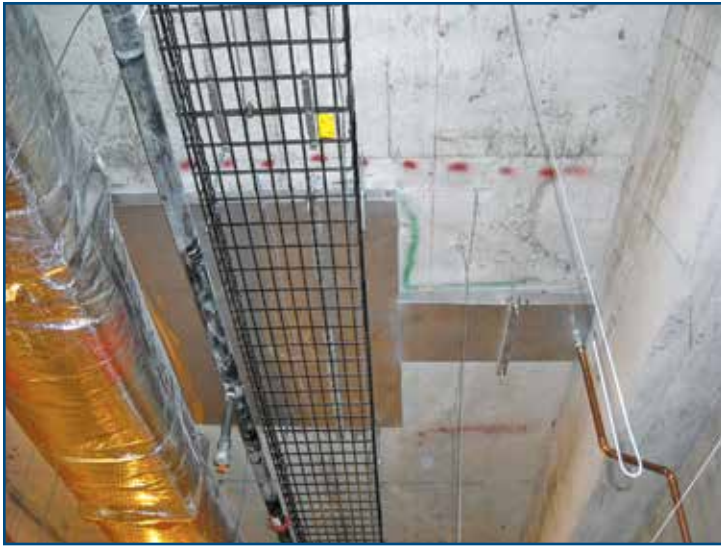
**Figure 8 – Drain pan system.**

Traffic approximately 20 feet above the tunnel would continue to cause almost constant vibration over the roof of the tunnel. Pans had been installed above the suspended ceiling to catch water seeping through the roof of the tunnel (*Figure 8*). During periods of substantial water infiltration, the pans would have to be emptied several times per week. In the past, building management had several waterproofing subcontracting firms install injection repairs in these areas; however, after many attempts and limited success, a new system had to be developed. A repair protocol was created to provide for the larger crack repairs in the roof deck of the tunnel to stabilize these areas. After injection repairs, a kerf drip edge was cut around the crack area to prevent migration of leak water to other areas. Enlarged stainless-steel pans were installed under the leak areas, and each pan was fitted with a drain. The drain was plumbed with copper fittings to route leaking water from the roof of the tunnel to the thermoplastic gutter system.

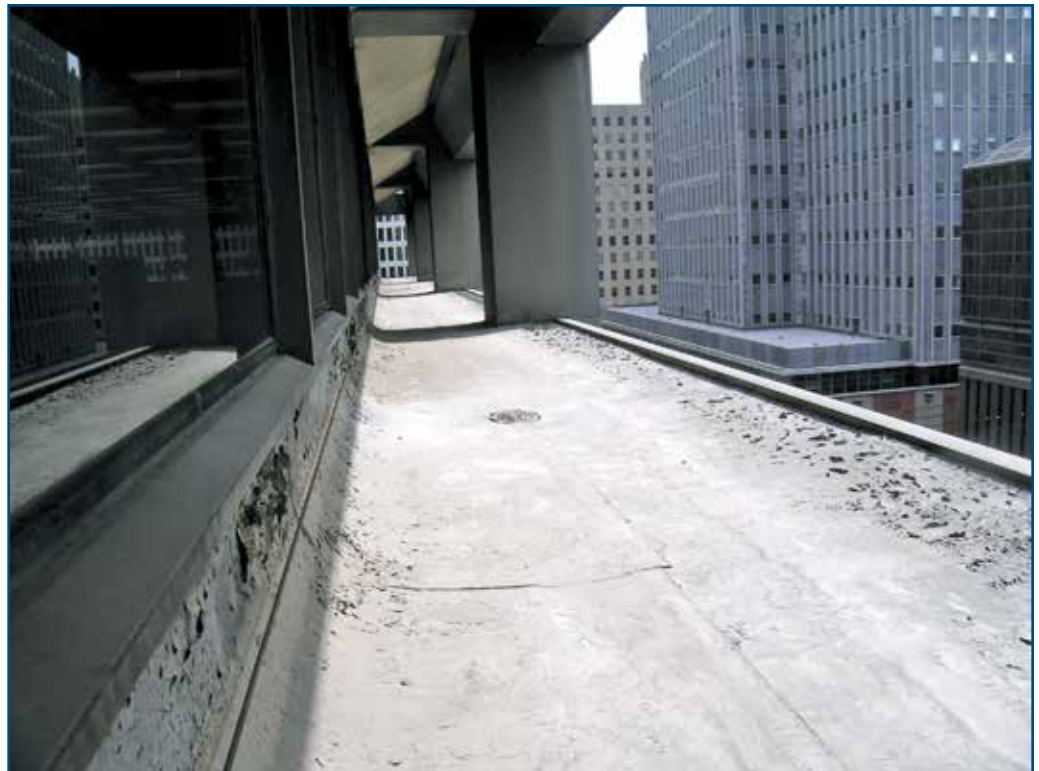
The original design of the balcony decks included minor slope only (in most instances approximately 1/16 to 1/8 in. per ft.), resulting in many areas of ponding water. The original system was a layered asphalt roof system installed directly onto the concrete balcony deck. In the past, these areas had been reroofed with asphalt-based granulated modified-bitumen (mod-bit) roof systems to provide a proper walking surface for window-washing and maintenance personnel. Because of prolonged exposure to sunlight and ponding water, they would often fail prematurely. The deck drains for the balconies had been routed through columns, as was typical of construction during the 1960s. Many of the cast-iron drains had corroded, allowing stormwater to deteriorate the concrete around the drain leader pipe.

Building management personnel indicated that the roofs of the balconies had been an ongoing problem during the service life of the building. The owners expressed concern regarding a reroofing plan that would include “another typical roof system.” Another concern voiced during these meetings was the fact that when previous asphalt-based systems began to deteriorate because of ponding water, the surfaces of the balconies became slippery, causing a hazard to maintenance workers.

**Figure 9 – Typical balcony, original condition.**

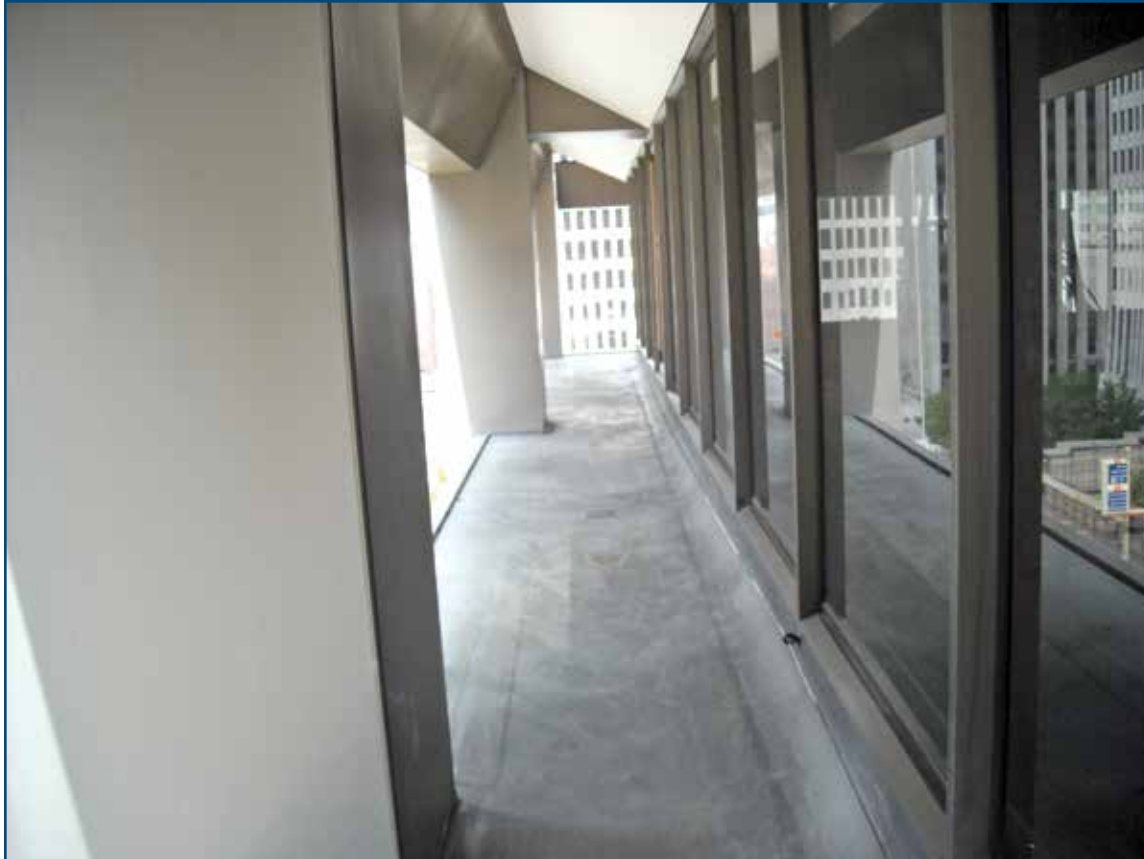
Figure 10 – Renovated balcony.

To meet the 20-year service life requirements and to provide a strong wear-resistant, slip-resistant surface, a poly(methyl methacrylate) (PMMA) liquid waterproofing system was specified for installation on the balcony decks. The system is a seamless, fully reinforced waterproofing system that can be used in conjunction with mod-bit base ply membranes. As stated earlier, the

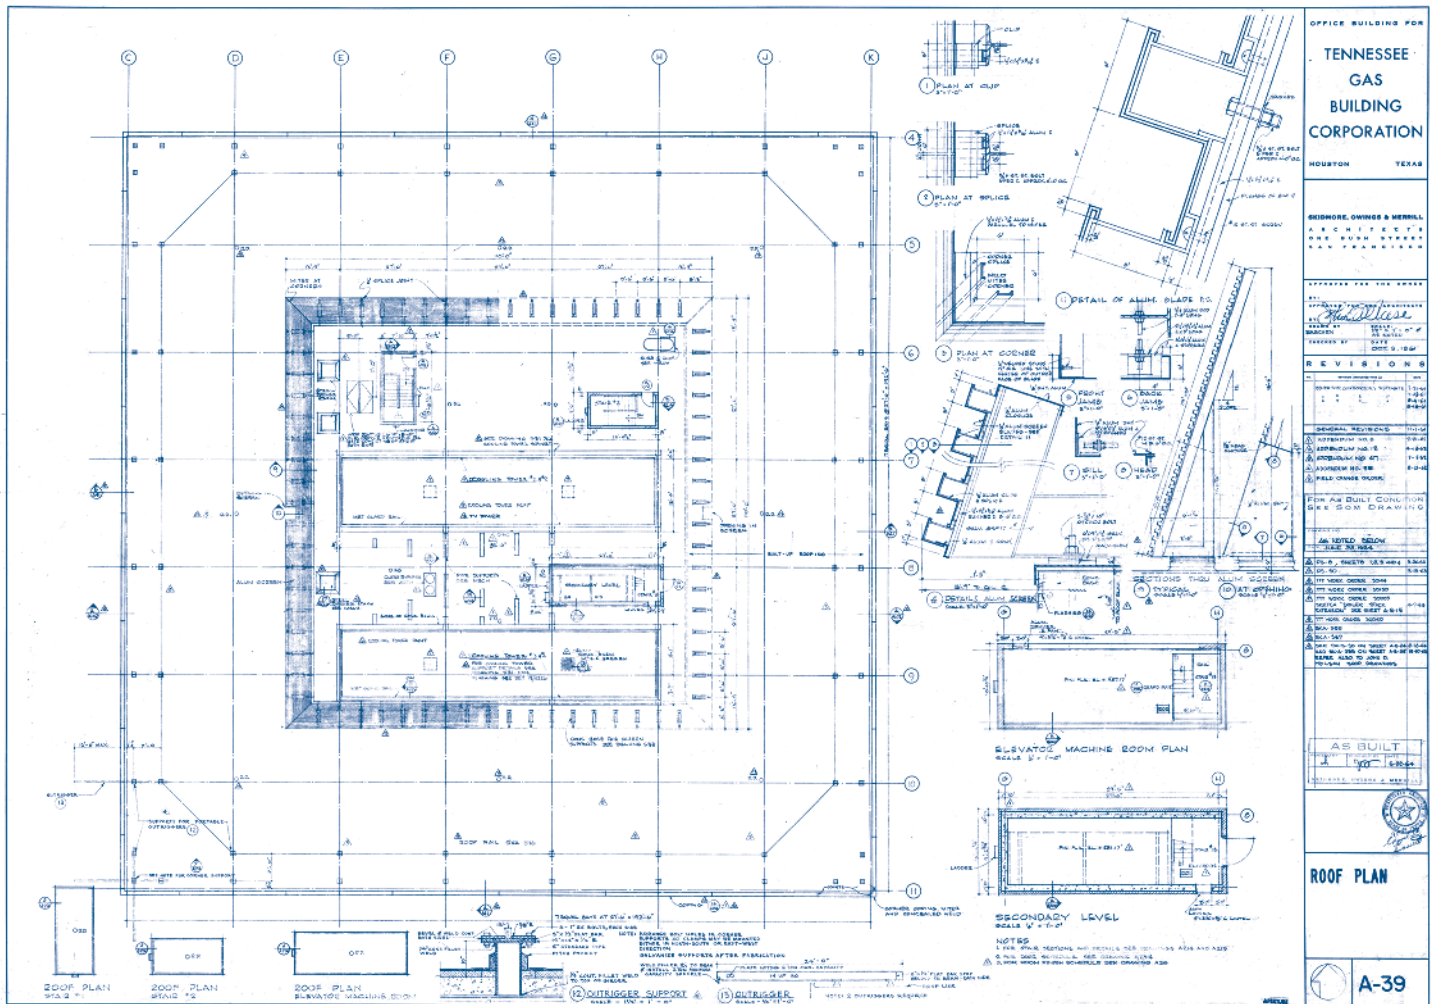
Figure 11 – Original roof plan.

The original roof system specified for the building was an asphalt built-up roof system with fiberglass insulation, three-ply organic felts, and a flood coat with gravel surfacing (Figure 11). This system was typical for the U.S. for 1960s-vintage construction. Numerous studies of posthurricane damage specifically cite roof gravel as a

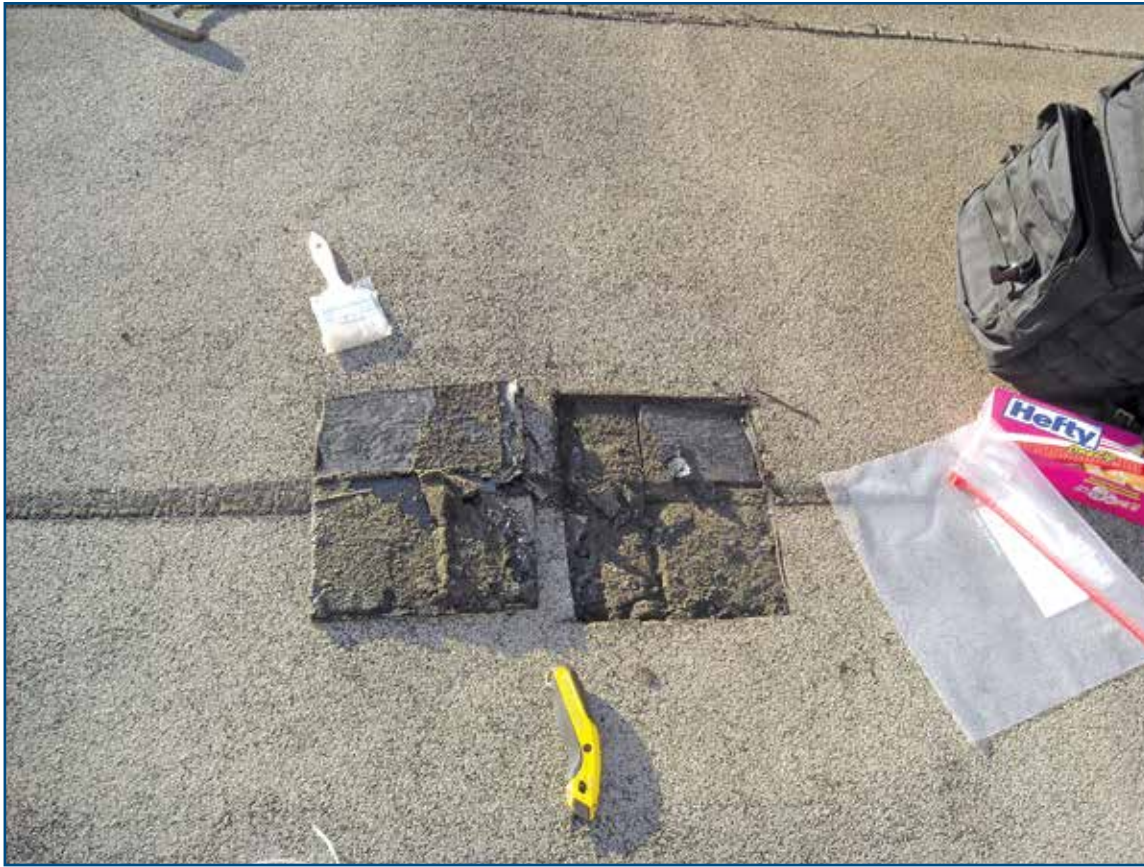
**Figure 12 – Roof test cuts.**

maintenance workers. With the low slope, the ponding areas accumulated water and dirt, causing areas of the roof to become “spongy” and deteriorated. This problem was exacerbated by the constant “wetting” of the roof surface from the mist of the cooling towers, which were operational almost year-round. To provide a walking surface for the workers, wood walkways were constructed around mechanical units and the chiller towers. These walkways then became a second maintenance problem because of Houston’s humid environment and from the continual water spray from the two chillers.

We scheduled representative test cuts at the central equipment area and at the roof perimeter. The test cuts revealed areas of the mod-bit roof system that evidenced significant water infiltration (*Figure 12*). Some of the wet areas were at the base of the cooling towers, which could be expected. However, several areas were considerably far from the equipment on the roof, and all wet areas would require extensive drying of
