Building Envelope Technology Symposium

THE LAST FEW FEET: PARAPET DESIGN, ISSUES, AND REPAIR

WISS, JANNEY, ELSTNER ASSOCIATES, INC.

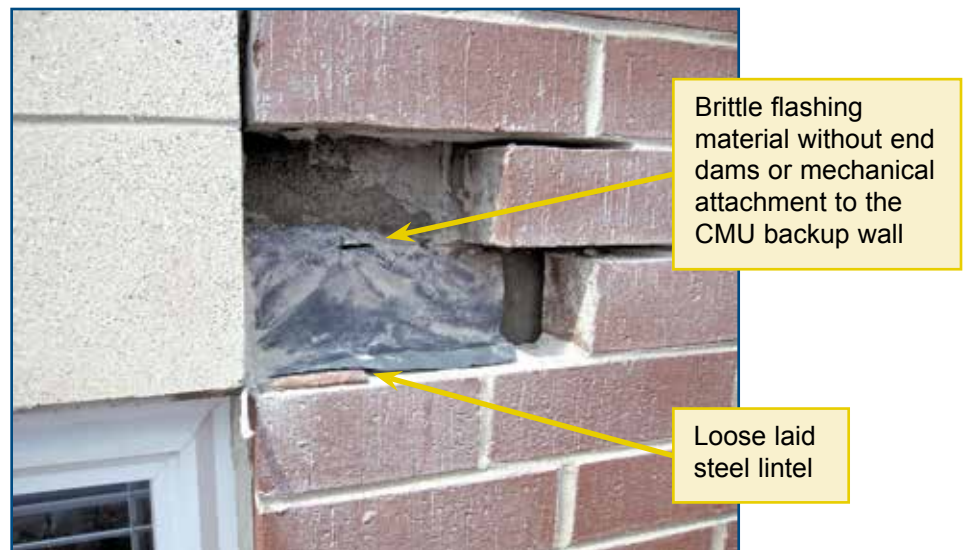
Figure 1 – Typical view of inspection opening with inadequate flashing details.

the shelf angle at the fifth-floor windows to observe the condition of the underlying flashing and construction of the façade walls. The inspection openings revealed that the original flashing had numerous issues, including but not limited to embrittlement of the flashing membrane that allowed cuts and splits in the membrane, lack of sealant at membrane splices, lack of mechanical attachment of the membrane to the backup wall along the top leading edge, and missing end dams at the ends of lintels (*Figure 1*). In addition to flashing issues, the as-built construction of the wall system was also problematic. The backup wall was CMU with open head joints. No flashing system or weather barrier had been applied to the backup wall, and the cavity space between the backup wall and the backside on the face brick was insufficient for a true cavity wall system. The cavity space was actually a collar joint that measured approximately ½ to ¾ in. wide and was partially filled with mortar.

Based on our testing and observations from the inspection opening, we determined that the interior leakage was a result of improper flashing details and installation, and as-built construction. Water that entered the parapet wall past the face brick could migrate past the flashing system and enter into the building. We recommended that the face brick from the window head of the fifth floor, up to and including the parapet coping, be removed to allow for the installation of new flashing at the window head, repair of the backup wall construction, installation of a new weather barrier on the backup wall, and reconstruction of the brick veneer with new copings.

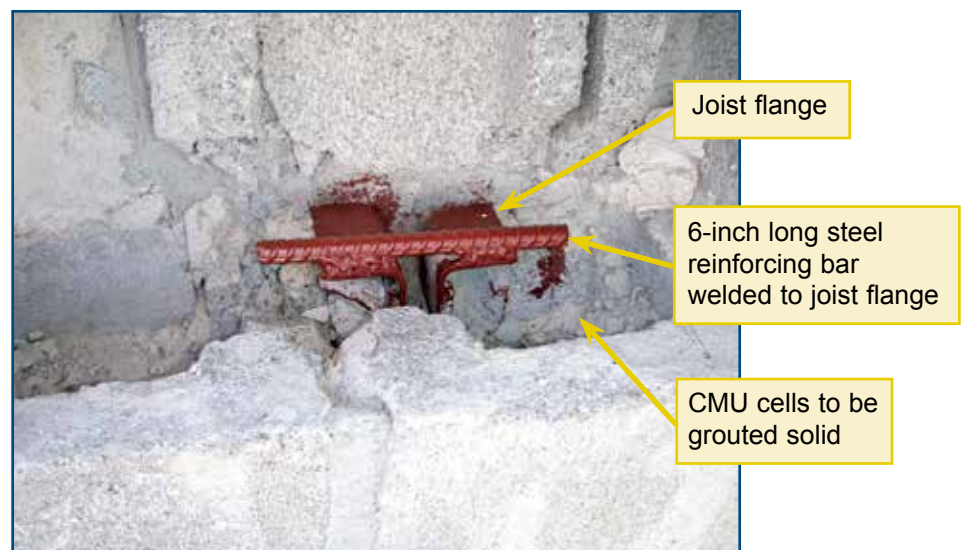
Figure 2 – Typical repair of steel joists in CMU wall.

- The exterior face shell of CMU was removed at the embedded joist locations, and new 6-in.-long horizontal steel reinforcing bars were welded to the top of the joist flanges. The cells with the horizontal bars were grouted, and the face shells reinstalled. See *Figure 2*.
- The remaining CMU backup was pointed to fill the open joints solid.
- Steel shelf angles were cleaned and painted. None of the angles had experienced significant section loss; therefore, replacement was not required.
- A vapor-permeable liquid weather barrier was applied on the exterior face of the CMU wall.
- Self-adhered flexible membrane was installed on top of the shelf angles and turned up onto the face of the backup wall.
- Stainless steel lateral wall ties were installed at 16-in. centers vertically and horizontally and staggered for

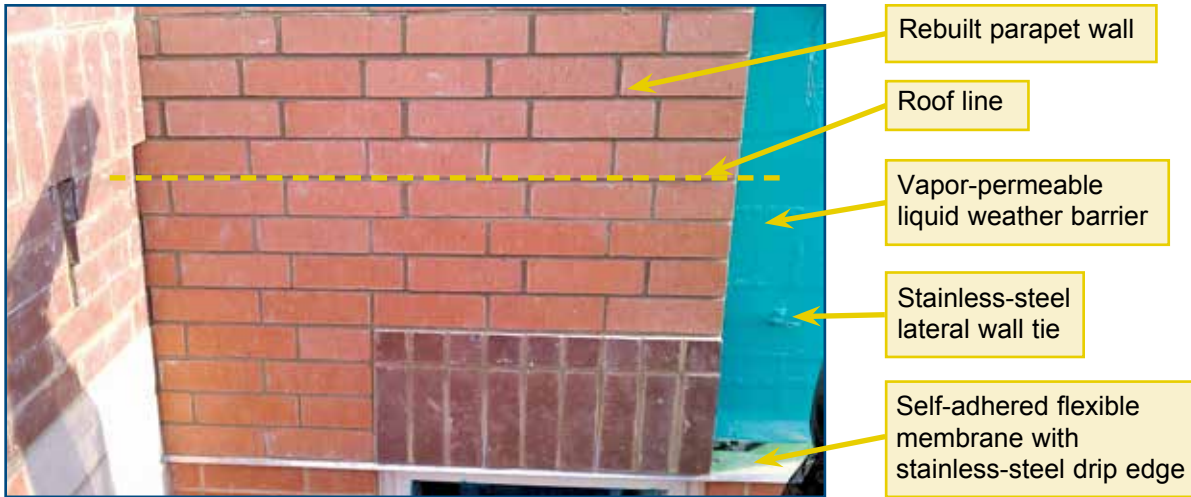
Figure 3 – Typical repair at parapet wall.

- Reduced the parapet wall height to approximately 16 in. above the roof level. CMU and brick veneer were removed and the top course of the remaining CMU wall was grouted solid to allow for anchorage of wood blocking and installation of a new

See *Figure 3* for typical view of parapet repair.

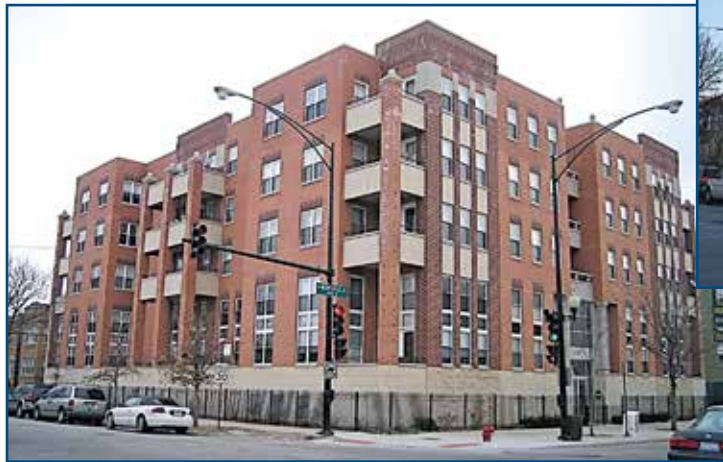
Figure 4 – Building façade before repairs.

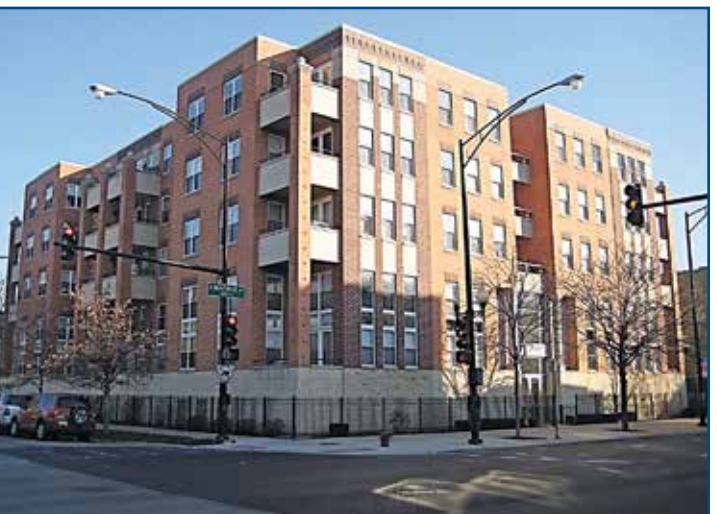
Figure 5 – Building façade after completed repairs.

To prevent the new parapet wall from looking like a typical flat surface, we utilized some aspects of the original parapet wall, such as using two different brick colors (one color at the flat walls and one color at the building corners and center of the façades) and various brick patterns at the building corners and center of the façades. These areas of decorative brick patterns also incorporated changes in the plane of the wall to provide an aesthetic appearance that mimicked the original design. See *Figures 4* and *5*.

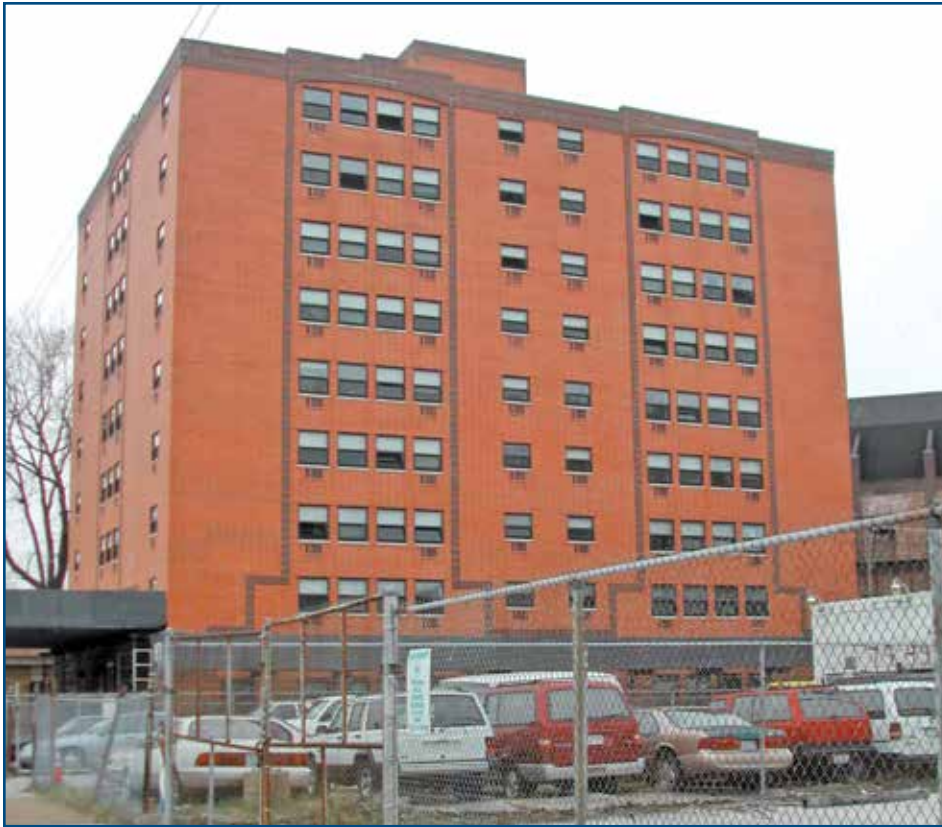
ing and displacement of brick at the parapets and façade corners. In 2002, masonry repairs were performed at the parapet. In 2003, cracks and distress in the masonry parapets were again reported and subsequently repaired. In 2004 and 2006, the center section of all four-parapet walls, equal to 50 percent of the total length, was rebuilt in another effort to address issues of cracking and displacement. Later in 2006, the parapet wall was deemed to be imminently hazardous during a routine façade examination of the building as required by the code. The building installed a protective sidewalk canopy in 2006 to mitigate the life safety hazard. In 2007, the building owners contacted WJE to investigate the cause of continued cracking and displacement of the masonry façade and parapet and to provide repair recommendations.

Figure 6 – View of the south façade of the building in 2007.

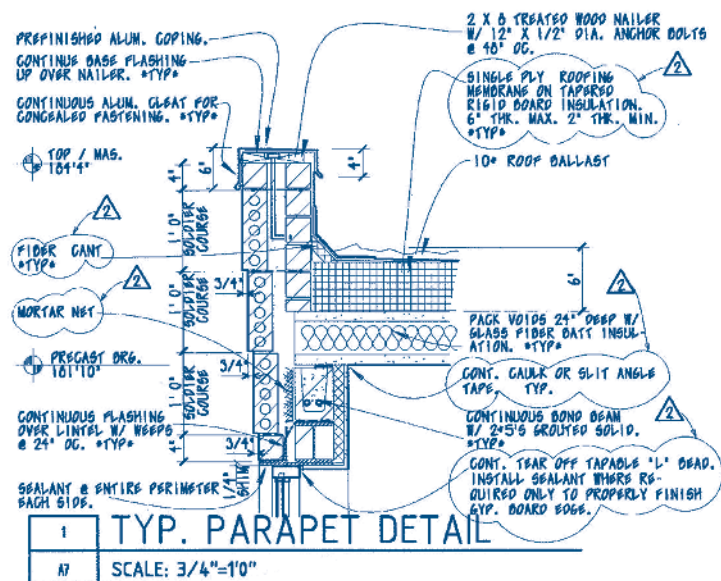
As originally designed, the parapets are two wythes thick and three brick soldier courses tall that are corbelled outward (Figure 7), and the lowest parapet brick course is arched above the ganged window bays. The inner wythe of the parapet consists of six courses of running-bond brick supported on hollow-core concrete roof planks.

Figure 7 – Typical parapet detail from the original design drawings.

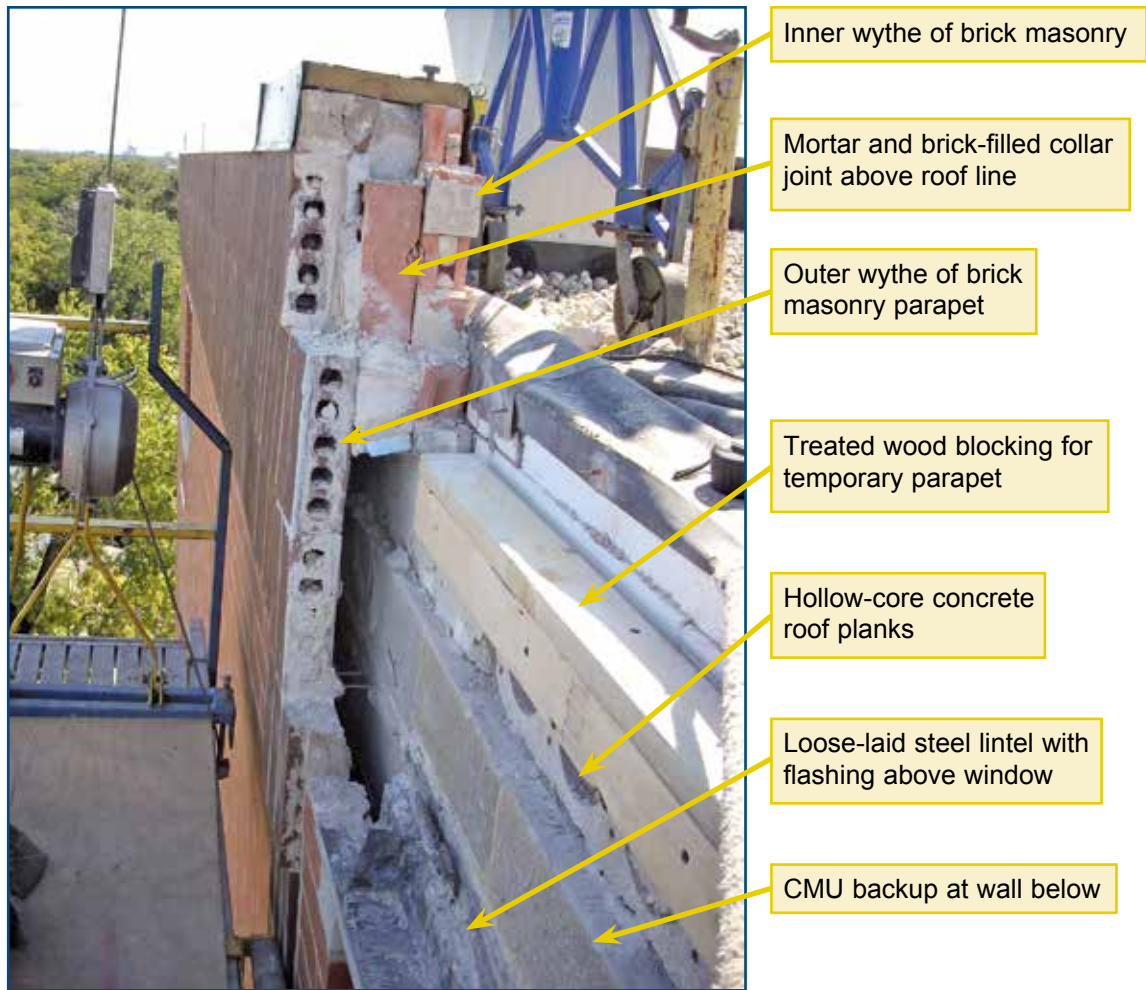
The as-built condition of the parapet varied from the original design and was altered a number of times in attempts to repair the distress exhibited by cracking and inward displacement of the masonry. The as-built condition of the parapet in 2007 consisted of a collar joint filled with mortar and brick above the roof slab, typically without lateral ties. See Figure 8 for typical as-built condition during parapet disassembly in 2008.

Figure 8 – As-built condition of the parapet from 2007. Photo taken during parapet disassembly in 2008.

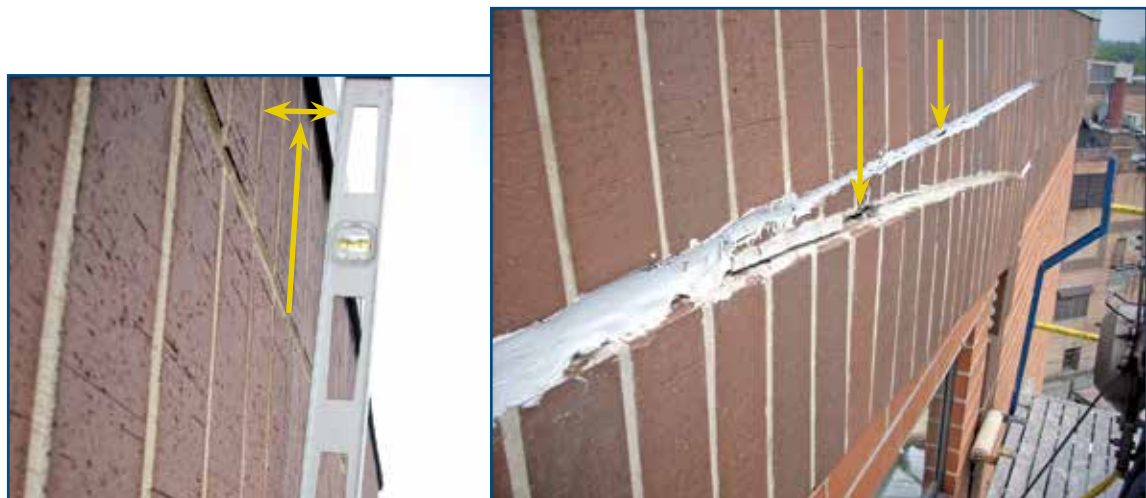
Our investigation in 2007, six years after completion and after multiple repair campaigns, revealed the current state of the parapet wall consisted of an inward lean of approximately 1 to 3 inches in three vertical feet at the top-three soldier courses of brick masonry above the arches (Figure 9). Cracking of mortar joints and brick masonry also existed on the parapet (Figure 10).

veneer and typical exterior bearing walls were structurally adequate to resist design loading. However, evaluation of expansion and shrinkage of the façade resulted in the total differential movement between the CMU backup wall and the brick veneer of approximately 1.2 in. The estimated vertical expansion (moisture and thermal) of the brick masonry for the full height of the building was approximately 0.9 in., and the estimated total shrinkage of the CMU was approximately 0.3 in. This differential movement is consistent with the observed angle of displacement at the parapet wall.

The total differential movement was more pronounced at the parapet due to lack of relief angles and horizontal expansion joints in the field of the wall, which accommodate differential vertical movements by creating brick “panels” that move with the structure. In the field of the wall, the brick veneer and CMU backup were “isolated” with a cavity wall and adjustable lateral ties, permitting independent movement. In contrast, the parapet was constructed in a manner that integrated these two systems, essentially bridging the isolation. Due to the sum of differential movements increasing at higher levels, this integration resulted in the inward lean of the parapet and cracking of the brick masonry. The inward lean was more pronounced at the center along the length of the parapet wall due to the

Figure 10 – Typical cracking of mortar joints at parapet wall in 2007.

Figure 9 – Typical inward lean of masonry parapet wall in 2007.

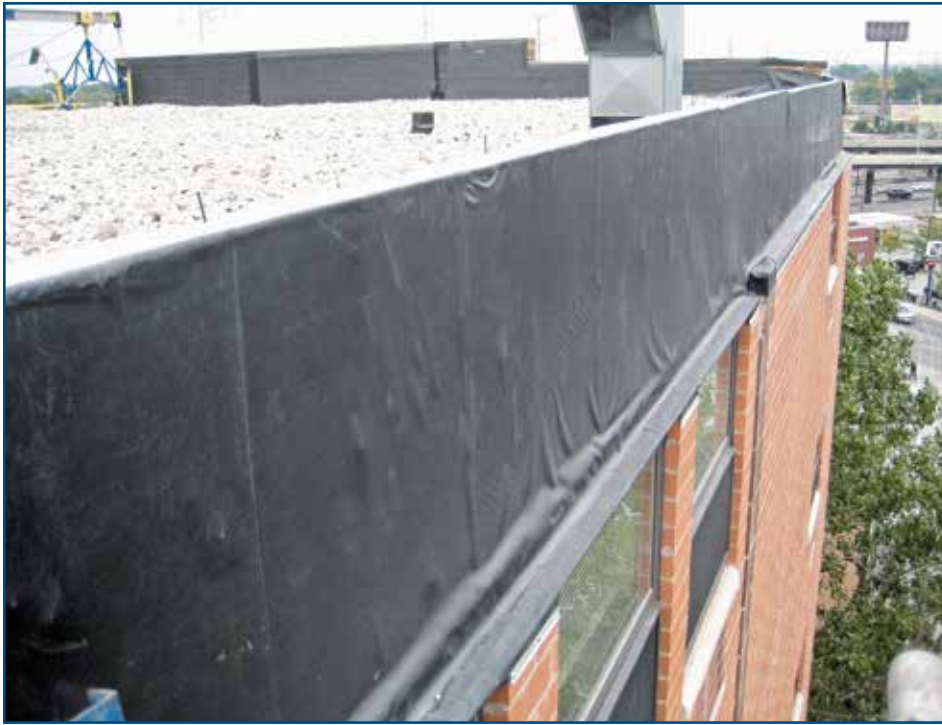
Figure 11 – Temporary treated wood-framed parapet wall installed in 2008.

Following the investigation, we recommended that the parapet be disassembled and redesigned. In 2008, the parapet was disassembled and replaced with a temporary parapet constructed of treated wood studs, plywood, and roofing membrane. The EPDM roofing warranty holder was contacted to coordinate the removal of the parapet so that the existing roof warranties were not voided. (See *Figure 11*.)

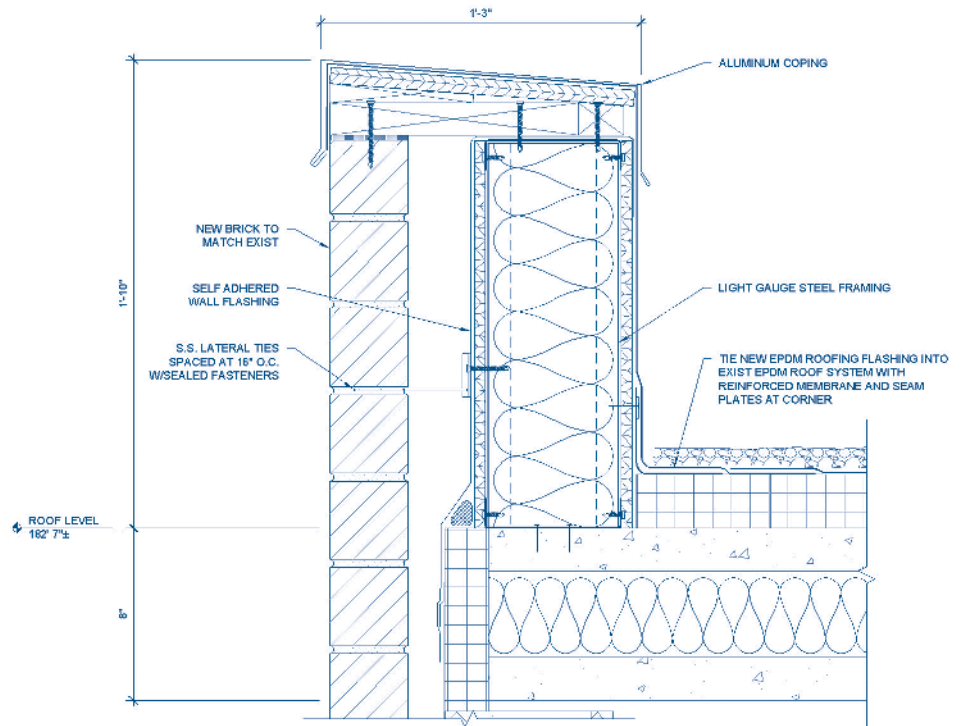
Figure 12 – Typical repair detail for a new parapet wall.

Construction of a new parapet is currently in progress. The new parapet design consists of light-gauge, steel-stud framing with a brick veneer in running bond, and an aluminum coping at a height of approximately 2 ft. above the roofline. The light-gauge, steel-stud framing is anchored to the hollow-core concrete roof planks with powder-actuated fasteners. The brick veneer is laterally tied back to the framing with stainless-steel lateral anchors spaced at 16 in. on center. Vertical expansion joints are designed to be installed in the same location as the existing vertical expansion joints.

roof. The tie-in of the new roofing flashing consists of a fully adhered EPDM flashing membrane extending over the wood blocking and down the back face of the parapet, and adhering to the existing EPDM membrane with seam tape. A reinforced membrane attachment with seam plates and fasteners will be integrated at the interface of the parapet wall and roofing to ensure the membrane does not fail at the corners. See *Figure 12* for a typical parapet repair detail.
