# 28<sup>TH</sup> RCI INTERNATIONAL CONVENTION AND TRADE SHOW

## INNOVATIVE FAÇADE REPAIR SOLUTIONS: 3-D LASER SCANNING AND PROJECT TEAM COLLABORATION

**MATTHEW KUTZLER, PE, CDT**

*FACILITY ENGINEERING ASSOCIATES*

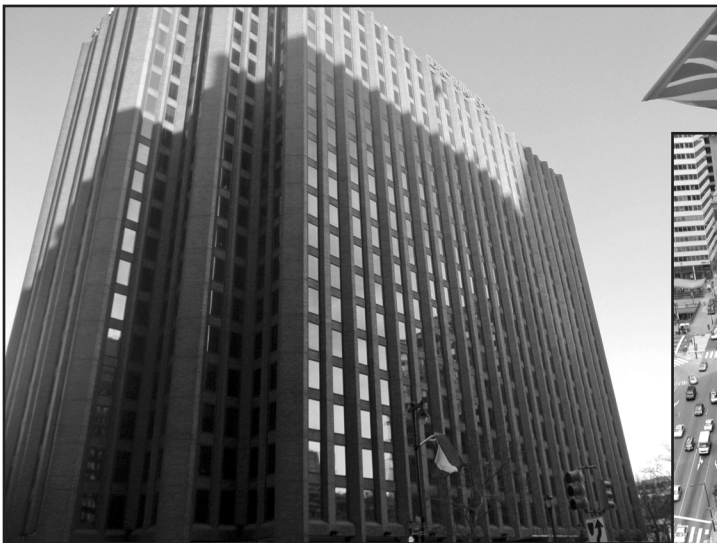
The aforementioned property was a 20-story commercial office building that was constructed in 1970 in the center city of Philadelphia (see *Photo 1*). The rectangular structure consisted of a concrete frame-and-brick veneer at each of the four elevations. Vertical mechanical chases of alternating depths projected outward from the building, creating a recessed appearance at narrow window bays between chases (*Photo 2*). The building was uniform throughout its height, terminating at its peak with a wall around the perimeter that sloped toward

*Photo 1 – Typical façade overview of subject building.*

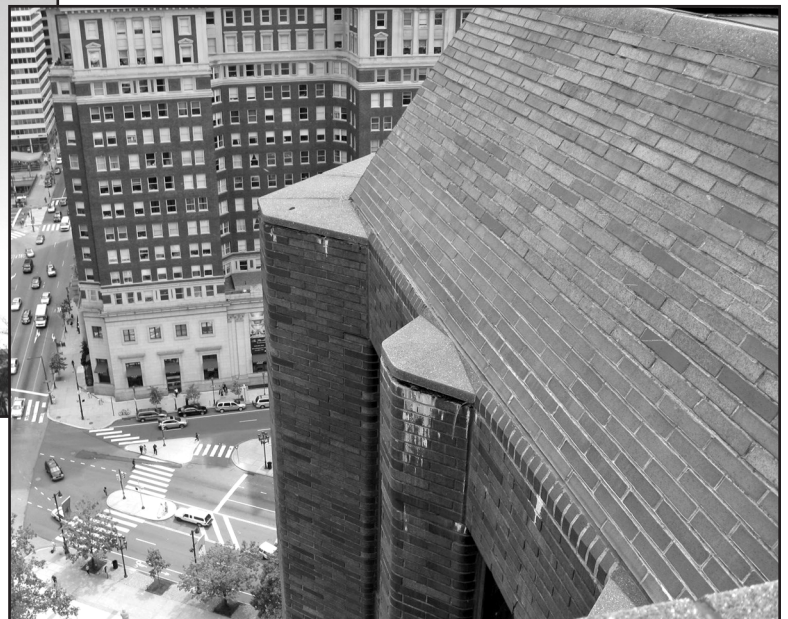
*Photo 2 – Top of mechanical chase projections and sloped wall.*

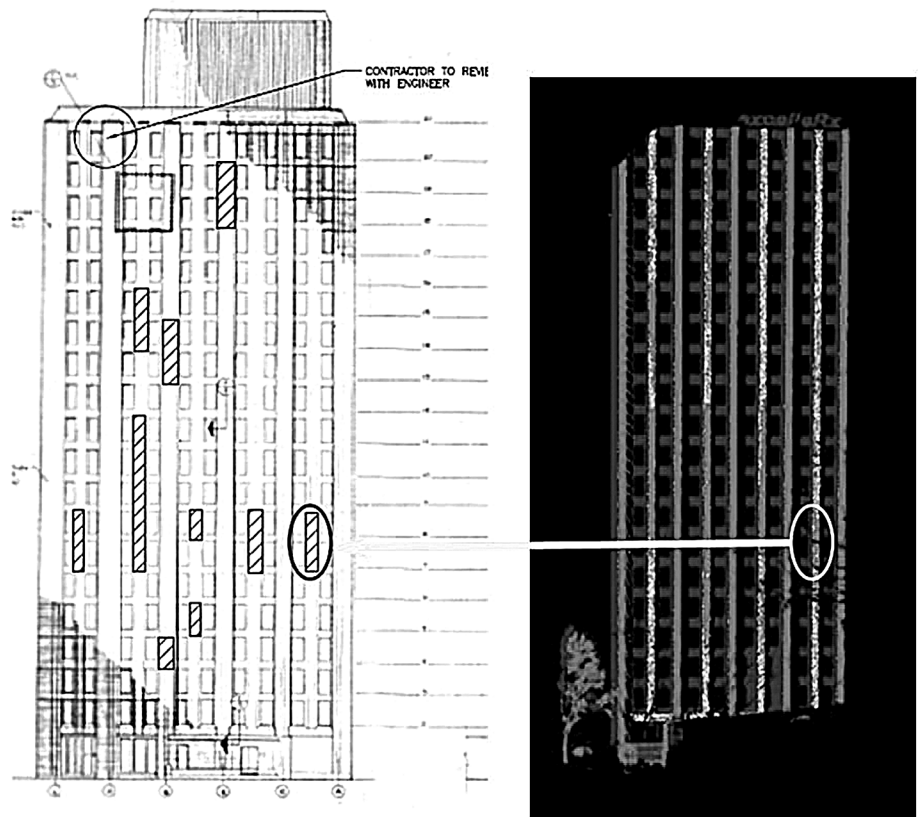
In the case of the subject building, the scanning was used to establish a uniform plane at each elevation. Once a base plane was established, limits could be placed on the point data to determine their location relative to the plane. For example, an analysis could be performed to identify any point that is more than 1/2 inch away from the base plane. These points, gathered together, would represent brick movement away from the building and a possible area where retrofit masonry wall ties should be installed

**Photo 5 – Drawing provided to contractor (left) depicting retrofit tie installation locations (superimposed on original building elevation drawing). Scan image (right) showing variation from analysis plane. The circled area is just one example of locations that were out of plane and then transposed to the bid documents.**

With this data in hand, locations where brick movement had occurred were identified on elevation drawings and included in the construction documents for repair. Detailing related to spacing for retrofit masonry ties was also included, providing clear direction to the contractor as to where the ties should be installed. Ties were not unilaterally installed everywhere at unneeded locations, and a contracted quantity of ties was established that was largely adhered to during the course of work.

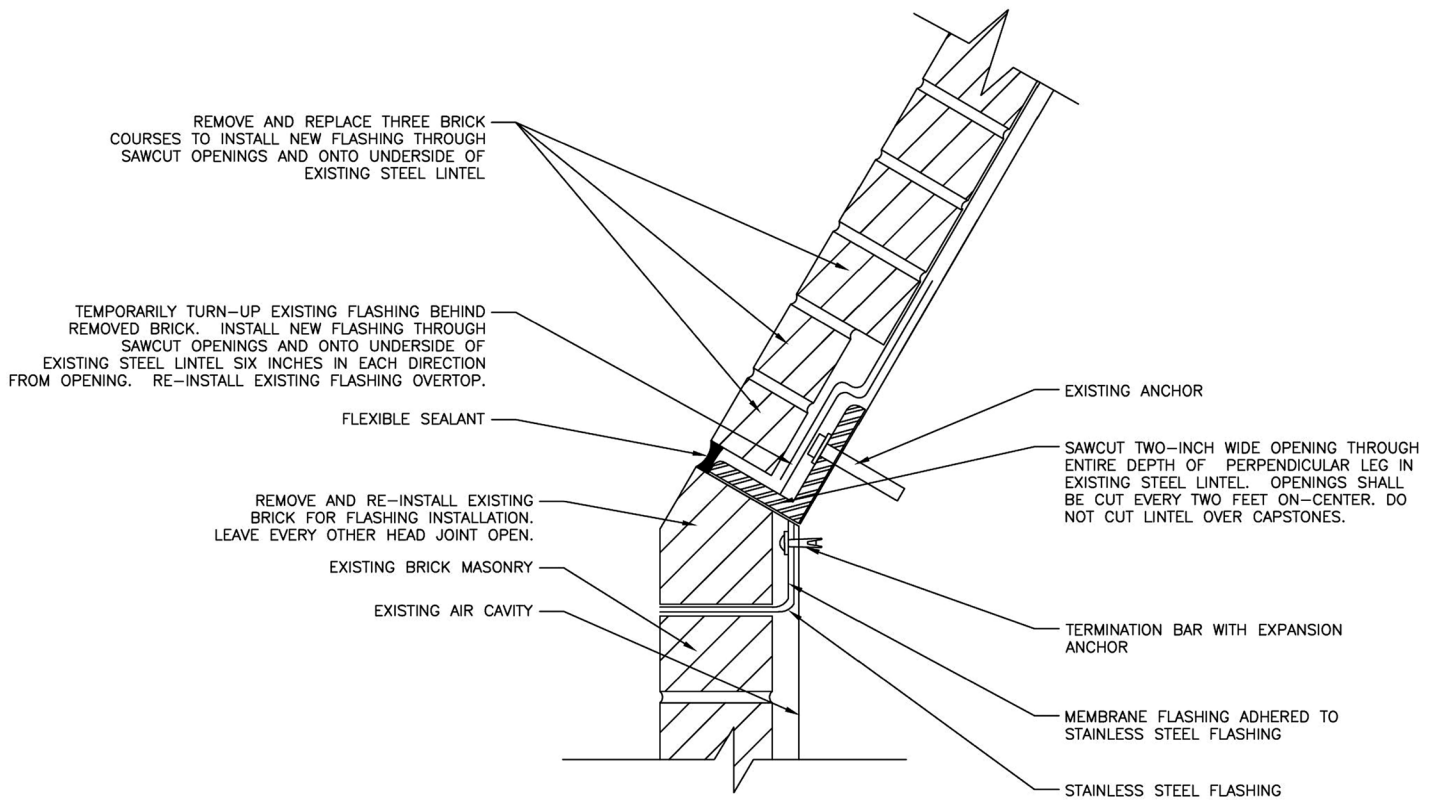
**Photo 6 – Through-wall flashing detail at base of sloped wall.**

flashing at the base of the sloped wall, both on the steel angle and directly below at the five-sided transition brick. Several improvements in the design were made (*Photo 6*). Cell vents replaced weep tubes (which had frequently clogged), and were spaced at a greater frequency. A stainless steel flashing with a drip edge was specified for the transition brick in an effort to keep water away from the brick face below and address the presently unsupported, sagging condition of the membrane flashing within the brick cavity. Lastly, the shelf angle at the base of the sloped wall was tilted back such that any water traveling down the flashing behind the wall was effectively trapped at the lowest point of the angle. Holes were to be drilled into the base of the shelf angle to allow moisture behind the brick veneer to follow the new flashing down to the stainless steel termination below.

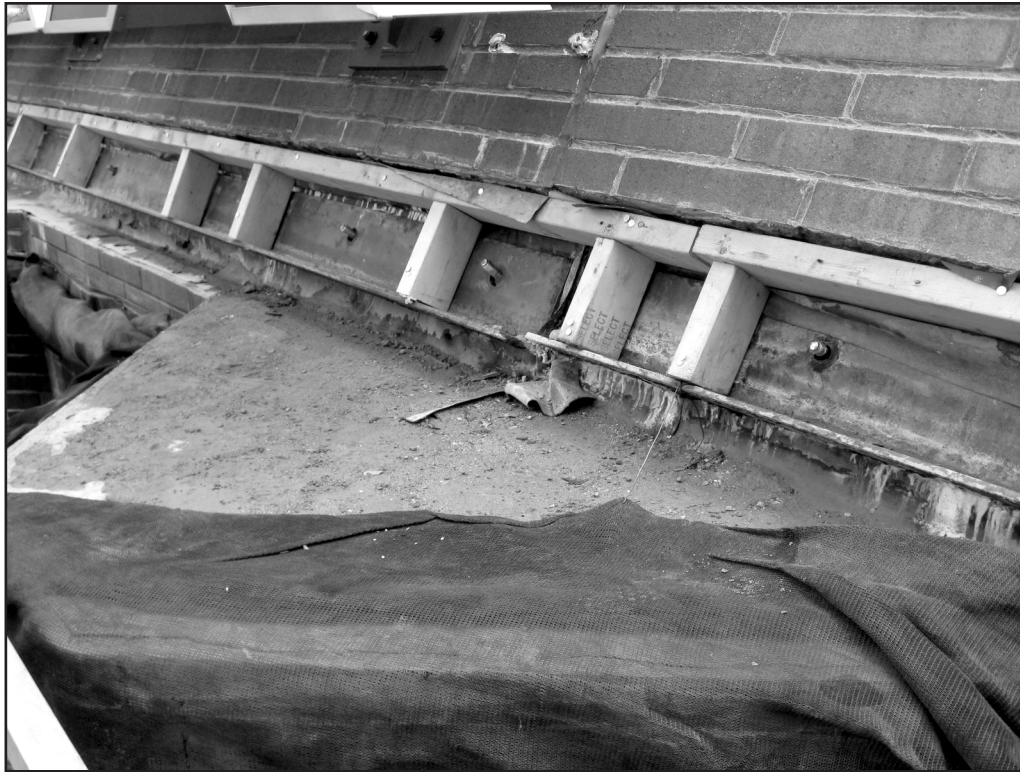
**Photo 7 – Conditions at the base of the sloped wall created difficulties in addressing lintels and installing new through-wall flashing.**

The repairs proceeded through a mock-up process but at a slower-than-desired pace due to a few issues (Photo 7). To maintain support for the sloped brick face above, through-wall flashing was being installed in short runs. The condition of the shelf angles was slightly worse than anticipated, with some loss of cross section, necessitating removal of several angle sections for replacement. The lintels that could remain were cleaned, primed, and painted in place, but drilling of holes for water to pass through was difficult for the crew to achieve under the circumstances.

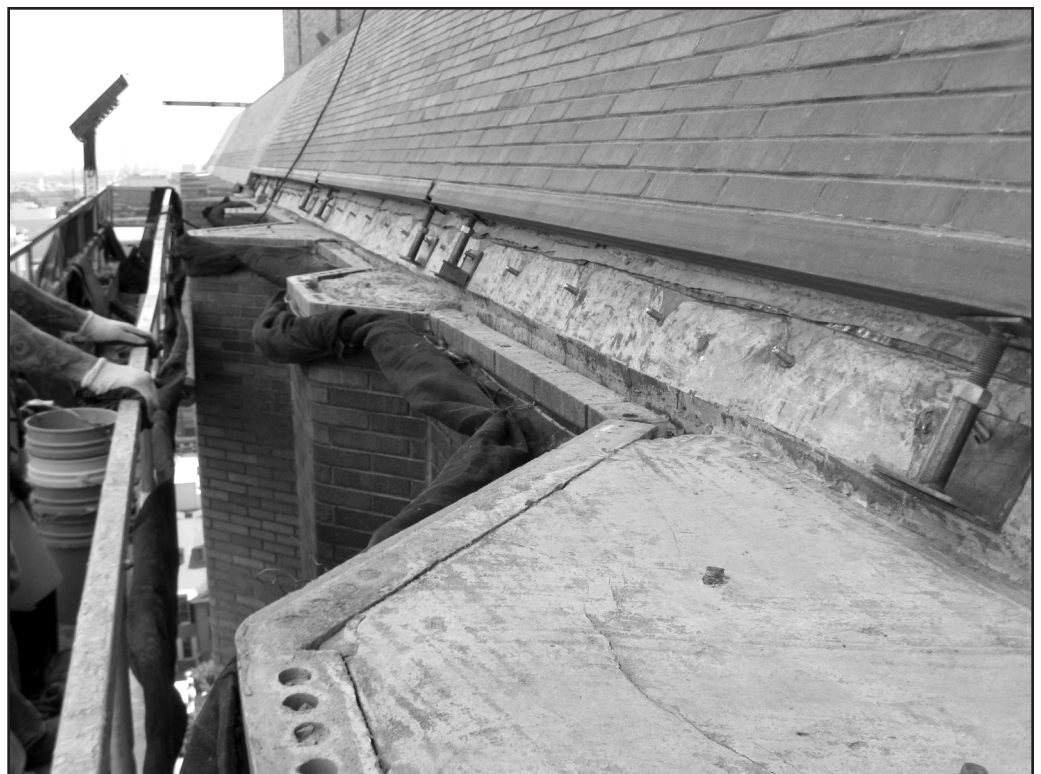
**Photo 8 – Sloped brick supported with temporary steel and fabricated clips at angle fasteners.**

ideas led to several changes in the flashing approach and creation of a new mock-up. Since several angles required removal for replacement, a method to support the brick above was required. After removal of three courses of brick and the existing flashing and angle, the contractor placed small, temporary steel angles at the bottom of the remaining brick, which were in turn supported with clips fabricated to slide onto the shelf angle fasteners and abut the temporary angle above (Photo 8). The steel angle could now more easily be prepared, primed, and painted at the roof rather than in place.

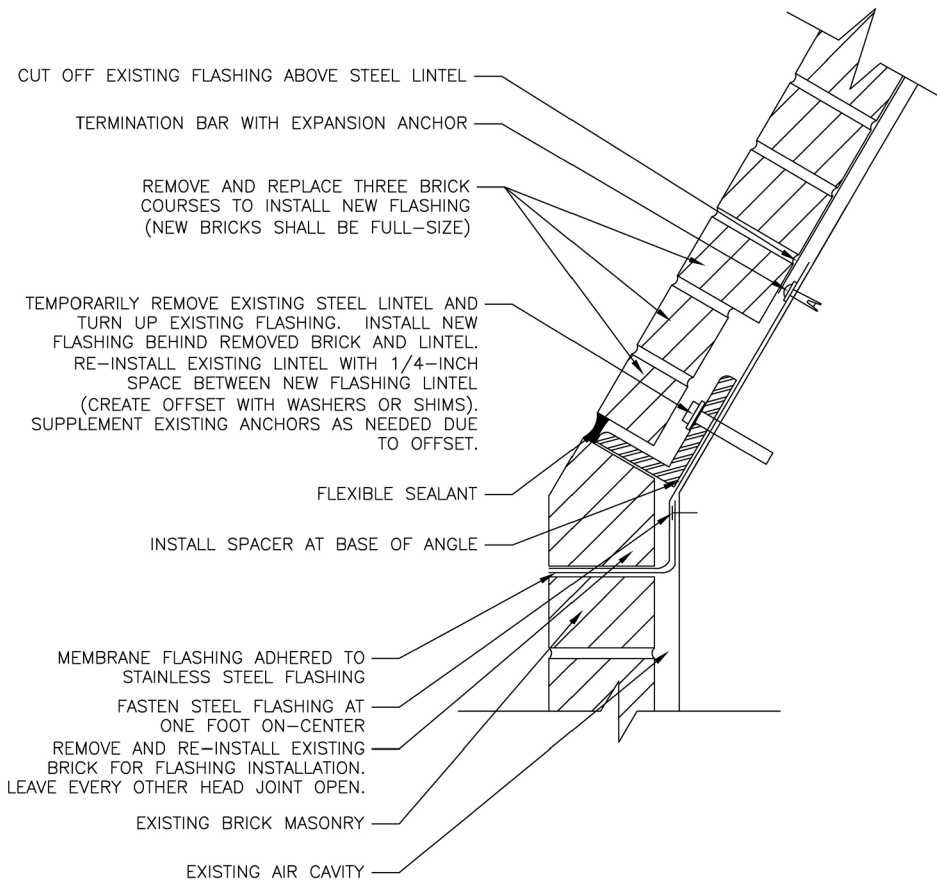
**Photo 9 – Revised through-wall flashing detail following collaboration with contractor.**

With removal of the shelf angles, it became apparent that a one-piece flashing could be installed at the base of the sloped wall and extended below the five-sided brick and pre-cast caps at the top of the mechanical chase projections (Photo 9). This was more ideal than the detailed two-piece flashing. Doing so also removed the need for holes in the bottom of the shelf angles and the associated waterproofing that would need to be performed at each opening. The amount of termination detailing was substantially

Installing the through-wall flashing behind the shelf angles as opposed to over top maintained the previous dam condition, as water traveling down the flashing would encounter the top of the steel and eventually settle at the low point of the tilted angle. To address this, an offset was created between the flashing and angles by placing two washers on the fasteners prior to reinstallation of the angles. The minimal space could accommodate water flow behind the angle but was slender enough to prevent angle rotation.

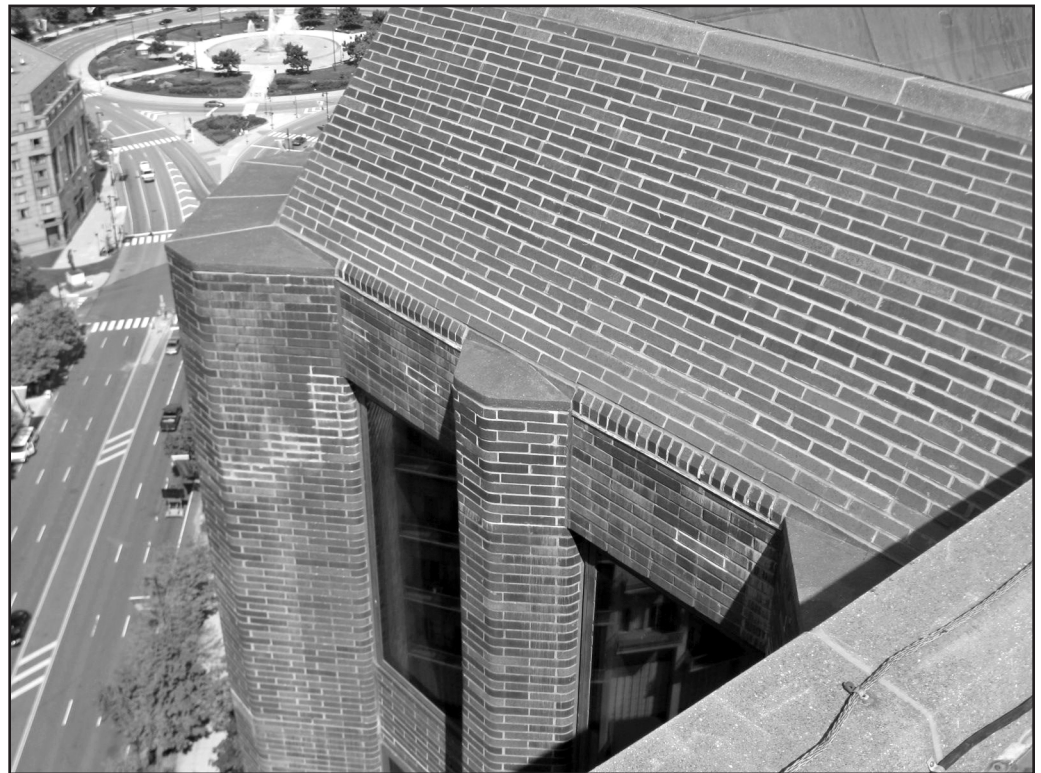
**Photo 10 – Completed appearance at sloped wall, five-sided brick, and capstone. Contrast with soiled, unrepaired appearance below.**

Despite the issues encountered related to retrofit masonry ties and installation of an effective waterproofing detail at a problematic area, the project was completed successfully (*Photo 10*). Three-dimensional laser scanning led to a cost-
