Building Science and Physics vs. Architectural Sensitivity; Design of Enclosures in the Most Hostile of Environments

KIPP GAYNOR, PE, CDT, LEED AP

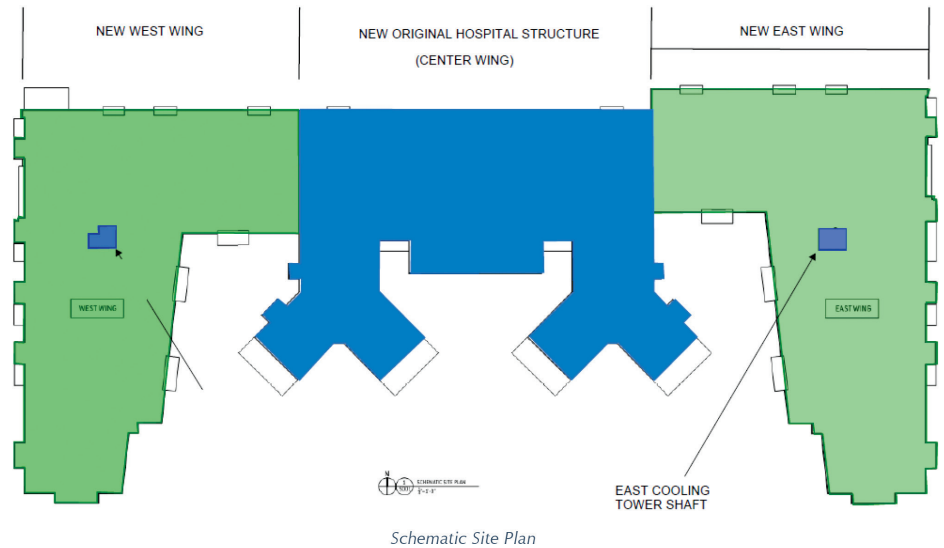
Figure 1 – Schematic Site Plan.

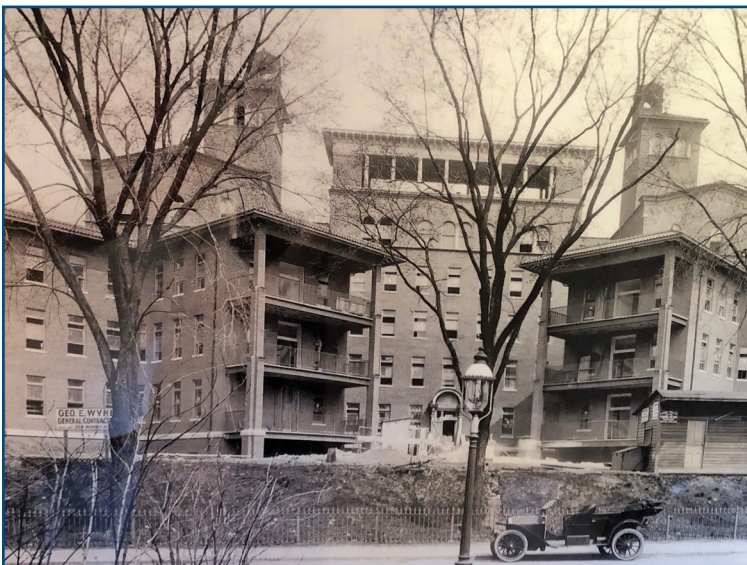
Figure 2 – Columbia Hospital for Women.

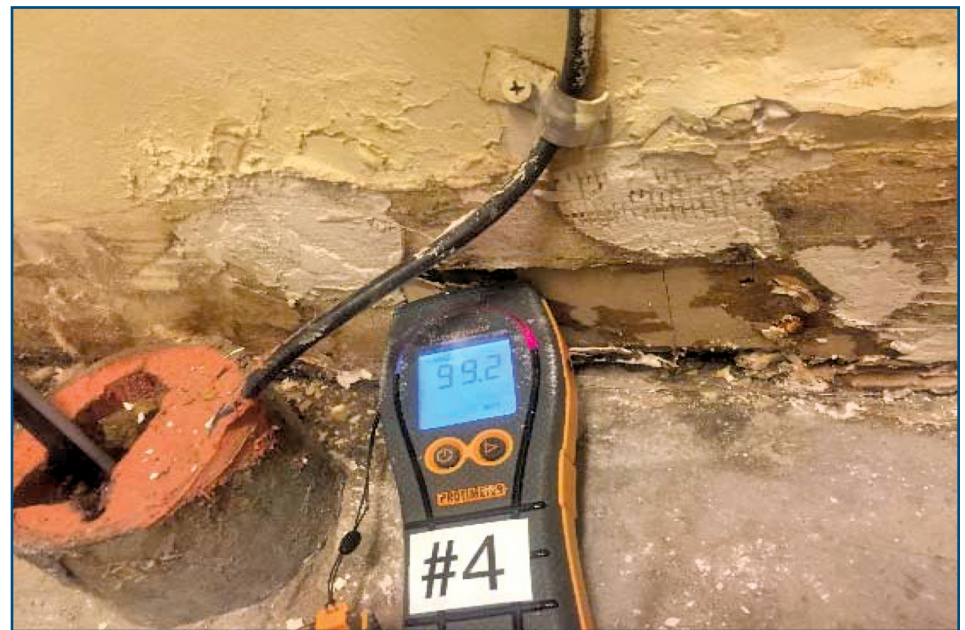
Figure 3 – Telephone closet at floor line. Note moisture reading during summer proposal visit.

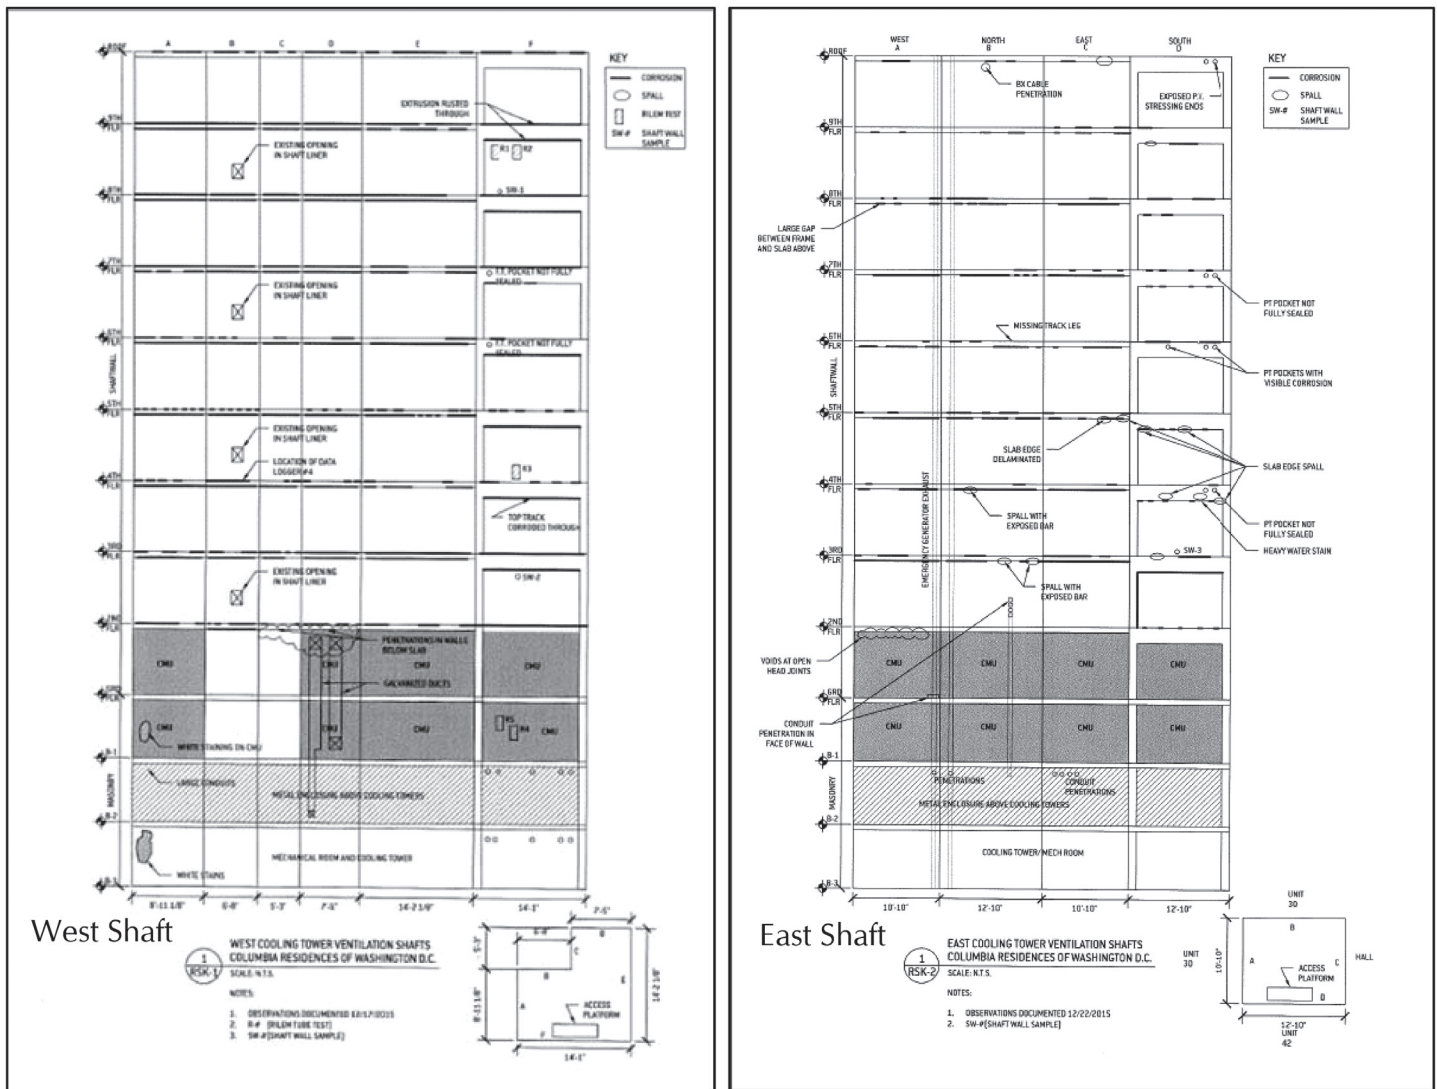
Figure 4 – Significant visual observations of shaft conditions from swing stage access (through vertical shaft).

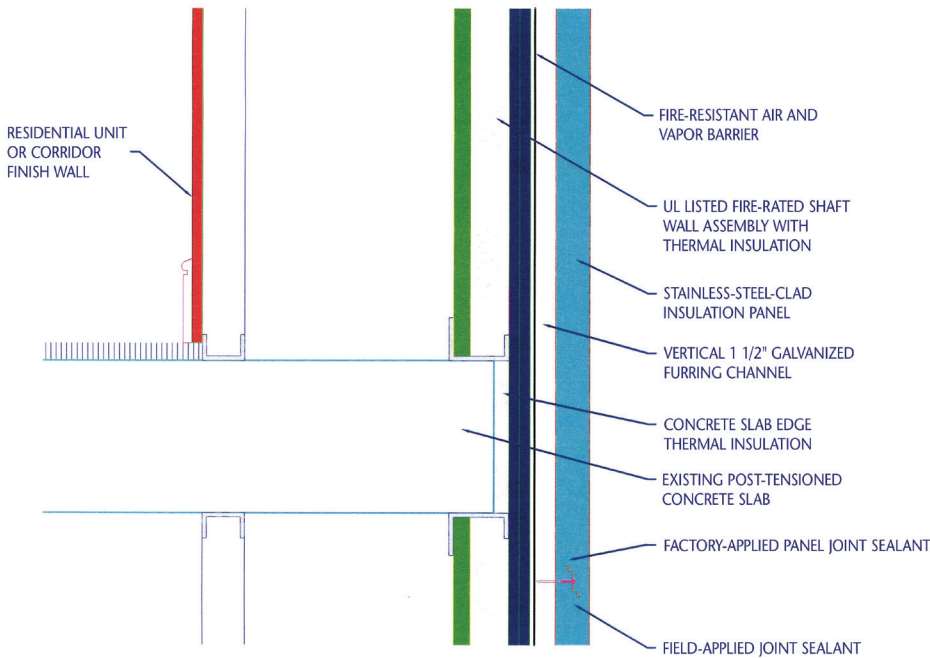
3 TYP SECTION DETAIL AT SLAB EDGE & INSULATED PANEL JOINT PLAN AT EAST CHILLER SHAFT
SCALE: 1" = 3'-0"

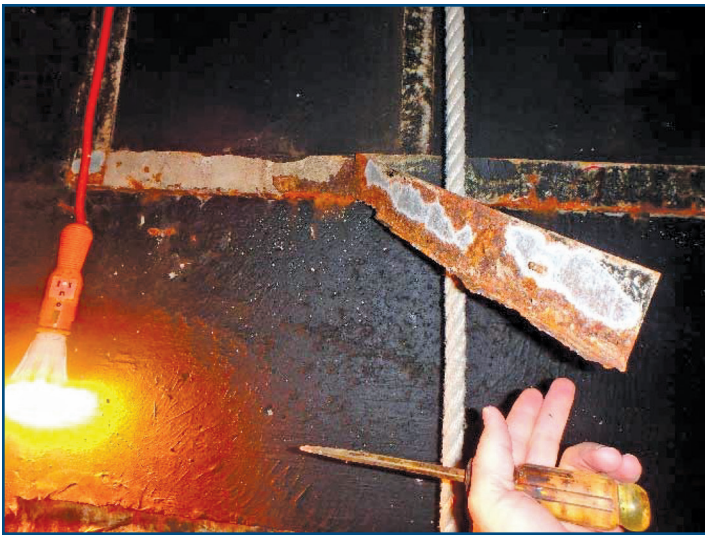
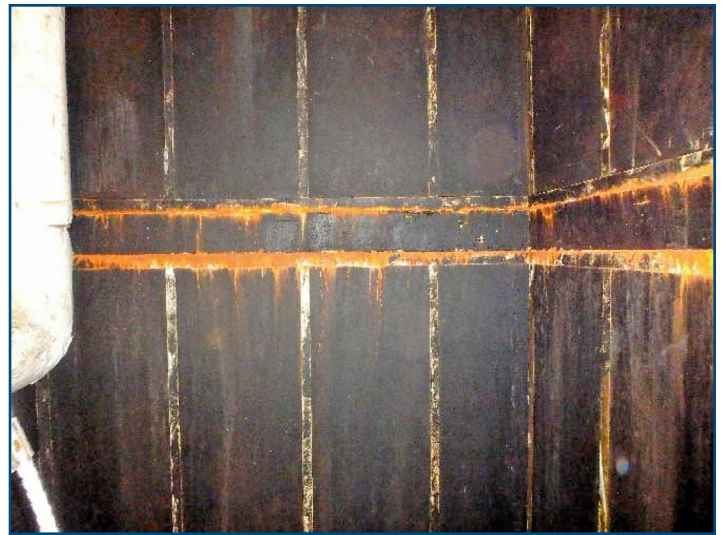
Figures 7A and 7B – Severe corrosion of sill and head tracks encountered at various floor lines.

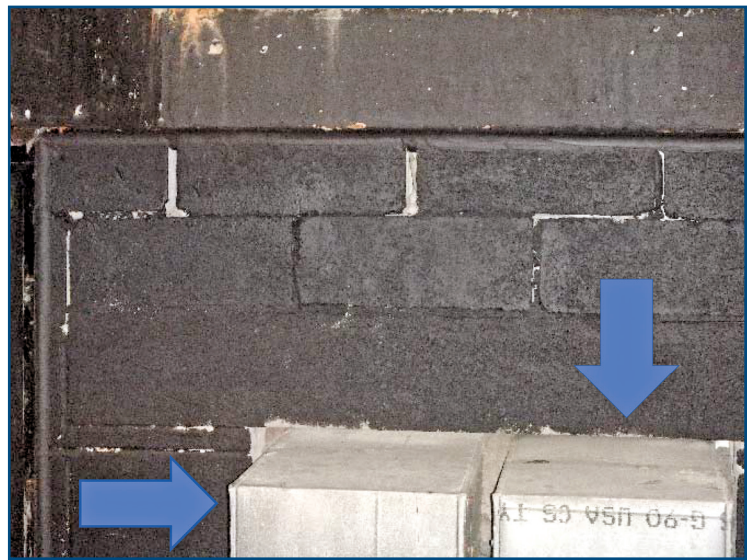
Figure 8 – Fire-rated masonry wall separating shaft area and commercial/first-floor level. Note supply and return ductwork inside shaft with unsealed wall penetrations (see blue arrows).

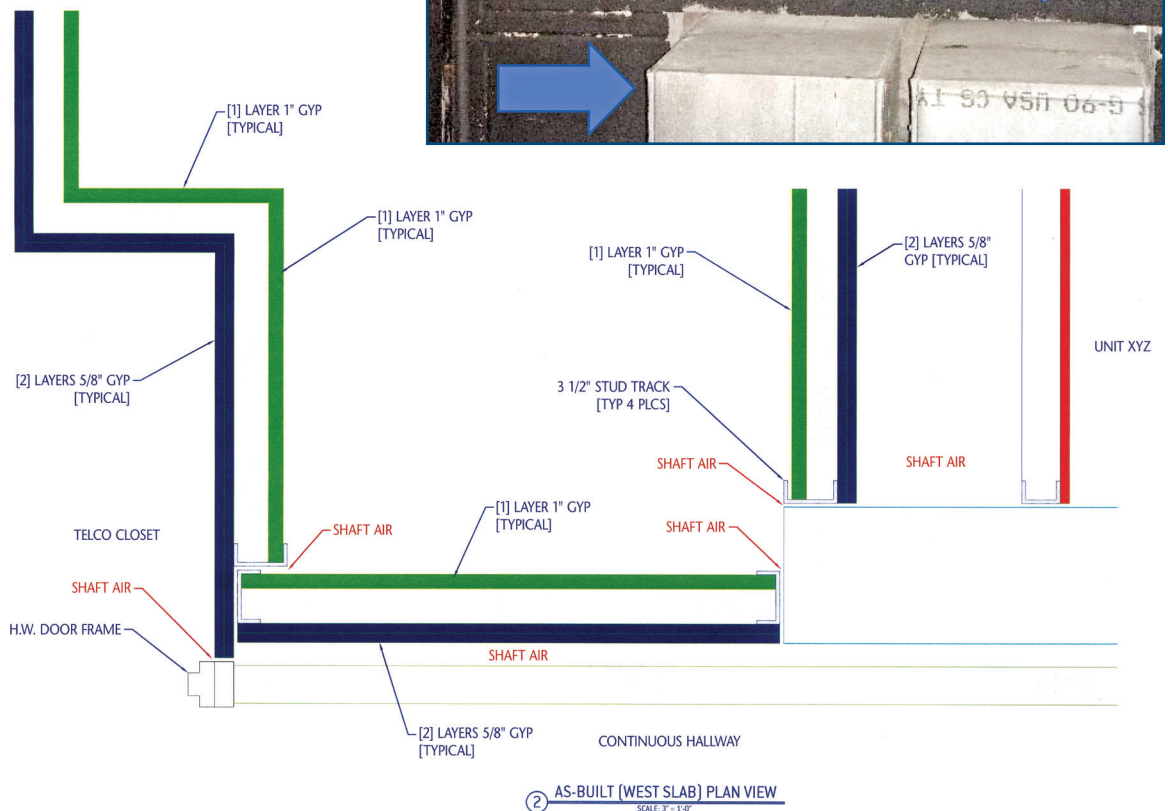
Figure 9 – As-built (west slab) plan view.

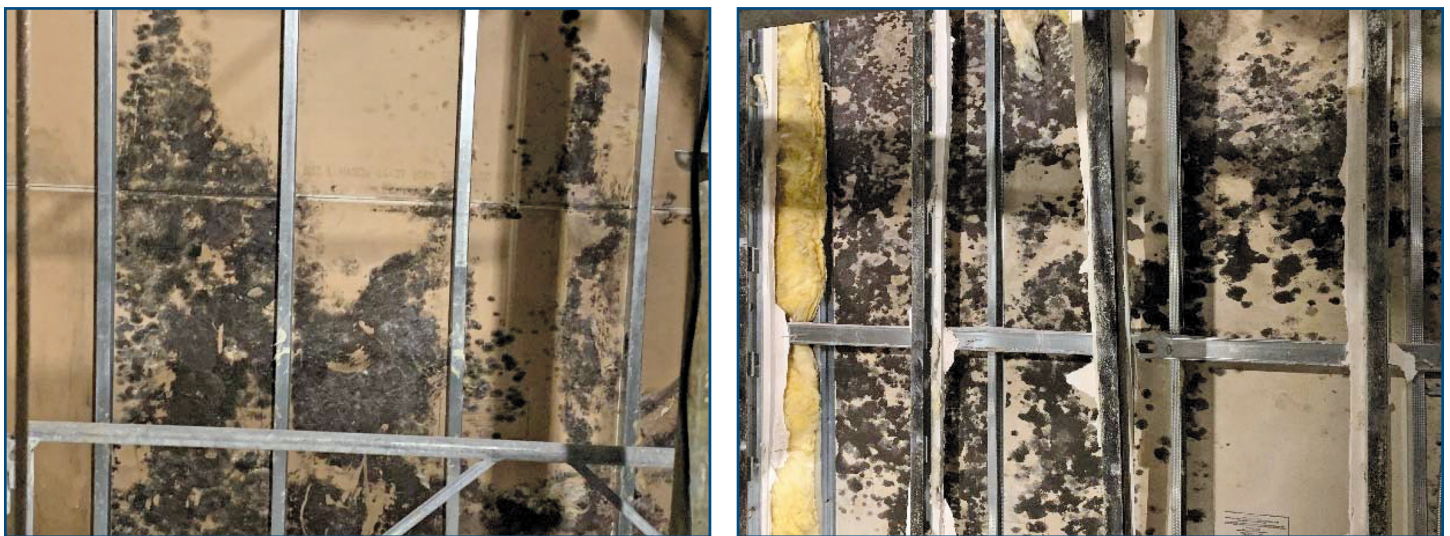
Figures 10A and 10B – Organic growth was encountered at various locations on the cavity side of the demising partitions that required abatement.

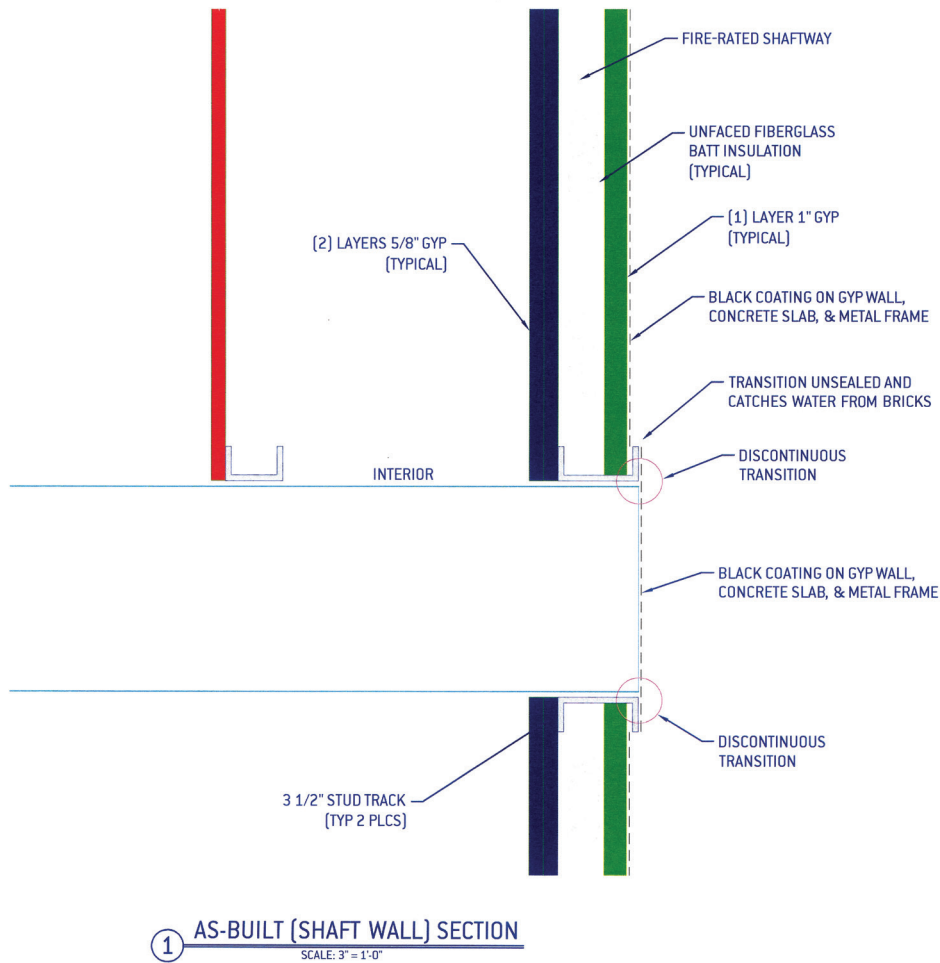
Figure 11 – Typical section detail at slab edge and insulated panel joint plan at east chiller shaft.

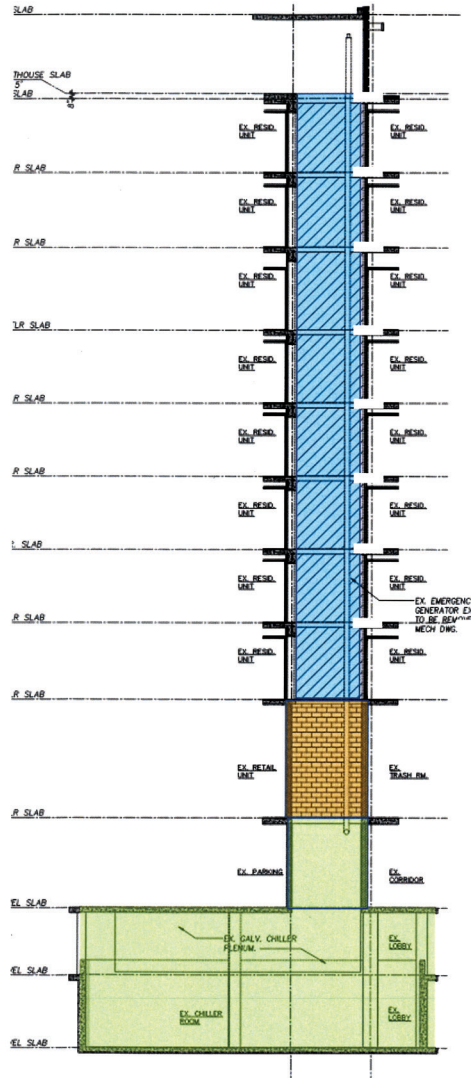
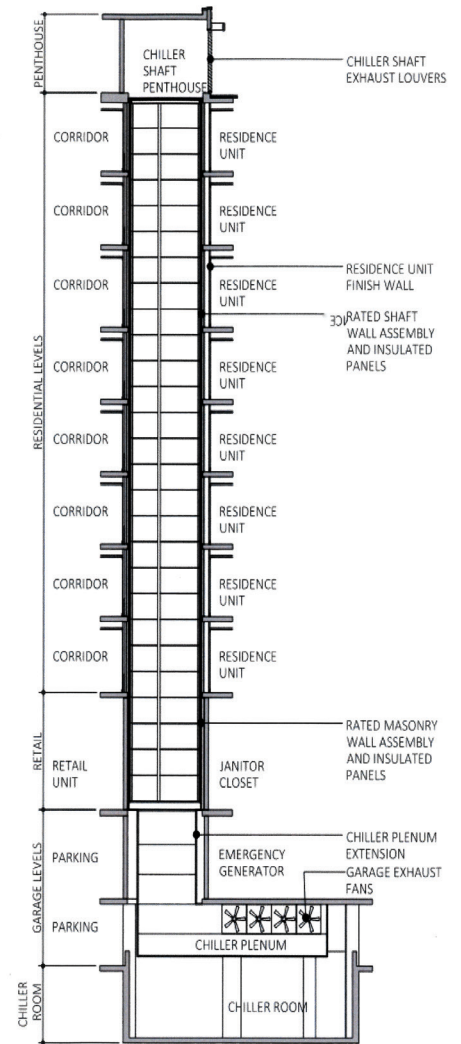
Figure 12 – Section view of east shaft.

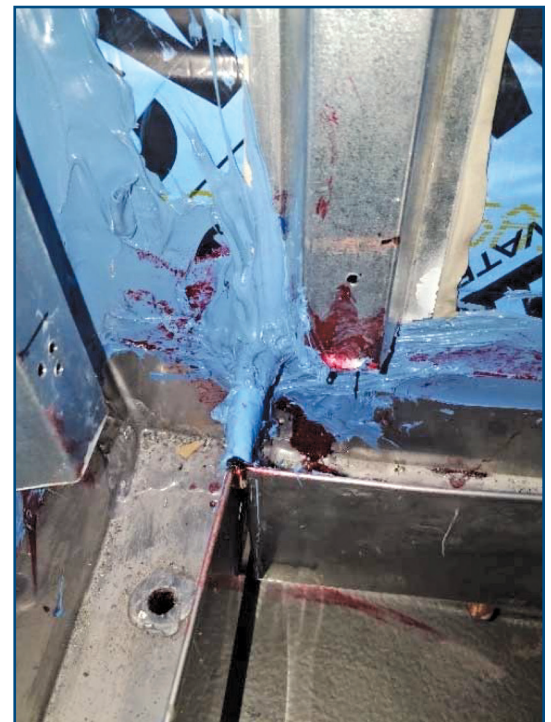
exhaust), as well as at a telephone/communication closet located at the fifth-floor level and in the shaft wall cavity. Data collected during the first summer (cooling) season of operation were retrieved and reviewed to see how the air cavity behind the insulated panels performed in relationship to the exterior and interior environments. Humidity in the cavity was significantly less than the shaft environment, and the cavity temperatures mitigated the potential for condensation in the shaft wall and demising wall construction during the cooling season.

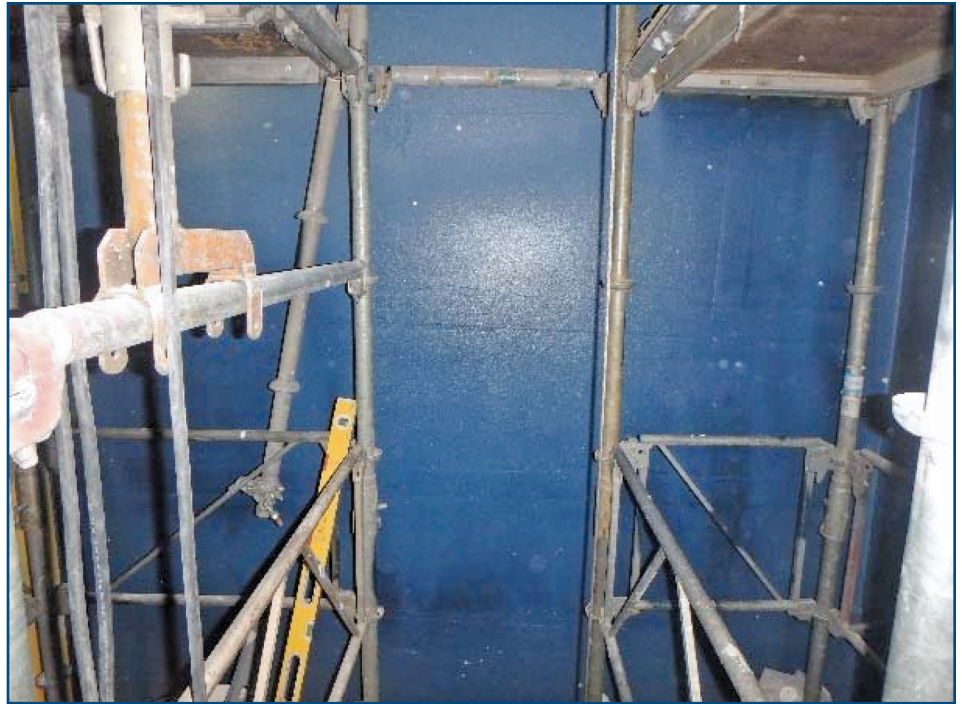
Figure 15 – Note the limited physical access between the scaffolding and shaft wall plane. Note the continuous blue air and vapor barrier.
