IIBEC BUILDING
ENCLOSURE SYMPOSIUM (BES+)
NOVEMBER 9, 10, 12, 16, 17, 19, 2020

A Modern Makeover – A Failed, Tired Masonry Façade Gets a New High-Performance Look

Timothy A. Mills, PE, LEED AP, CIT II

TAM Consultants, Inc.

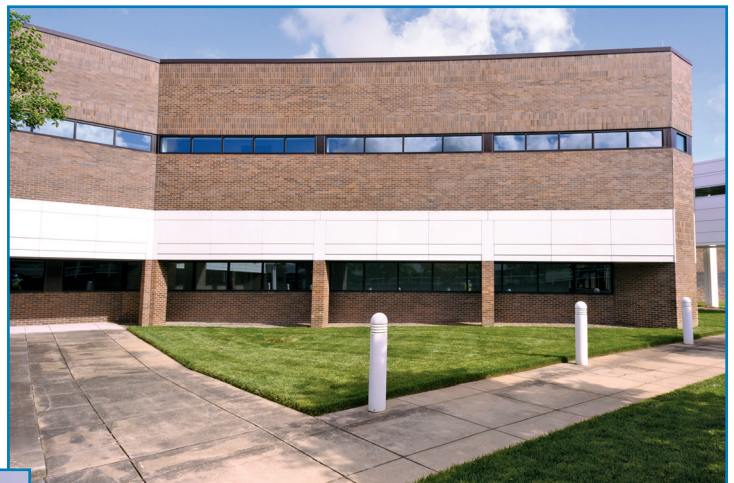
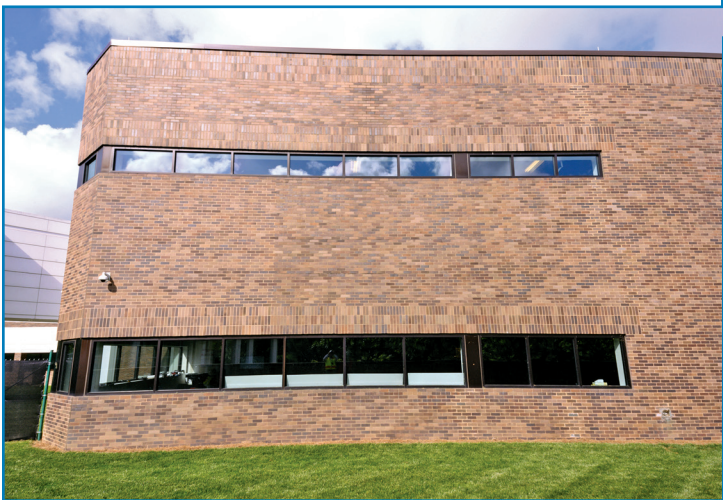
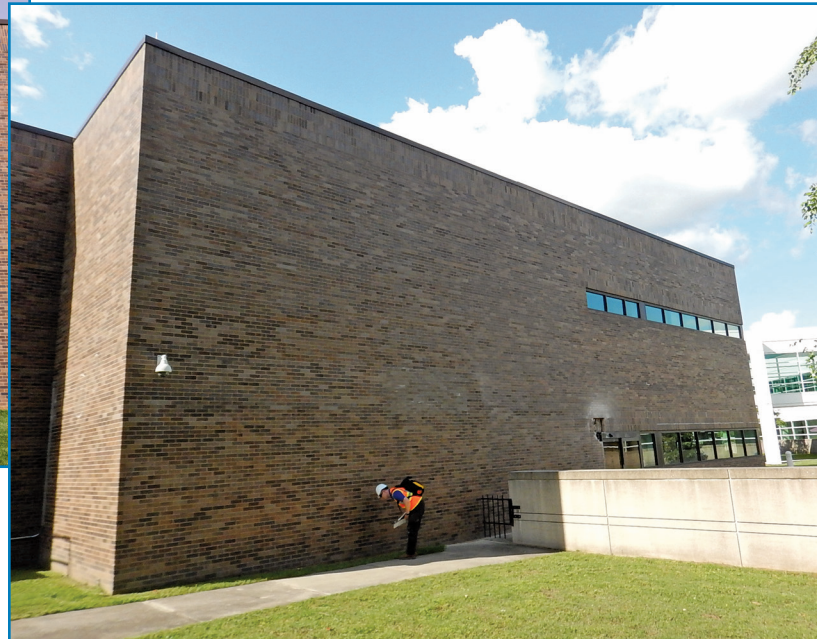
The design team discovered a significant number of horizontal and vertical hairline cracks in the exterior brick cladding, particularly at locations where steel relief angles were expected to be located. Initially, the design team chose to design and detail extensive exterior masonry repairs to the cladding system.

Figures 1, 2, and 3 – Elevation views of brick façade prior to project commencement.

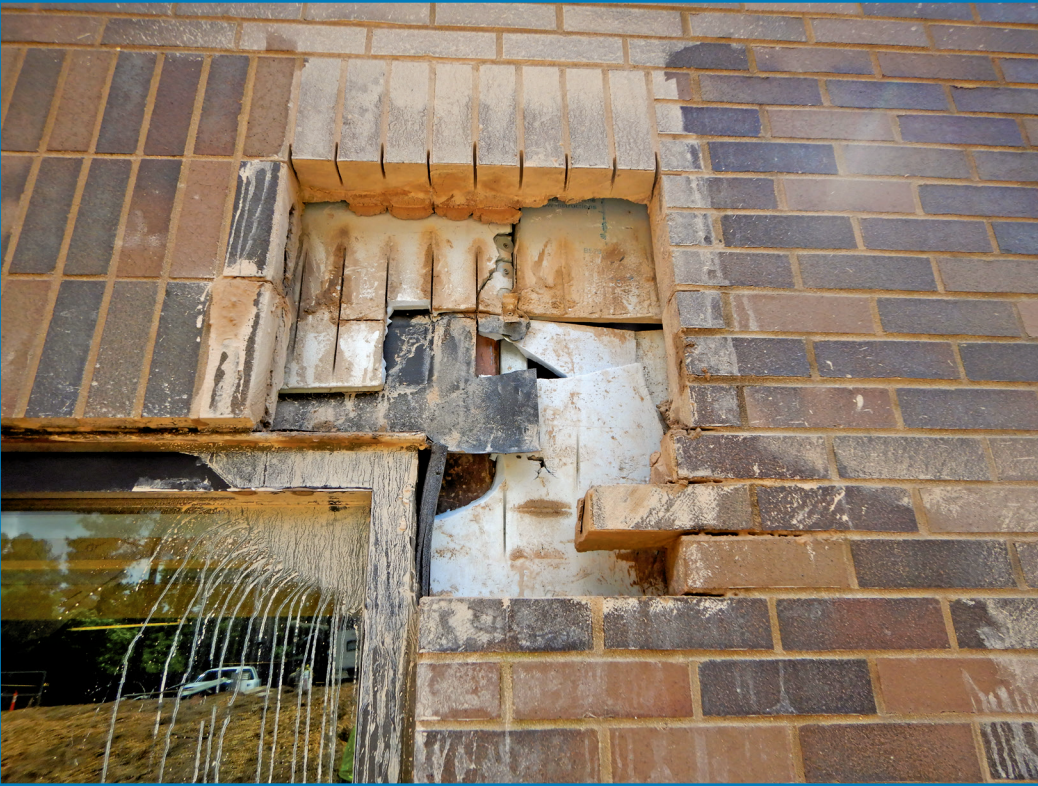
Figure 4 – Inspection location at a window head corner revealing the condition of the loosely placed rigid foam board sheathing and poorly installed PVC flashing.

In addition, it was determined that the exterior foam board sheathing was installed loosely with screws and washers with no efforts made to seal joints or provide any sort of weather or air barrier. In most instances, masonry cavities were found to be bridged with excessive mortar.

Through-wall flashings were found to be composed of a plastic PVC membrane sheet, which was loosely fastened to the

foam board insulation or run up behind it where gaps occurred between adjacent insulation boards. The plastic flashing had long since lost its flexibility and was brittle and easily damaged.

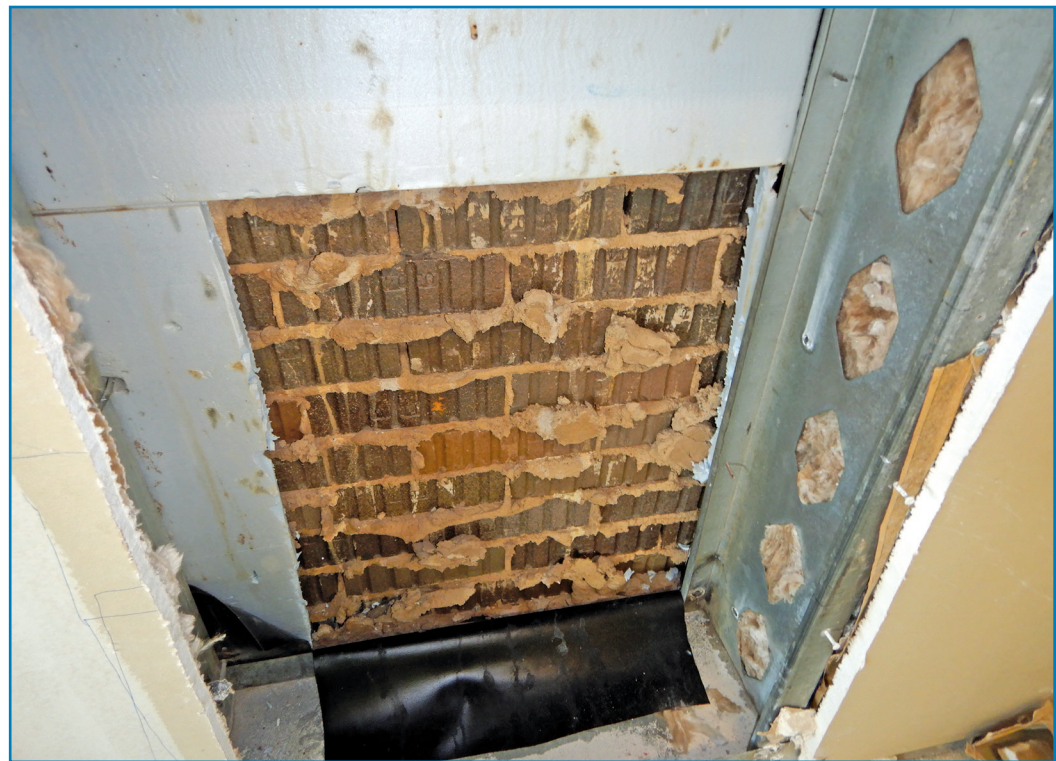
The findings of the forensic study changed a few significant assumptions regarding the condition of several of the building cladding, structural, cavity, and wall assembly elements. It became apparent that the as-constructed condition of the brick did not provide for any masonry control joints. Masonry control joints were not shown on the original plans. There were no vertical control joints near corners, at openings, or at the ends of the brick

Figure 5 – Forensic study image where the brick cladding was inspected from the inside of the building by removing interior finishes and sheathing. Note through-wall flashing at bottom of photo.

panels supported by steel relief angles. There were no soft joints (backer rod and sealant joints) in any of the masonry cladding systems. The lack of soft joints at critical areas to allow for a certain amount of stress relief in the masonry cladding, for differential movement between brick cladding that is footing supported, and brick cladding that is building-frame supported, was determined to be the primary cause of the horizontal and vertical cracks on the building. Horizontal cracks in mortar joints occurred at every relief angle location, and vertical cracks occurred close to building corners, as might be expected in the building where vertical control joints are normally expected. Industry associations generally recommend control joint placement at changes in wall height; at changes in wall thickness, such as at pipe and duct chases and pilasters; at movement joints in foundations and floors; at movement joints in roofs and floors that bear on the wall; near one or both sides of door and window openings; and adjacent to corners of walls or intersections within a distance equal to half the typical control joint spacing. The study also found a limited number of step cracks at window head corners—primarily due to distress caused by the different load-bearing conditions (steel vs. footing-supported masonry).

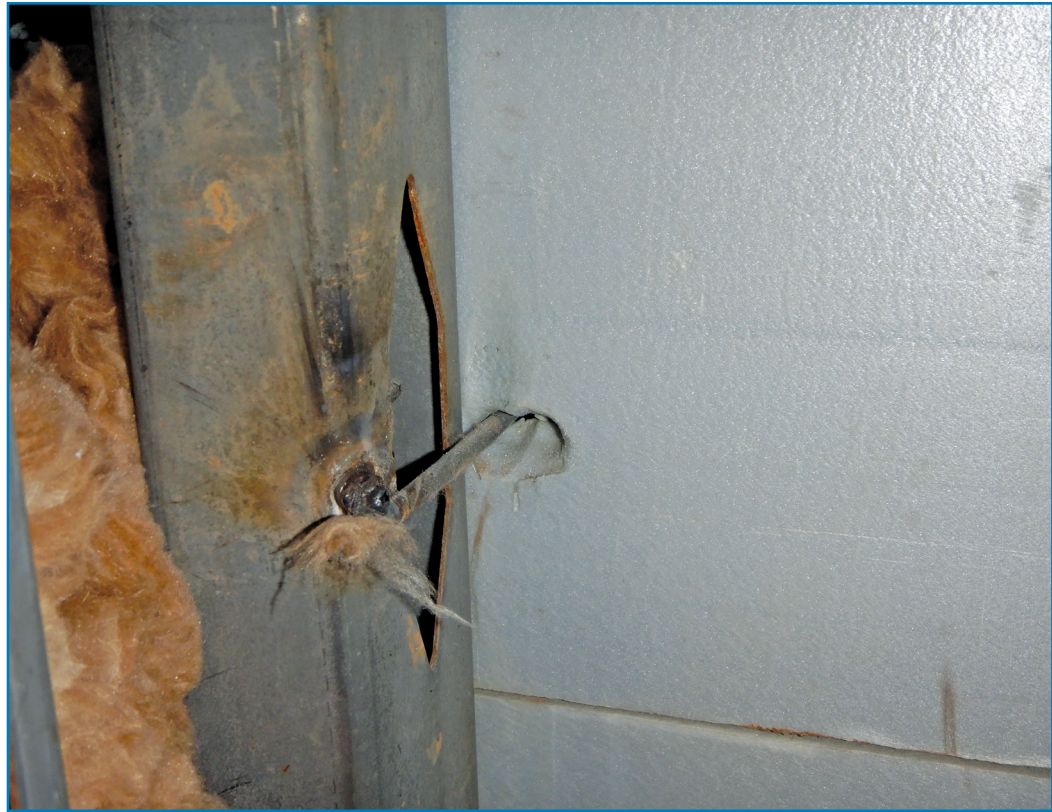
Figure 6 – Forensic image of one of the methods used, fastening brick cladding anchors to the steel studs where the anchors were field-welded in place; note large hole melted in the foam sheathing.

Findings also included some unique features where the brick masonry ties were welded to interior studs or welded to steel washers, which were welded or screw-fastened to the interior studs (*Figure 6*).

This construction technique must have required pushing the masonry anchors through the exterior extruded insulation board to allow the anchor to be welded to the studs. This construction technique created thousands of holes in the exterior sheathing, as well as burn marks and melted insulation due to the welding activities.

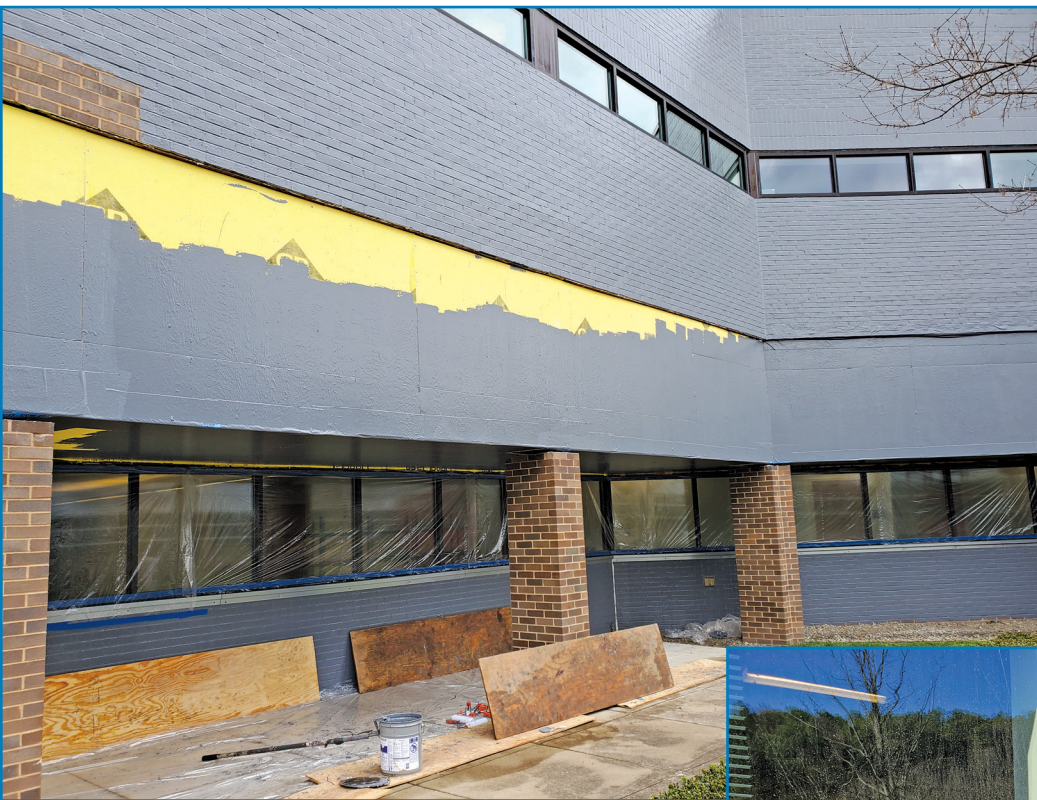
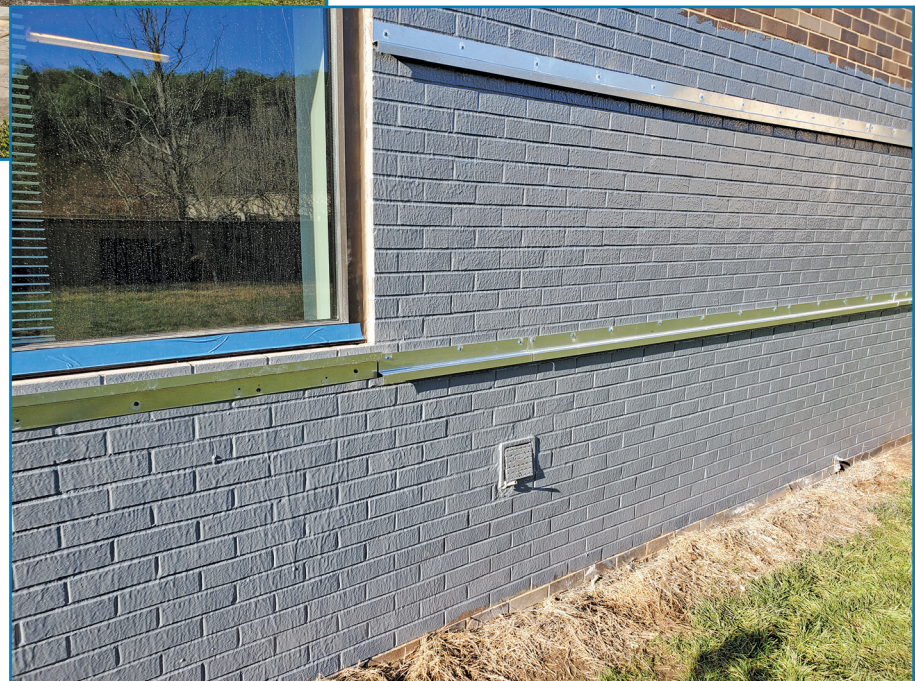
Figures 7 and 8 – Ongoing installation of the liquid-applied vapor-permeable air and weather barrier being applied to exterior gypsum sheathing and brick cladding.

panel selections with a custom layout and custom accent colors. The new assembly included a vapor-permeable liquid-applied air barrier installed over the existing brick (Figure 7), horizontal or vertical light-gauge Z members (Figure 8) with an additional layer of mineral wool insulation (Figures 9 and 10).

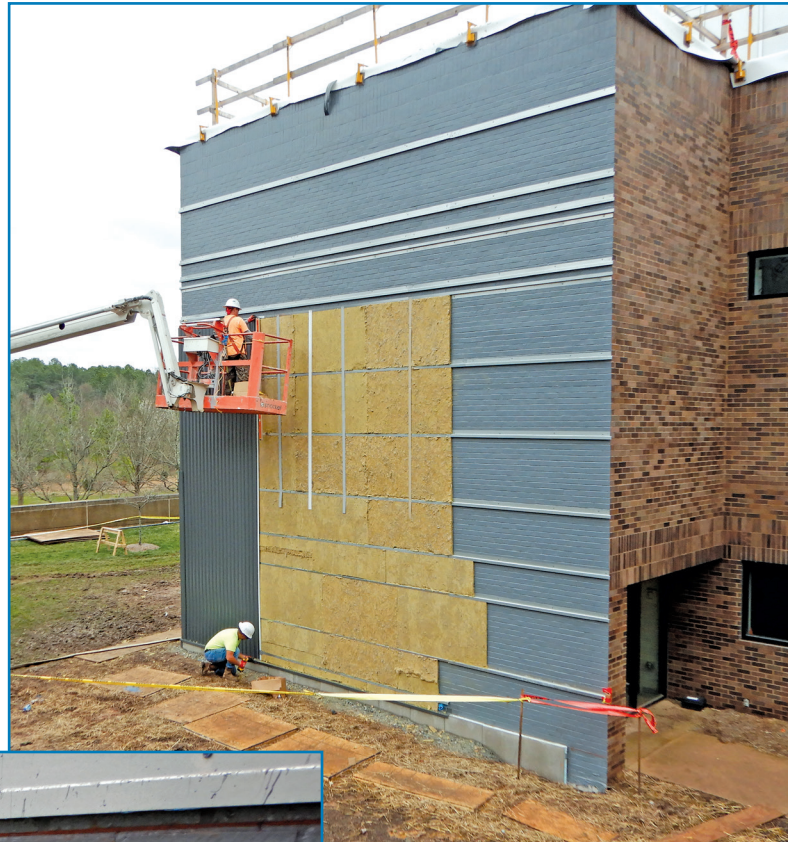
Figure 10 - Ongoing work where the liquid-installed air barrier is visible, as well as horizontal Z tracks and thermal insulation prior to installation of metal wall panels.

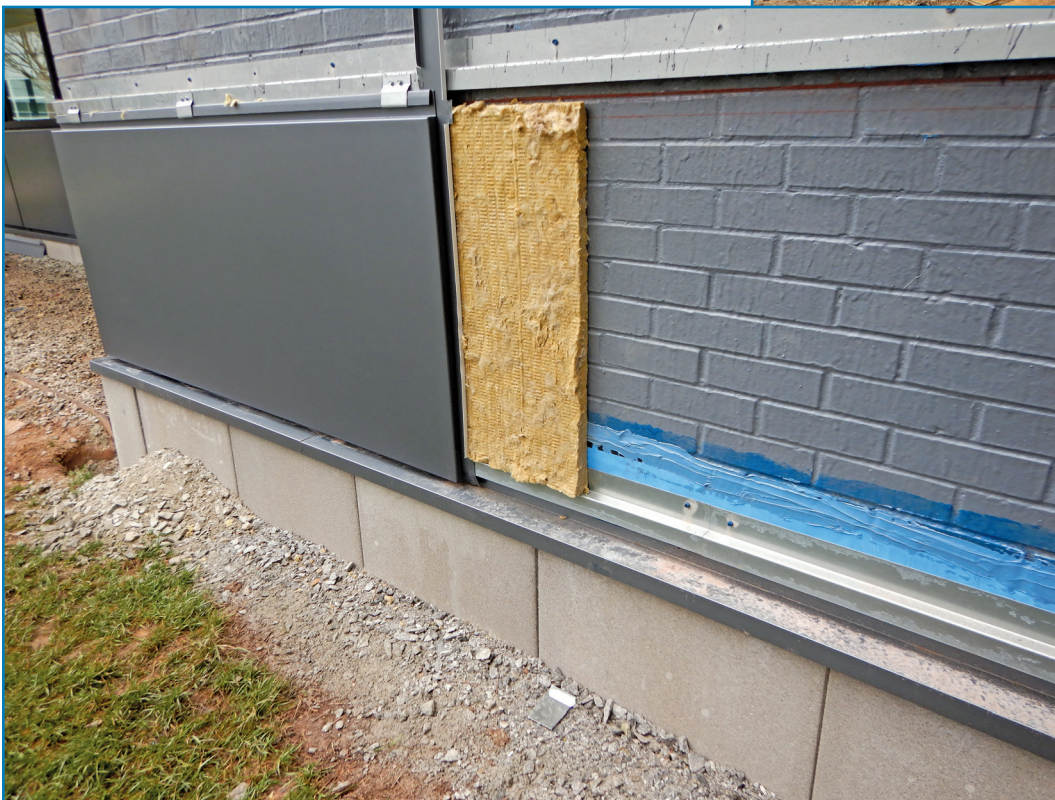
Figure 9 - Base-of-wall condition where through-wall flashing is secured to the primed air-barrier membrane to flash out water before the base-of-wall insulated concrete panels below.

The architect also elected to provide additional thermal insulation at the base-of-wall condition, tying the new metal cladding system to an insulated concrete panel system using extruded insulation which extended to below grade (Figure 9). At some locations, a new below-grade bentonite-based waterproofing system was

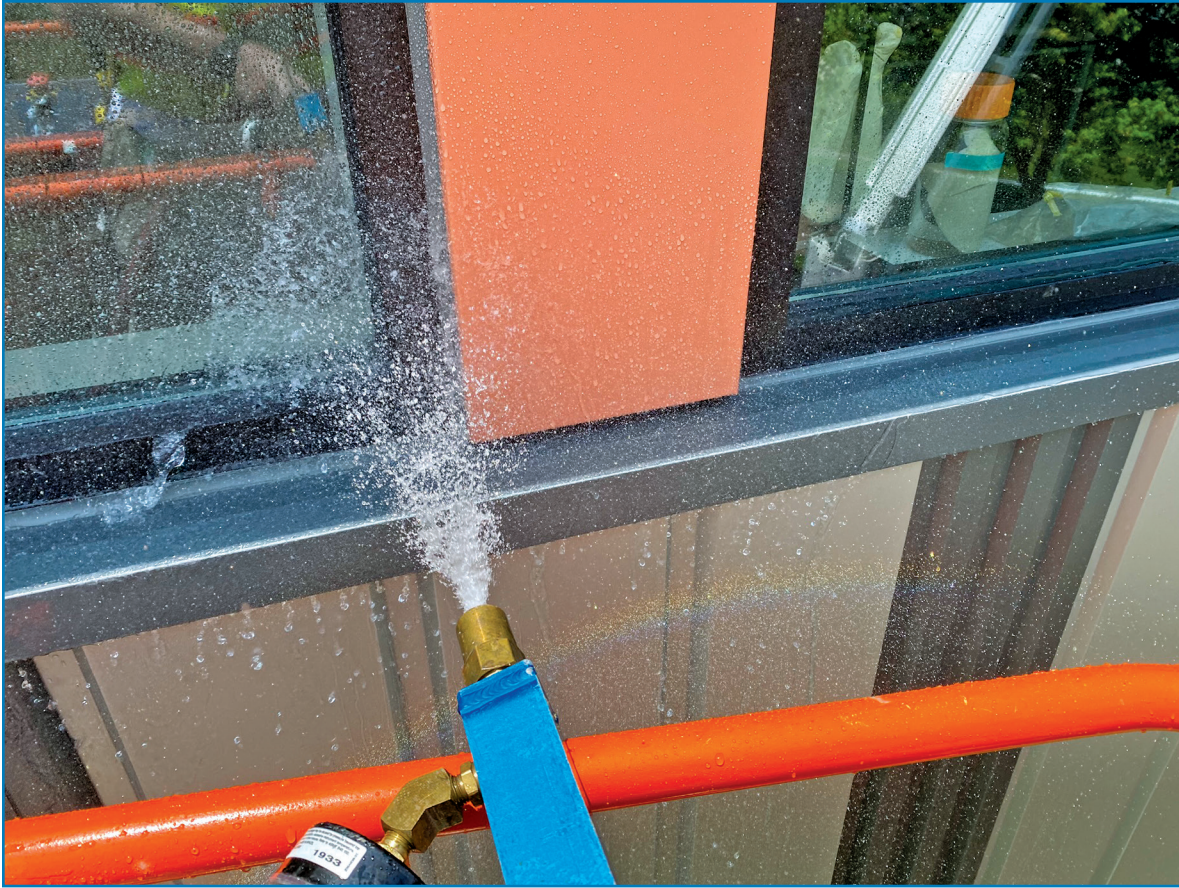
Figure 11 – The installed cladding system was tested using ASTM spray nozzle techniques.

also installed. The architect went to great lengths to detail as many of the as-built conditions as possible and tie the new system into the existing building elements. Finally, water-hose nozzle testing was used to field-verify weathertightness of the new installation (Figure 11).

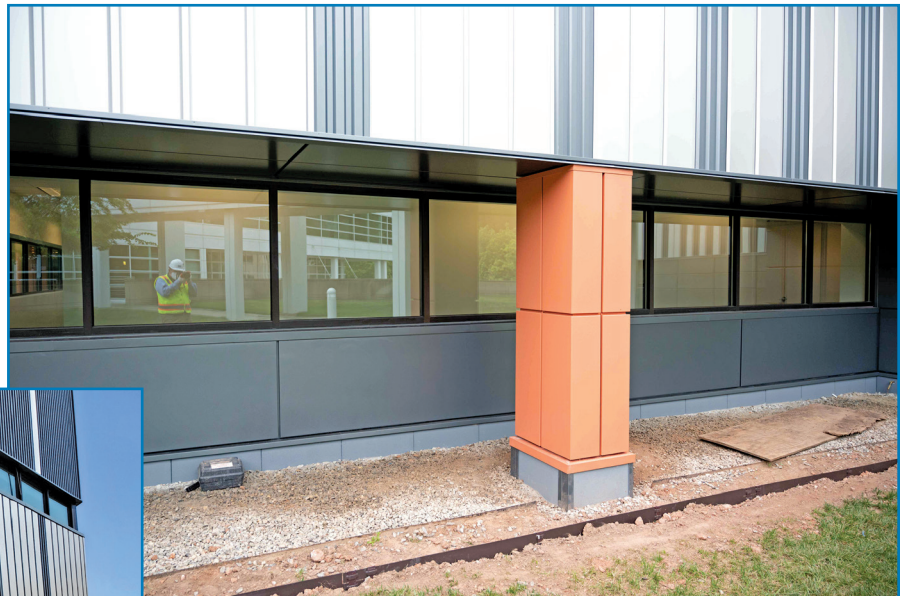
Figure 12 – Finished metal cladding system depicting custom colors and variation of panel types and details.

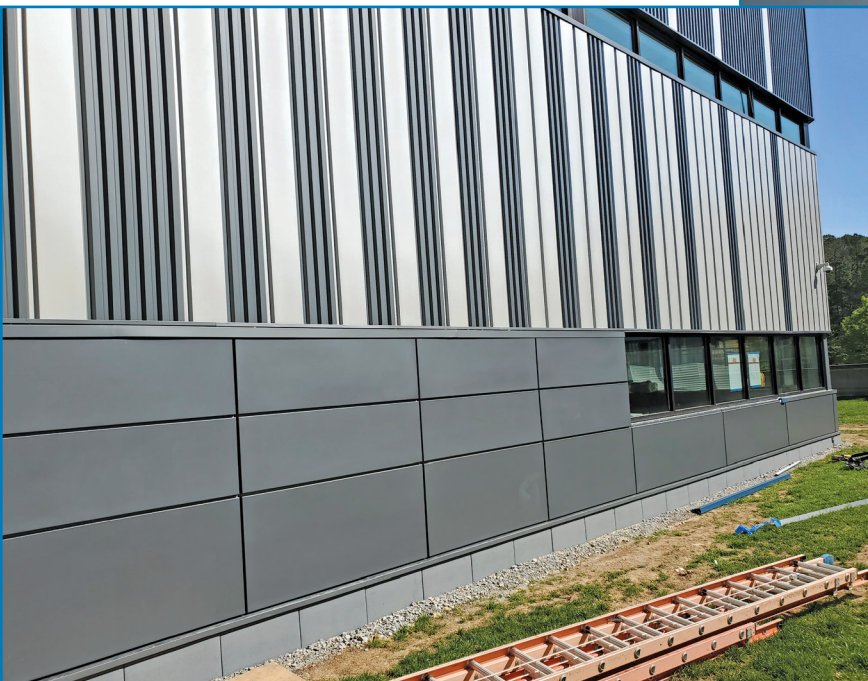
Figure 13 – Completed wall depicting various metal panel types as well as insulated concrete-coated rigid insulation panels at base of wall.

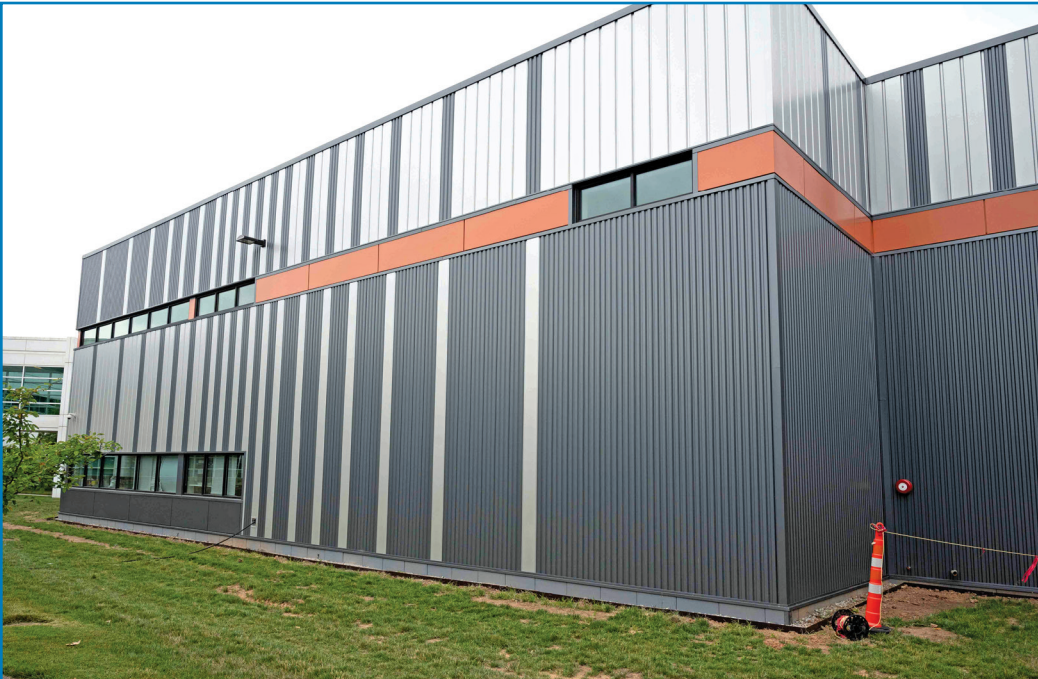
Figure 14 – Completed end wall with custom colors and variation of metal building wall panels.

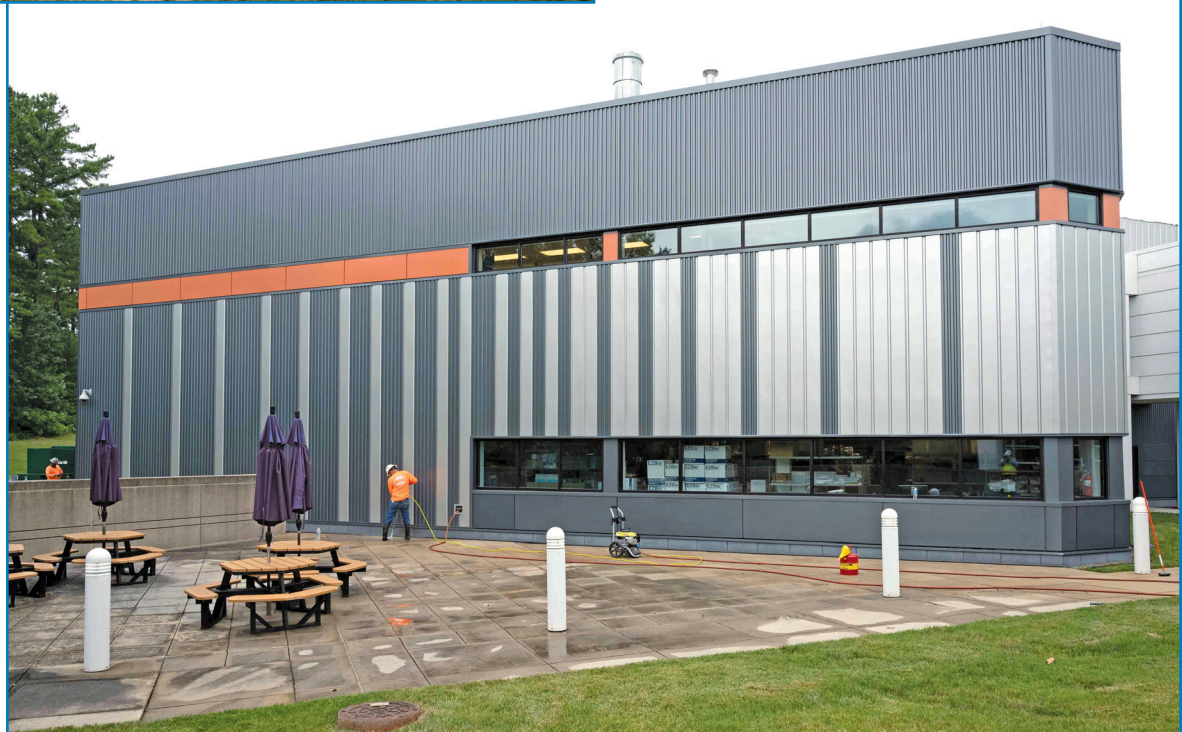
Figure 15 – Another view of the completed end wall with custom colors and variation of metal building wall panels.
