# Performance Analysis of Aged TPO Membranes

**IIBEC 2020 Virtual International  
Convention and Trade Show  
June 12-14, 2020**

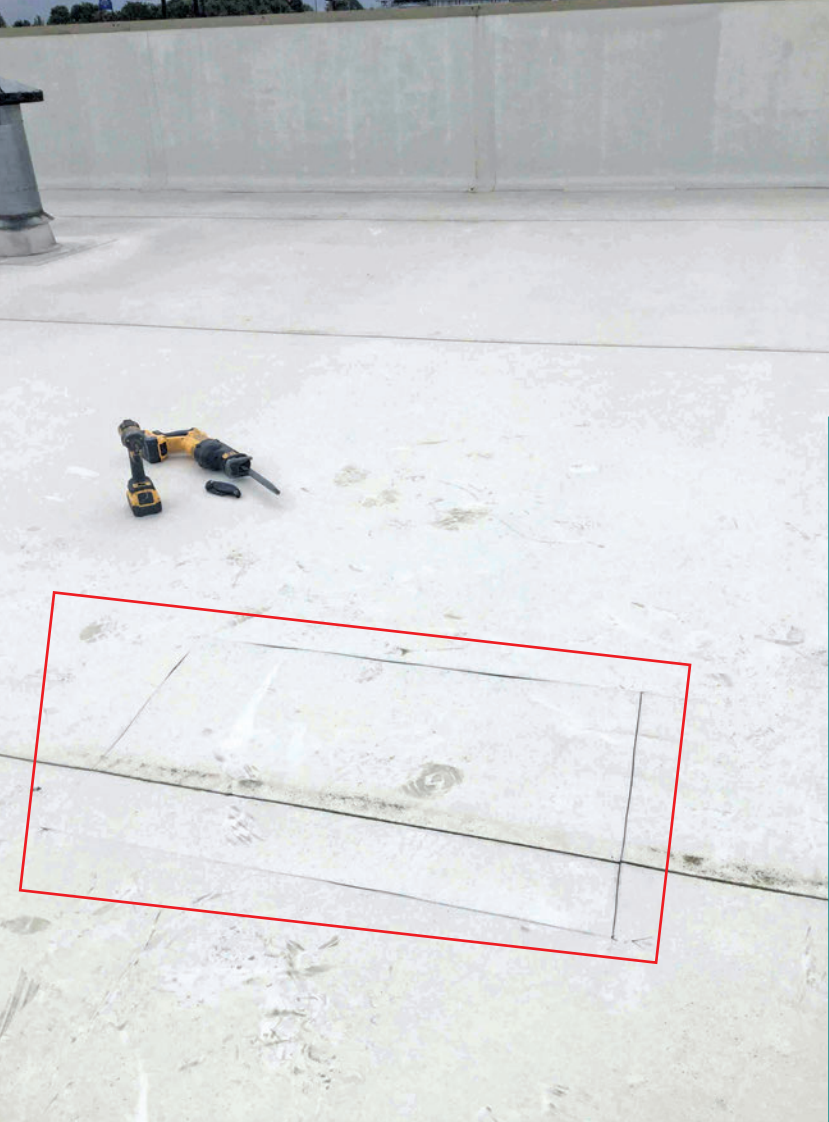
**Figure 1 – Typical 2- x 3-ft. field sample.**

Two samples were taken from each roof. Each sample was 2 by 3 ft. and captured a field-welded seam. One sample was taken from the field of the roof (see *Figure 1*), and the other was taken in a location that resulted in increased heat exposure (see *Figure 2*). To date, the increased heat-exposed samples were located adjacent to the north parapet wall. In the future, this ongoing study will include areas where sunlight reflects off adjacent glazing or metal.

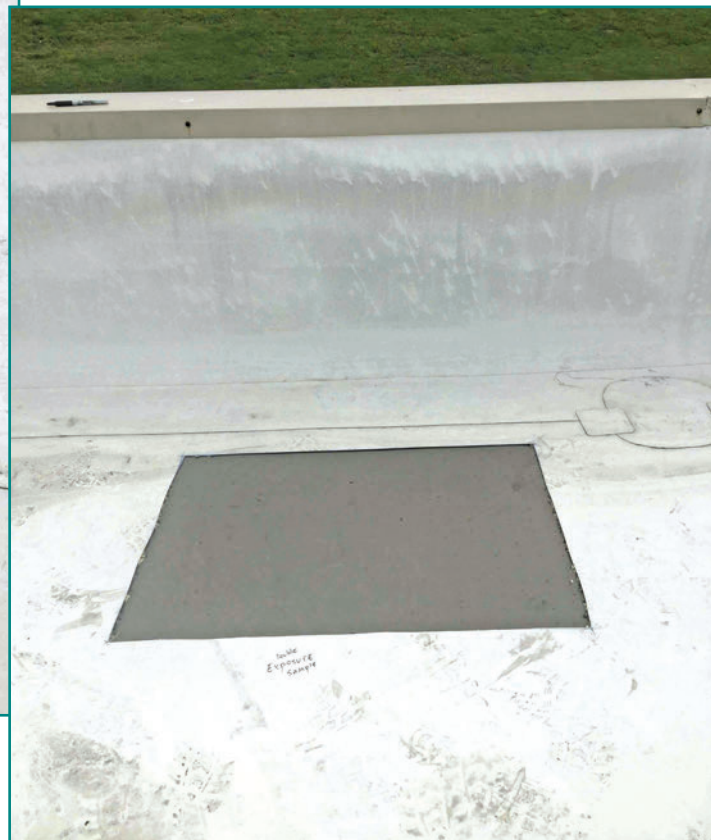
**Figure 2 – Typical north parapet, 30 inches in height.**

To date, the increased heat exposure samples have been limited to the membrane adjacent to the north parapet wall. No measurable differences in performance between field and increased heat-exposed samples have been observed. However, it is hoped that samples that have been subjected to a harsher exposure, such as reflection from glass or metal from an adjacent building, can be located.

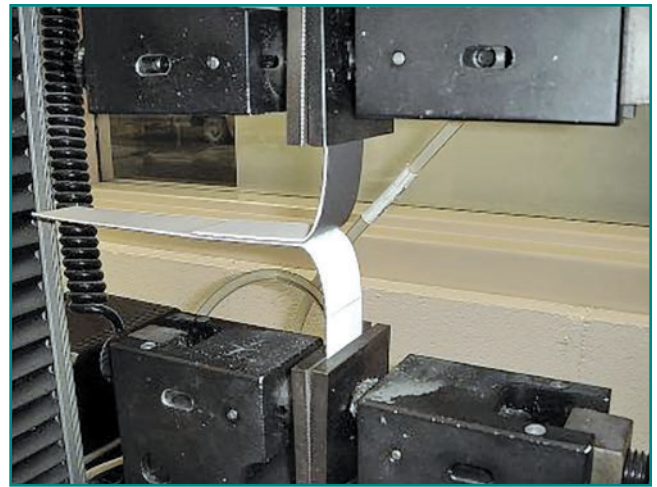
**Figure 3 – The ply adhesion test in progress.**

ASTM D1876<sup>12</sup>, also referred to as the T-Peel Test, was used to evaluate the welded seam ply adhesion. The ply adhesion of the aged weld was tested, as shown in *Figure 3*. The initial peak load caused by breakage at the edge of the weld area, and the series of lower peak loads during delamination of the membrane, were recorded. The ply adhesion is calculated by averaging the load during the first five delamination events.

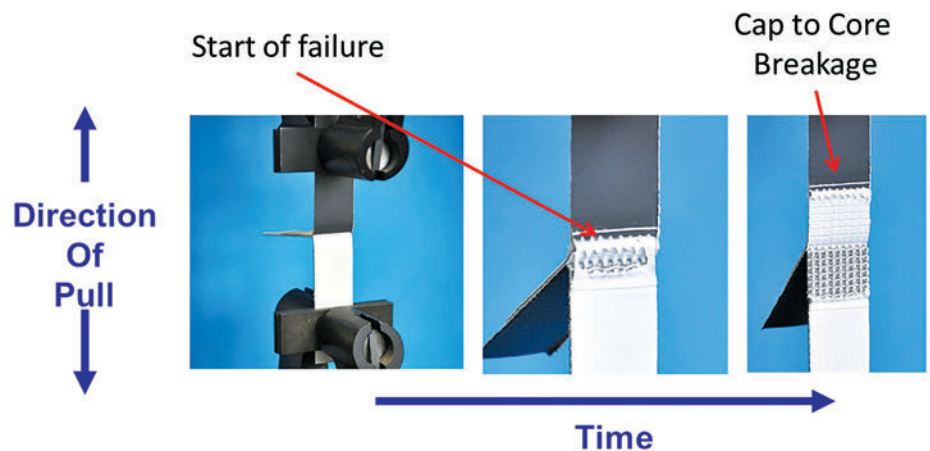
Ply adhesion testing of a proper weld will fail cohesively, exposing the underlying scrim. This is called a “film tearing bond” and is also used to evaluate the integrity of the weld. For the purposes of this evaluation, anything over 70 percent film tearing bond was considered a proper weld. *Figure 4* shows a 100 percent film tearing bond, indicating a complete and proper weld.

**Figure 4 – Illustration of the ply adhesion test and a full film tearing bond, indicating a complete weld.**

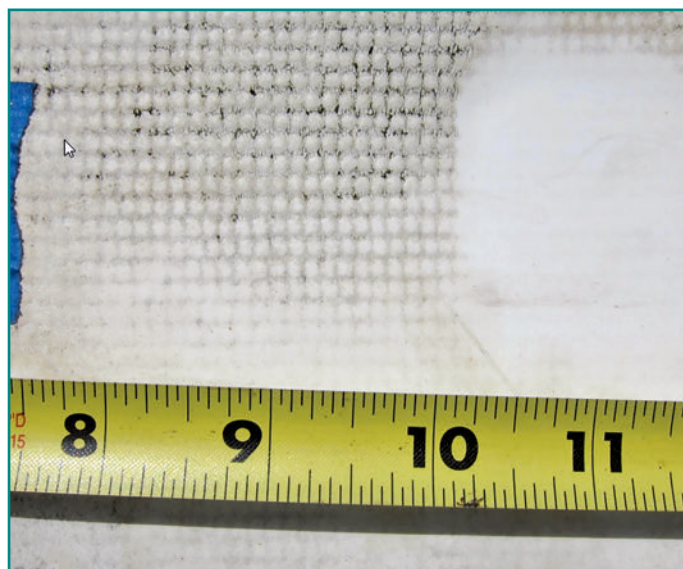
formance, as it provides the UV and heat stabilization properties of the membrane. As the cap erodes, the scrim can become exposed and the weathertightness of the membrane is then compromised, as shown in *Figure 7*.

**Figure 7 – Premature failure as cap erodes and exposes scrim. Image courtesy of René Dupuis.**

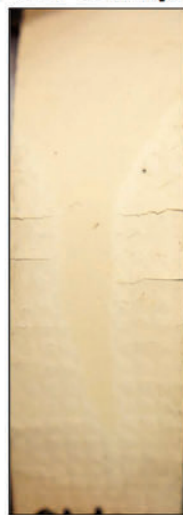
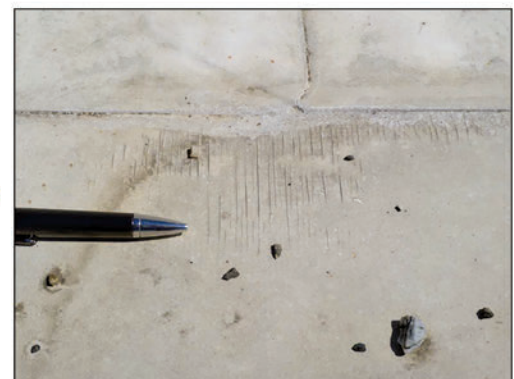
**Figure 9 – Prior testing performed by René Dupuis illustrates the reason why we look at cracking of the membrane. The test sample is from laboratory exposure and the real-world sample is from an aged roof (not directly related to this study).**

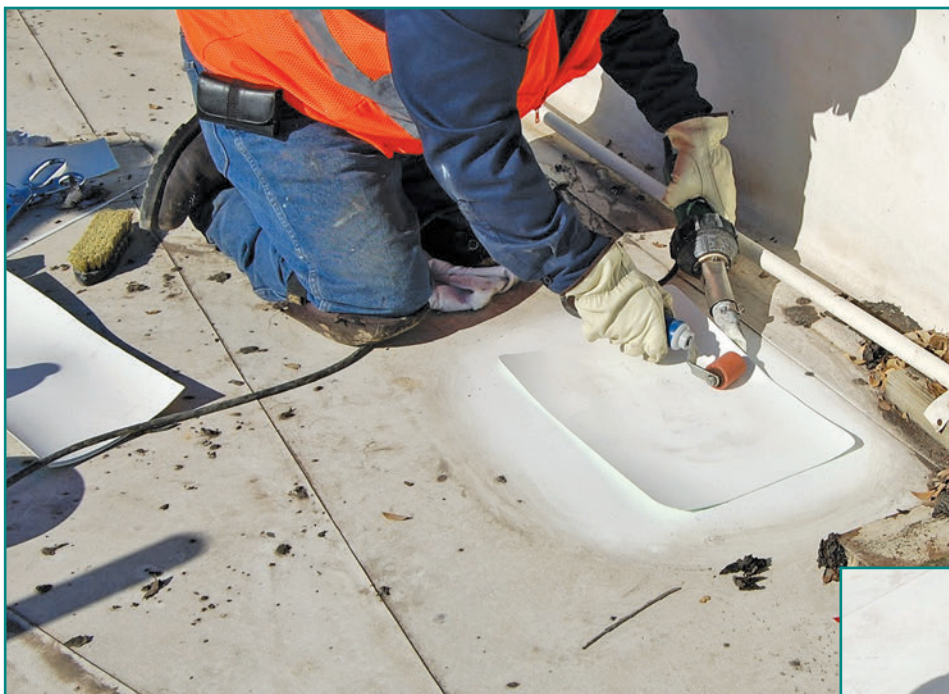
**Figure 11 – Repair of aged TPO membrane with a new patch welded to the aged cap.**  
Image courtesy of WSRCA.

The ply adhesion of the new membrane to the aged cap averaged 43 lbf/in. for 45-mil membranes and 47 lbf/in. for 60-mil membranes. For the new membrane welded to the aged core, the ply adhesion averaged 53 lbf/in. and 57 lbf/in. for the 45-mil and 60-mil membranes, respectively. Representative data are shown in Figure 13.

To address questions around the ability to repair aged TPO membranes, this study examined the adhesion of new membrane to aged membrane. Two approaches were examined: welding the new membrane to the cap of the aged membrane (see Figure 11), and welding new membrane to the core of the aged membrane (see Figure 12).

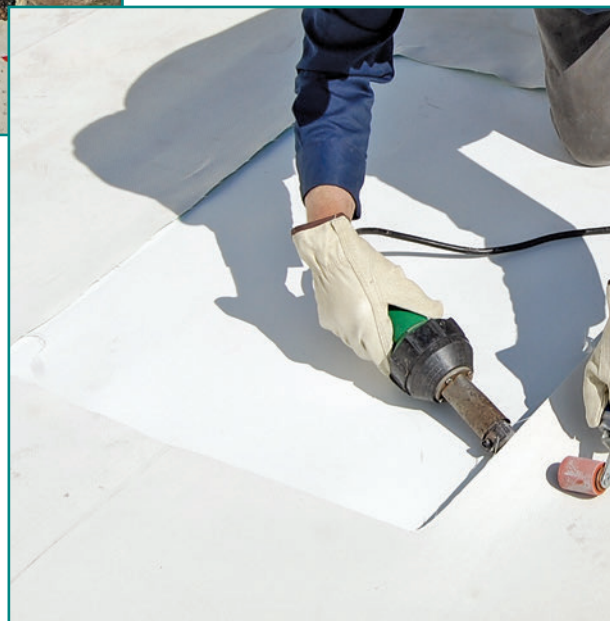
**Figure 12 – Repair of aged TPO membrane with a new patch welded to the aged core.**  
Image courtesy of WSRCA.
