Reviving a Historic Landmark: Restoration and Monitoring of “Detroit’s Largest Art Object,” the Iconic Fisher Building

By Ziad Salameh, PhD, PE

This paper was presented at the 2023 IIBEC Building Enclosure Symposium.

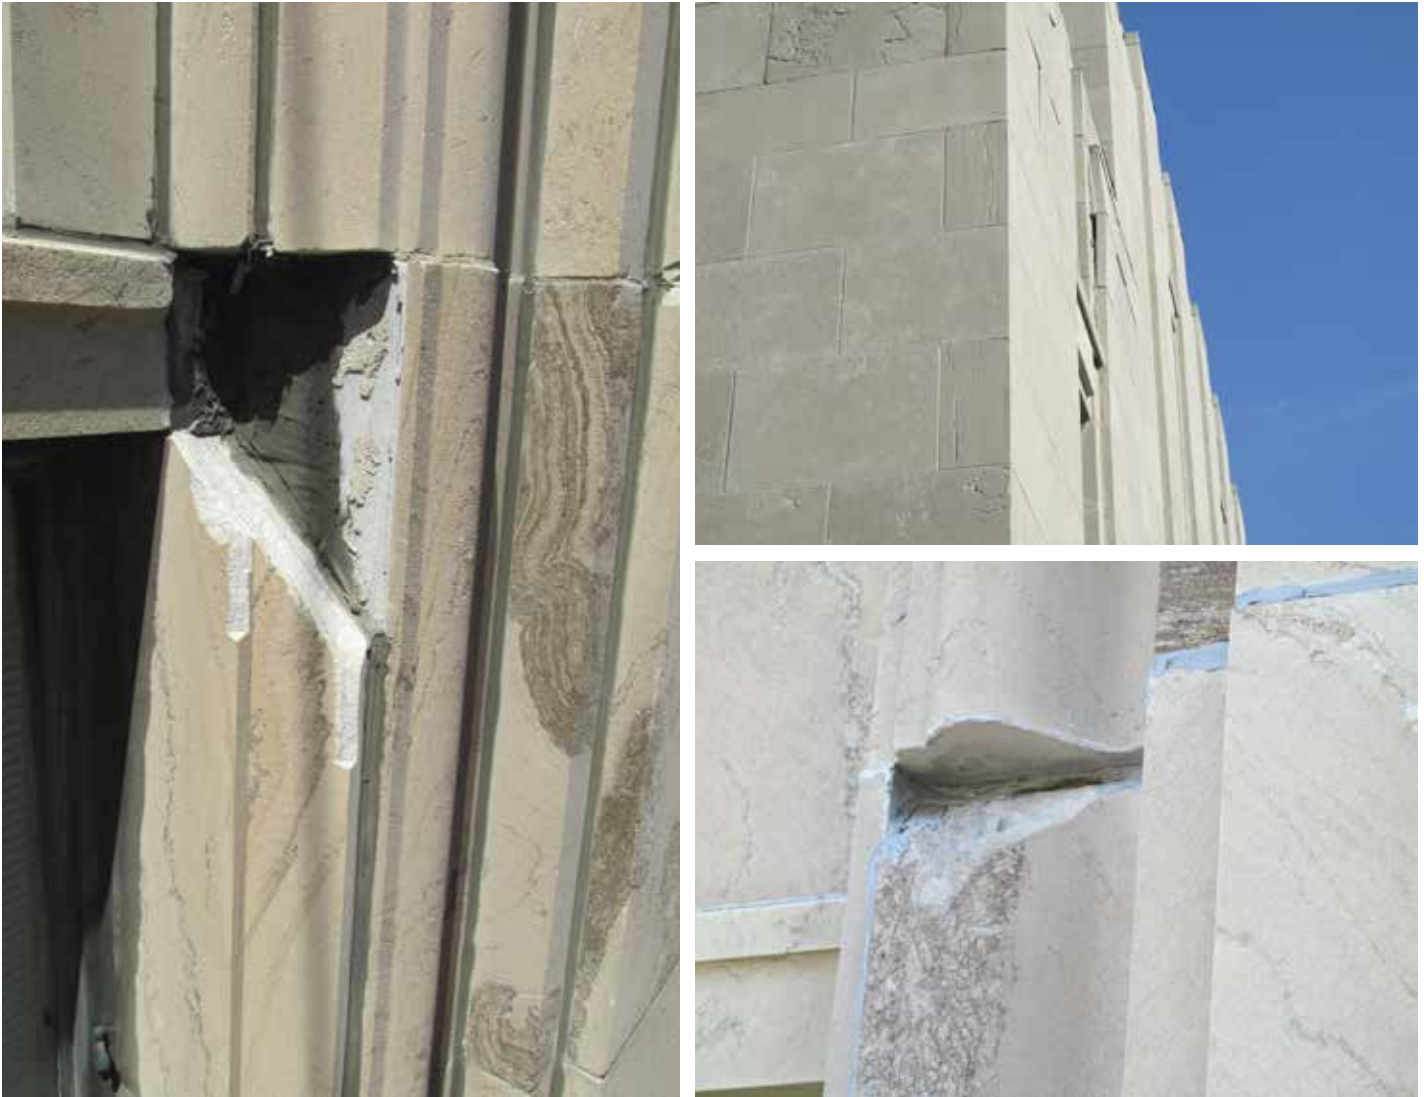
The comprehensive assessment uncovered various types of distress and classifications for each cladding material. These distresses included damaged/spalled units, failed repaired units, unsafe/ready-to-fall units, displaced units, cracked units, deteriorated coping units, failed mortar joints, failed sealant joints, unsafe cladding and supports at bronze sculptures, and deteriorated brick-clad areas (Fig. 4). The extent and severity of these issues were meticulously documented on as-built facade elevations, created from laser scans and converted into digital twins using Scan-to-BIM (building information modeling) technology.

- Damaged/spalled marble/limestone/granite units.
- Previously repaired damaged/spalled marble/limestone/granite units.
- Unsafe/ready-to-fall damaged/spalled marble/limestone/granite/brick units. The observed unsafe damaged/spalled units and areas are occurring at locations that are in direct contact with (or near) embedded steel elements which indicate that the damage was primarily caused by corrosion of embedded steel. To protect the public, building users, and pedestrian traffic from the falling hazard of these units and

Figure 4. *Examples of cladding distress observed.*

- Displaced/out-of-plane movement at marble/limestone/granite/brick units. The majority of the displaced units are located near embedded steel units and exhibited signs of active movement (that is, split open vertical sealant joints, visible out-of-plane movement, and plane deviation).
- Low-severity cracked marble and limestone units.
- Unsafe/ready-to-fall cracked marble and limestone units.
- Deteriorated/damaged/displaced marble/limestone coping units.
- Deteriorated/failed mortar joints repaired with multiple layers of sealant/caulk products.
- Unsafe/damaged cladding and supports at bronze sculptures.
- Unsafe deteriorated brick-cladded areas.

The observed damage and instability of the facade cladding primarily resulted from the corrosion of embedded steel elements, such as shelf angles and tie anchors. Furthermore, previous improper repair campaigns, including inadequate patching, incorrect removal of spalls, anchoring unstable damaged cladding with mild steel supports, and the improper application of sealant to repair cracks or mortar joints, contributed significantly to the ongoing deterioration.

The assessment report proposed a comprehensive make-safe campaign, involving a yearly 100% hands-on inspection to remove or stabilize damaged cladding areas. This included hammer sounding and removal of all ready-to-fall masonry pieces and spalls, installation of engineered netting systems at

displaced and cracked units, and installation of engineered shoring systems at projecting elements. In addition to the locations identified by examination of the laser scan point cloud, engineers marked the locations of all new make-safe measures on building elevation sheets in real time during hands-on inspections. These elevation sheets created from the point cloud served as a record of work for construction crews with easily verifiable locations and extents. Final certification inspection was performed using these sheets for comparison.

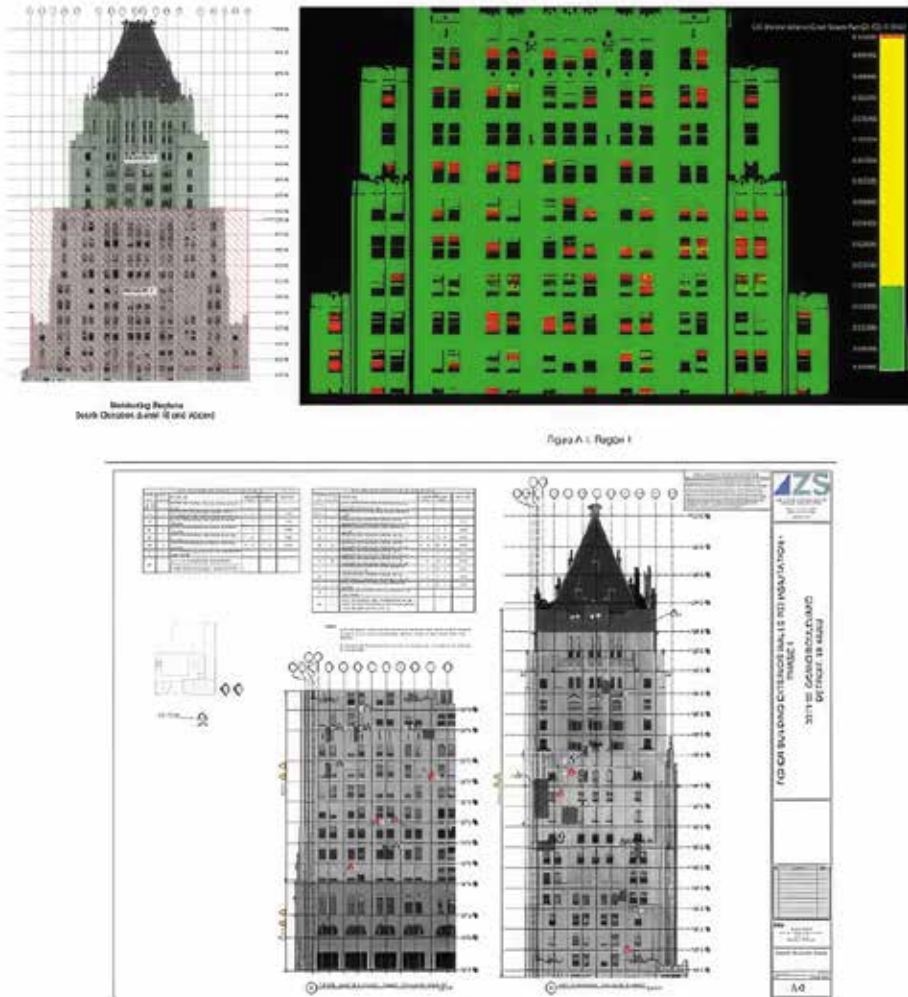
Figure 5. Laser scanning monitoring plots.

Additionally, we recommended semiannual laser scanning of the cladding to detect out-of-plane movement using point cloud-to-point cloud analysis (**Fig. 5**). The initial laser scans have been archived as a baseline model to serve as a point of comparison. Through the use of state-of-the-art scanner and supporting software, subsequent laser scan point clouds can be generated and utilized to perform cloud-to-cloud deviation analysis for each

exterior wall elevation. This analysis technique uses software that automatically colors the new point cloud data using the least squares method based on the distance from the prior cloud data. Subsequent scans will reveal significant local movement in the building street facades. Any new critical repairs can thus be identified and performed in a timely manner. The recommended repair schedule and exterior wall classification can also be continually evaluated and adjusted during the planning phase for long-term repairs.
