# Not All It's Cracked Up to Be? Surface Fracturing of PVC and KEE Membranes

By Kade Gromowski, PE, RBEC, CBECxP

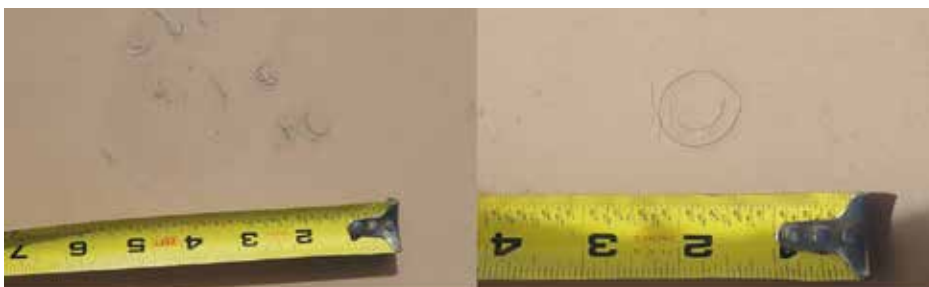
In general, it is widely accepted in the industry that hail fractures to thermoplastic membranes are most commonly spiral-shaped fractures, star-shaped or "crow's foot"-shaped fractures originating from a central point, or concentric circular fractures (**Fig. 1**). These fractures can allow water to infiltrate past the membrane due to their penetration through the membrane, which can lead to substrate deterioration or interior leaks. They also can allow water into the membrane's reinforcing scrim, which may shorten the service life of the membrane.

Figure 1. Typical hail fracture shapes on a PVC/KEE membrane.

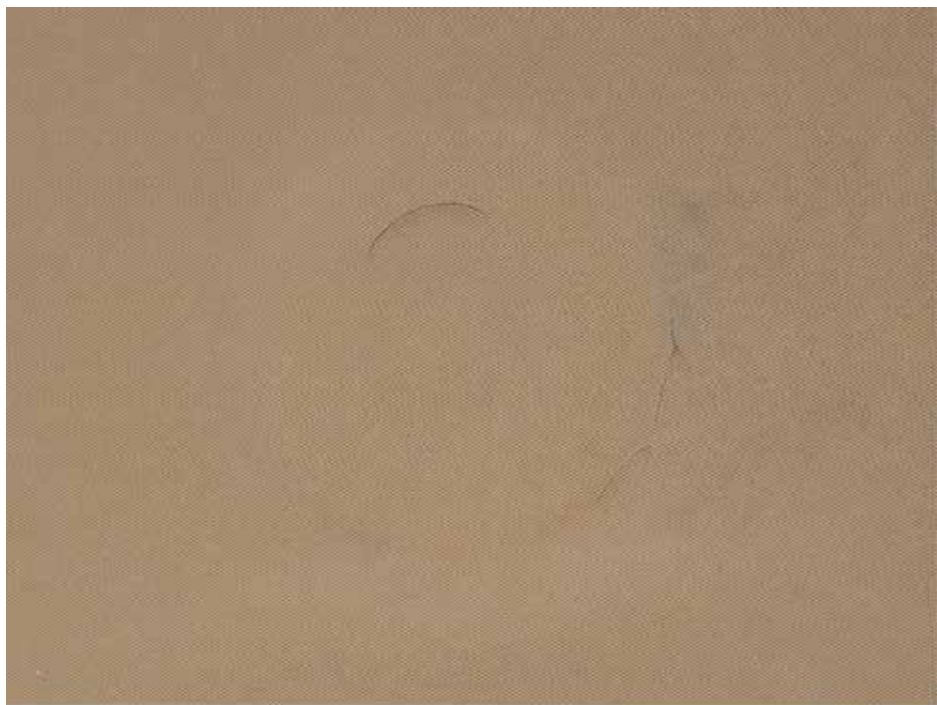
On both buildings, arc-shaped fracturing was observed around the perimeters of the fastener plates for the coverboard and membrane fasteners (Fig. 2). The prevalence of these arc-shaped fractures at each fastener varied, but many of the fractures interrupted one another and did not correspond to the spatter marks on the membrane. They were therefore not consistent with hail impacts. At isolated unsupported areas of membrane on the roofs, fracture shapes consistent with hail impacts which coincided with spatter marks were observed.

Figure 2. Arc-shaped fractures that interrupt each other at a fastener plate.

It was ultimately recommended that the roofs be evaluated by Manufacturer X for warranty purposes, and if no warranty loss was identified, that they receive a waterproof coating. The

coating was recommended in lieu of patching, as it was unlikely that the pinch-type hail fractures could be reliably differentiated from the arc-shaped fractures without performing test

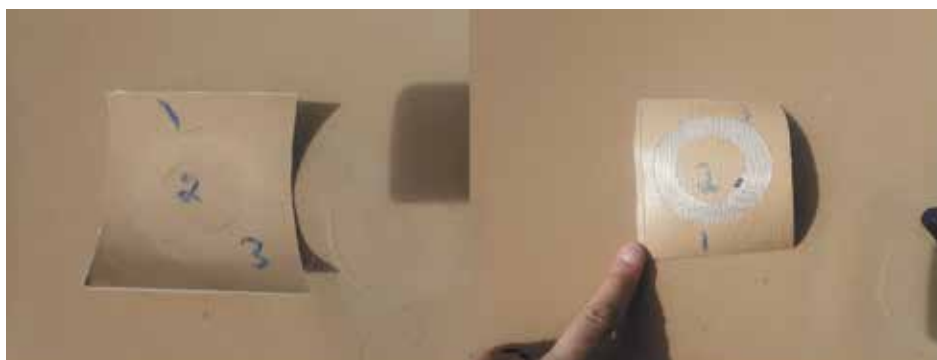
Several test cuts were performed on the roofs to evaluate the observed fracturing. In general, it was found that the arc-shaped fractures around the fasteners did not extend to the bottom of the membrane (Fig. 3). No fractures or damage to the underlying substrate materials or their facers were observed.

Figure 3. Test cut at fastener plate; note fractures not present on membrane underside.

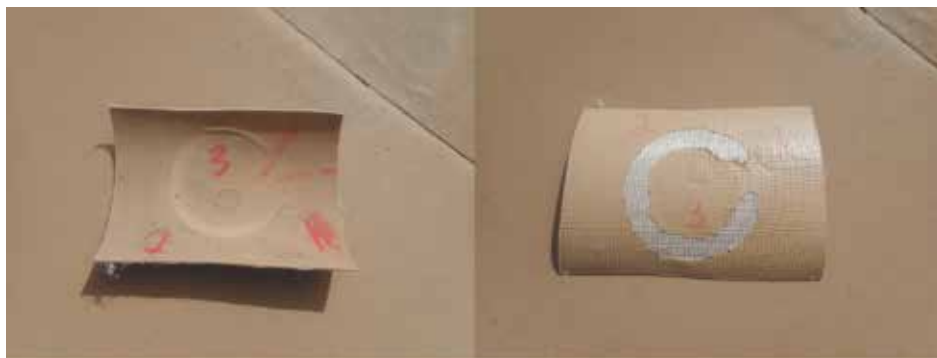
There were a very limited number fasteners where a "pinch-type" fracture was suspected, due to more circular fractures visible on the membrane surface which corresponded to spatter marks on the roof surface. Test cuts at these locations showed that the "pinch-type" fractures were visible on the underside of the membrane, and therefore consistent with hail impacts, but that arc-shaped fractures on the same fastener did not extend through the membrane thickness (Fig. 4).

Figure 4. Pinch-type/"anvil strike" hail fracture on a membrane test cut, marked "3," visible on both top and bottom surfaces of membrane. Note that while the surface fracture marked "1" on the membrane is visible as an indentation on the bottom of the membrane, no actual separation of the membrane's underside was present at this location.

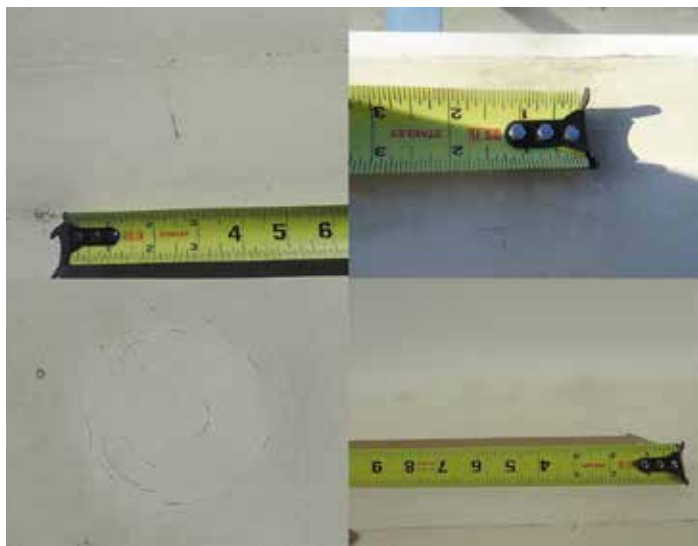
On all roof areas evaluated, including the membranes manufactured in 2019 and installed in 2020, very small diameter arc-shaped fractures were observed at the overlapping membrane of the seams throughout the roofs. These arc-shaped fractures coincided with the edge of the underlying membrane below, and commonly interrupted one another (Fig. 5). Similar fractures were observed at the edge metal stripping plies, above the underlying edge of the metal flashing (see Figure 5). In addition to the fracturing at the edges of seams and metals,

arc-shaped fractures were observed at every coverboard fastener plate immediately below the membrane, and in the corner bends of the roof-to-wall transition (see Figure 5). In general, these arc-shaped fractures were most prevalent on roof membranes ranging in likely manufacturing age from 2008 to 2011, and directional conditions such as the roof-to-wall corner conditions were more prevalent on south-facing and west-facing surfaces. Test cuts at these fractures throughout the buildings assessed did not show any of these fractures extending to the membrane underside.

Similar to the first case history, the arc-shaped fractures at seams, edge metals, corner bends, and fastener plates which were so prevalent throughout these roofs were not consistent with hail impacts, but were likely related to weathering, membrane stresses, thermal factors, or a combination of these causes.

**Figure 5.** Typical arc-shaped fractures at back of a seam (upper left), back of an edge metal flashing (upper right), a cover board fastener plate (lower left), and roof-to-wall corner bend (lower right).

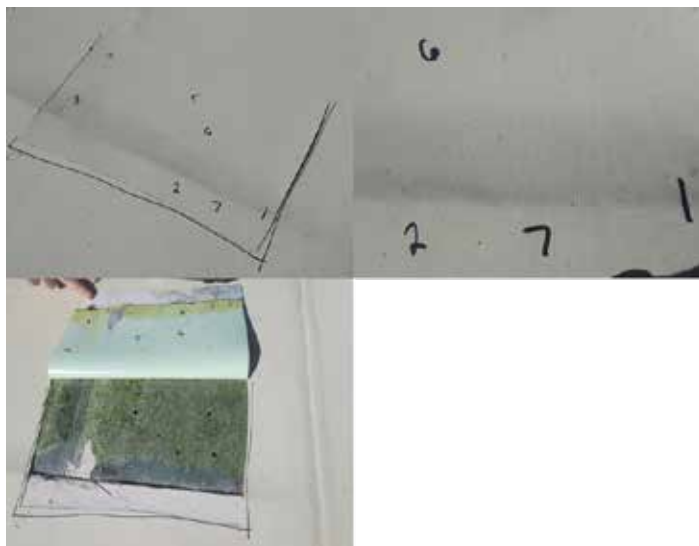
The wrinkle in this assessment came when numerous, widespread, consistently shaped fractures were observed on some roof areas with membranes whose manufacturing likely predated 2011. These circular-shaped fractures were generally 1/2-inch or less in diameter, and were consistent in distribution with hail impacts. However, test cuts at these fractures did not show fractures at the back sides of the membrane for these fractures, even when these fractures coincided with relatively vulnerable unsupported membrane areas (Fig. 6). In addition, none of the fractures coincided with damage to the substrates or facer materials. So were they hail-related, or not?

**Figure 6.** Test cut at an unsupported membrane exhibiting small-diameter circular surface fractures, upper left. Close-up of surface fractures, upper right. No fracturing to cover board or back of membrane, lower left.

It was recommended that the roofs be evaluated by Manufacturer Y for warranty purposes throughout the roofs, which this author understands to be ongoing at the time of the submission of this article. If no warranty loss is identified, this author has recommended that roofs exhibiting the widespread, circular fractures in the field of the roof receive a coating in response to these fractures, as hail cannot be ruled out as a cause for these fractures due
