Project Report:

Florida International Museum Reroofing – A Decision-making Process

By David H. Siple, RRC, FRCI

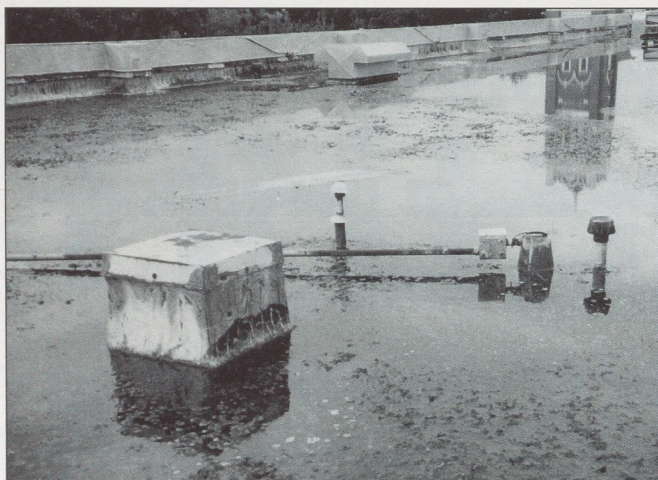
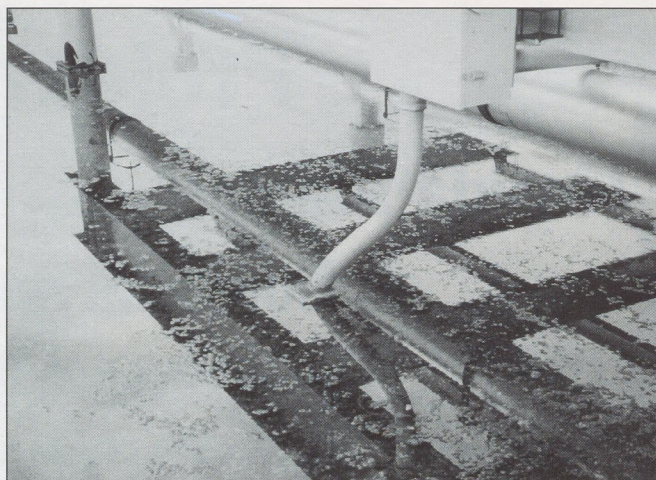
We went onto the roof (which was totally ponded with water) during the rain and slogged through water and large clumps of algae. The water was 2" deep in the shallow areas and up to 4" deep in two areas. Even though the water was quite murky, it was evident that blisters were present. On the parking deck, water was up to 1/2" deep in a number of areas.

(Left) Ponding water conditions with colonies of algae floating in the water. (Right) The pitch pan for the new chiller electrical supply was too low and not enough space was allowed from the conduit to the sides of the pan.

We again slogged through all the water and measured its depth. Of the two places that were 4" deep, one was selected as the best place to install the relief drain and run the horizontal line out through the rear wall and down to the alley. Answer: install one relief drain, ASAP.

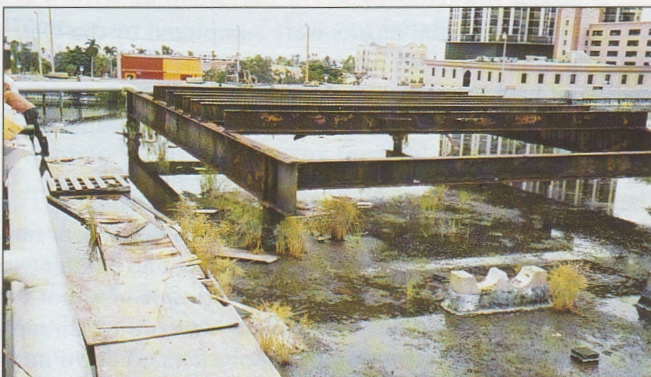
(Left) The rusting supports for the old cooling tower were left on the roof. (Right) Unused HVAC equipment was covered with tarps because leaking occurred through it.

Decision #6 - Which unused HVAC equipment needs to be removed? All of the unused equipment where leaking has occurred must be removed. Some other equipment had not caused a problem. To hold down the repair cost, it could be left in place.

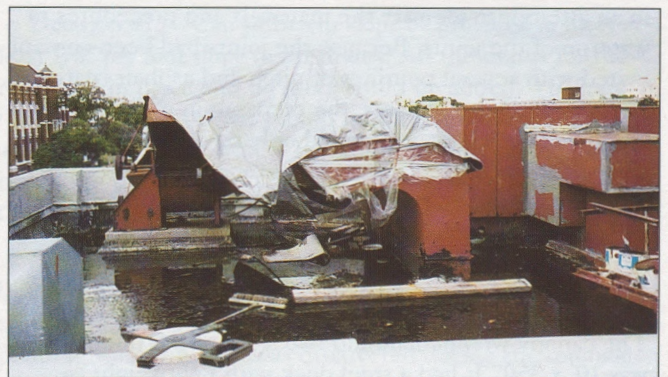
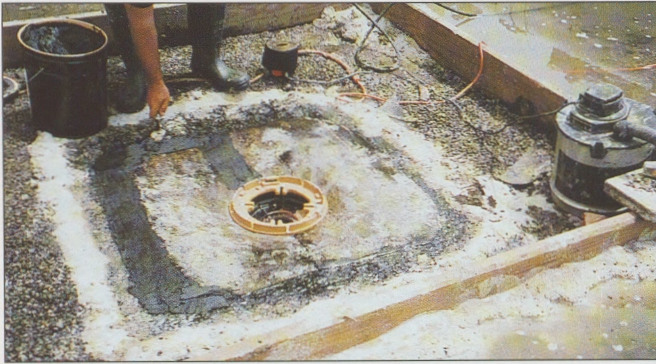
A coffer dam was built in 4"-deep water. A new relief drain was installed and flashed into the existing pitch roof membrane.

12' x 12' area, with 4" of water resisting. Little success was made with the brooming. A 10' x 10' dam of 2" x 8" wood was set over the area and a Bentonite clay stop-leak powder was poured all around the outside. The water was removed with a sump pump followed by shop vacs. The gravel was spudded back, a hole drilled through the concrete, the drain set and the drain line run. The drain was flashed in with an SBS modified, torched to the existing pitch membrane and followed with a complete troweling of pitch mastic over the tie-in. This whole process took about three hours and then the dam was removed. Within two hours, about 80% of the ponded water was removed from the roof.

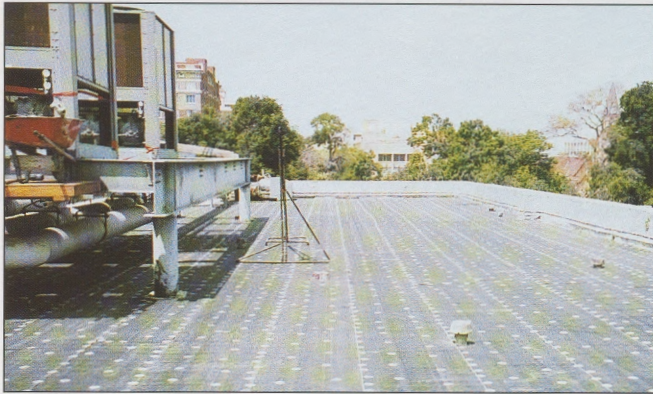
The venting base sheet has been fastened with base ply fasteners with 1-90 plates.

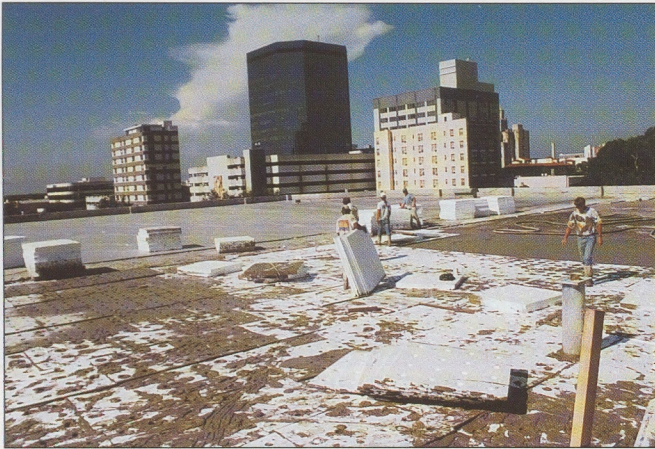
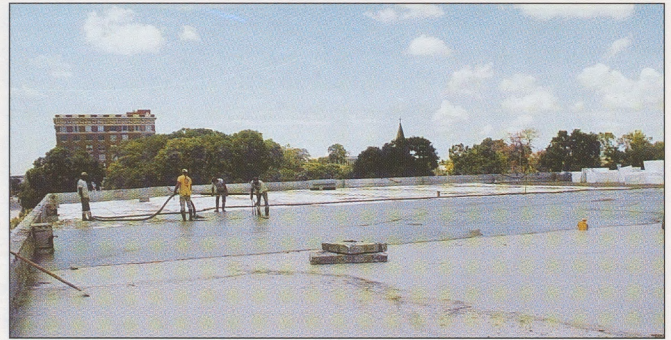
(Left) The cellular insulating concrete pour is in progress, with filler boards being set in the slurry. (Above) 2" to 3" of cellular concrete are being poured over the stepped insulation boards.

Also very popular in Florida is the installation of cellular concrete pours. A flat or tapered pour would work very well but it would take four to five days to pour, two days to dry and another four to five days to get the plies mopped down to make the roof watertight. This would require almost two weeks of dry weather in the middle of the summer. And if rains did occur, procedures must be in place to deal with the wet cellular system. This system might be much quicker to install, but rains would cause problems. A structural analysis was performed to verify that the added dead weight load would be within the capacity of the structure. It was determined that both flat and tapered boards and flat and tapered cellular would work well, but they both had disadvantages in the timing of their installations.

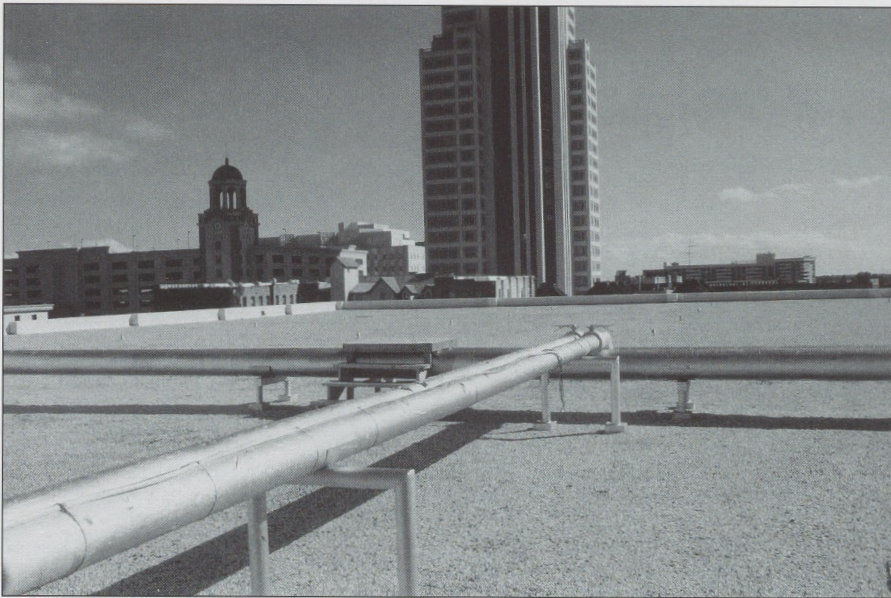
The new, completed roof.
