# Microscopic Roof Leaks Destroy Fasteners And Insulation

By John Willers, RRC, FRCI, PE

## The Project

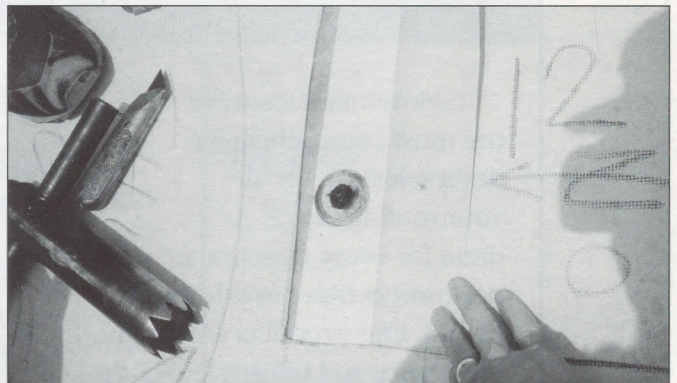
1. (Left) 12" x 12" membrane sample No. 12 before cutting. Note membrane lap and rust stains adjacent to the edge of the overlying membrane. 2. (Above) 12" x 12" membrane sample No. 12 after cutting. Note the large rusty spot in the center of the stress plate which is the rusted fastener head.

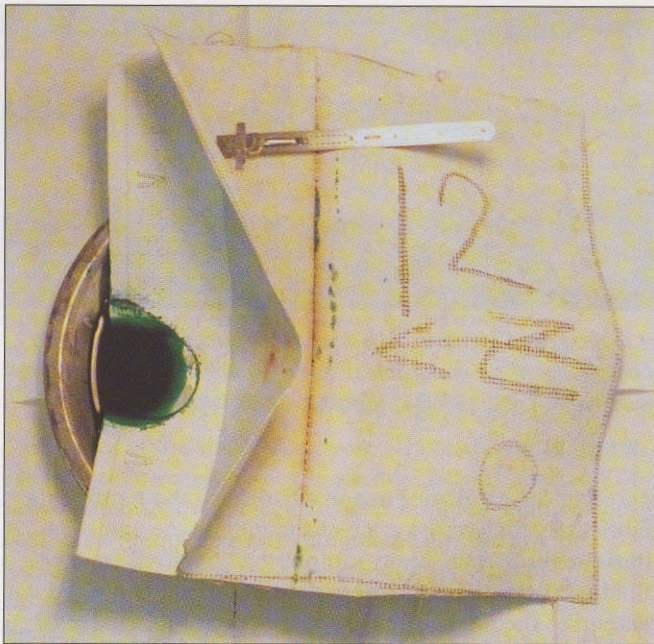
3. (Left) 12" x 12" membrane sample No. 12 with fastener hole exposed to green food dye over night. Note the original rusty stains adjacent to the edge of the heat welded lap, and the green stains from the food dye that had traveled through the membrane capillaries from the fastener hole. 4. (Above) Weathered surface of the membrane. Note the green food dye stains and the faint, rusty stains at the perimeter of each of the green stains. The scale is divided in 64ths of an inch.

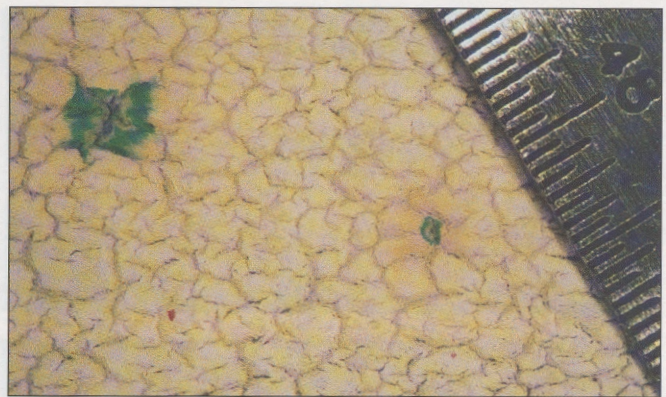
Within six years, the surface layer had weathered from a thickness of 0.020" to an average thickness of 0.013". Additionally, the surface of the membrane had weathered to form crevices as shown in photograph #4. These crevices were deep enough to expose the reinforcing fabric.

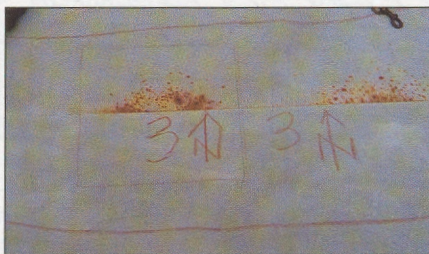
5. (Left) An example of rust stains adjacent to the edge of a heat welded seam. The spacing between the center of each stain is approximately 12", which matches the spacing of the fasteners in the membrane lap. 6. (Center) The bottom layer of the membrane has been peeled away to expose the reinforcing fabric. 7. (Right) Closer view of photograph #6. Note the void spaces adjacent to each strand of reinforcing fabric.

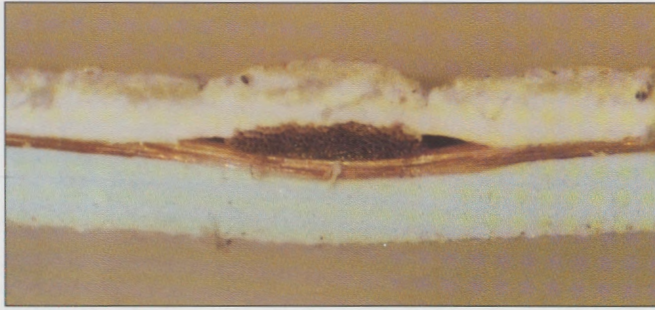
8. (Left) Cross sectional view of membrane. Note void spaces adjacent to the strand of fabric. Also note the crevices in the weathered surface of the membrane. 9. (Right) Photograph #8 after setting the opposite edge of the membrane in green food dye. Membrane sample was 1/2" wide and set on edge for viewing. Green food dye was visible within seconds after applying it to the opposite edge of the sample.

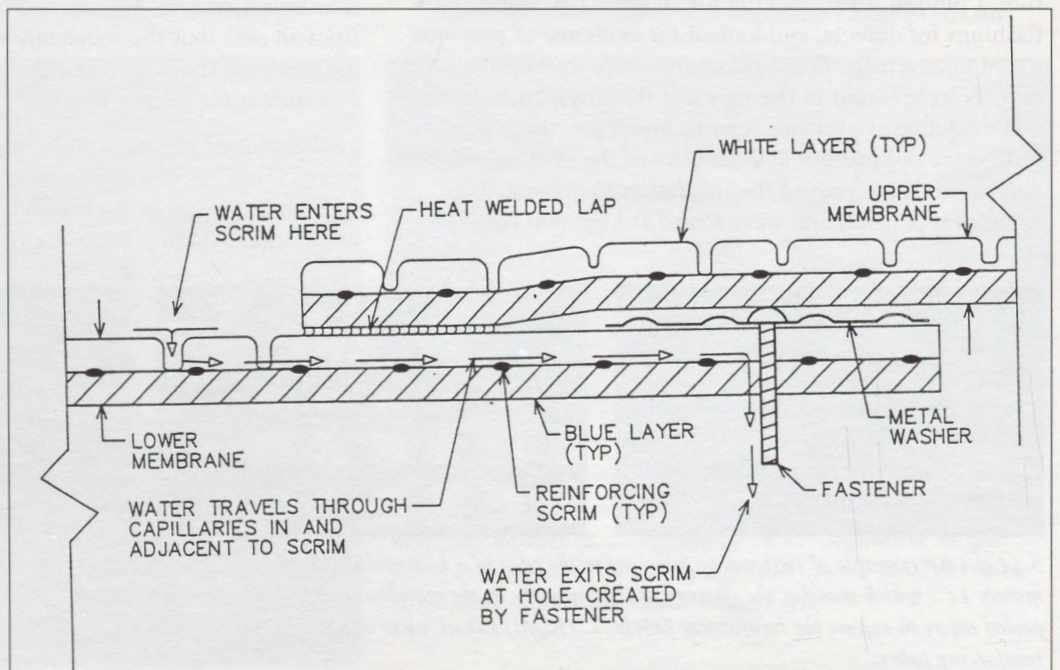
Another examination of the membrane samples revealed laps that also contained fasteners and stress plates. Some only contained the head of a fastener and the stress plate as the shaft of the fastener had completely rusted through. This was the answer! The outlet for the moisture was every 12" in the lap where the fastener punctured the membrane and the reinforcing fabric. That could also explain why there were rust stains adjacent to the membrane laps as mentioned above, and why many of the samples taken at seams were not secured. The shaft of the fastener had rusted through and the interior of the lap con-

I took one of the membrane samples, placing the lower portion of the lap in a pan of green food dye. I was careful to elevate the balance of the membrane so that only the fastener hole was in contact with the green food dye. I left the sample over night. The next morning the rusty edge of the lap was now green. Green spots were visible to the naked eye within approximately 6" of the fastener hole (See photograph #2). The source of the moisture had been found as shown on the accompanying drawing.

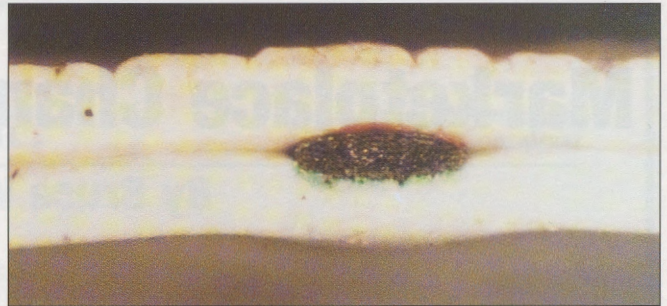
10. (Top) Another example of green food dye traveling through capillaries. 11. (Bottom) Edge of membrane at fastener hole. Note the frayed reinforcing fabric.
