A Long Term Evaluation of Mechanical Attachment of Thermoplastic Systems

Colin Murphy,
Trinity Engineering, Inc.,
Seattle, Washington

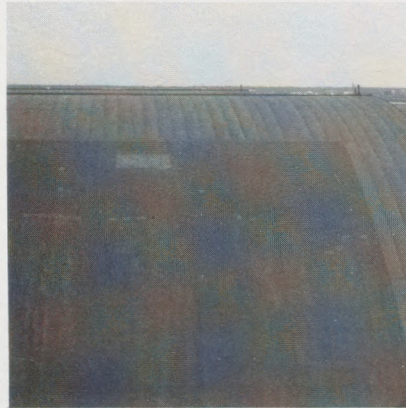
Photo 1
Hanger project installed in 1979. The manufacturer carried out frequent repairs to perimeter and barrel shoulders for the first four years of the installation.

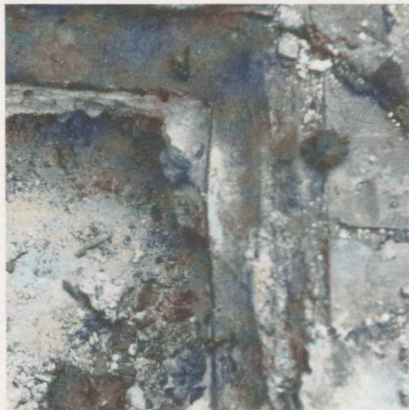
Photo 4
Finding a solid substrate for attachment.

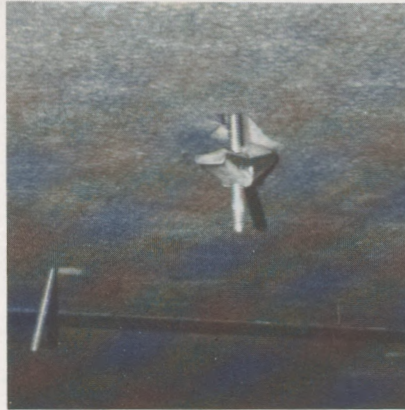
Photo 5
Toggle attachment systems with lost or loose toggle wings.

- ¹ See Appendix A
- ² Exposure definitions can be found in the Data Sheet 1-7, ANSI A58.1 and ASCE 7-88
- ³ Toggle bolts lost wings in all toggle installations (see photo 5). Due to toggle sample size, toggles were not included in the comparison.

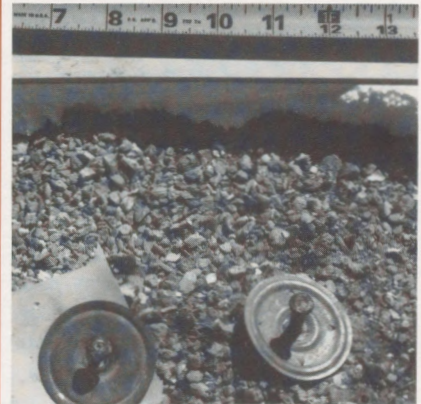
Photo 6
Removal of roof membrane and insulation to test fasteners during re-inspection.

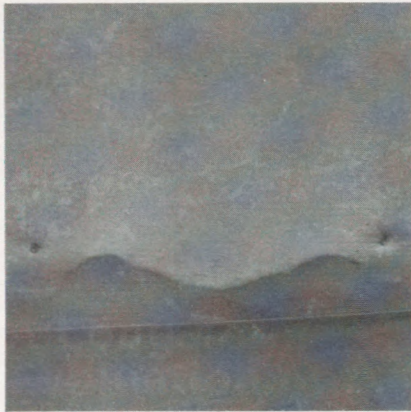
Photo 7

High uplift conditions stressed the weld and the lap plates causing bending of the plates and loss of fastener leads.

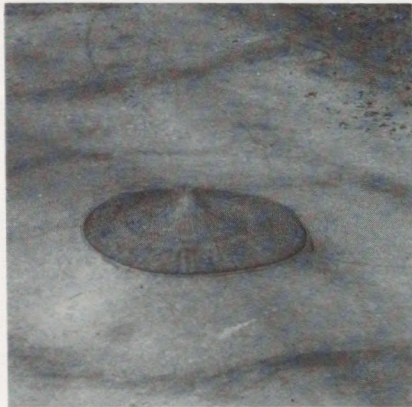
Photo 9
'Tented' fastener under a patch repair.

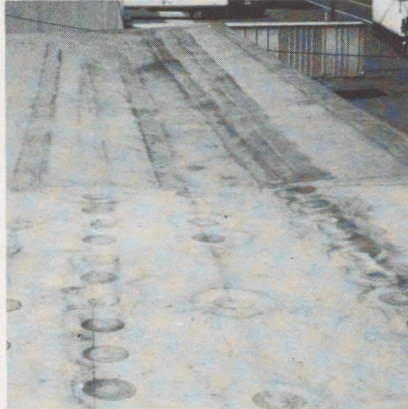
Photo 8
Corner repair with strips and individual fastener repairs with round patches.

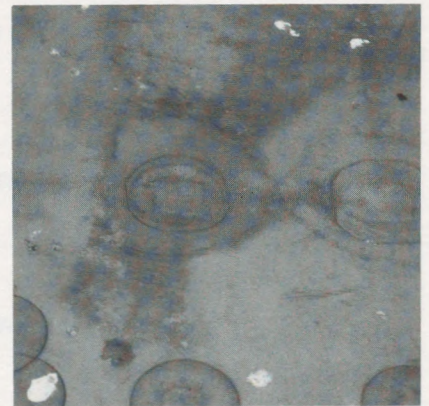
Photo 10
Concrete deck repair due to corroded fasteners.

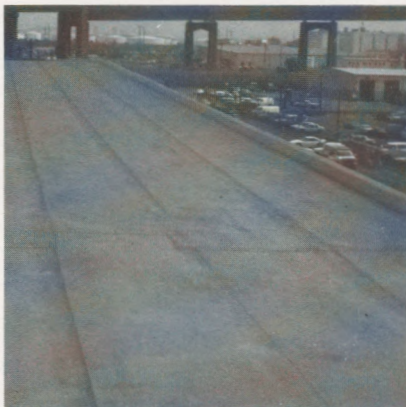
Photo 11
'Early' spot adhered and lap combination system with increased corner and perimeter attachment densities performing well after nine years.

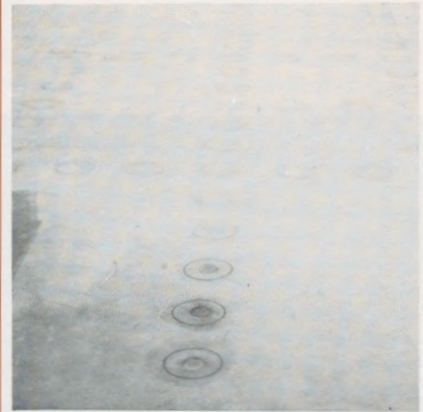
Photo 12
Early 'disc-over' system with no repairs needed over nine years.

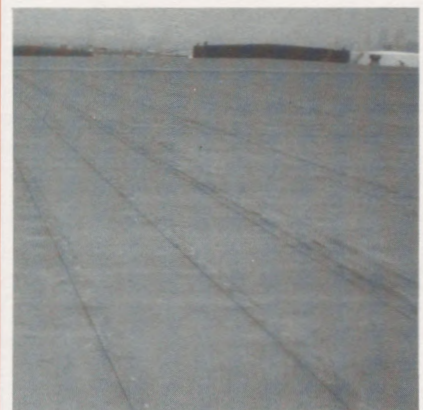
Photo 13
A 1986 installation installed in compliance with ANSI A58.1, the perimeter width measuring 40% of the building height. No corner or perimeter repairs were observed.

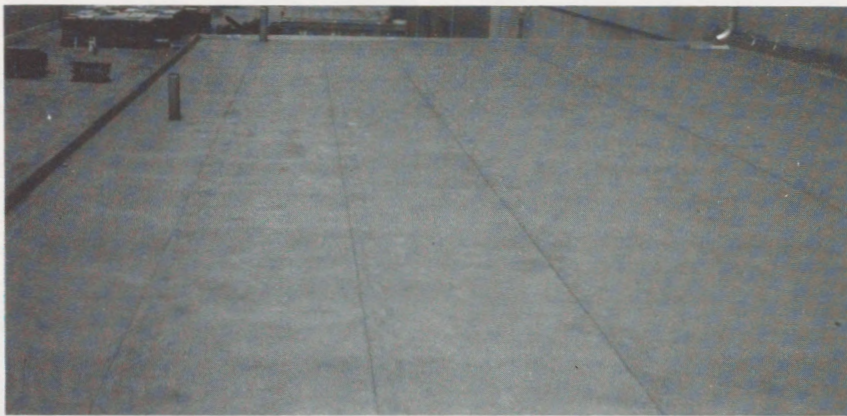
Photo 14
1986 installation of lower roof. Four half sheets, three at outer perimeter and one at the main building. Two full width sheets with fastening pattern at 12" o.c. (1:6 ft.²)

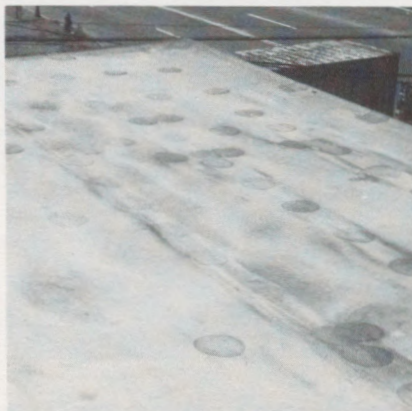
Photo 15
Multiple visits to the same repair area, a prevailing wind corner.

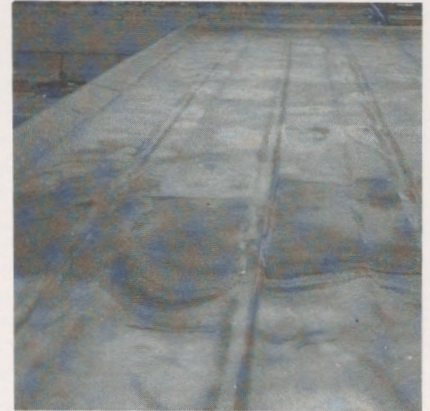
Photo 16
Wind damage to a 1983 installation with one perimeter half sheet.

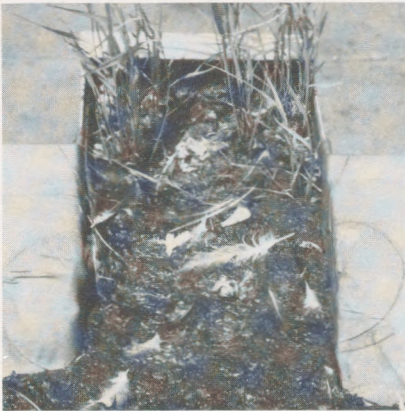
Photo 17
Poor maintenance was a common problem on all roofs in the survey.

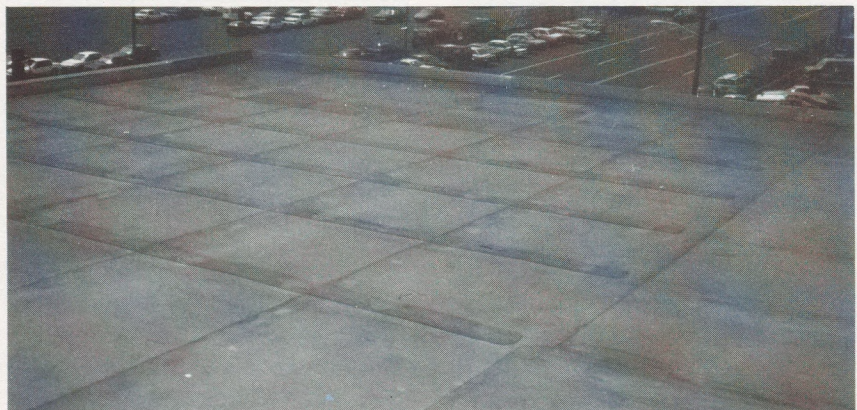
Photo 18
Subsequent corner repair meeting area calculation of ANSI A58.1.
