Hail Resistance and Performance Analysis of Elastomeric Coated SPF Roof Systems

BY DAN T. KASHIWAGI, PH.D., PE AND MANOJ K. PANDEY, M.S.

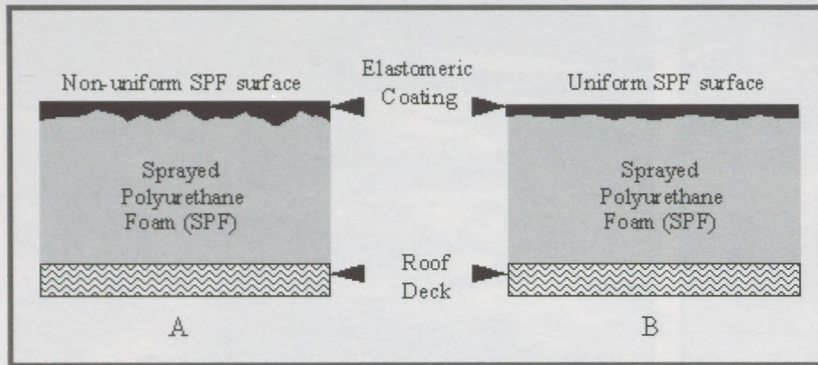
1. Inconsistency in meeting the physical properties specified by the manufacturer.
2. Elastomeric coating thickness specified in "gallons of coating per square" which are difficult to verify and sometimes meaningless due to the variation in coating thickness caused by the unevenness of the SPF application.
3. A more even SPF surface profile on a SPF installation requires less elastomeric coating (Figure 2A) to meet the min-

Figure 2: Sprayed Polyurethane Foam (SPF) roof system showing uniformly- and nonuniformly-applied SPF surface.

imum coating thickness requirement. Conversely, a more uneven SPF surface profile requires more coating material (Figure 2B) to be applied (due to high spots where the coating will gravitate to lower areas.)

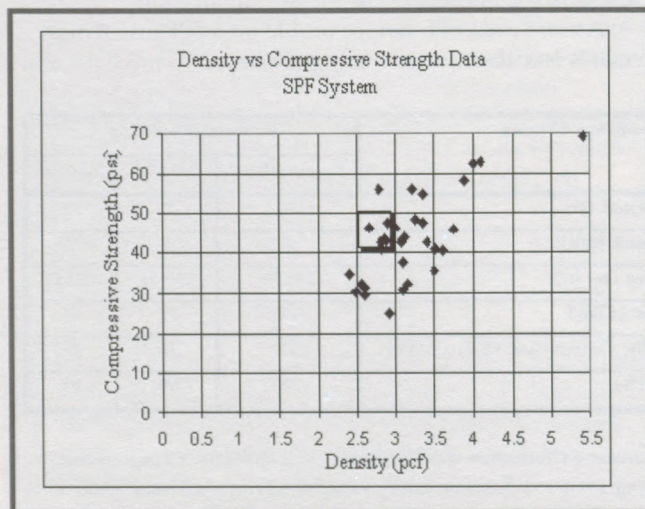
Data collection has shown that installed SPF compressive strengths and densities (Pandey, 1996) have large variations. Figure 3 shows that only 7 out of 33 random "in-field" samples of SPF from roof installations installed by performing contractors in 1995 met the manufacturer-specified (Kashiwagi and Pandey, 1996) 2.5 - 3.0 pcf density and 38 to 50 psi compressive strength requirements.

Figure 3: Density vs. compressive strength data for HCFC in-field SPF system (uncorrected for elevation), 1995.

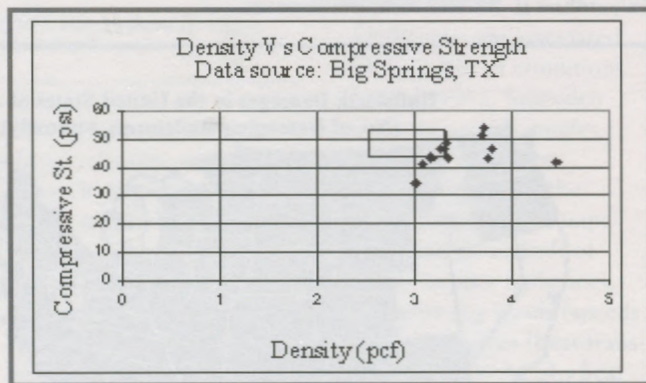
Big Springs, Texas and its surrounding area experienced heavy hailstorms on May 10, 1996. The damage to property and crops was estimated at \$25 million. Most of the property damage was caused by softball-sized hailstones (Kashiwagi and Pandey, 1998). SPF roof systems at the middle school were impacted by the softball-sized hailstones. The polyurethane-coated system, having an average coating thickness of 45 mils, 3.0 pcf, and 45 psi compressive strength average SPF, withstood up to at least 3-inch diameter hailstones. The correlation between density and compressive strength shows that the samples which resisted the impact of oversized hailstorm met the criteria specified by the manufacturers (refer to Figure 8).

Figure 8: Density vs. compressive strength analysis.

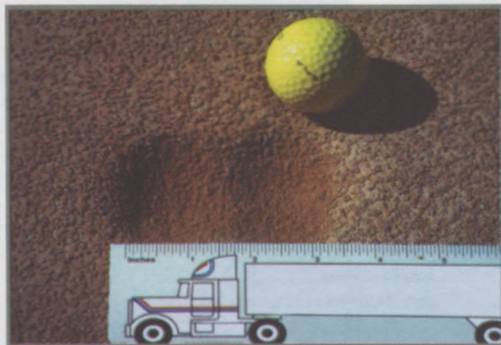
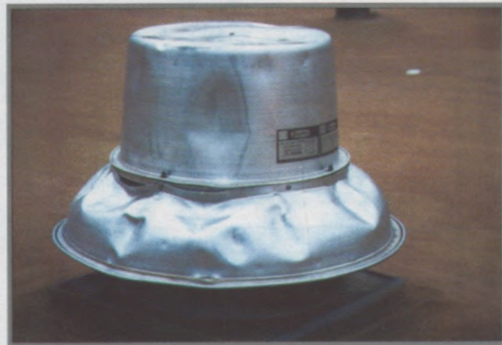
The damage of the oversized hail was compared to the damage of the "severe" hail damage. The indentations created by the hailstones were measured a year and a half after the hailstorm (results shown in Table 6). The indentation diameter created on the polyurethane-coated SPF system by the simulated FM SH hail resistance test has the range of 31 mm (1.2 inches) to 37 mm (1.5 inches) with an average of 33 mm (1.3 inches). The average indentation depth of the FM SH test was 7.6 mm (0.25 inches). The indentation diameter created by the hailstones at Big Springs, Texas ranged between 38 mm (1.5 inches) and 76 mm (3.0 inches).

Figure 7A (left): Polyurethane-coated SPF roof system impacted by "oversize" hail in Big Springs, Texas. The average indentation diameter was almost 2.7 inches (210% bigger than the indentation created by FM-SH golfball-size (1.3 inches) hail impact). Figure 7B: HVAC unit showing the indentations created by "oversized" hail in Big Springs, Texas (May, 1996).
