Electric Heating Systems For Combatting Icing Problems On Metal Roofs

BY JAMES BUSKA, WAYNE TOBIASSON, ALAN GREATOREX AND WILLIAM FYALL

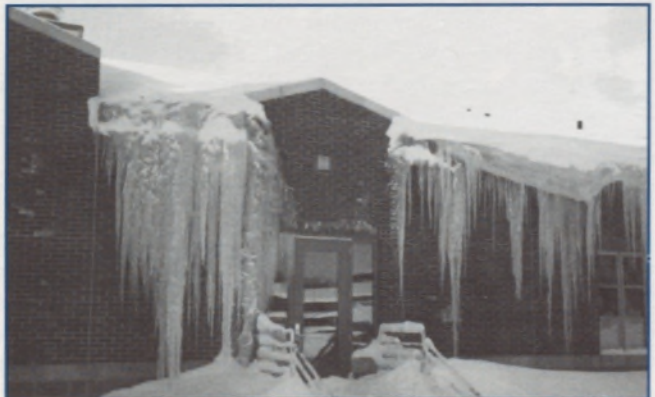
Figure 1. Severe, problematic icings and ice dams along eaves of a dining facility at Fort Drum in upstate New York.

Many new standing seam metal roofs at Fort Drum, near Watertown, NY, suffered from severe icing and leakage problems (Figure 1). The authors determined the primary cause to be excessive attic heat³ and developed natural and mechanical attic ventilation improvements that solved most of these problems.

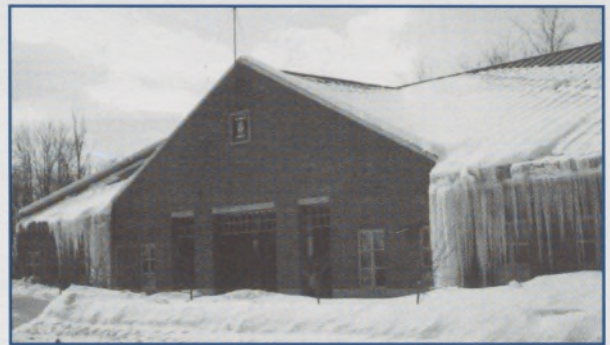
Figure 2. Large ice dams and icicles form where the gable parapet ends at the bottom of valleys.

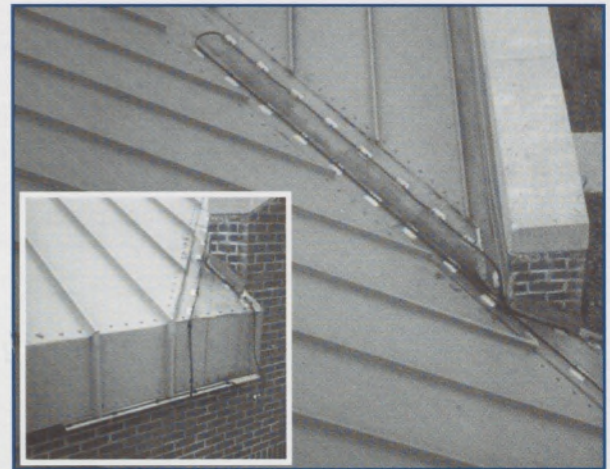
Figure 3. System with single heater loop in valley. Inset shows heater runs on the fascia and drip edge at this location.

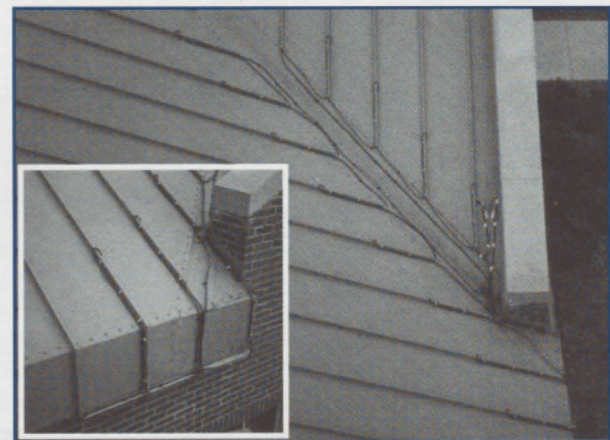
Figure 4. System with multiple heater runs in the valley, behind the parapet and on several standing seams. Inset shows heater runs at its fascia and drip edge.

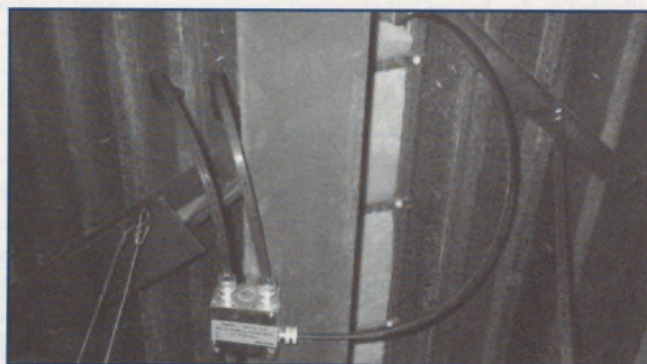
Figure 5. System with high output heater installed below the metal roof in a valley.

Electric heaters placed under the metal roofing of one valley (Figure 5) kept a wide, clear melt path down the valley. However, the 1649 watts provided in that valley (Table 1) was too much and it melted more snow than was necessary. That extra meltwater refroze on cold portions of the fascia and created a large, dangerous icicle (Figure 9a), even when no icings were forming on the control valley. The authors concluded that too much heat was provided in all valleys. Meltwater was produced by the heaters even when it was too cold outside for the warm roofs of these buildings to be producing meltwater. The low output heater used on one roof provided enough heat to create a melt path through the ice dam and to avoid ponding there.

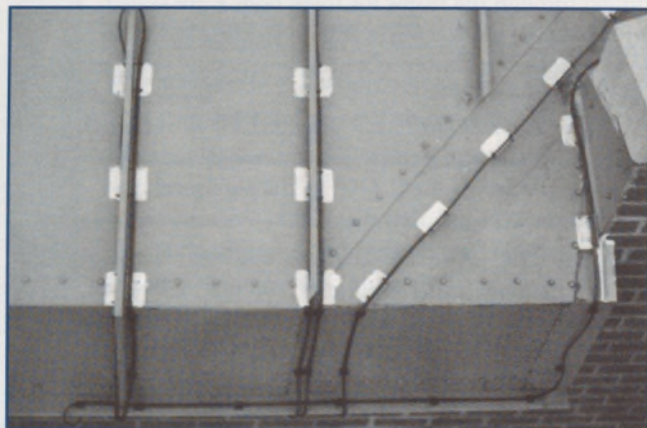
Figure 6. Typical attachment of nylon mounts to fascia with epoxy. Angle clips on the roof itself are attached with neutral-curing silicone. Note horizontal heater all along drip edge.

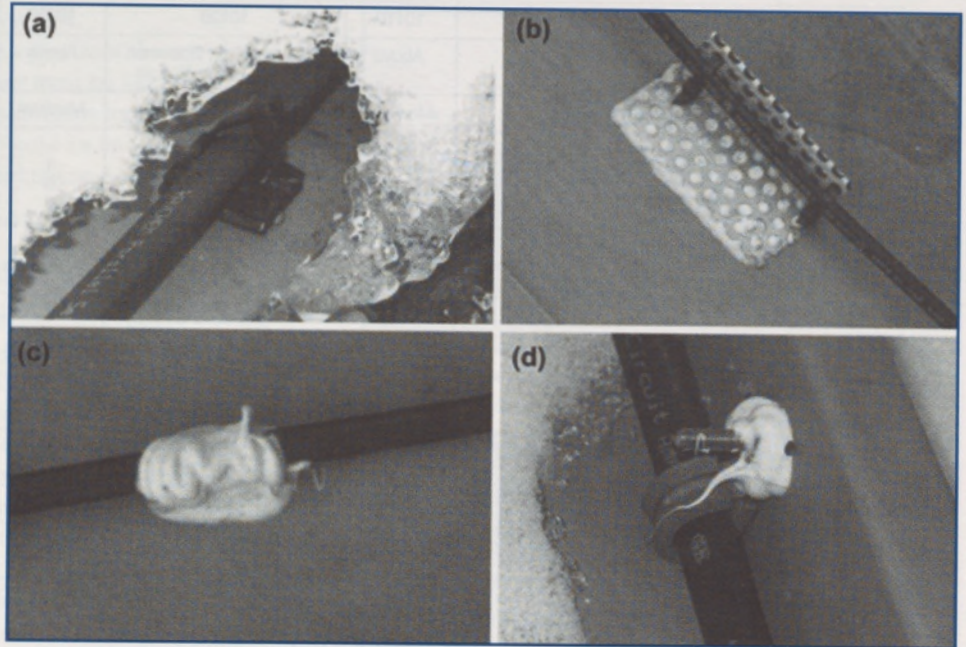
Figure 7. Heater attachments: (a) epoxy adhered plastic mount, (b) angle clip adhered with neutral-curing silicone, (c) heater adhered with silicone only and (d) mechanically attached stainless steel loop clamp high on the standing seam.

The weakest attachment method was the nylon mounts adhered with epoxy. By the end of the winter, 73 percent of them had failed (Table 1) and heaters were hanging down from all six test valleys. Some of the epoxy failed adhesively at the nylon mount, but most failed at the coated metal roof. The mechanically-attached loop clamps worked quite well and can be used wherever holes can be accepted. One mechanical loop clamp failed when a large icicle with a fascia heater embedded in it fell off the roof, pulling that clamp out of the weak soffit screening. The adhesively-attached perforated angle clips also worked well. Sliding snow and ice bent them over, but most remained in place. Two failed adhesively when sliding snow and ice from the roofs above took them out. A lower profile clip may have survived. None of the silicone puddles holding a heater loop on the roof behind a parapet failed. Their success was related to three angle clips (one which failed due to sliding snow) on the same heater loop that provided most of the resistance.

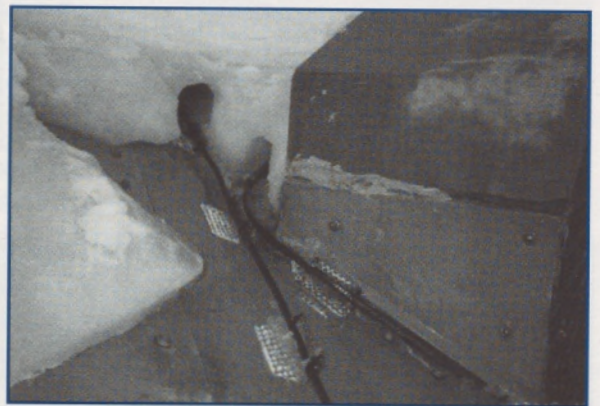
Figure 8. Heaters provide melt paths through snow and ice for meltwater to drain off the roof. Some ice was removed to expose these paths for this photo.

All six electric heater systems provided melt paths through the ice dams in their valleys and prevented ponding from occurring there (Figure 8). In most cases, this greatly reduced the size of the icings and the risk of roof leaks. Roof leaks were reported under control valleys that winter but not under the heated valleys.

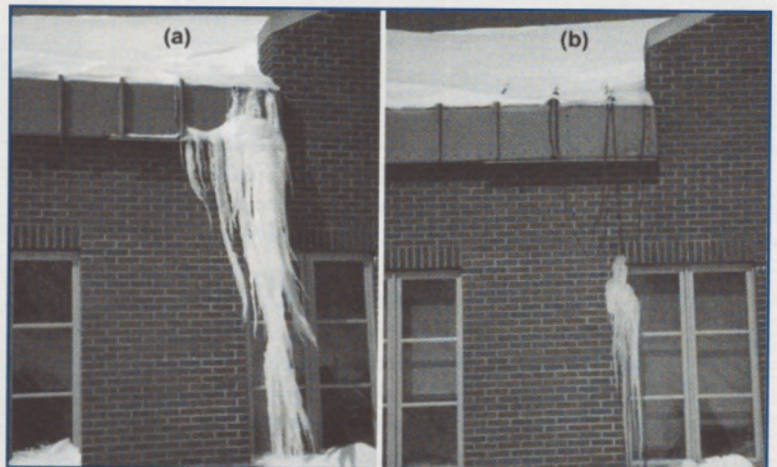
Figure 9. (a) Large icicle created by a high-powered valley heater and (b) three days later, its remnant hanging from the displaced (but still operating) heater.

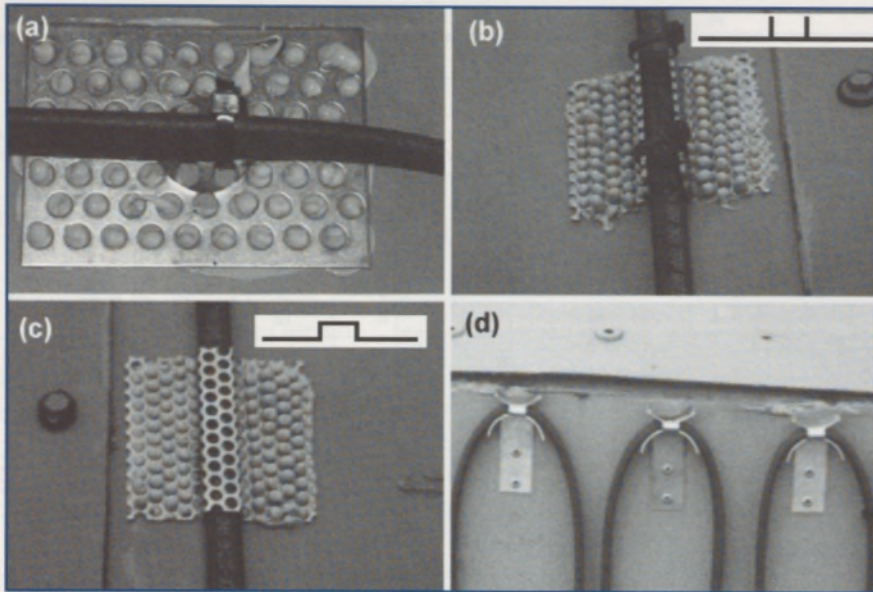
Figure 10. Heater attachments adhered with high-strength, neutral-curing silicone are: (a) dome, (b) channel, and (c) tunnel clips. The commercially-available butterfly clip (d) was mechanically attached with rivets or screws.

The dome clip attachment method continued to suffer from broken cable ties which had to be replaced often. The angle, channel, and tunnel clips provided better mechanical support and resisted downslope movement of the heater, even when a cable tie broke. These perforated clips let the silicone adhesive squeeze through their perforations as shown in *Figures 10a, 10b and 10c*. This allowed the adhesive to cure better and provided some mechanical connection between the adhesive and clip.

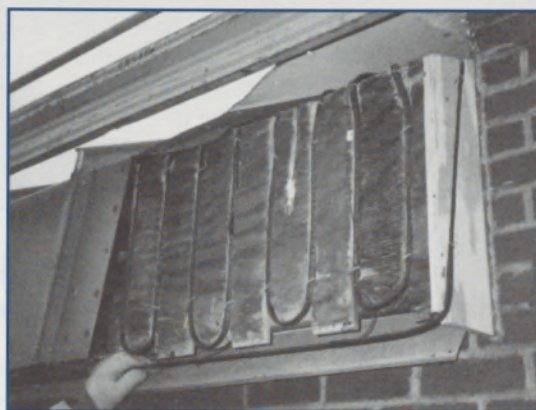
For aesthetic and thermal efficiency reasons, some heaters were placed behind the metal fascia. On two buildings, plywood sheathing behind the metal fascia was routed out and the heater carefully stapled in these channels (*Figure 11*). Upper loops from the heater's fascia runs were held tightly to the sloped metal roofing. The end of the heater ran horizontally at the bottom of the fascia to warm the drip edge. When the metal roofing was replaced, these two buildings had all their heaters located below the metal roofing. This was difficult to do but it was tried for the aesthetic, maintenance and thermal efficiency benefits gained.

Figure 11. Heater laid in channels routed in the plywood sheathing behind the fascia metal.

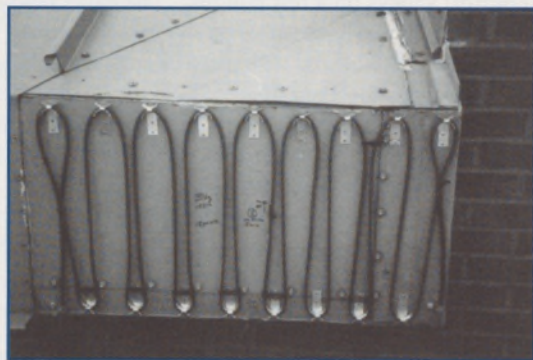
Figure 12. Heater looped over butterfly clips mechanically attached to fascia.

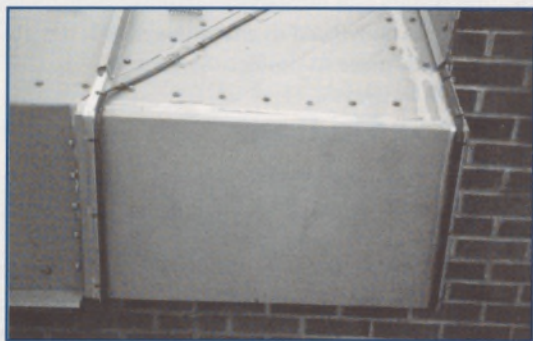
Figure 13. False closed-top fascia installed over heater shown in Figure 12. Note heated vertical baffles (water diverters) at each end.

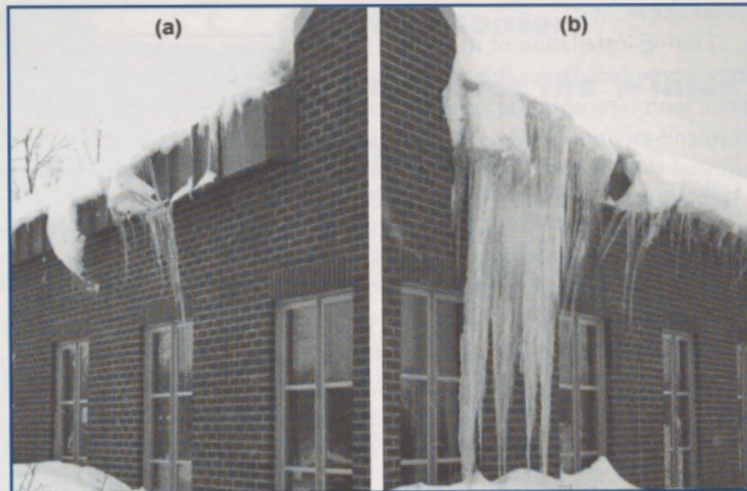
Figure 14. Comparison of heated and unheated valleys at Building 10210 on Feb. 22, 1993: (a) Heated valley and heated false fascia clear of ice. (b) Adjacent unheated valley and fascia encased in ice.

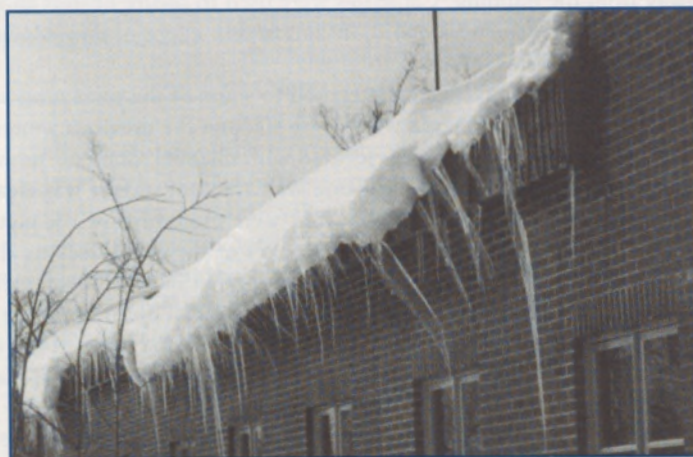
Figure 15. Icings forming on a creeping, overhanging mass of snow and ice, bypass the heated fascia on this building. Note exposed heaters at near end of fascia.
