CORROSION OF METAL COMPONENTS in Wood Construction—

BY STEVEN A. MANDZIK, RRC, CDT

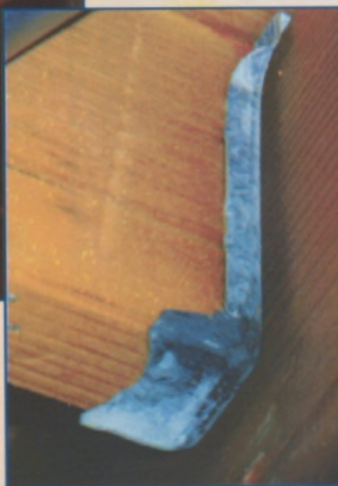
CLEAN SUB-PURLIN HANGER WITH WHITE POWDER BEGINNING TO FORM

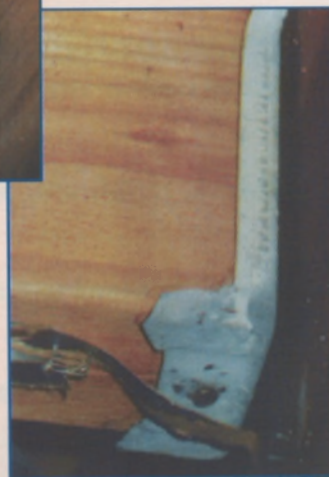
WHITE POWDER COVERING ENTIRE SUB-PURLIN HANGER

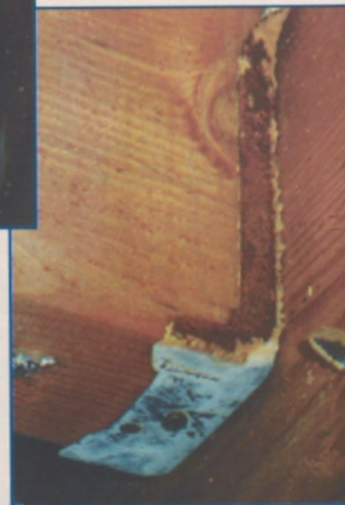
SURFACE RUST ON SIDE OF SUB-PURLIN HANGERS.

In each of the four cases noted above, we spent considerable time researching the cause of the rusting. We found tenants in each building were not conducting any high-level humidity operations. In terms of age, three of the buildings were 16 years old, while the fourth was 11 years old at the time of discovery. The 11-year-old building demonstrated the worst case of rusting. The interior humidity was recorded in this last building at floor level in two different areas and measured 28% and 44% while the exterior humidity was 44%. Although the floor level humidity did not appear extreme, there must have been a considerable amount of humidity trapped above the ceiling foil to cause the severe rusting. During the normal cycles of daily weather changes from hot to cold, the dew point was achieved in the roof cavities, and this humidity condensed on the surfaces of the metal hangers. Since there were no gaps left at the edges of the stapled foil, no venting of moisture vapor was possible.

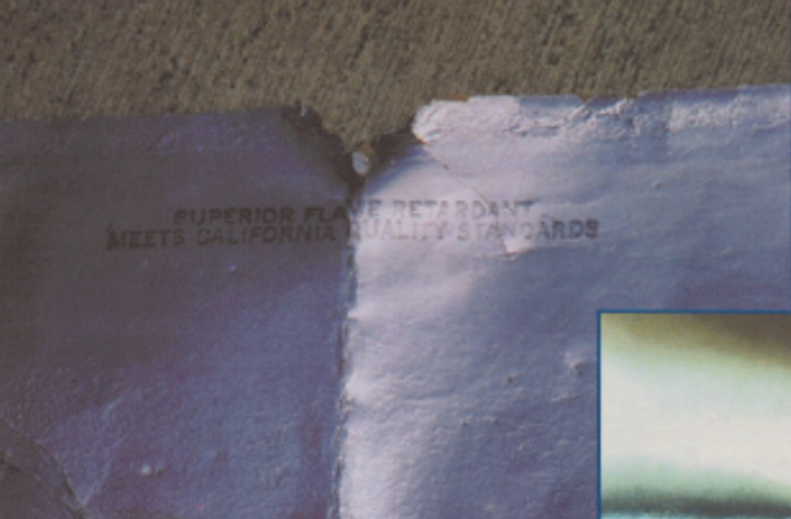
TYPICAL CEILING FOIL PAPER STAPLED BENEATH SUB-PURLINS

It has been a very complicated procedure to inspect this condition and just as difficult to find conclusive recommendations from professionals. The ceiling foil may only be a radiant barrier and completely removing it is probably the first step in reducing or preventing the condensation. However, city building departments, fire marshals, and architects are unwilling to comment on, or put in writing, the use of the foil and if it can be taken down.

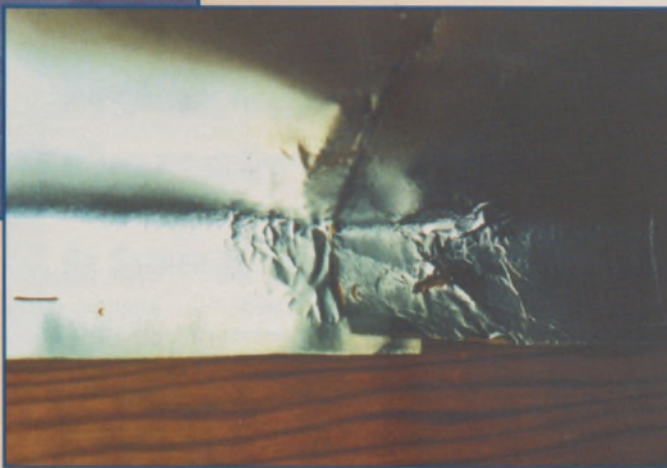
CONDENSATION STAINING ON PAPER CEILING FOIL DIRECTLY BENEATH SUB-PURLIN HANGER

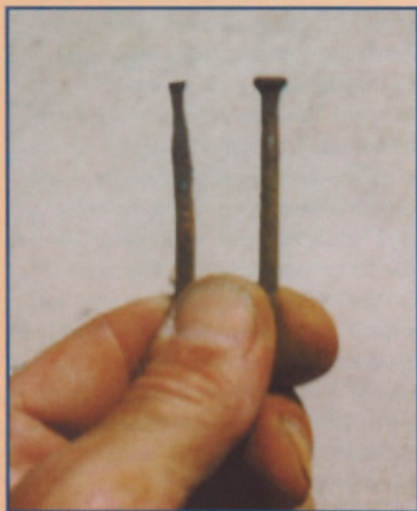
RUSTED HEAD AND SHANK OF PLYWOOD DECKING NAIL.
