# POST-INSTALLATION FIELD EVALUATION

## OF A PRESSURE-EQUALIZED SINGLE-PLY ROOFING SYSTEM TO DETERMINE DRYING EFFECTS ON A MOIST, CEMENTITIOUS, ROOF DECK

BY WARREN R. FRENCH, P.E., RRC, CCS

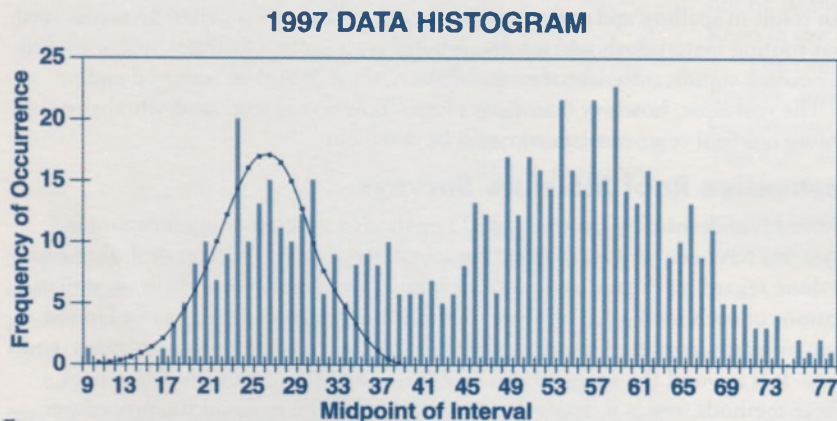
Figure 2

1997 MOISTURE CONTENT CORRELATION

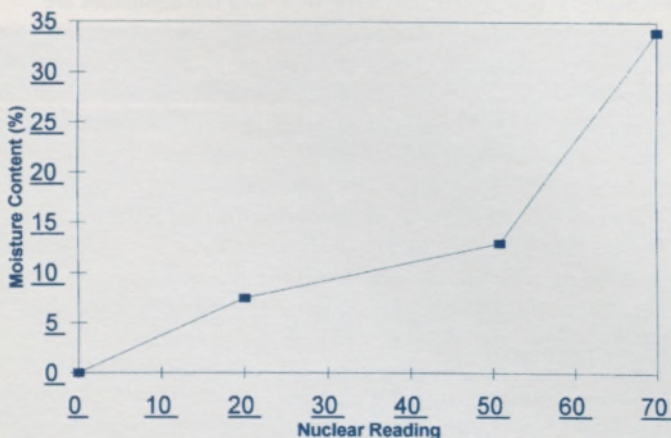
Figure 3

As previously stated, the 1997 roof moisture survey indicated that the original wood fiber insulation was saturated, with a large majority of the roof area exhibiting moisture contents in excess of 30% and ranging as high as 600% by weight. Previous studies indicate that wood fiber insulation can exhibit a moisture content of up to 580% when subjected to immersion (Anderson, 1985), which correlated well with our results. In contrast, based upon our study, the moisture content of the lightweight insulating fill was significantly lower than the wood fiber, with most of the roof area (86%) exhibiting moisture contents below 25%. (Reference Figures 1 through 5.)

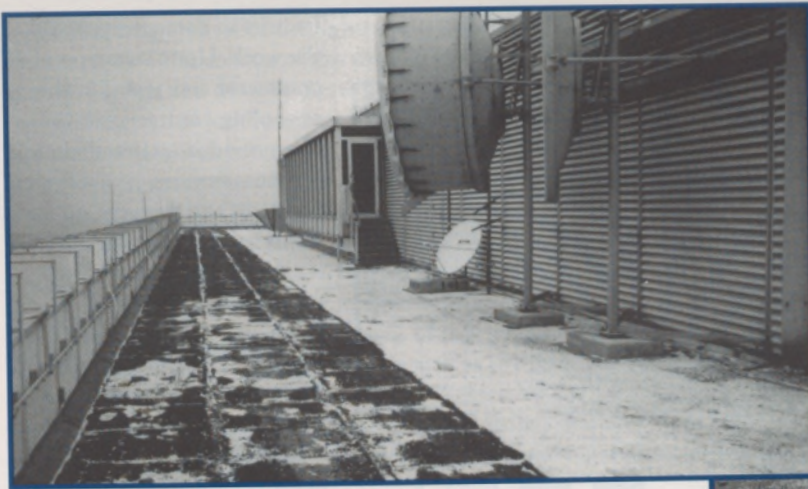
Left: Lower roof prior to re-roof.

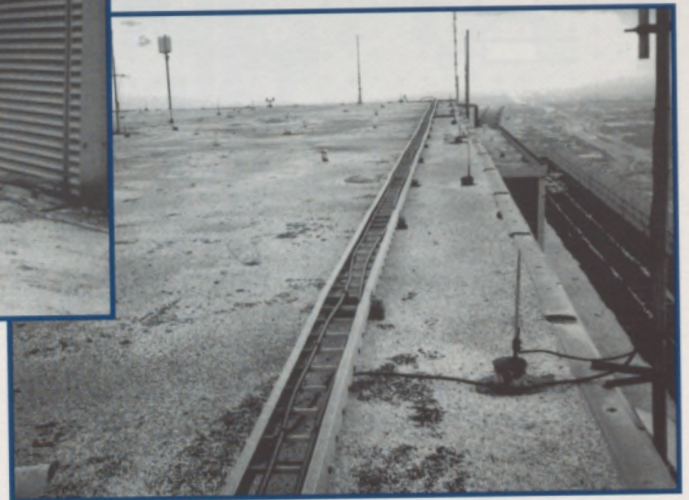
Below: Upper roof after renovation.

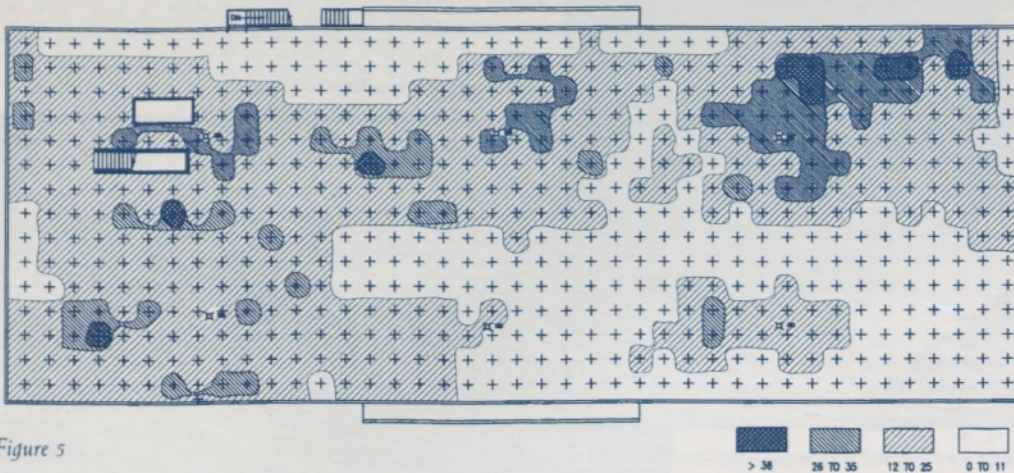
Figure 5

1997 MOISTURE CONTOURS

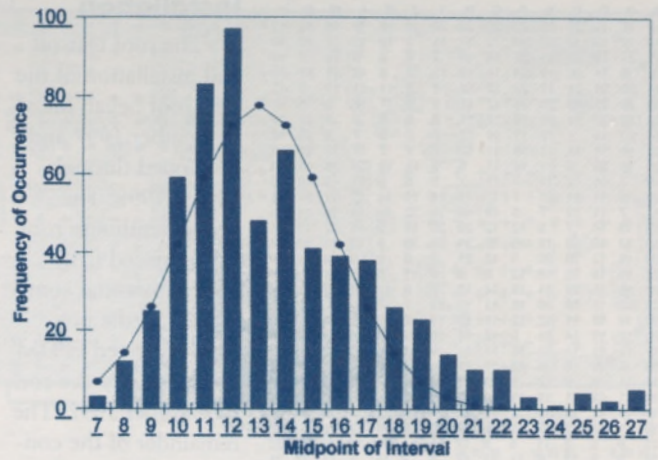
Figure 7

1998 DATA HISTOGRAM

The 1998 roof moisture survey also consisted of 608 data points and indicated extremely consistent conditions within the gypsum sheathing layer of the new roof. Although the moisture content of these materials was slightly elevated (with moisture contents ranging between 17.8% and 18.2% by weight), the integrity of the water-resistant sheathing had not been adversely affected. In addition, although no isocyanurate insulation samples were extracted, moisture probes using a Delmhorst meter indicated no significant moisture in that roofing layer either. However, the lightweight insulating fill still exhibited moisture contents ranging from 4.7% to 33%. The mean moisture content throughout the readings of the entire roof was 15%, with a standard deviation of 5.6%. (Reference Figures 6 through 10.)

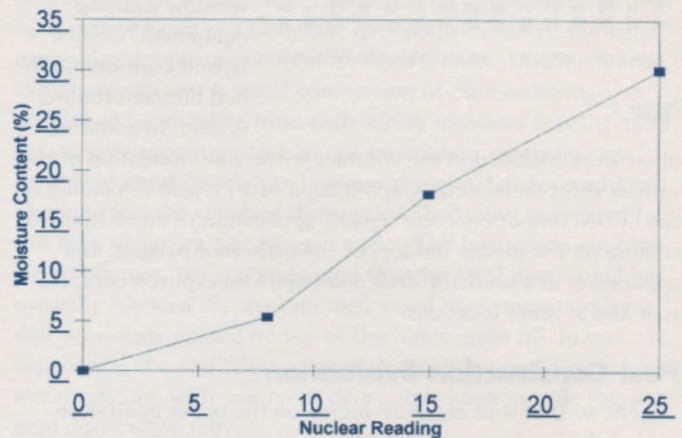
Figure 8

1998 MOISTURE CONTENT CORRELATION

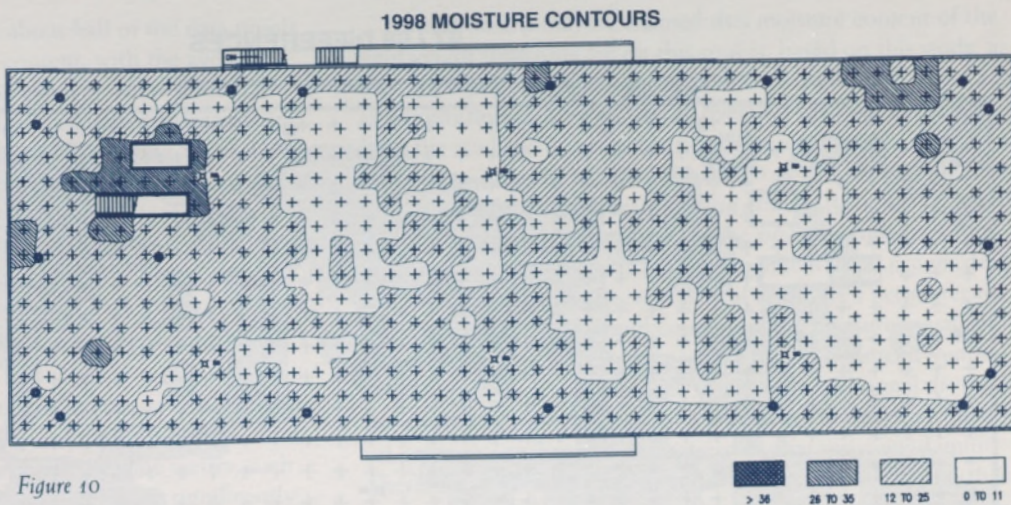
Figure 10

A final evaluation of the two studies indicates that the 1998 survey exhibited apparent "drying" of specific areas such that the one-way pressure-equalization vents tended to be within or on the edge of the closest drying area. Sixteen of the eighteen P.E. vents installed on this roof (89%), when located on the contour map showing change of moisture contents at specific data points, occur adjacent to or within an area exhibiting drying. In our opinion, this is a fairly strong correlation between the location of these vents and the drying observed on this roof.

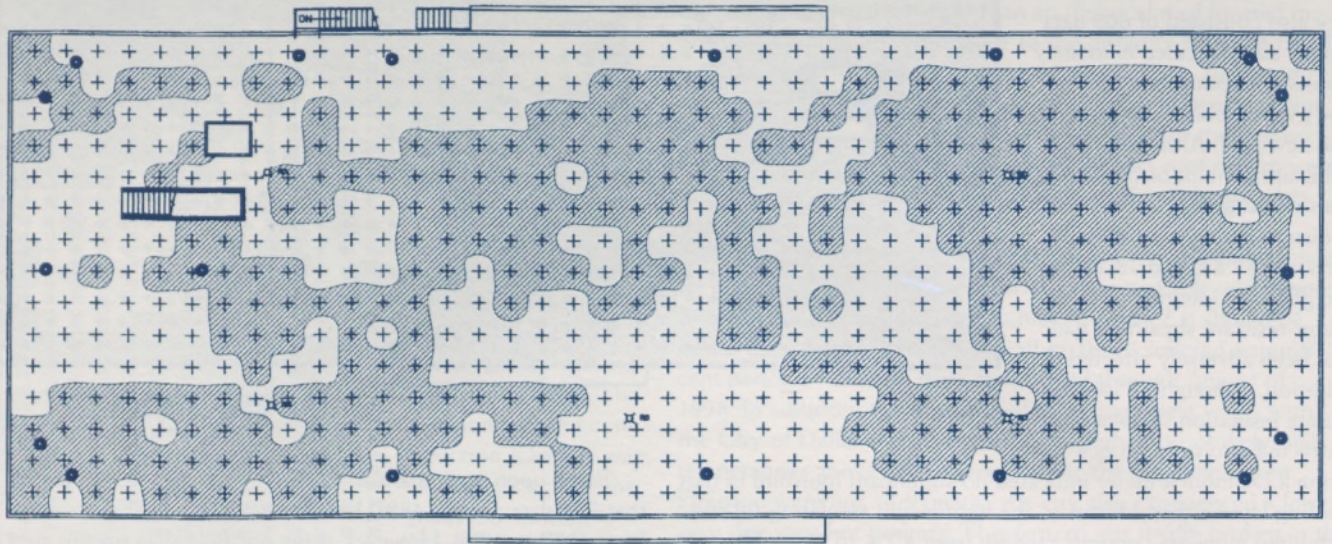
Figure 11

Based upon a comparison of our two surveys, it was noted that 289 data points (48%) had decreased in moisture content from 1997 to 1998. However, using our field data on this roof, it was noted that 318 data points (52%) in the 1998 survey exhibited an increase in moisture content when compared to the 1997 survey. (See Figure 11.) Only one data point exhibited the same extrapolated moisture content for both surveys, which is statistically insignificant. A visual comparison of the two histograms developed for the data from each survey indicates that the 1998 data is very consistent and, in our experience, represents an extremely good correlation between the actual meter readings obtained and the standard distribution (bell curve) expected for this type of survey. See Figures 2 and 7. The histograms are obviously different, but it is suggested that the 1997 data would be naturally "skewed" by the saturated wood fiber insulation layer that previously existed on top of the lightweight fill. In our experience, the 1997 data are consistent with a roof that exhibits wet insulation, with numerous data points lying outside the standard distribution curve.

about 32%. By contrast, for those 318 points exhibiting an increase in moisture content, the average increase (or overall change) at each individual grid point was about 61%. So, essentially, it could be said that individual grid point locations on about half of the roof area increased in moisture content and did so by about twice the amount that the other half of the roof decreased. The cause of this observed anomaly is not known but it is somewhat instructive to tabulate the data points with respect to the various ranges, or breakdowns, of moisture contents utilized to draw the moisture contour maps for each survey. Although the break-down divisions are completely arbitrary, using identical breakdowns for both surveys allows a direct graphical comparison of the moisture contours within the roof as determined by the two surveys. In addition, tabulating these data points allows another measure of the changes exhibited by the lightweight insulating fill material. (Reference Table 1.)

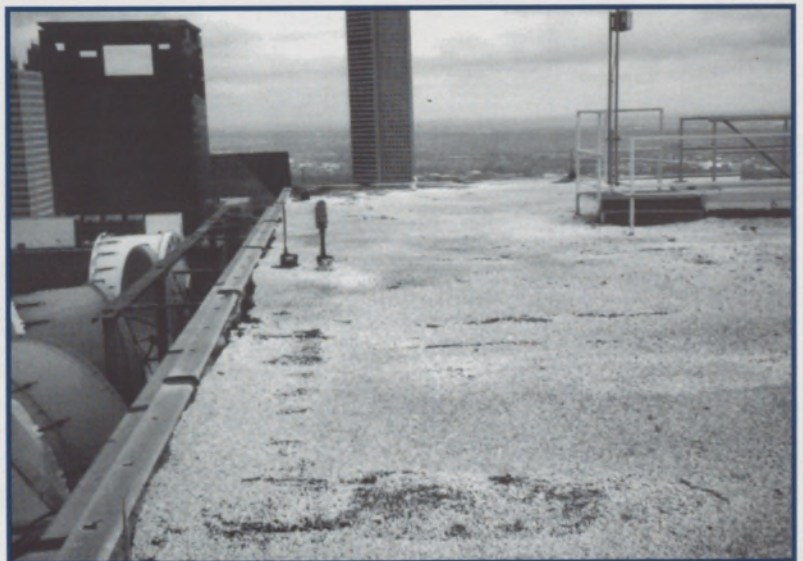
Upper roof after renovation.
