A Deep Dive into Hail-Caused Dents: A Study of Corrosion Resistance within Dents in Galvalume-Coated Steel Roof Panels

By Jordan Beckner, PE, RRC; and
Stephen Patterson, PE, RRC

This paper was originally presented at the 2024 IIBEC International Convention and Trade Show.

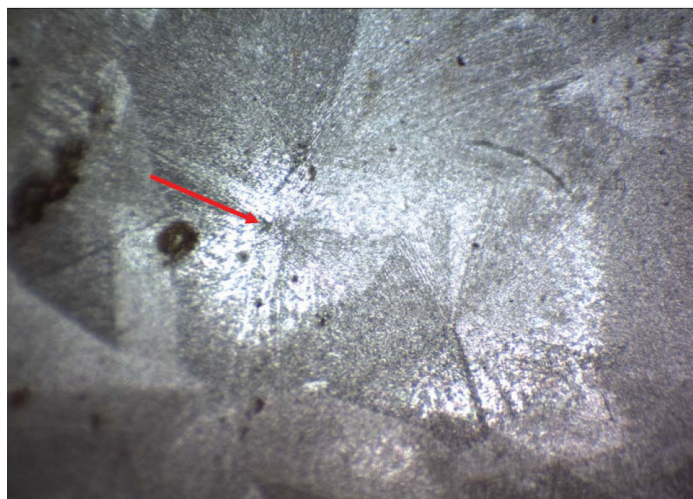
However, the examination of these rust-colored spots "revealed that the rust-colored spots were extremely superficial" and, upon further investigation, were found to be caused by residuals from the steel ball—an effect that would not occur with real hailstone impact. Madhani⁸ noted that there was "no evidence of cracking or pitting of the coating" at the impact locations. The spots were cleaned and examined and "no cracking or corrosion of the coating or the substrate" was observed.

Figure 5. A view of a 1.75-inch steel ball impact point center under 80x magnification. The red point indicates a coating scuff.

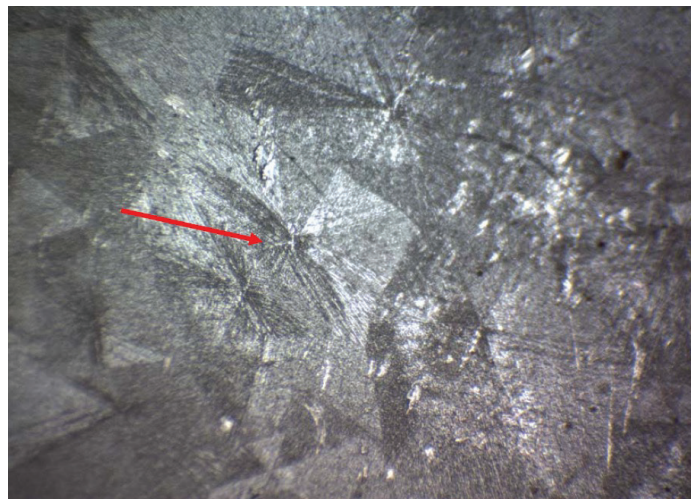
Figure 6. A view of a 2-inch steel ball impact point center under 80x magnification. The red point indicates a coating scuff.

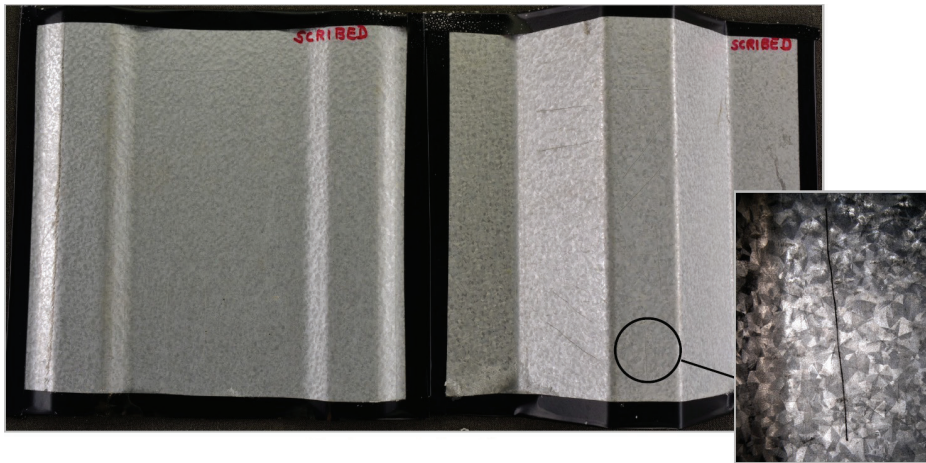
The scribed sample, which was tested to simulate a crack in the coating, revealed no evidence of rust after 336 hours of salt spray (fog). The cracks extended through the coating and into the carbon steel and were visible without magnification. Madhani⁸ concluded,

“the absence of corrosion of the carbon steel demonstrates the galvanic protection provided by the coating on exposed areas of the substrate.” **Fig. 7** is an excerpt from Madhani⁸ showing the scribed area after 336 hours of salt spray (fog) testing with no evidence of corrosion. However, at the crimped area of the foot-pressure-created rib buckle, corrosion was evident after 162 hours in the salt spray at the crimped area of the footstep buckle. **Fig. 8** shows the corrosion at the footstep buckle after 162 hours.

Figure 7. Photograph of the scribed samples of Galvalume roof panel sample showing the lack of visible evidence of corrosion following 336 hours of test cycle. Reproduced with permission from Madhani (2017).

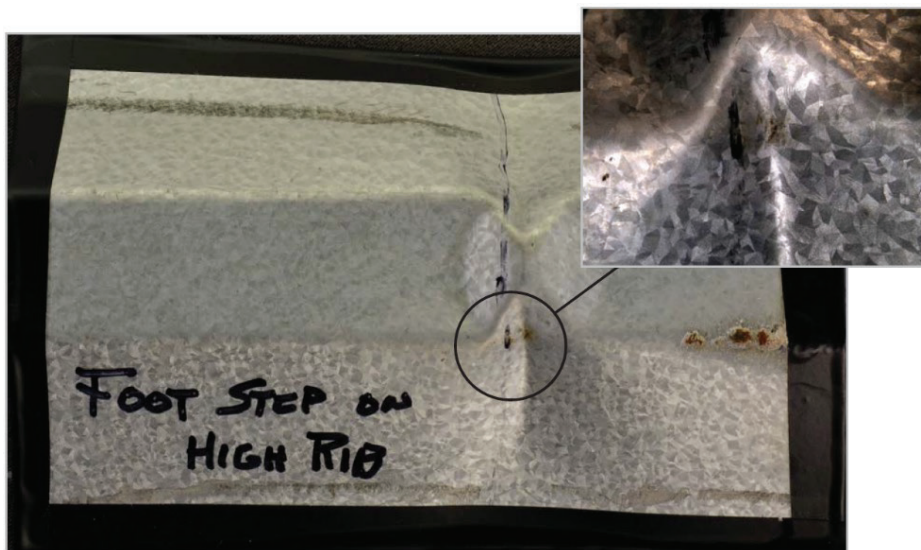
No visual evidence of corrosion (specifically, iron oxide or rust) was observed on the scribed roof surface after 336 hours. Isolated rust was observed within the footstep buckle after 72 hours. Slight rust-colored spots were observed on the dented ribs from the 1.75- and 2.00-inch simulated hail impacts after 252 hours on the 1.75-inch test sample and after 336 hours on the 2.-inch test sample.

Figure 8. Photograph of footstep buckle showing corrosion after 162 hours of salt spray testing. Reproduced with permission from Madhani (2017).

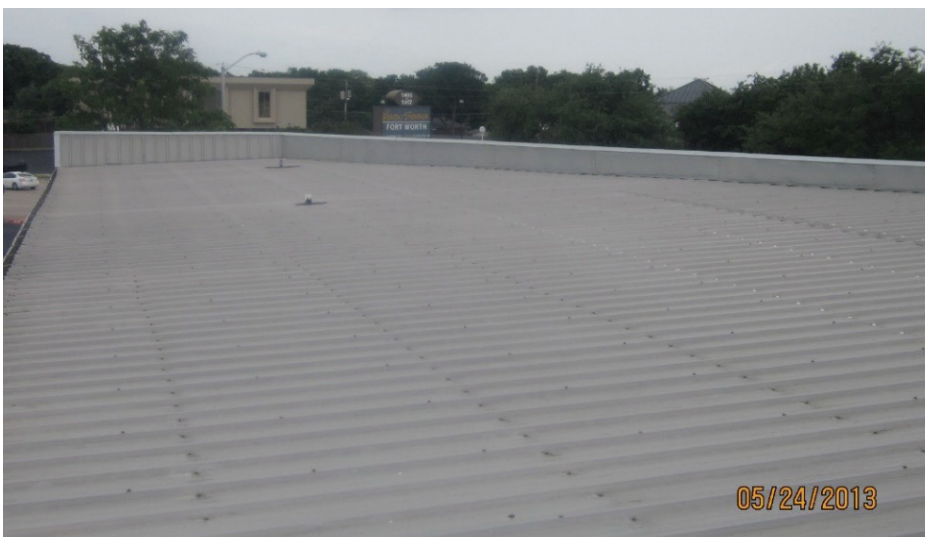
Figure 9. Photograph of the case study roof taken in 2013, approximately 18 years after the hail event, when the roof was 27 years old.

The roof on the building was subjected to impact from hailstones up to at least 2 inches in diameter, with some hailstones possibly reaching 4 inches. The roof was not replaced after the Mayfest Storm. The roof on the building had numerous dents but no hail-related leaks. The building has a history of minor leaks occurring at the end laps of the metal panels and at screws. In 2013, one of the authors reinspected the roof to evaluate its performance. **Fig. 9** is a photograph of the roof taken in 2013, approximately 18 years after the hail event, when the roof was 27 years old. The roof leaks were minor and in generally the same locations, related to end laps and screws, as they were in 1995. There were a few repairs to the screws and penetrations.

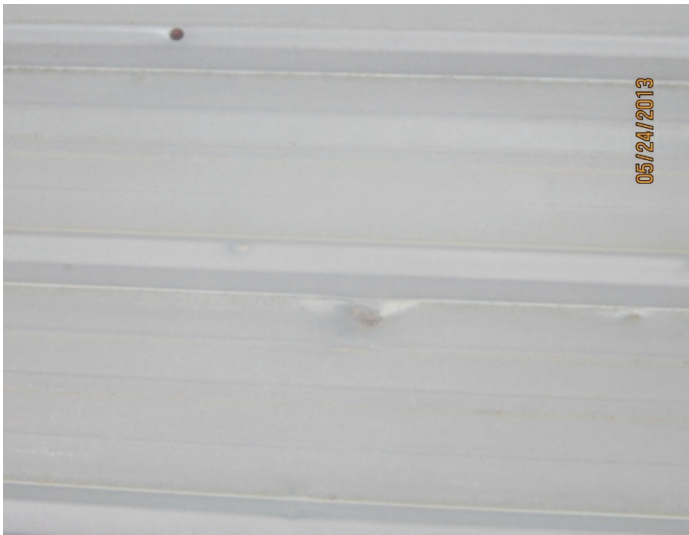
Numerous hail-caused dents were visually examined, including examination at 10x to determine if there had been any deterioration as a result of the hail-caused dents. **Fig. 10** shows typical hail-caused indentations with stains in the dents that were randomly spaced across the roof.

Figure 10. Photograph of the dents in the case study roof caused by the Mayfest Storm.

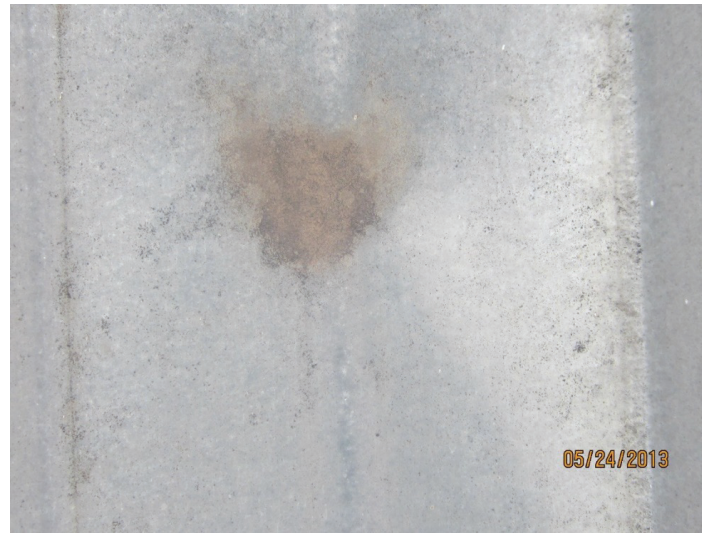
The larger hail-caused dents were stained with sediment in the dents. **Fig. 11** shows a close-up of one of the larger hail-caused dents with stains. **Fig. 12** shows the hail-caused dent cleaned. There was no evidence of corrosion or other evidence of deterioration. **Fig. 13** shows a 10x view of the impact area. There is no visible corrosion or deterioration of the Galvalume coating at 10x.

Figure 11. Photograph of typical hail-caused indentations with stains in the dents.

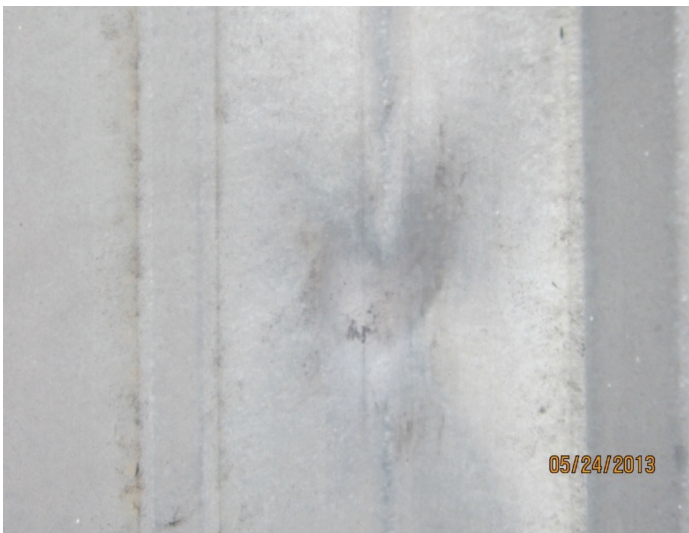
Figure 12. Photograph of a cleaned hail-caused dent—note the absence of evident corrosion.

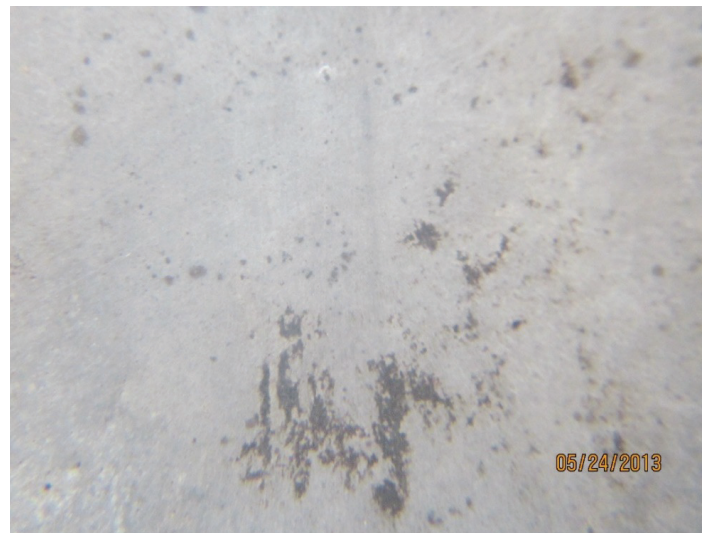
Figure 13. Photograph of a cleaned hail-caused dent under 10x magnification—note the absence of evident corrosion.

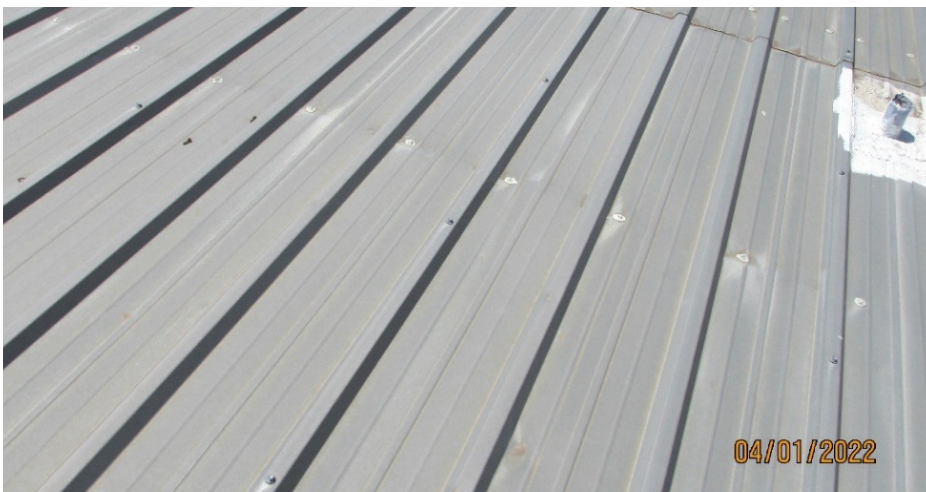
Figure 14. Photograph of case study roof taken in 2022 approximately 17 years after the Mayfest Storm.

In 2022, one of the authors again reinspected the roof to evaluate its performance. **Fig. 14** shows an overview of the roof on the building taken in 2022 approximately 27 years after the Mayfest Storm. The roof was approximately 40 years old at the time of this inspection. Overall, the appearance of the roof was in a substantially similar condition to its condition at the previous inspection.

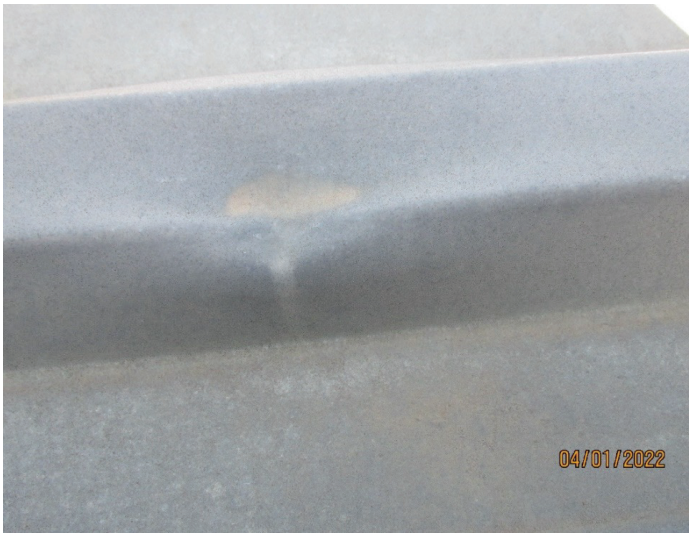
Figure 15. Photograph of large dent in the rib of the panel.

Again, numerous hail-caused indentations were visually examined and examined under 10x magnification. **Fig. 15** shows a large dent in the rib of the panel with sediment accumulation. **Fig. 16** shows a 10x view of a rib dent after cleaning with no evidence of corrosion. However, small spots of corrosion were beginning to show at the eaves after 40 years of service, shown in **Fig. 17**.

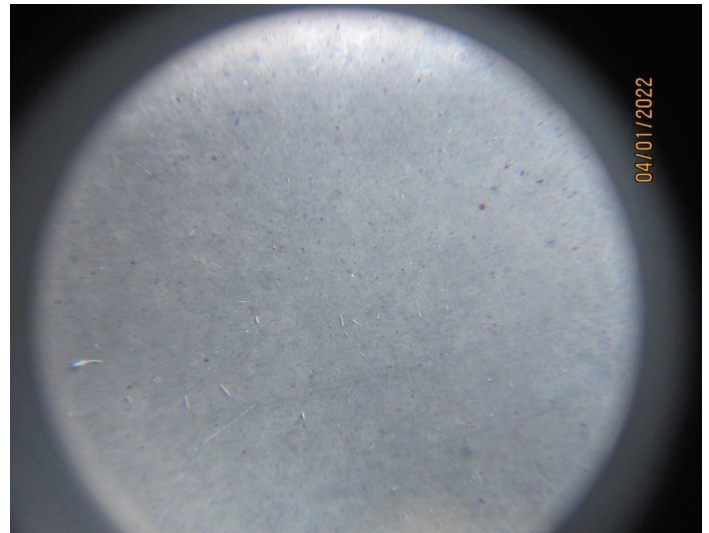
Figure 16. Photograph of cleaned dent in the rib under 10x magnification.

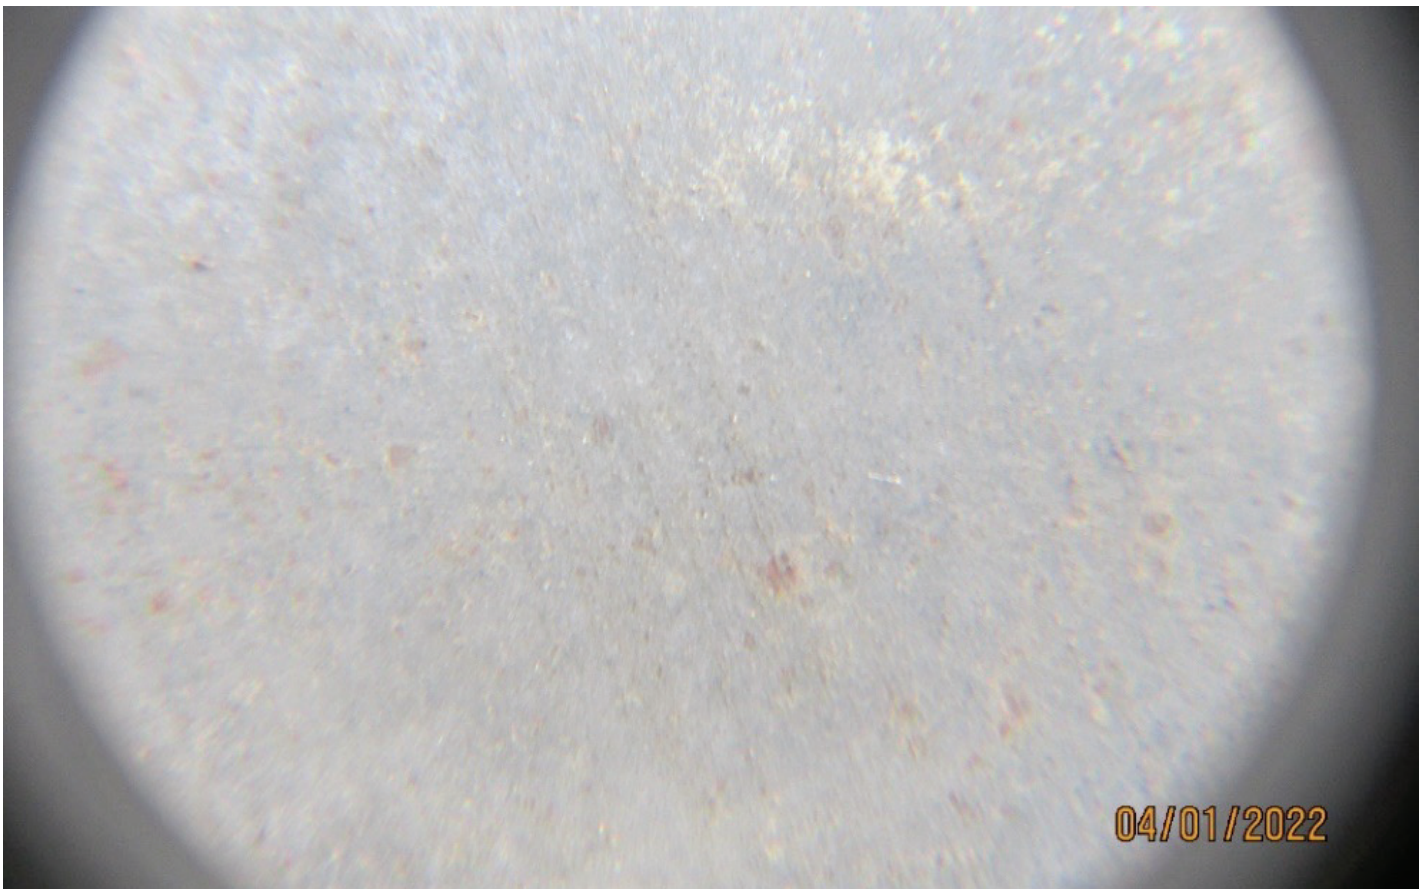
Figure 17. Photograph of small spots of corrosion at the eave panels of the 40-year-old roof.
