# Finding the Leak

By David A. Rash, RRC

## BUILDING PROJECT BACKGROUND

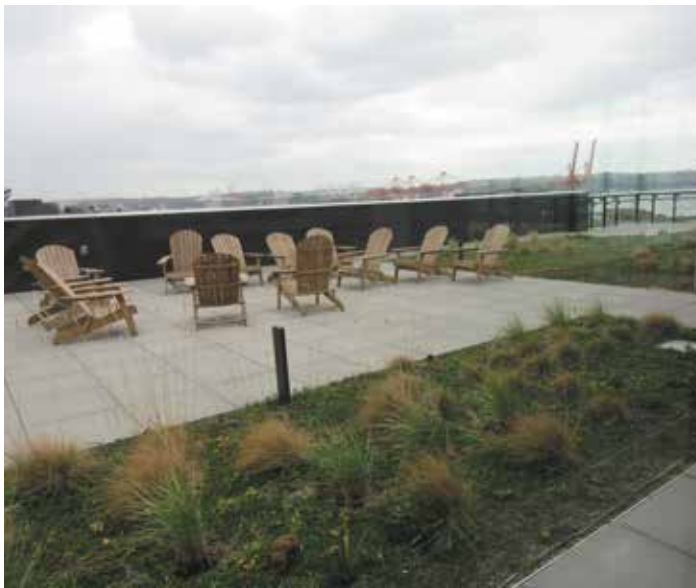
**Figure 1.** Southern view from company boardroom with paved patio area and vegetative roof areas (2/17/2019).

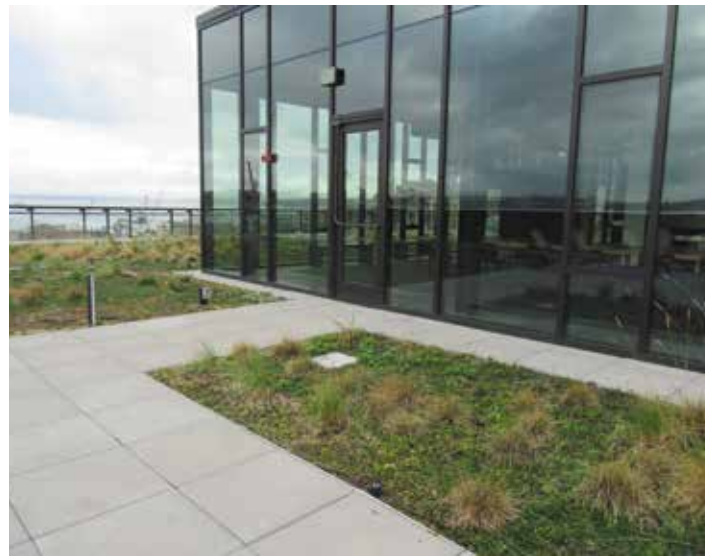
(**Fig. 2**), reinforcing the importance and desirability of the garden roof, which was visible from the boardroom.

**Figure 2.** View of eighth-floor green roof with pavers and south end of penthouse structure with glazed wall of company boardroom (2/17/2019).

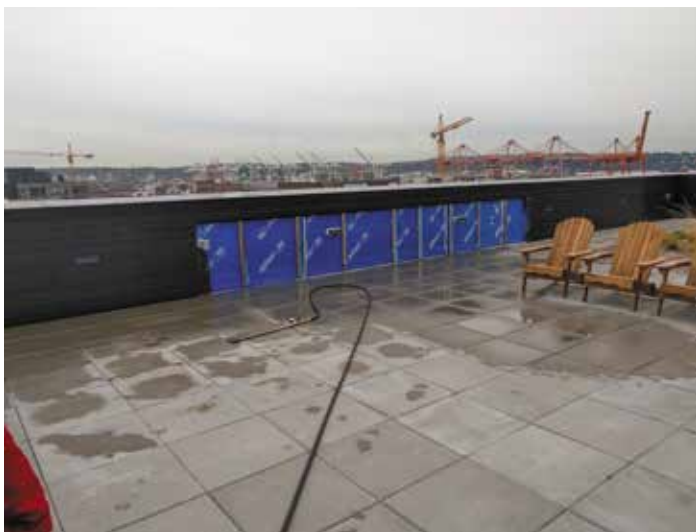
the investigation team performed tests on both the inside and outside face of the south parapet using a calibrated spray wand (**Fig. 3**), based on the American Architectural Manufacturers Association's AAMA 501.2 testing standard.<sup>1</sup> The water tests did not replicate the leak, and the initial repairs made by the roofing contractor appeared to address the leak issue.

**Figure 3.** Eighth-floor parapet water tested with a calibrated spray wand shortly after the building was occupied with metal panel cladding removed to identify potential leak path(s) (2/11/2016).

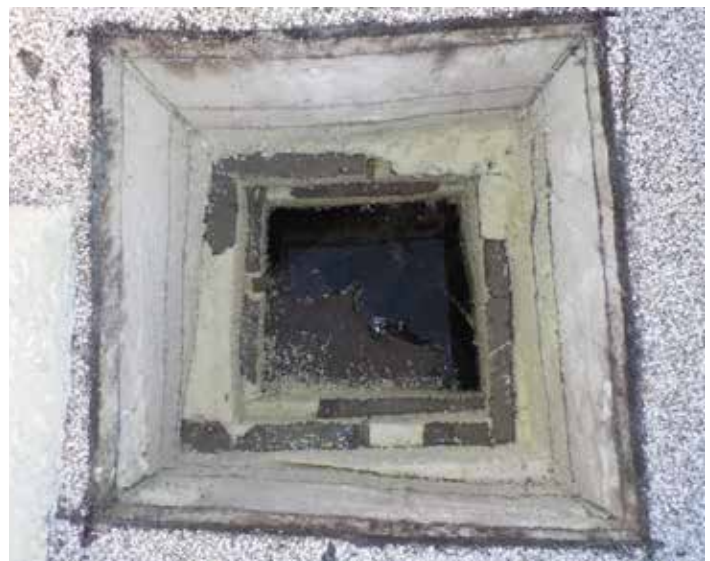
number of exploratory openings were made, which indicated that water was collecting at the level of the air/vapor barrier (**Fig. 4**), but no breaches were discovered in the air/vapor barrier. The inspection ports (**Fig. 5**) were an attempt to monitor water volume during rain events to see if there was some correlation between water volume and recurrence of the leak, but they were ultimately not useful in understanding the source(s) of the roof leak.

**Figure 4.** Exploratory opening revealing water at the level of the roof air/vapor barrier, but no breaches (2/02/2017).

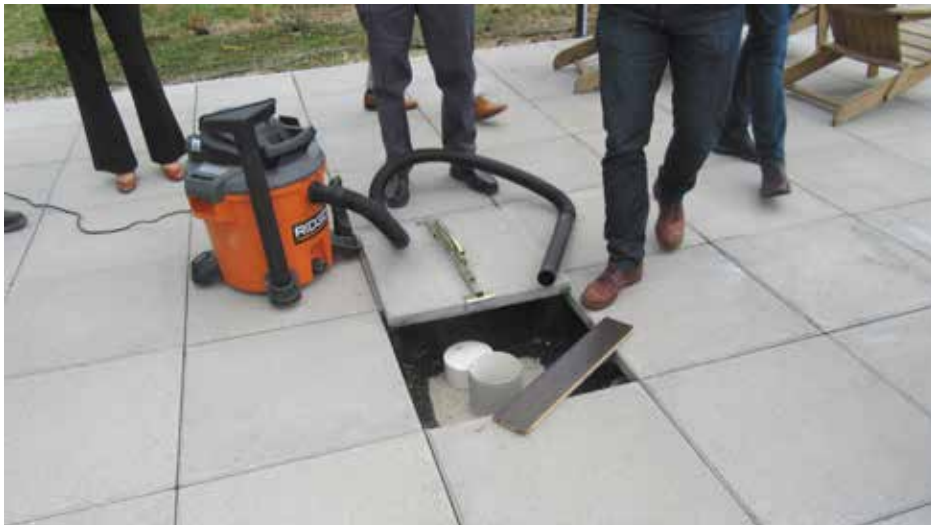
**Figure 5.** Inspection port installed under pavers on pedestals at south patio area of eighth-floor green roof (2/17/2019).

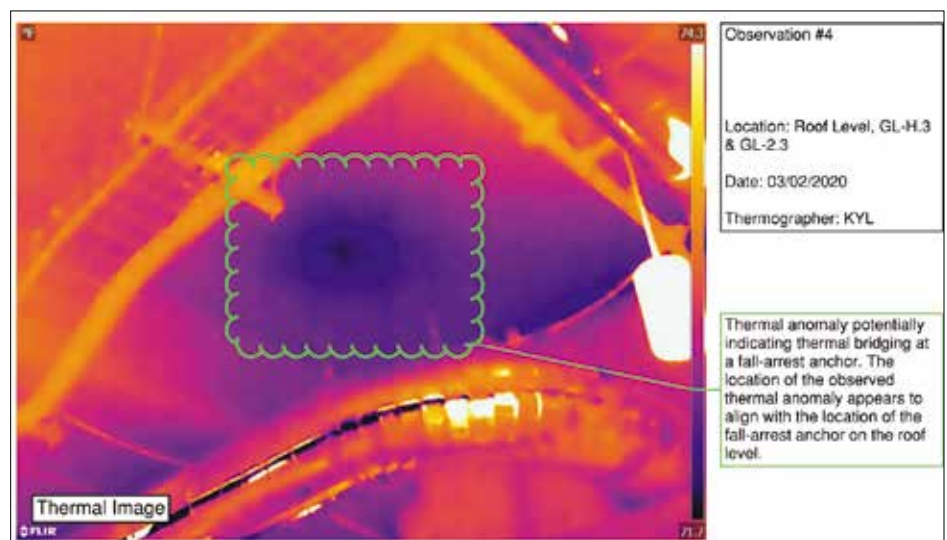
The first component of the leak investigation was an infrared thermographic survey of the underside of the concrete roof deck, which was performed on March 2, 2020. Some minor thermal anomalies were identified; however, none were indicative of significant water absorption into the concrete deck (**Fig. 6**).

**Figure 6.** Interior thermographic survey confirmed no excessive moisture accumulation in concrete deck, while also identifying minor thermal bridging from fall-arrest anchors attached to the deck (3/02/2020).

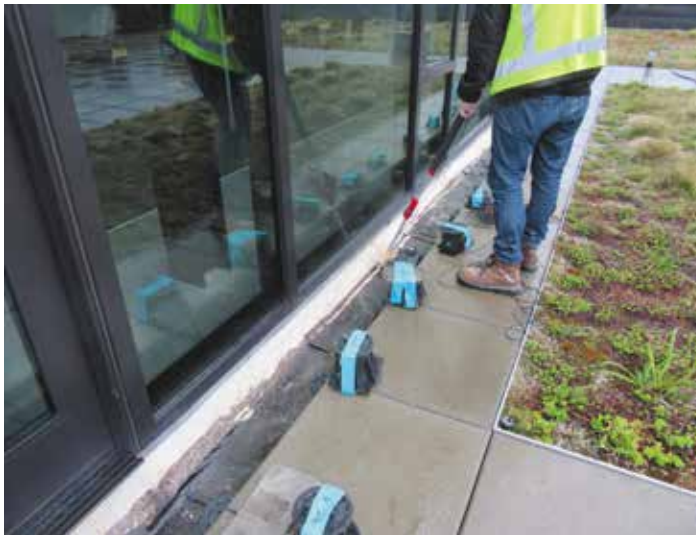
The second component was an ELD test performed on the base flashing membrane at the south end of the level 8 penthouse. No breaches were found in the base flashing membrane, although several anomalies suggestive of potential breaches were identified (**Fig. 7**); these were mainly small portions of side lap edge conditions that did not appear to be fully sealed.

**Figure 7.** Electronic leak detection was used to confirm no breaches in base flashing membrane along the base the penthouse structure (3/02/2020).

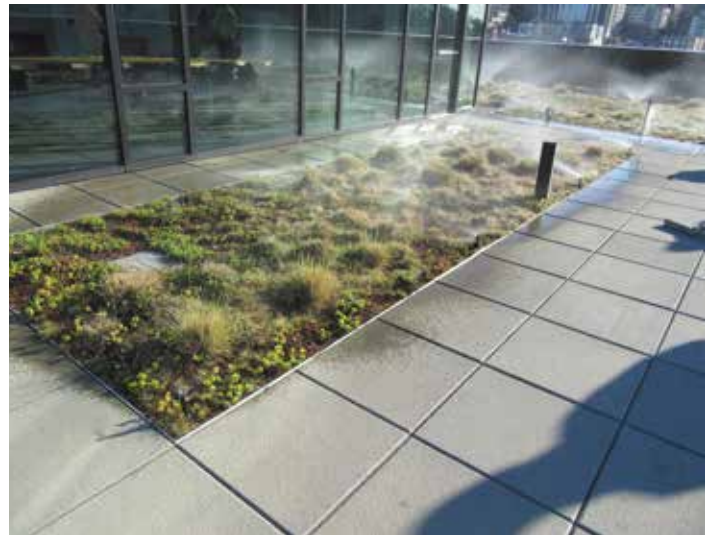
The third component was a water test of the three vegetated roof areas at the south end of the building, which involved running the irrigation system continuously without blocking the roof drains (**Fig. 8**), eventually saturating the vegetated assembly. Prior to initiating the water test, the roofing contractor reinstalled one of the inspection ports to determine whether water from the testing was infiltrating down to the vapor barrier and collecting in the roofing assembly in conjunction with the roof leak; the inspection port was located near the central valley line of the roof deck. The inspection port was a short piece of polyvinyl chloride piping that extended several inches above the roofing assembly and down to the vapor barrier; it allowed the investigation team to confirm whether water was infiltrating down to the vapor barrier, but it did not allow one to ascertain through which layers of the assembly that the water might be percolating. This water test replicated the leak for the first time, although

**Figure 8.** The three vegetative roof areas at the southern end of the eighth-floor roof were saturated with water from the irrigation system, which replicated the leak for the first time (3/16/2020).

it did not identify which roof area might be the source of the leak or if all three areas were contributory; water was also observed in the inspection port.

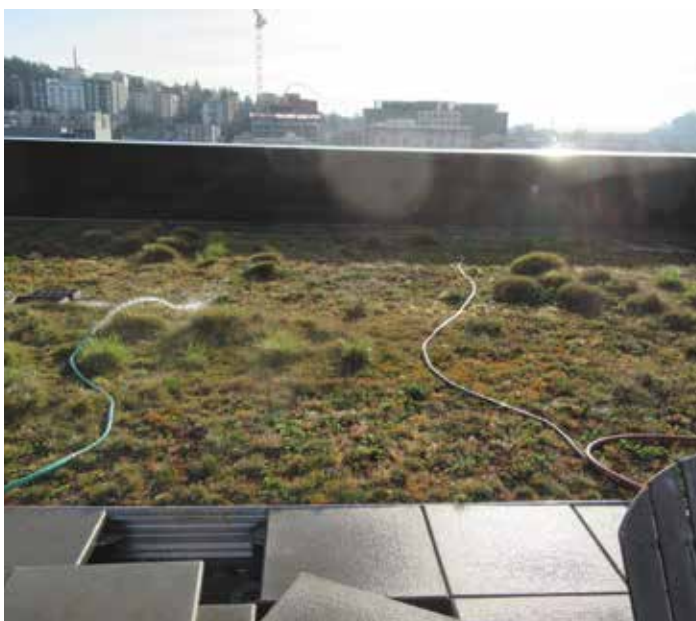
The fourth component was a water test of only the southeast vegetated roof area (**Fig. 9**). This water test replicated the leak for the second time; replication took less time to occur than during the prior (third) component of the investigation.

**Figure 9.** The southeast-corner vegetative roof was saturated with water, replicating the leak for the second time (3/17/2020).

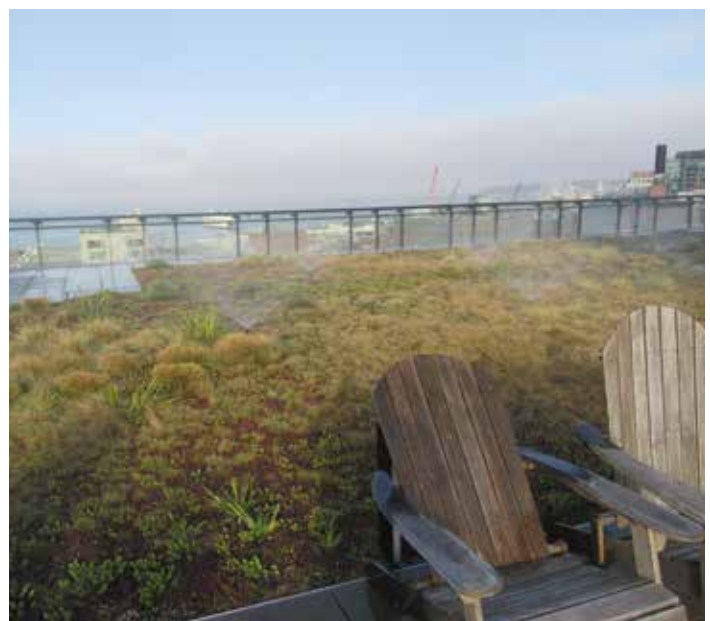
The fifth component was a water test of the southwest vegetated roof area (**Fig. 10**), running water continuously so that the vegetated assembly became saturated. This water test did

not replicate the leak, nor was further water observed in the inspection port.

**Figure 10.** Saturating the southwest vegetative roof separately did not replicate the leak (3/18/2020).

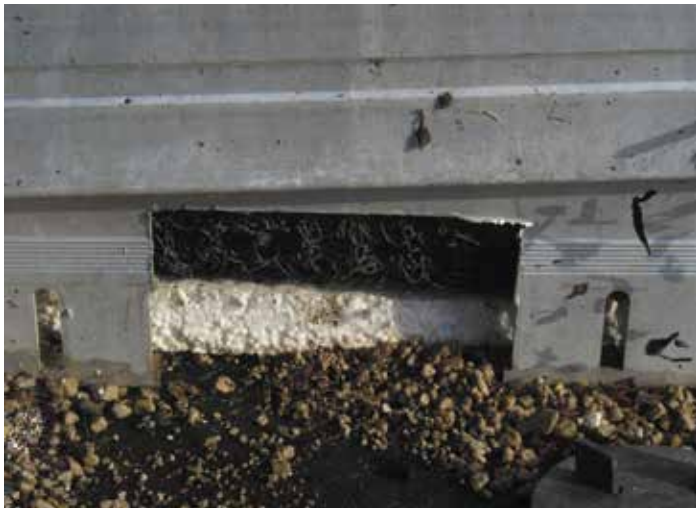
During the testing of the southwest vegetated roof area, a review of the perimeters of the vegetated areas found that the southeast vegetated assembly was installed with expanded polystyrene (EPS) insulation directly over the roofing membrane (**Fig. 11**), while the southwest vegetated area had EPS insulation installed above the drainage composite. The change from XPS insulation to EPS insulation was presumably a cost-saving measure during construction.

**Figure 11.** Southeast vegetative roof area was discovered to have expanded polystyrene (EPS) insulation resting directly on the roofing membrane, with the drainage composite installed over the EPS insulation (3/18/2020).

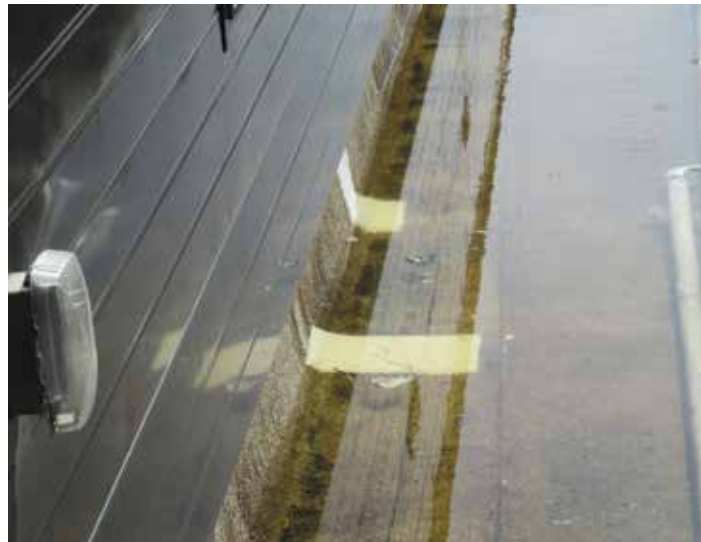
**Figure 12.** Minor deficiencies patched with polymethyl methacrylate membrane, after which the southeast vegetative area was separately tested, resulting in a third replication of the leak (3/19/2020).

the roofing anomalies by applying PMMA flashing membrane over the anomalies, primarily seams where the laps did not appear to be fully sealed adjacent to the southeast vegetated roof area, expressing the concern that standing water around the vegetated roof area might be the source of the leak. After the repairs were completed, the southeast roof area was retested (**Fig. 12**). Although it took longer, the leak was replicated for a third time, suggesting that the PMMA repairs may have resolved contributing breaches in the roofing membrane, but the primary cause of the leak was still unresolved.

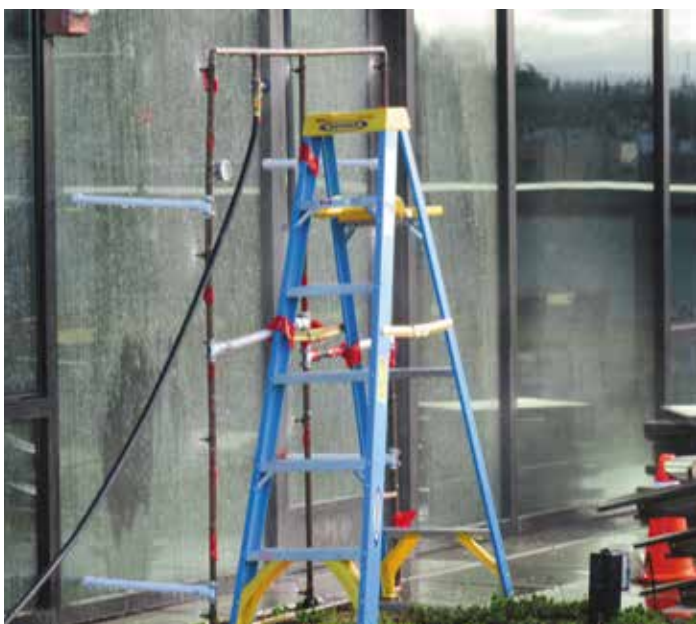
The sixth component was a water test of the glazing assembly of the south elevation of the penthouse (**Fig. 13**). For this test, a spray rack was utilized without a pressurized chamber on the interior side of the glazing, as the test was to determine whether water penetration was at the interface between the glazing assembly and the base flashing membrane at the concrete support curb at the perimeter of the penthouse structure. The roof leak was not replicated, nor was water observed in the inspection port.

**Figure 13.** A spray rack was used to determine if the interface between the glazing assembly of the penthouse and the base flashing membrane of the roofing system contributed to the roof leak (3/23/2020).

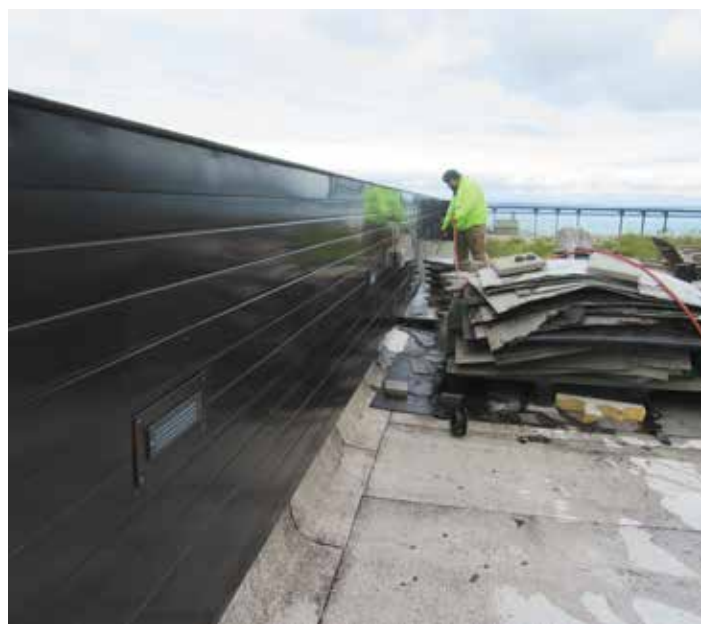
bottom of the parapet, then the lower half of the metal siding, followed by the upper half of the metal siding, and finally the metal plate coping (**Fig. 14**). At no point during this testing was the roof leak replicated, nor was water observed in the inspection port.

**Figure 14.** The south building parapet was tested using a calibrated spray wand at the base of the parapet, the metal cladding of its interior face, and the coping, in sequence from bottom to top (5/19/2020).

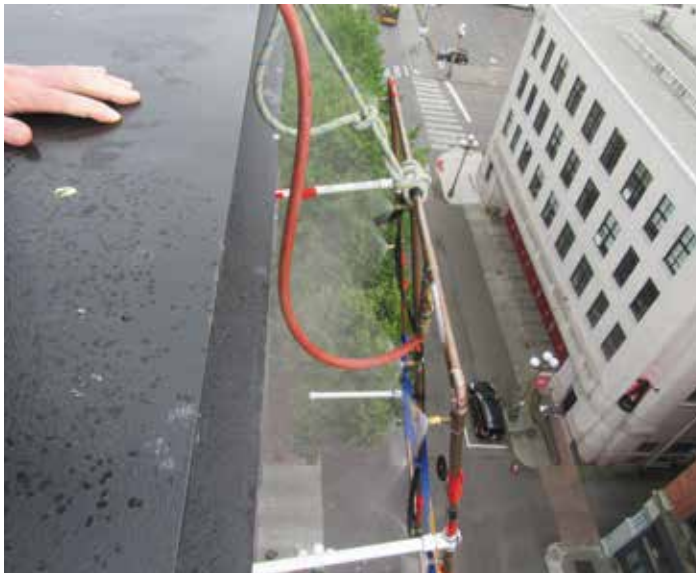
The eighth component was a water test of the outside face of the south building parapet (**Fig. 15**). For this test, a spray rack was utilized to apply water to the metal plate coping and the brick facing above the uppermost window heads. Each section of the parapet was tested for 15 minutes, with the middle third of the

**Figure 15.** Spray rack was used to water test the exterior face of the south building parapet (5/20/2020).

south elevation being tested (centered at the interior leak location). The roof leak was not replicated.

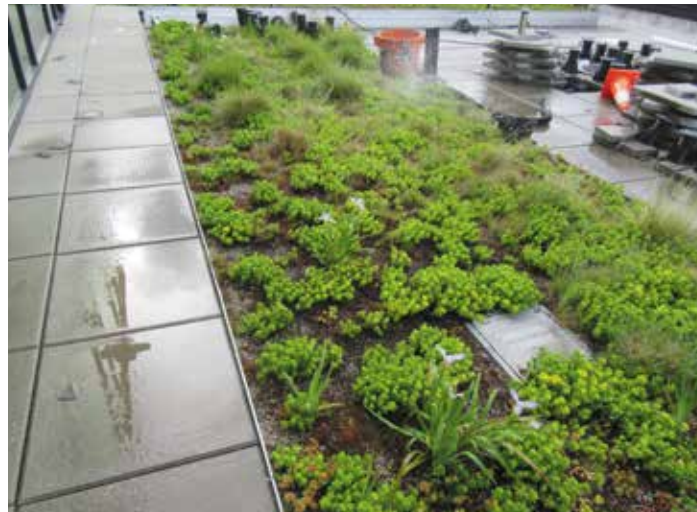
**Figure 16.** South-central vegetative area was also water tested separately, but it did not replicate the leak despite having expanded polystyrene insulation resting directly on the roofing membrane (5/22/2020).

The ninth component was a water test of the small south-central vegetated roof area (**Fig. 16**), running water continuously so that the vegetated assembly became saturated. Even though the installed vegetated assembly of this roof area was similar to the southeast vegetated roof area in that there was EPS insulation directly on the roofing membrane with the drainage composite above the EPS insulation, there was significantly less growing medium due to its location straddling the peak in the tapered roof insulation of the roofing assembly. This water test did not replicate the leak, nor was water observed in the inspection port.

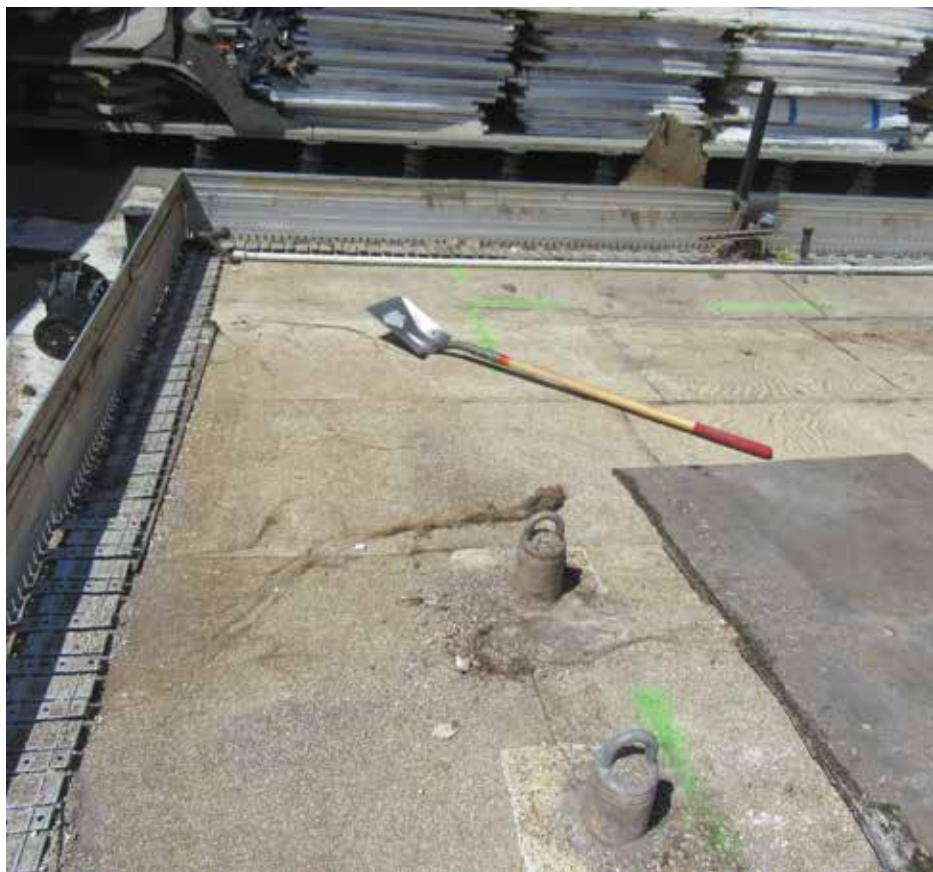
After the vegetated assembly had been removed, the exposed roofing membrane was reviewed in company with the roofing contractor (**Fig. 17**). Some minor roofing anomalies were observed, such as minor loss of granules from the cap sheet and lack of bitumen bleed-out along portions of the side laps, but none appeared to be obvious breaches in the membrane that might allow

water intrusion. Plant roots were also evident on the surface of the roofing membrane, but these were sufficiently small as to be considered inconsequential for possible water intrusion, as none had breached the cap sheet.

**Figure 17.** Vegetative assembly removed from the southeast corner of the main roof. Minor root growth was discovered to have penetrated the root barrier but without evident damage to the roofing membrane (7/14/2020).

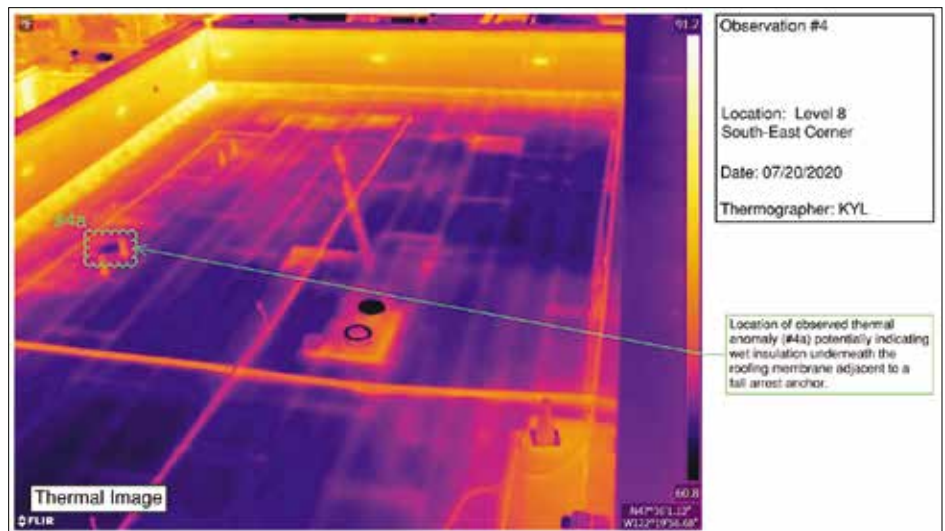
In hope of better understanding how water might be infiltrating the southeast roof area, an infrared thermographic survey was performed (**Fig. 18**). Some minor thermal anomalies were identified that did not appear to be large enough to indicate that they were part of the water path but were marked on the cap sheet of the roofing membrane. Six exploratory openings were performed by the roofing contractor at locations chosen by the investigation team and the chief building engineer. At four locations south of the roof drain, the top facer of the roof insulation was wet, but the polyisocyanurate core was dry. At two locations north of the roof drain, the roofing assembly was dry.

**Figure 18.** Infrared thermographic survey identified a few thermal anomalies, but none proved to be the “smoking gun” for the roof leak (7/20/2020).

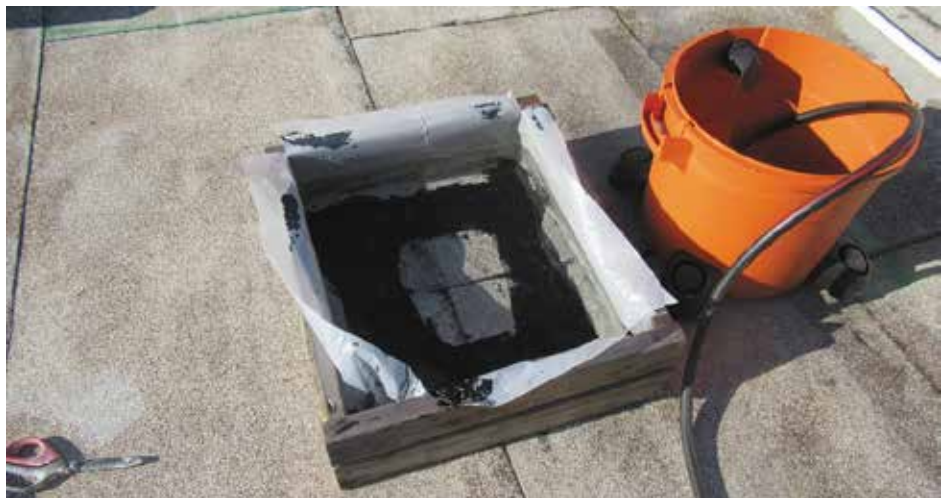
Despite the infrared thermographic survey and exploratory openings, no obvious sources of water entry were evident from a review of the exposed roofing membrane. After an inspection of the roofing membrane, a T-lap approximately 12 ft (3.7 m) inboard of the south building parapet was selected for a targeted flood test. A temporary box dam, approximately 2 ft (0.6 m) square in size, was constructed and sealed to the cap sheet (**Fig. 19**). Approximately 5 in. to 6 in. (12.7 cm to 15.2 cm) of water was allowed to accumulate inside the dammed area. After approximately 1.5 hours, water was observed seeping out of two other adjacent cap sheet T-laps, as well as at the cap sheet edge of one exploratory opening (**Fig. 20-22**). All locations were upslope from the flood test location and more than 20 ft (6.1 m) from the roof drain. Once the water test was removed, water migration ended.

**Figure 19.** Flood test performed at a T-lap location suspected of being compromised (7/29/2020).

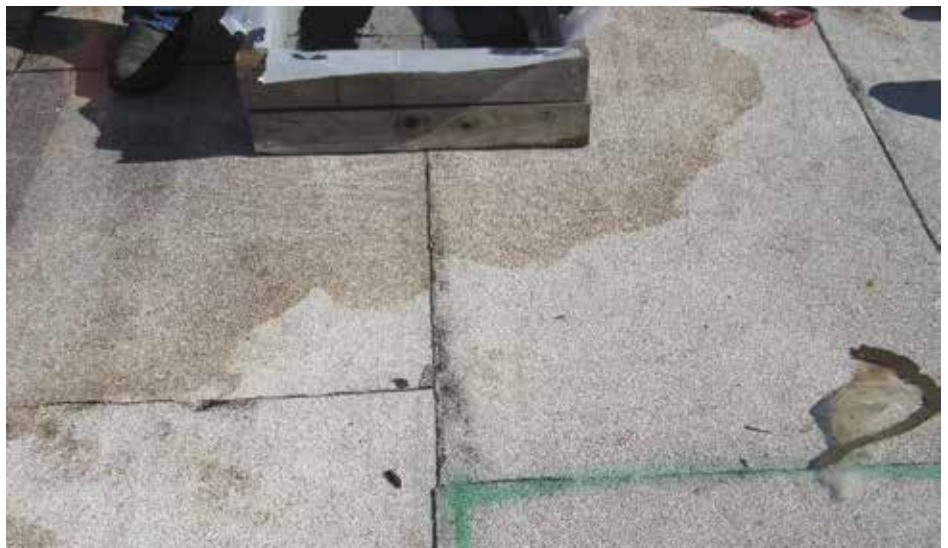
Based on these observations, it was concluded that the roof seams were allowing water ingress when under hydrostatic pressure, as occurs when the vegetated assembly becomes fully saturated and becomes increasingly heavy and exerting pressure on the cap sheet similar to what would occur during a flood test. This allowed water to migrate laterally through the roofing assembly until a penetration, like a fall-protection anchor, allowed the water to migrate vertically to the roof deck and subsequently to the south edge of the roof deck and materialize on the interior of the south exterior wall.

**Figure 20.** General view of roofing membrane upslope of flood test location with water visibly seeping out of the T-lap seam (yellow circle) (7/29/2020).

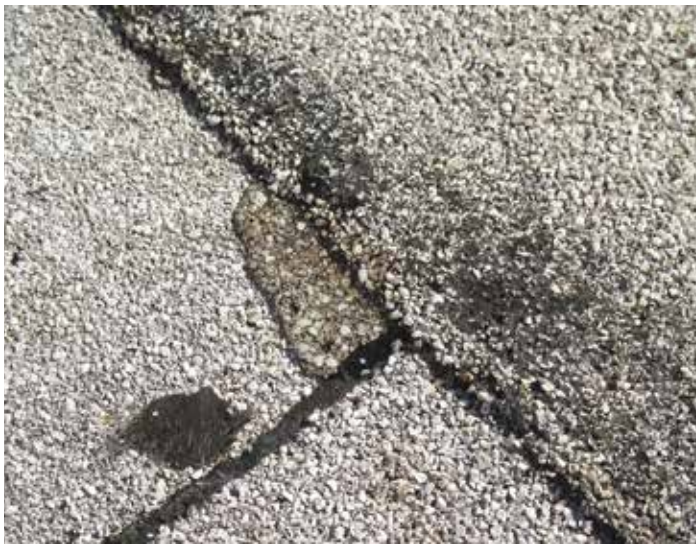
**Figure 21.** Close-up view of water seeping out of the roofing seam (7/29/2020).

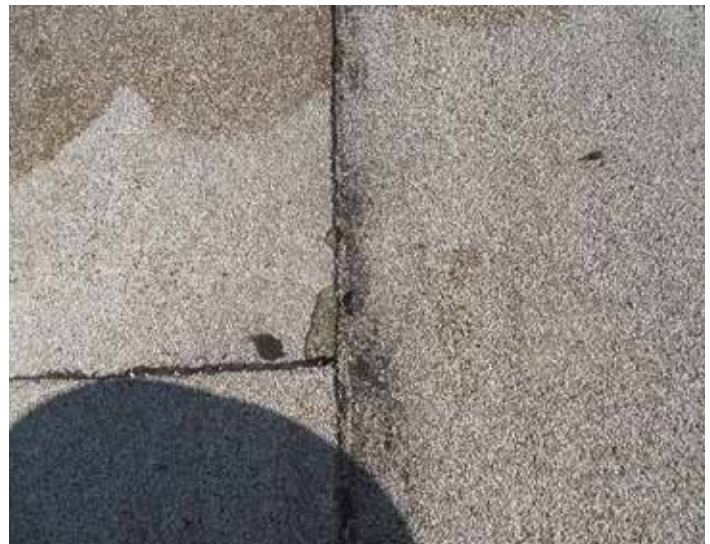
**Figure 22.** Additional water seepage from the roofing seam subsequent to the time recorded by Figure 20 (7/29/2020).

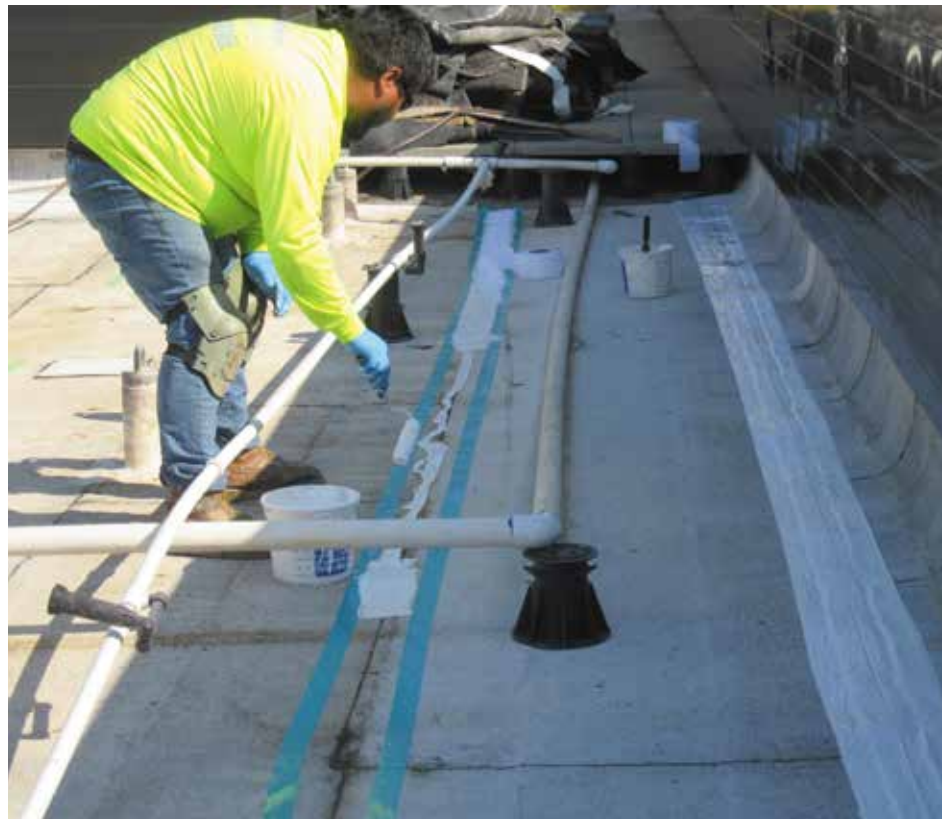
**Figure 23.** Polymethyl methacrylate flashing membrane being applied to all roofing seams in the southeast vegetative roof area (8/05/2020).

Ultimately, the roofing contractor chose to apply a PMMA reinforced flashing membrane at all the roofing membrane seams of the southeast vegetated roof area. This was likely the most conservative corrective action that could be taken, but it was also the option that minimized the potential for a recurrence of the leak. A 4 in. (100 mm) wide strip of PMMA membrane was installed, centered over the leading edge of the roofing membrane seams (**Fig. 23**). When the seam stripping was approximately two-thirds complete, an adhesion pull test of the PMMA membrane

was conducted, which indicated that good adhesion was being achieved. In addition, a technical representative of the roofing materials manufacturer also reviewed the corrective work prior to the reinstallation of the vegetated assembly.
