Can You Feel the Heat?

Cross-Typology Building Facade Performance Evaluations Using Infrared Analysis

By Stephen Holland, RRC, PE, and
Terrance Dumoulin, EIT

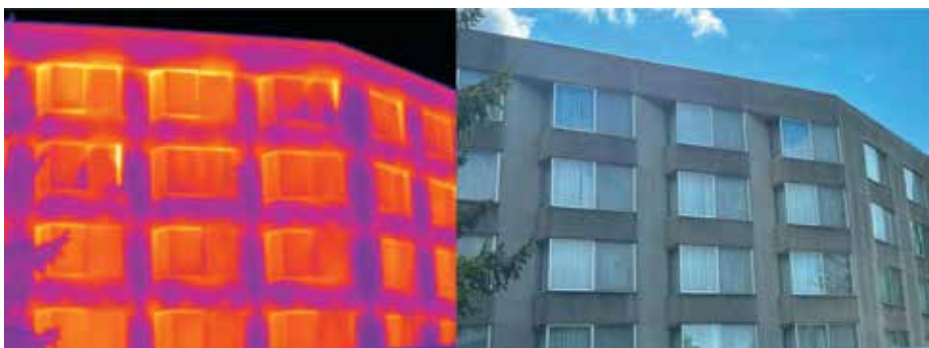
ASTM E1186, *Standard Practices for Air Leakage Site Detection in Building Envelopes and Air Barrier Systems*,¹ provided the basis for the study. The goal was to identify heat loss through building enclosures, and IR thermography is an excellent way to capture this. In an IR image of a building facade, adequately performing components will appear dark, which indicates colder temperatures. This is because heat is not being transferred through the building enclosure, and the components are the same temperature as the exterior. If a component appears lighter in the image (that is, warmer), it can indicate an anomaly where heat from the building is escaping, generally in the form of thermal bridging or air exfiltration (**Fig. 1**).

Figure 1. Thermal anomalies across the precast concrete building's facade.

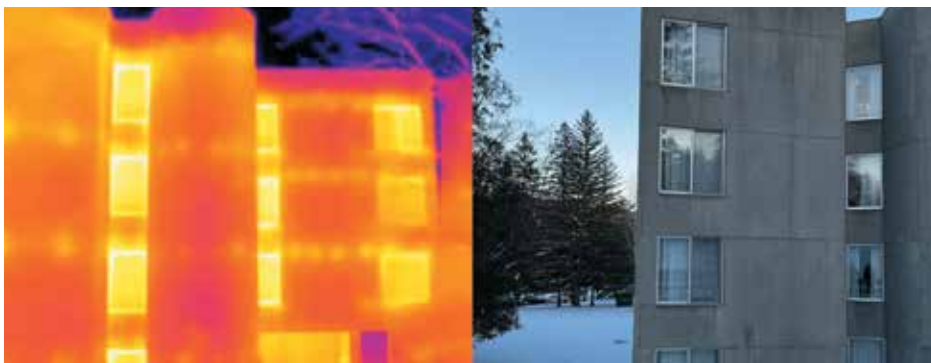
Figure 2. Thermal bridging at slab-to-wall connections.

of this building's age, the precast concrete panels are likely hung off of the floor slabs. These discrete dots of increased heat transfer align with steel connections from the interior structural slab anchors to the wall outside. Without any insulation to impede the flow of heat, every individual connection appeared brighter than its surroundings (**Fig. 2**).

- Precast Concrete Panel Building:** Because the panel-to-slab connections are integral to the structure of the building, they cannot be removed. However, continuous exterior insulation installed over the concrete would mitigate these thermal bridges. The team opted for an overclad solution with exterior insulation and cladding added over the concrete surface. This was chosen for a myriad of reasons, but it is an ideal solution for addressing the anchor thermal bridges.

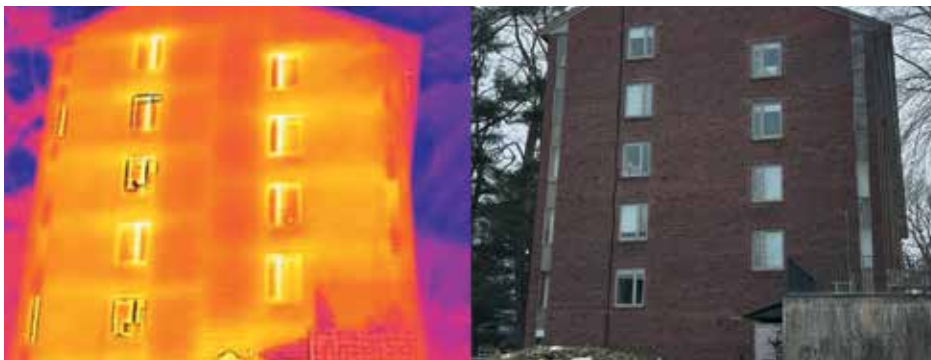
Figure 3. Slab thermal bridging at a masonry veneer assembly.

intermediate floor slabs, the concrete slab itself extended into the wall cavity at locations with a masonry veneer. The result in the thermal imaging was clear, bright lines showing exact locations of slab intersections (**Fig. 3**). In contrast, the expected point thermal bridges resulting from masonry tiebacks to the superstructure behind did not appear on thermal images.

- Masonry Veneer:** In this instance, an overclad option was not possible because masonry veneer cannot support the loads of new cladding. At the same time, interior insulation would not reduce thermal bridging at slab edges. Instead, the wall type would require a reclad where the brick is stripped down, insulation is added, and the brick is replaced. This was deemed impractical for the project and was not pursued.

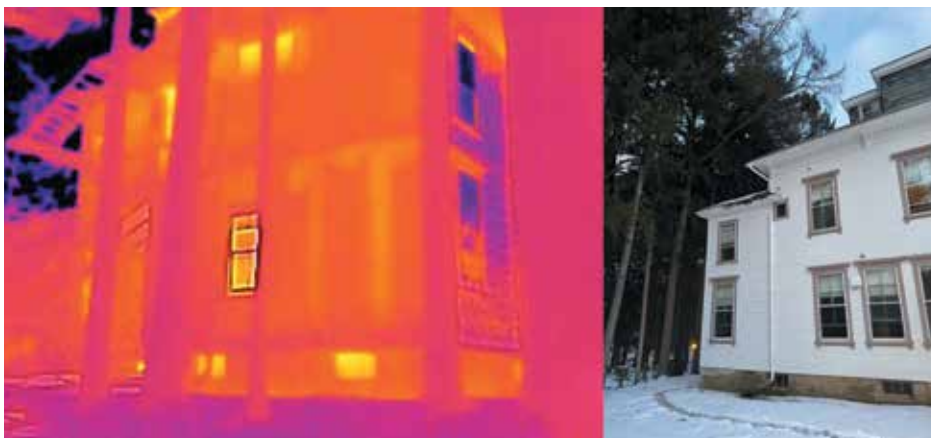
Figure 4. Missing bays of insulation at a wood-framed building.

This building type and vintage presumably includes wood stud walls filled with insulation. However, it would not contain wide, vertical structural members that would explain the thermal bridging. This led to the realization that the culprit was missing insulation between the wood studs, not thermal bridging (**Fig. 4**).

- Wood-Framed Building:** The easiest solution of the three, the insulation was installed into the missing bays.

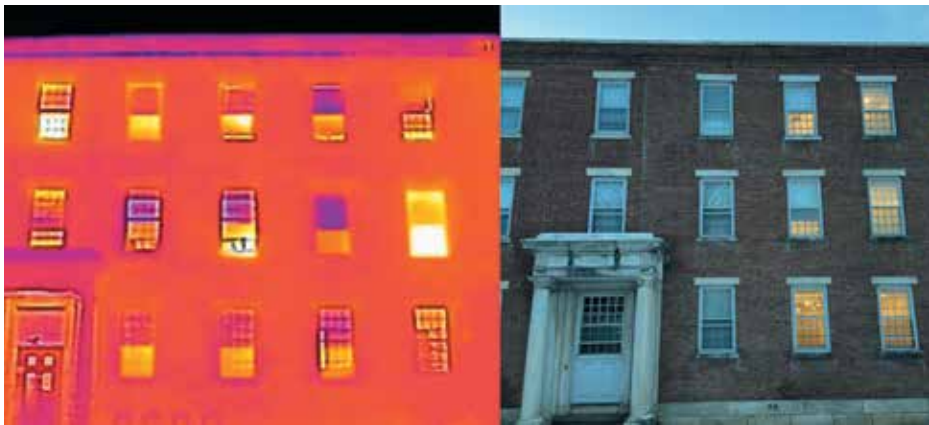
The next variety of thermal anomalies was present at the windows. At the mass masonry and wood-framed buildings, each window included a single-paned, single-hung, wooden fenestration with a single-paned exterior storm window. The assembly was identical at each window, but the IR scan showed a very different story. Some windows were cold, some were hot, and some appeared to be open despite outside temperatures below 10°F (-12°C) for the duration of testing. During the daytime analysis, it was apparent that occupants often had either their window or storm window closed, but not both (**Fig. 5**). During interviews with occupants, some were unaware they had two windows to close. Others said they enjoyed the external cooling to counteract their robust heating units. The project team noted this as an opportunity for facilities to align heating set points and loads with occupant thermal comfort. While the human element was affecting performance, the windows were free

Figure 5. Varying window positions reveal opportunities for educating occupants on proper closure practices.

- **Mass Masonry and Wood-Framed Buildings:** The team opted to inform occupants and facility members about the importance of closing both their windows and storm windows. The mechanical equipment was also reviewed for better occupant control. These windows are earmarked for replacement over the next 10 years, but the institution is utilizing these temporary measures to improve performance in the interim.
- **Precast Concrete Facade and Masonry Veneer Buildings:** These windows will be replaced with modern fenestrations due to widespread air leakage and lack of feasible retrofit options.

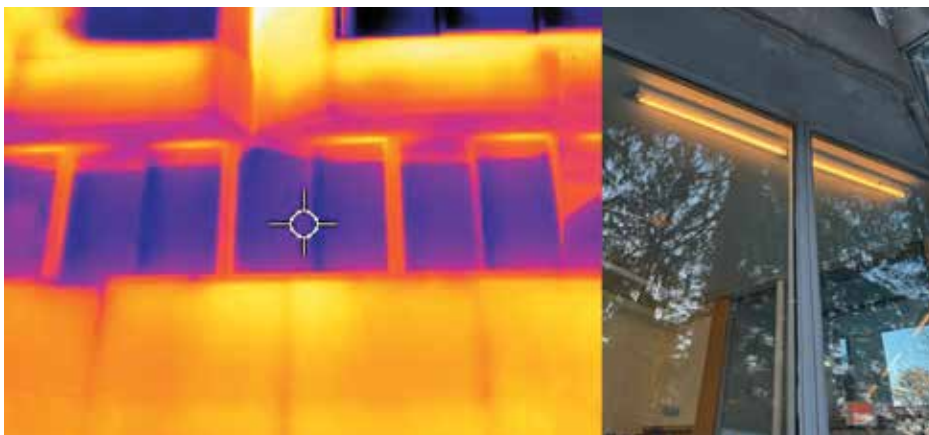
Figure 6. Air leaks present along window heads and meeting rails.

head and meeting rail (**Fig. 6**). This was not surprising, as sliding windows and hung windows are difficult to gasket seal. This is further compounded by age, as the windows are nearly 50 years old. While the sealant joints were generally continuous, they appeared brittle and otherwise showed their age. All masonry veneer buildings on campus

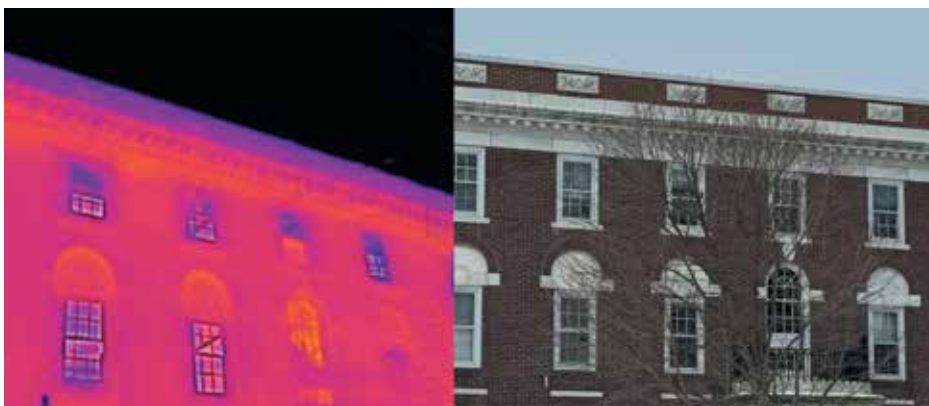
Figure 7. Air leakage at a mass masonry wall to roof transition.

The mass masonry buildings rely on their homogenous mass to mitigate air infiltration. The structures investigated displayed little dramatic air leakage. Air leaked from window surrounds, but exterior-applied storm windows often mitigated this phenomenon. Air exfiltration was most prominent at the roof eaves, where the walls transitioned into the steep-slope slate or low-slope membrane roof replacement systems (**Fig. 7**). This is unsurprising given that watertightness was often prioritized over airtightness at these transitions for buildings of this vintage.

- **Mass Masonry Buildings:** While these buildings have minimal air leakage, the team has discussed installing spray foam on the interior at the roof-to-wall connection to mitigate the thermal bridging. This same

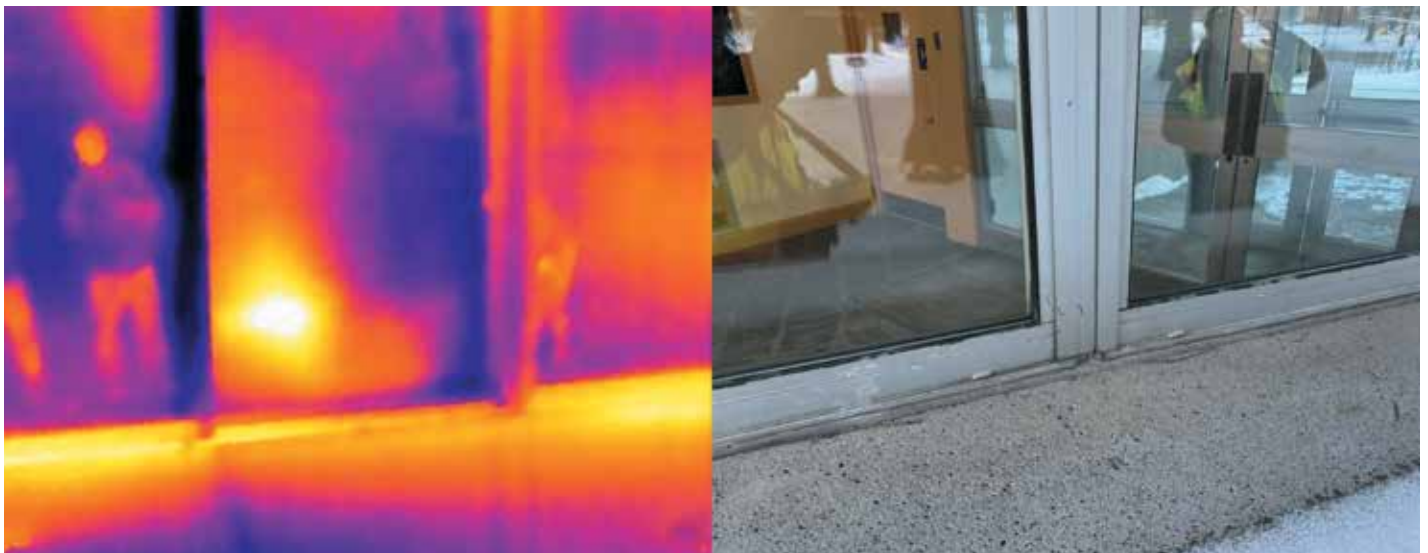
membrane could be easily integrated with precast concrete panels for an airtight connection. For sealing purposes, air barrier continuity is maintained by sealing the windows and doors directly to the surface of the concrete. During the investigation, windows had to be carefully examined to determine whether a thermal anomaly was present at the entire window surrounds or only at parts of the window. While most of the punched windows leaked, the larger curtainwall at the front of the building was generally performing adequately, save for discontinuous sealant joints at the sill (**Fig. 8**).

Figure 8. Air leakage at a discontinuous sealant joint at the curtainwall-to-concrete connection.

- **Precast Concrete Panel Building:** Because the team considered the precast concrete to be the component providing airtightness, air barrier continuity can be maintained by re-establishing the seals of the concrete panels to the curtainwall. Any discontinuous sealant joints were replaced.
- **Wood-Framed Buildings:** These walls represent primitive versions of rainscreens, which rely on a sacrificial cladding capable of shedding most bulk water. However, they are not the assembly component providing weathertightness. While not an ideal air

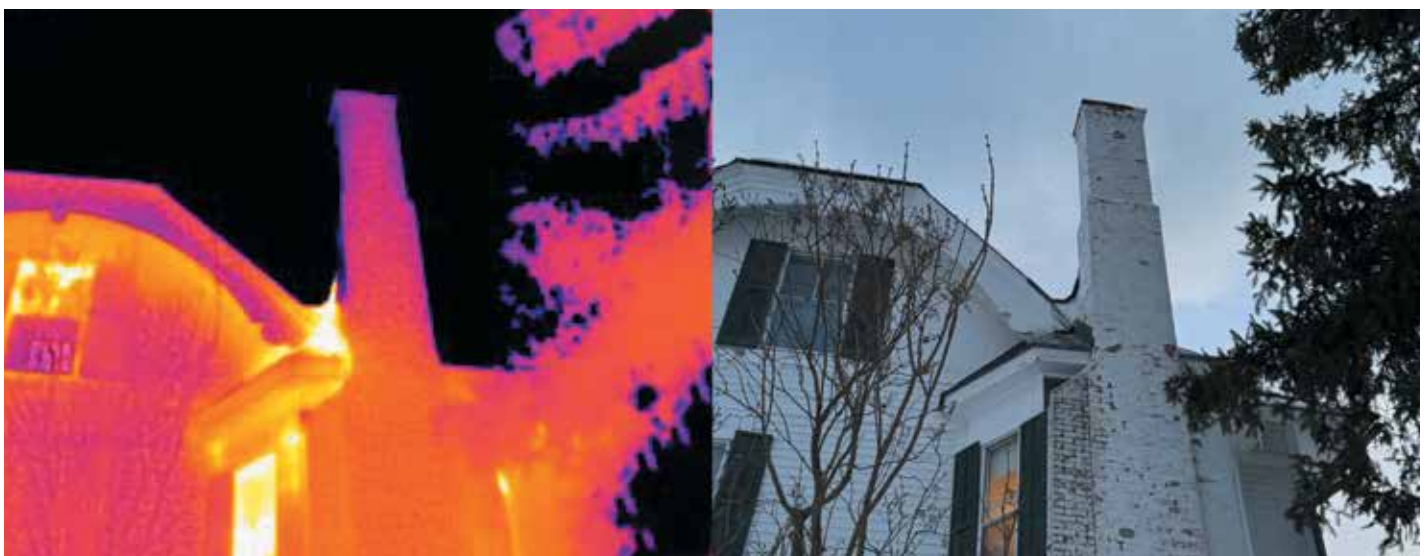
of unadhered building wrap, roofing felts, and mastics that help mitigate air infiltration. Most air leakage occurred at facade plane transitions, such as at corners or into the roof. At highly complex transitions where multiple assemblies converged, air flowed uninhibited to the exterior (**Fig. 9**). Air exfiltration findings at these locations highlighted the complex nature of wall-to-roof transitions, especially at steep-slope roofs.

Figure 9. Complex transitions at wood-framed buildings result in barrier discontinuities.

barrier, the unadhered building wrap behind the wood siding and roof was identified as the best location to establish an air barrier. Unlike precast concrete panels, the component providing airtightness is not at the surface and requires cladding removal. The wood siding was temporarily removed, and a modern air barrier was integrated with the existing building wraps and roofing papers as best as possible given their aged nature. Last, a sealant joint to the masonry chimney was installed.
