# The Silent Killer of Roofs: Water Intrusion and the Case for Proactive Leak Detection

By Shaun Katz

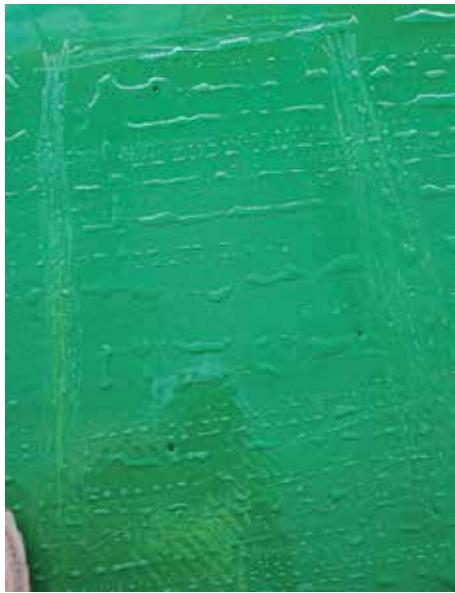
The average breach per square foot count on this project was one breach located per 245 ft<sup>2</sup> (23 m<sup>2</sup>) tested, most of which were pinholes (Fig. 5).

Pinholes are commonly found with cold fluids, including traffic coatings. These pinholes are often formed by off-gassing from the concrete below or exposure to rain prior to curing. Without performing ELD, it is highly unlikely that flood testing or a visual inspection would provide the same type of results.

**Figure 5.** Examples of pinholes located at light rail station.

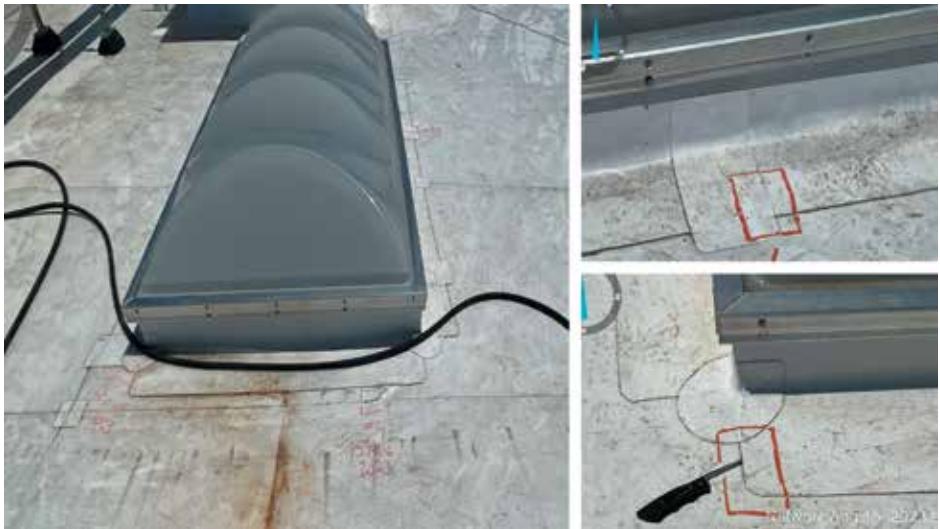
Upon performing a forensic test, nine breaches were located in approximately 22,000 ft<sup>2</sup> (2,040 m<sup>2</sup>). Breaches found included seam voids as well as trade damage (Fig. 6).

**Figure 6.** Examples of breaches found during forensic electronic leak detection testing at lab space in California.

If the client had included ELD testing during construction, the cost would have been far less than just a month's lost revenue due to moisture intrusion, not to mention the costs to repair the water damage.

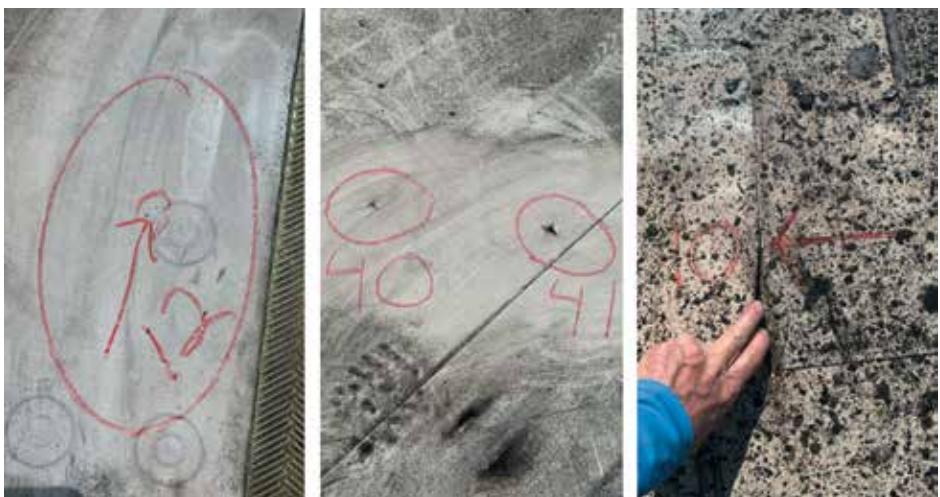
**Figure 7.** Examples of breaches found on one of the seven food manufacturing plants.

majority of breaches were seam voids and punctures from trade damage (Fig. 7 and 8). Many of these roofs were covered in debris, staged materials, and screws (Fig. 9).

If the customers had included a conductive medium in the assembly and performed ELD during construction, these breaches would have been found and repaired prior to starting

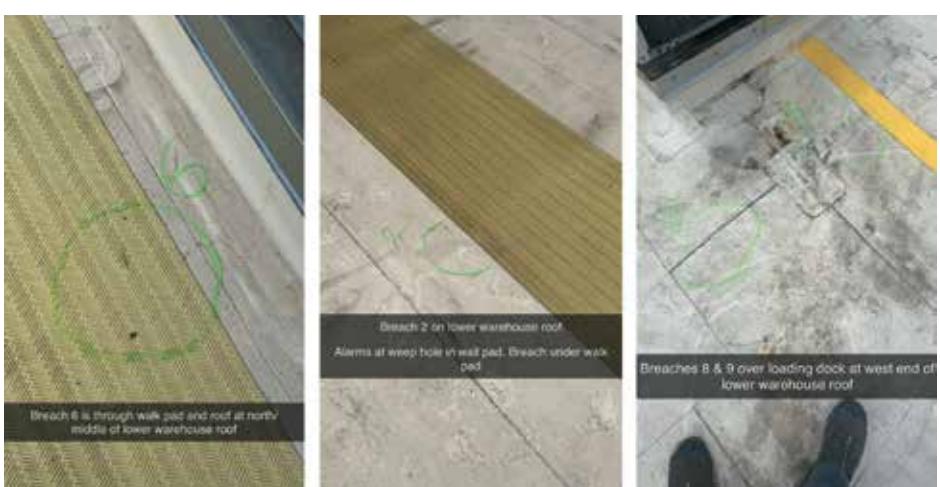
**Figure 8.** Examples of breaches found on one of the seven food manufacturing plants.

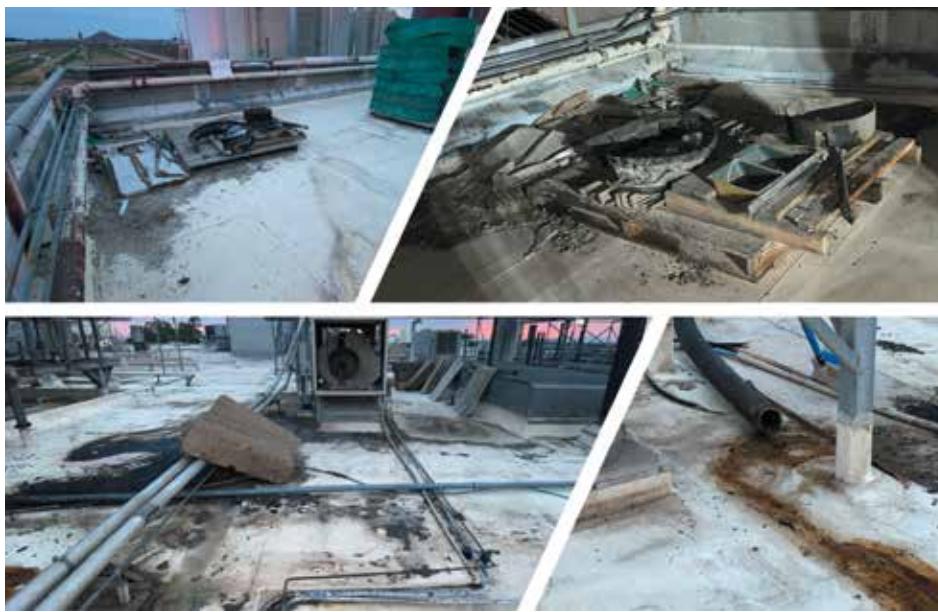
**Figure 9.** Site conditions on one of the seven food manufacturing plants.

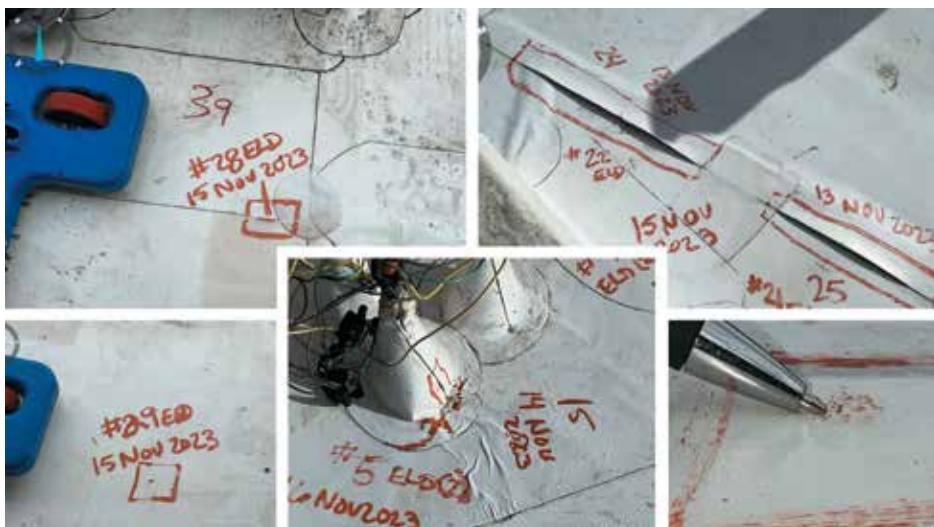
The impedance testing located numerous areas of trapped moisture, and construction defects were visible throughout the area. Upon further inspection, it was found that the improperly placed conductive mesh had punctured the membrane. After performing forensic ELD, breaches and seam voids were pinpointed (Fig. 10).

**Figure 10.** Examples of seam voids and punctures found at office building in California.

If a noninvasive conductive medium, such as a conductive primer, had been installed correctly, directly below the membrane where it is required to be, then these breaches would have been found in the initial quality control test. Unfortunately, this specific conductive medium

was improperly installed below the cover board, which invalidated the ELD test and damaged the membrane. This resulted in complete removal and replacement of the entire roof assembly.

When ELD testing is to be included on a conventional roof, a conductive medium must be installed *directly below* the membrane.

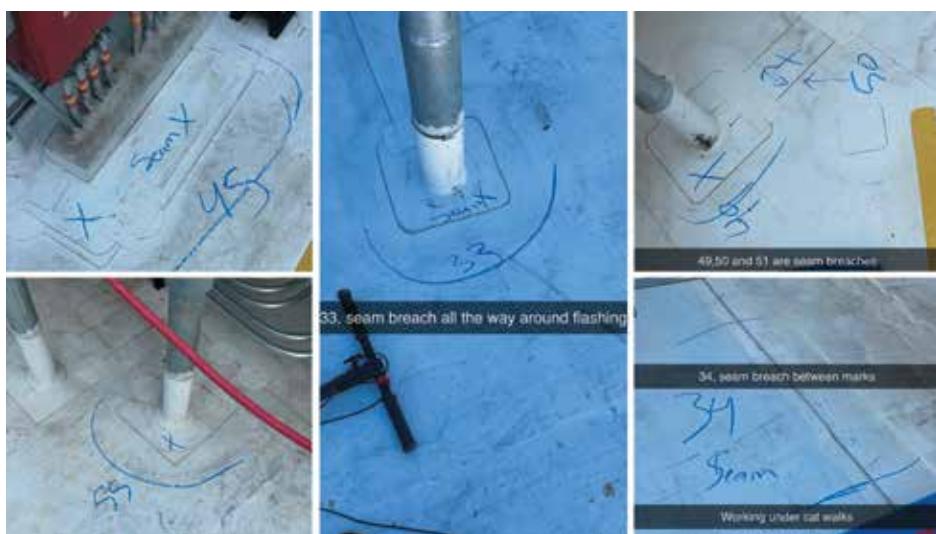
During the test, the ELD technician noticed that nearly all seams were alarming, indicating an electrical path to ground was present (also known as the breach). It was determined that all the cut edges were missing the cut-edge sealant, which allowed water to seep down to the conductive primer under the membrane (Fig. 11). After ELD testing, the roofing contractor added cut-edge sealant to these seams, and the areas were retested, all passing secondary inspection.

Figure 11. Examples of numerous seam voids at office towers in Washington.

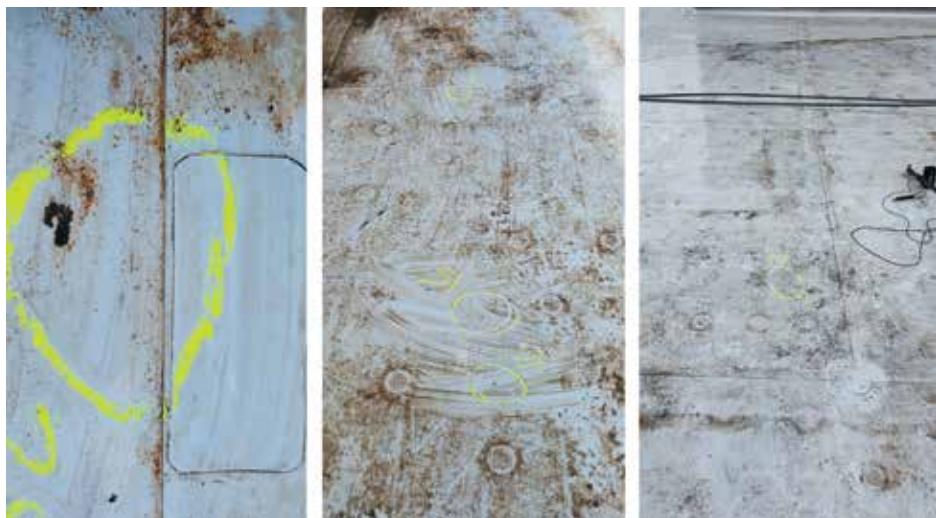
Just over 121,000 ft<sup>2</sup> (11,200 m<sup>2</sup>) of new PVC roofing was installed directly on top of a conductive medium. ELD testing found 133 breaches, which is an average of approximately 1 breach per 900 ft<sup>2</sup> (84 m<sup>2</sup>) tested. Seam voids and trade damage were found throughout the area (Fig. 12).

Figure 12. Examples of breaches and seam voids located at Department of Transportation in Texas.

With a properly installed conductive medium in a conventional roof assembly and performing ELD testing, breaches can be found, repaired, and retested prior to starting the warranty. Often, seam probing and a visual inspection are performed, which are not sufficient when it comes to determining the integrity of roof membranes. Another item to note is that damage caused by construction is commonly found, especially if these roof areas are used for staging materials or allow heavy foot traffic. Protecting the membrane from other trades is highly recommended; otherwise it is likely the area will be damaged.

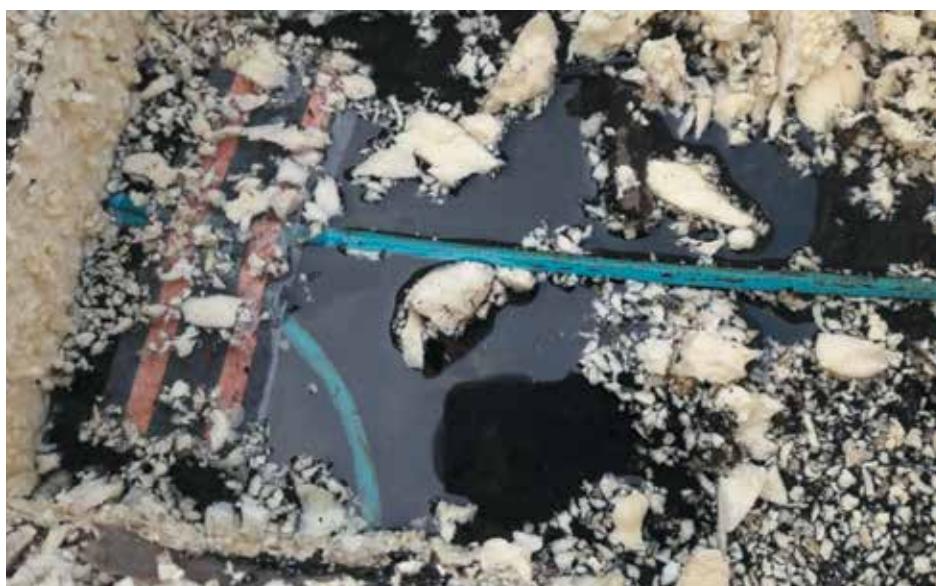
During a break in the construction schedule over Thanksgiving weekend, a zone went into alert. Within 45 minutes, water traveled to three additional zones. Each zone was approximately 15 ft × 15 ft (5 m × 5 m). The moisture monitoring system determined where the moisture presented itself at the vapor barrier, tracked where the moisture moved, and provided a time stamp. After the weekend, the roofer cut into the roof and found standing water at the vapor barrier. When the building sign-in log was checked, it was confirmed that someone had shown up on-site and cut a curb around a heating, ventilating, and air conditioning unit without informing anyone. It then rained over that long holiday weekend. Water flowed through the roof assembly and pooled on the moisture monitoring sensors, alerting the roofer in real time (Fig. 13).

Figure 13. Standing water on moisture detection sensors at apartment building in Oregon.

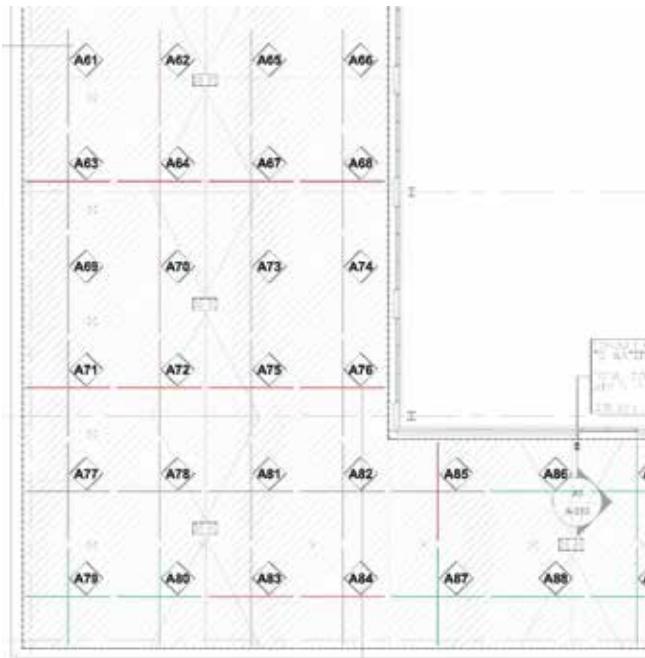
A few weeks later, 60 moisture detection zones (each approximately 225 ft<sup>2</sup> [21 m<sup>2</sup>]) went into alarm as they were flooded due to a failed drain pressure test (Fig. 14). All wet areas were removed and replaced.

**Figure 14.** Flooded zones at health care complex in Iowa.

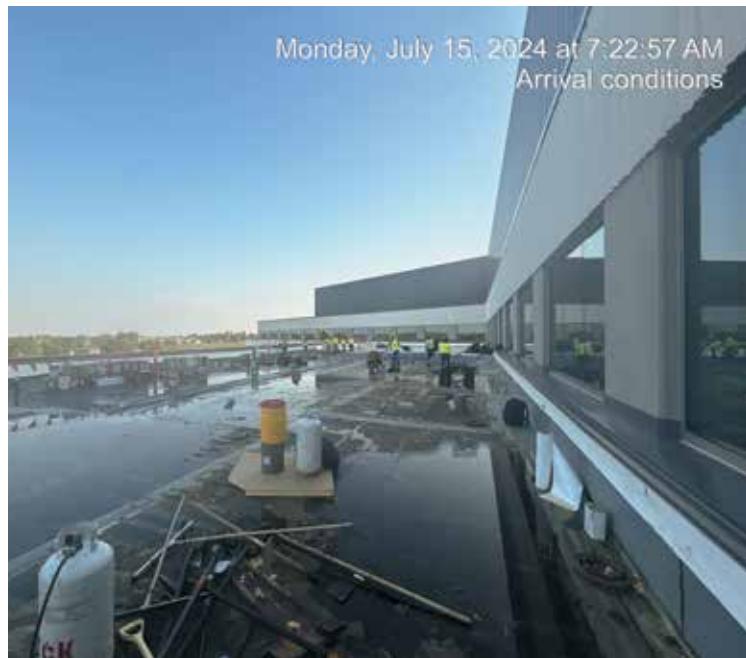
**Figure 15.** Two inches (50 mm) of standing water on the exposed roof.

On the following Monday, it was apparent that the night seal failed once again (Fig. 15). All areas were removed, dried, and replaced. The rest of the installation went smoothly, with occasional zones going into alert, but the moisture intrusion was caught right away and repaired quickly before it became a larger issue.

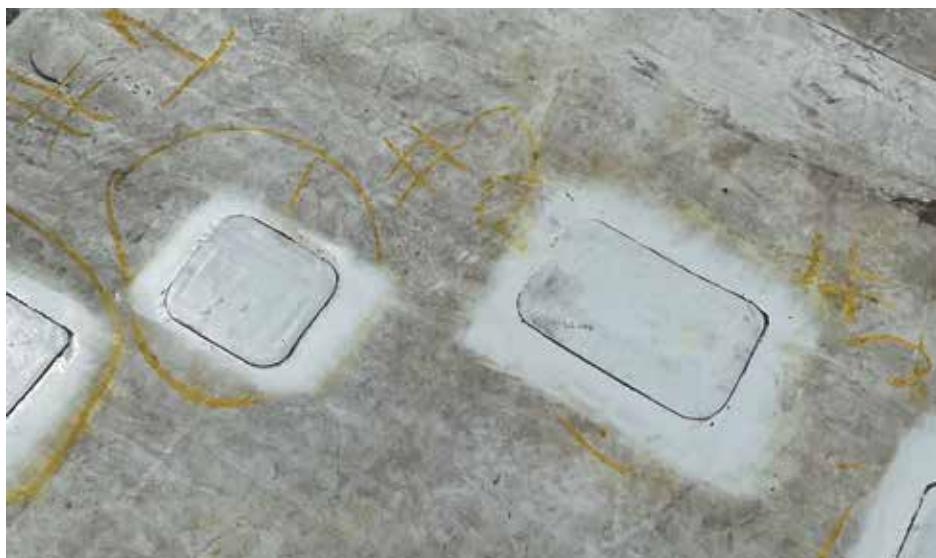
Towards the end of construction, ELD testing was performed on the single-ply roof which included a conductive medium directly below the membrane. Five breaches were found, repaired, and retested, preventing any future moisture intrusion (Fig. 16).

**Figure 16.** Breaches located, repaired, and retested at health care complex in Iowa.

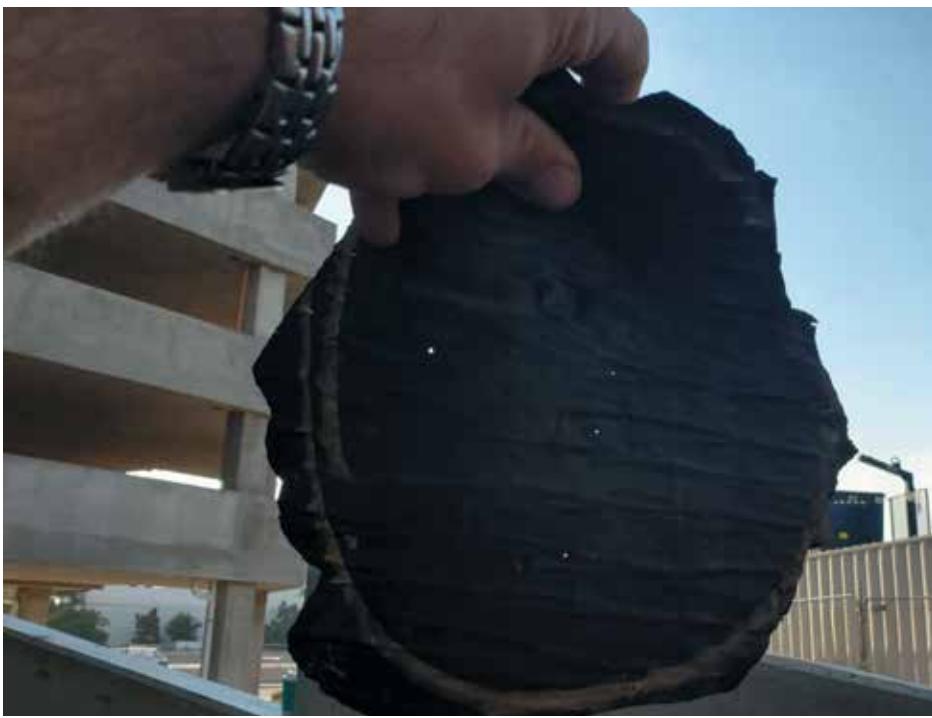
**Figure 17.** Example of clusters of breaches.
