# Facade Failures: Common Types, Causes, and Lessons Learned

By Paul Sujka, PE, and Matthew Normandeau, PE, LEED AP

*This paper was presented at the 2025 IIBEC International Convention and Trade Show.*

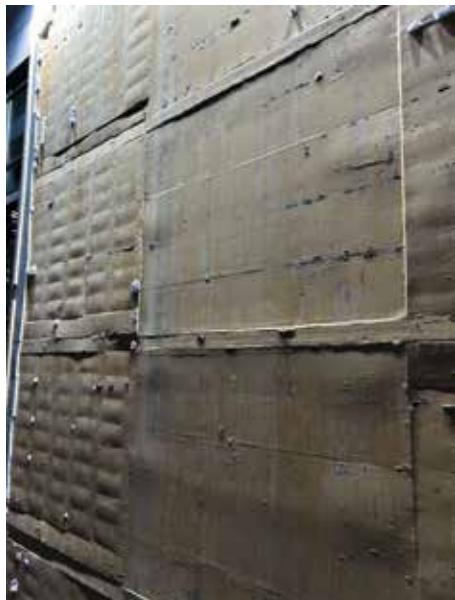
and/or inadequate substrate preparation. In 2024, SGH investigated a detachment failure of a 40 ft  $\times$  20 ft (12.2 m  $\times$  6.1 m) area of EIFS cladding 150 ft (45.7 m) above a busy roadway in New York City (Fig. 1). The maximum wind speed that occurred during the evening of the failure correlated to a negative wind pressure of approximately 35 lb/ft<sup>2</sup> (170.9 kg/m<sup>2</sup>) at corner conditions, which is approximately 55 lb/ft<sup>2</sup> (268.5 kg/m<sup>2</sup>) less than the wind pressure the EIFS cladding system should have been able to resist, as demonstrated by laboratory testing.

Through our emergency response to provide a safe facade system and our subsequent investigation, we concluded that substrate preparation deficiencies prevented continuous adhesion of the cementitious adhesive ribbons and that the failure appeared to occur at a building corner, where the wind pressures are greater than compared to field of wall conditions, which then progressed due to air flow behind the EIFS cladding. Upon review of failed wall sections, we observed many locations where less than 30% of vertical ribbons were bonded to the substrate, which was apparent because of the semi-circular dome profile of the cured adhesive (Fig. 2).

Figure 1. Substrate irregularities.

To reduce the potential for detachment failure of newly installed EIFS cladding, a primary focus should be strict compliance with the manufacturer's installation instructions, including providing a smooth and continuous substrate and compliance with the application rate and pattern of the adhesive. Recognizing the critical nature of these requirements, mockup repairs of substrate deficiencies and the application of adhesion should be performed and approved by the project team before the work is executed. Frequent on-site reviews throughout the application of insulation boards are also critical to identifying issues that will otherwise be concealed.

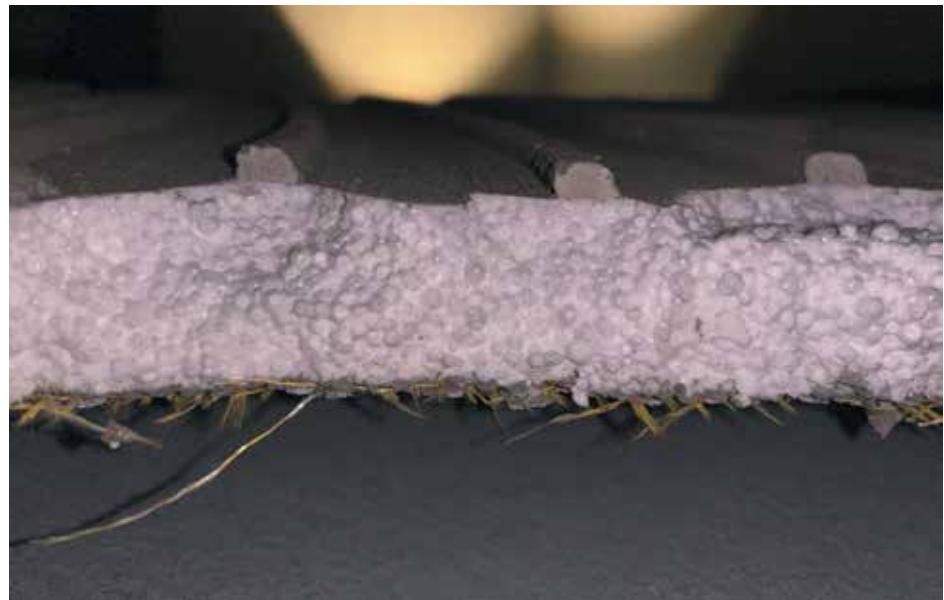
Figure 2. Semicircular dome profile of cured adhesive ribbons.

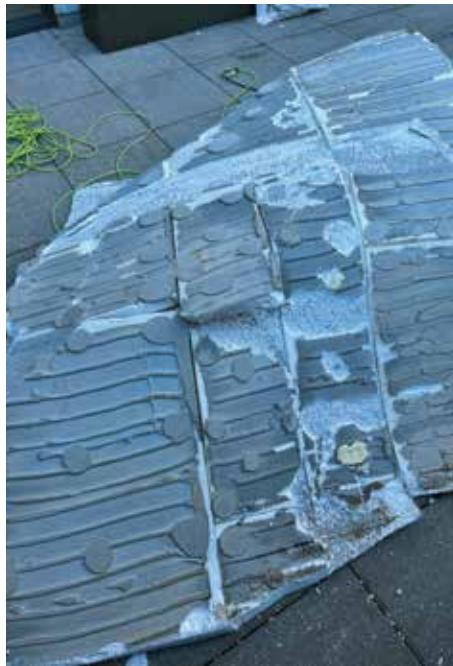
The installing contractor had applied adhesive ribbons, but the notched trowel provided inadequate depth to bond ribbons to the substrate due to the depth of planar deficiencies in the substrate. The installer elected to apply dollops of adhesive, in addition to vertical ribbons of adhesive, to address irregularities that varied in depth by up to 1 in. (2.54 cm). The dollops were irregularly spaced and ultimately provided an inadequate uniform bond compared to what should have been provided

with adhesive ribbons (Fig. 3). Additionally, the dollops observed were thicker than the vertical ribbons of adhesive in many conditions which prevented the adhesion of the vertical ribbons of adhesive.

**Figure 3.** Dollops of adhesive at failure of exterior insulation and finish system.

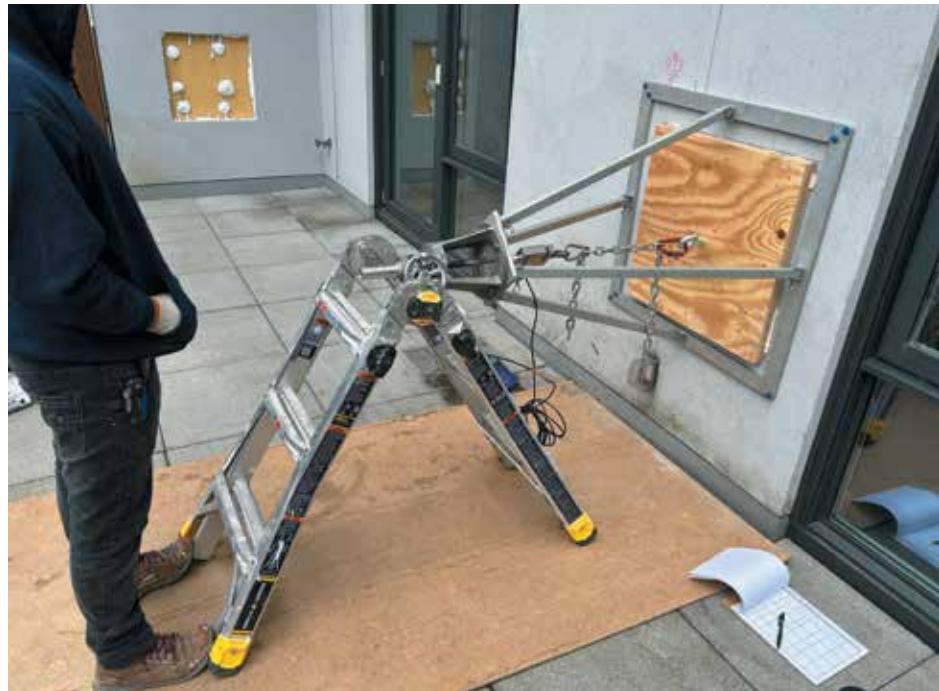
To enhance quality assurance, field testing per ASTM E2359, *Standard Test Method for Field Pull Testing of an In-Place Exterior Insulation and Finish System Clad Wall Assembly*, can be performed to review the installed system's adhesion relative to its required performance (Fig. 4). In our project example, we performed this testing to evaluate the condition of EIFS cladding beyond the failure to determine whether the failure was systemic. Our testing demonstrated that the wind pressure resistance of EIFS cladding beyond the failure was adequately above the governing component and cladding negative pressure requirements. We

concluded that the EIFS cladding at those areas had adequate adhesion, such that the recladding scope would be limited to the failed area and did not need to include the whole building.

**Figure 4.** Exterior insulation and finish system adhesion testing.

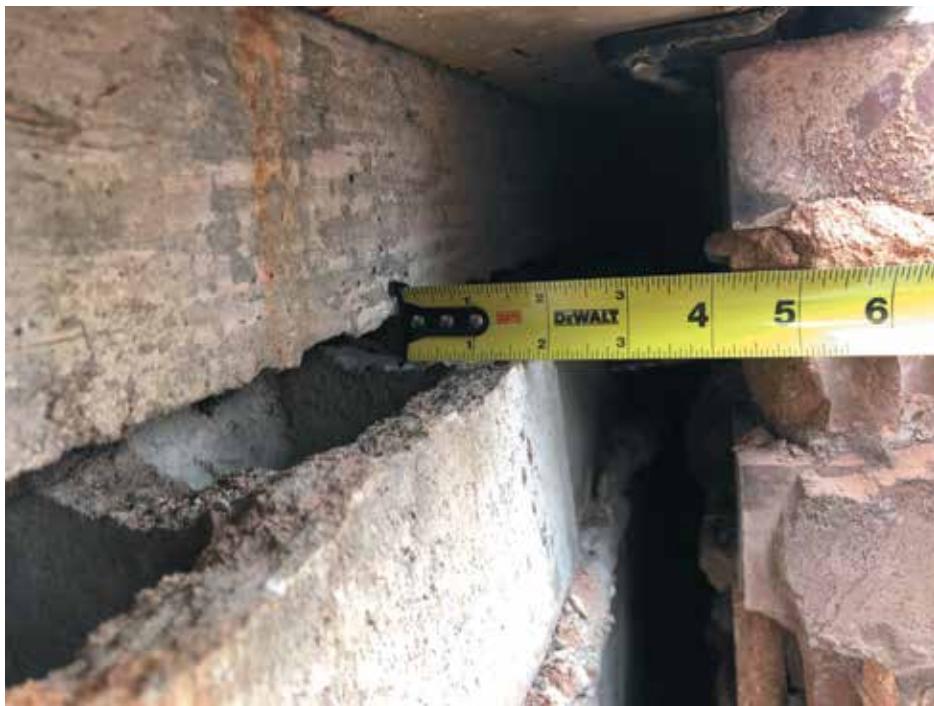
- **Backup Walls:** Midcentury brick cavity walls were often constructed outboard of backup walls that lack the provisions that would be required under current building codes and that were intended as part of the original construction. Often, these backup walls are constructed of 4 in. (10.16 cm) CMU that lacks adequate grouted reinforcing and attachments at the top and bottom to resist lateral loads imposed by the brick masonry veneer anchors and transfer such forces to the building structure. We have investigated midcentury buildings with displaced backup walls that contributed to the failure of brick masonry veneer cladding (Fig. 5 and 6).
- **Masonry Ties:** Some masonry-related failures are related to corrosion of masonry ties. SGH has investigated corrosion of ties that resulted in full section loss of ties causing mortar failures and detachment

**Figure 5.** Displacement of backup wall.

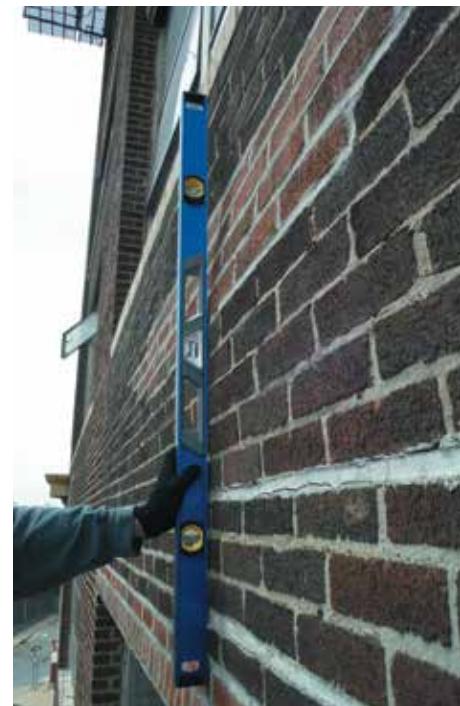
**Figure 6.** Displacement of brick masonry.

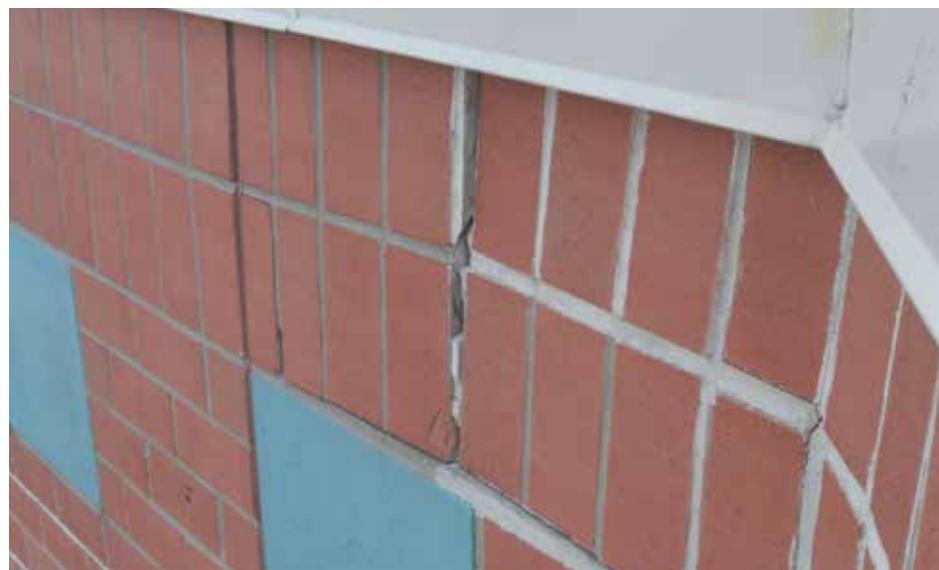
often contributes to the detachment and failure of these cladding systems. SGH has investigated many buildings where adequate expansion joints were not provided at the conditions noted, resulting in masonry distress and cladding reconstruction scopes (Fig. 7).

**Figure 7.** Displacement of brick masonry veneer.

such as the Brick Industry Association recommend incorporating adequately sized expansion joints in the masonry system.

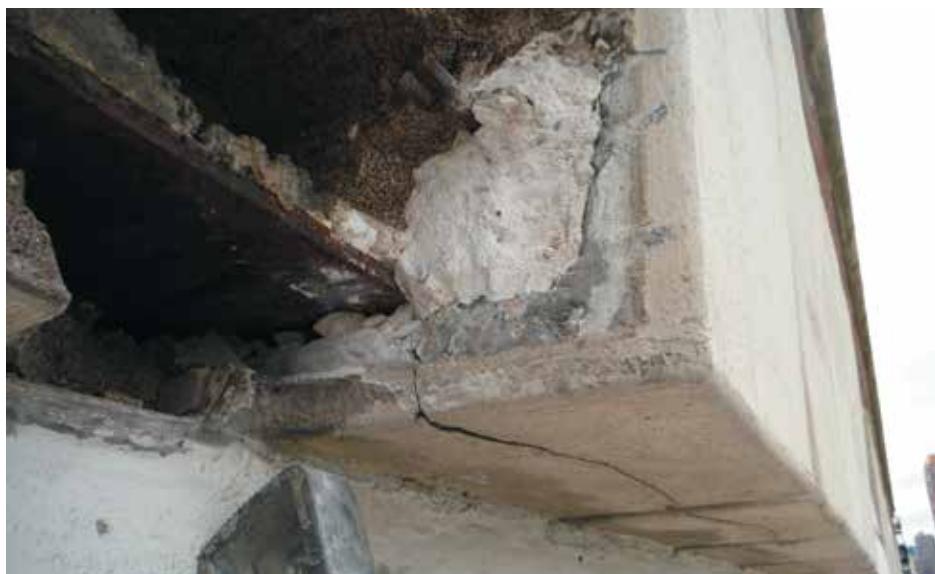
attachments. Further, this system is often more prone to water penetration because it is provided at parapets, which are exposed to increased wetting due to exposure on three sides, and sky-facing surfaces such as cornices and water tables. Traditionally, framing and anchors that secure terra-cotta have historically been steel; however, cast iron and wrought iron were also used, but to a lesser degree, given that they are more prone to corrosion. Decades of water penetration can eventually cause corrosion of the framing and attachments that can result in section loss of attachments and rust jacking, which is a phenomenon that occurs when rust builds up on metal, causing it to expand and put pressure on the surrounding materials. The combination of a reduction of the strength of the attachments due to section loss and the rust jacking process can cause stress at the terra-cotta connections which can fracture individual terra-cotta units (Fig. 8).

Figure 8. Cracked terra-cotta at corroded beam.

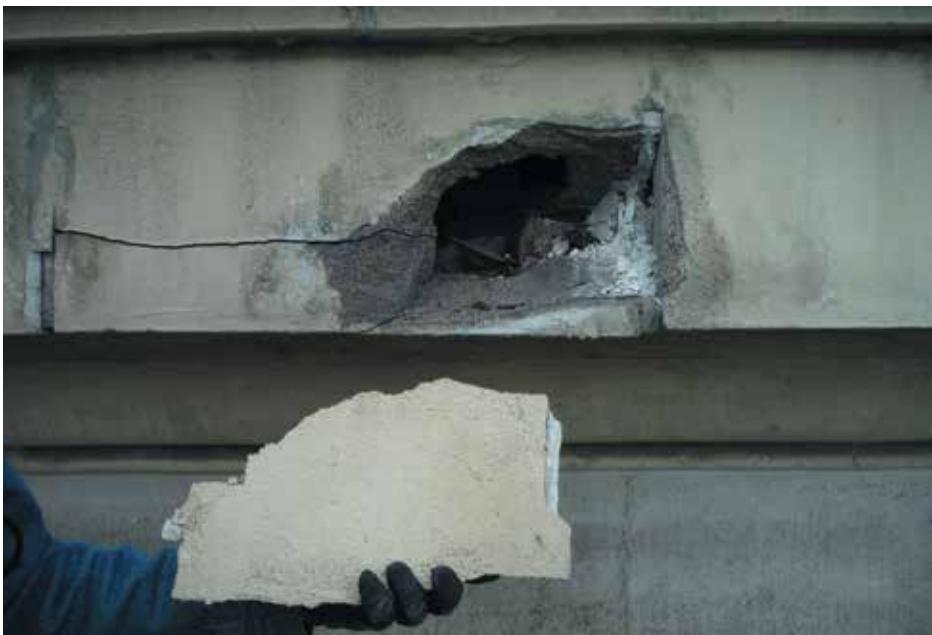
- **Material Failures:** The porous nature of terra-cotta makes it vulnerable to freeze-thaw cycles, where water absorbed by the material expands upon freezing, causing cracks and spalling in the terra-cotta units. Terra-cotta systems are particularly susceptible to localized failure that, if not remediated, can spread due to increased moisture penetration. These failures can result in glazing failures, where the protective glaze that seals the surface of the terra-cotta units cracks or delaminates and exposes the underlying bisque components. Once the bisque is exposed, the terra-cotta is much more susceptible to water absorption and freeze-thaw damage. This can happen even from a small failure in the glazing, which can

allow moisture to penetrate deep into the terra-cotta units, resulting in more widespread degradation and failure (Fig. 9).

**Figure 9.** Removed cracked and loose terra-cotta.
