# Exploring “Creep” Behavior in Building Construction

By L. D. Hogan, F-IIBEC, RRC, PE

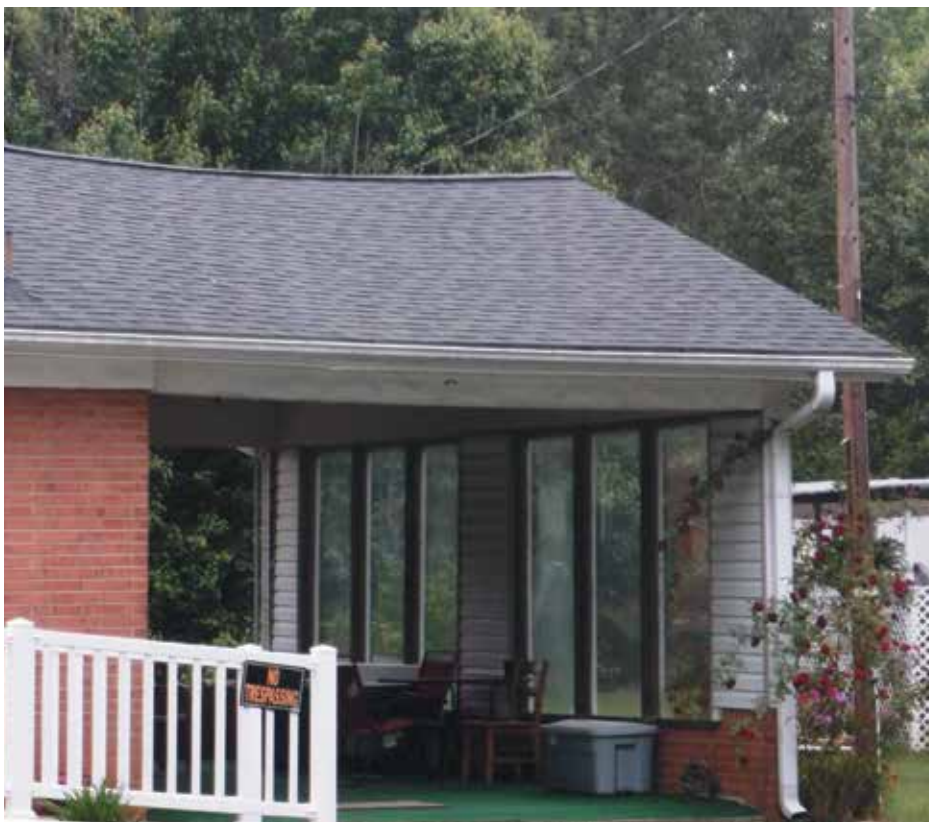
**Figure 1** illustrates a sagging roof ridge beam in residential stick-built lumber framing. The condition did not occur from a singular loading event. Outward bowing of walls (**Fig. 2**) is a frequent consequence of misbehaving ridge beams. Both of these are textbook examples of long-term creep where lumber size and span relationships were substandard.

**Figure 1.** Sagging ridge beam in residential stick-built roof framing; this did not occur from a singular loading event.

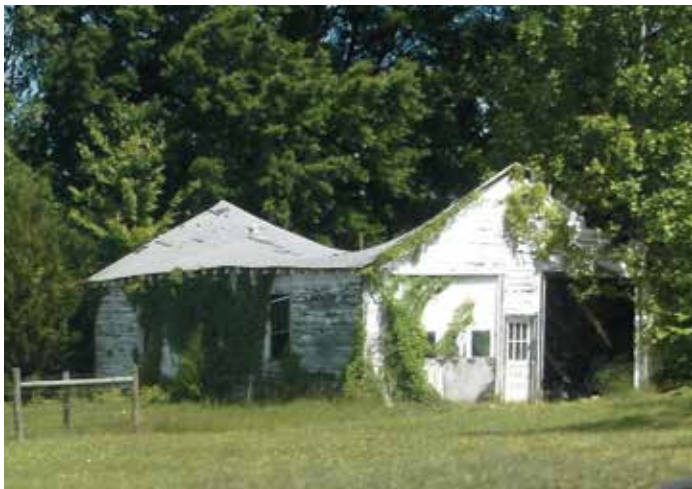
**Figure 2.** Extreme sagging of roof ridgeline and outward bowing of walls; this is a textbook example of long-term creep where lumber size and span relationships were substandard.

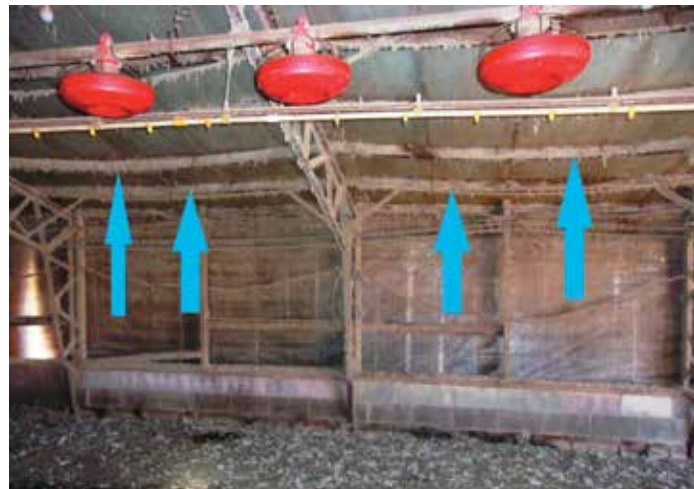
Agricultural structures (for example, poultry houses, farm equipment sheds, and barns) seem especially prone to creep. Similarly, **Fig. 3** depicts sagging of wood roof supports between

**Figure 3.** Sagging of wood roof supports between iron joists of a large poultry confinement house. The span and spacing were far too great for the size of lumber used.

iron joists of a large poultry confinement house. Span and spacing were far too great for the size of lumber used. **Figure 4** illustrates another poultry confinement house, which was 400 ft (122 m) long, experiencing extreme out-of-plumb leaning. Support posts and engineered roof trusses were 5 ft (1.5 m) on center, and ordinary shear diaphragm bracing was absent throughout. Radical auxiliary bracing was necessary just to stabilize the leaning. Structures of this variety are governed under a separate classification in the building code, as no one would consider building a residential

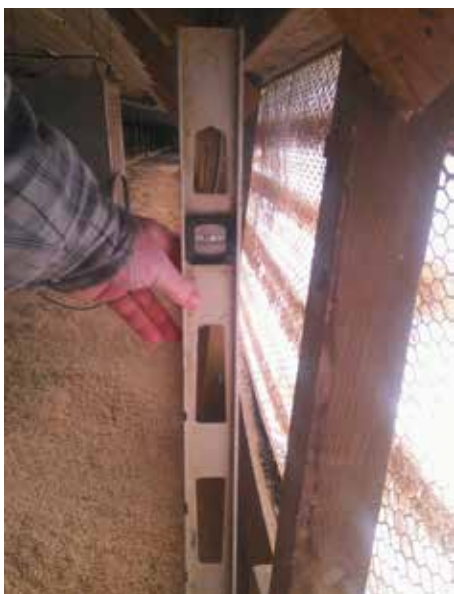
**Figure 4.** Another poultry confinement house (400 ft [122 m] long) experiencing extreme out-of-plumb leaning. Support posts and engineered roof trusses were 5 ft (1.5 m) on center, and ordinary shear diaphragm bracing was absent throughout.

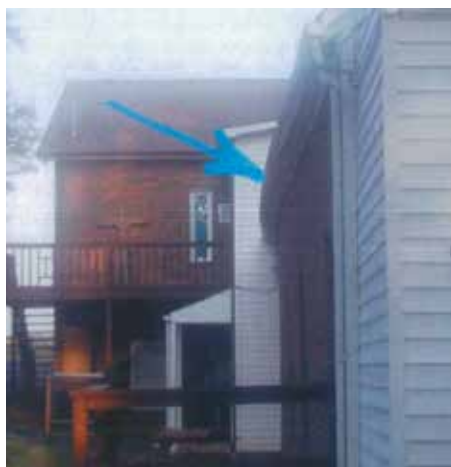
**Figure 5.** Outward bowing of walls of a church fellowship hall. Two large columns within had been removed, and the roof ridgeline slowly began sagging while walls responded by displacing outward at the top.

In another instance involving the outward bowing of walls of a church fellowship hall (**Fig. 5**), parishioners had carried out removal of two interior columns to accommodate more dining tables. The roof ridgeline slowly began sagging while walls responded by bowing outward; the behavior was so slow and gradual that occupants were unaware of it. Had there been legitimate structural overloading, other distress would have been generated, such as broken or splintered framing members. Absent that, however, the slow progressive distortion of the roof and walls signals creep behavior.

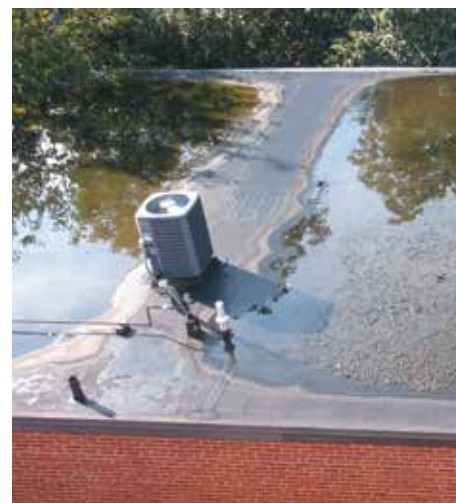
**Figure 6.** Severe deflection on a hollow-core concrete plank deck. High and dry region is that portion occurring above inside partition walls.

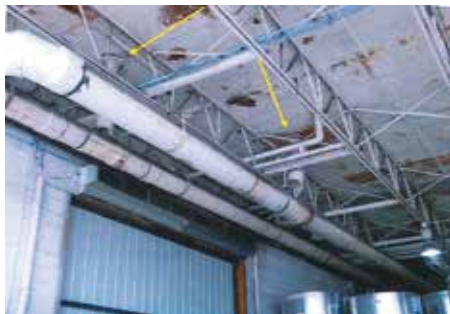
The orientation of internal drain lines (relative to the direction of bar joists) may be a factor in observed creep. It should be noted that large drain lines are a considerable structural load when flowing full. The horizontal pipes running parallel in **Fig. 7** caused concentrated loading on one or two joists, as opposed to being distributed across several joists. There was rooftop ponding water in this region only, and permanent surface deflection was present even during dry conditions. The same can occur when a single joist is loaded with large ductwork, process piping, a suspended conveyor line, or related burden. This loading arrangement can often be addressed with modification to joist spacing or by sharing the load among adjacent joints.

**Figure 7.** Internal drain lines running parallel to the direction of bar joists. This explains ponding only in a specific region on this roof; ponding had been present for decades.

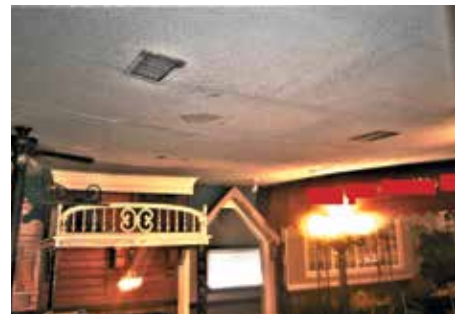
**Figure 8** illustrates severe ceiling sagging of an occupied restaurant (unknown to diners or the owner). Some instances of ceiling collapse are so abrupt and loud that witnesses have described an "explosion" in the attic. One instance of a slamming door set off a collapse of plaster finishes, but distress was clearly underway prior to the door's influence. On multiple occasions, elaborate shoring/bracing was necessary to stabilize and control propagation of a ceiling loss. Many fallen ceilings had an astounding unit weight when examined in the debris pile (especially those having old plasterboard backing). It should be noted that fastening relationships are crucial in overhead work. Some collapses had as many as three layers of materials and support grids, installed during decades of building use and renovations. In contrast with vertical gypsum drywall or plaster, the entire mass of a ceiling must be restrained against gravity. Fastener type, configuration, and spacing are all pivotal in the performance of a ceiling, as is the arrangement of support lath.

**Figure 8.** Severe ceiling sag in an occupied restaurant. Some instances of ceiling collapse are so abrupt and loud that witnesses have described an "explosion" in the attic.

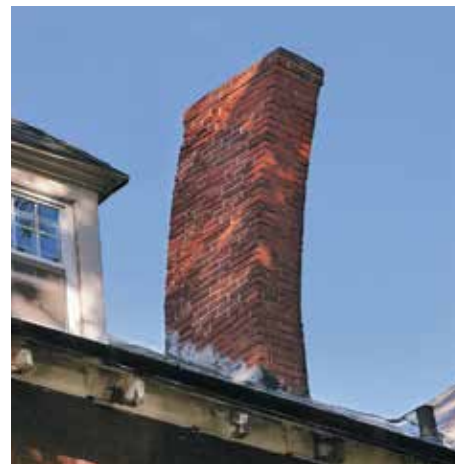
**Curving chimneys and meandering parapets:** A curving chimney is not the same thing as a *leaning* chimney—the latter being associated with inadequate footing projection and the fact that the chimneys are eccentrically loaded on a footing. **Figure 9** illustrates radical curving of a brick masonry chimney. Remember that creep can occur from both mechanical loads and persistent thermal loading. Curvature of a chimney stems from environmental influences over a long period (for example, wind or solar exposure). There are conflicting theories regarding what prompts the curving of

**Figure 9.** Radical curving of a brick masonry chimney, not from structural loading, but rather stemming from environmental influences over a long period.

a chimney. One theory holds that curving occurs *toward* the direction of the prevailing wind, as it is the quickest-drying face; the slow-drying side experiences widening of mortar joints from expansion of the internal salt crystals. The other theory holds that curving is *with* the direction of wind-driven rains. It remains debatable whether wind direction or solar exposure is the prime influencer for long-term curving, as the prevailing direction of wind may or may not be the same face experiencing the quickest drying. In any event, it is a long-term behavior, and the two theories share the notion that unequal deterioration of mortar joints is the primary driver to cause curving.<sup>2</sup>

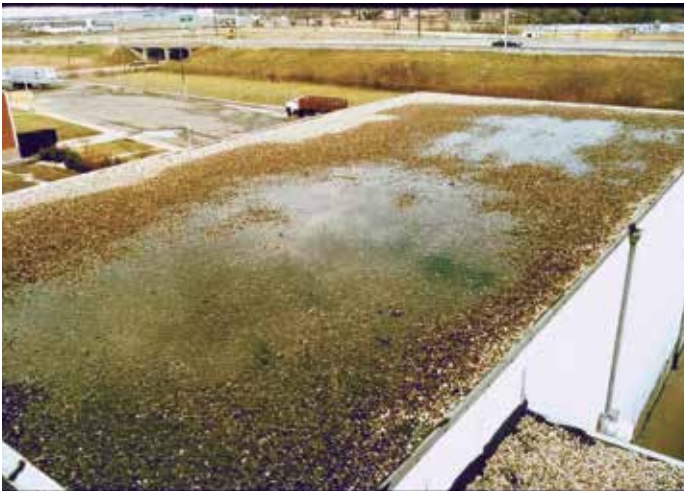
**Figure 10.** Older variety of structural insulated panel used for the walls and roof deck of a midwestern freezer facility. Severe deflection resulted from long-term ponding plus the mass of two roof layers (the outermost being stone ballasted). This behavior may be years in the making and well exemplifies creep.

**Structural insulated panels (SIPs):** Severe roof deflection shown in **Fig. 10** resulted from long-term ponding plus the mass of two roof layers (one being stone ballasted). While this midwestern freezer facility had a quite early

variety of SIP, the slowly sagging behavior was years in the making and well exemplifies creep. Modern SIP products are vastly improved over this 1960s construction, but they still should not be stretched out or overloaded. Roofs are experiencing creep when their surface deformation does not rebound after snow and water are removed.

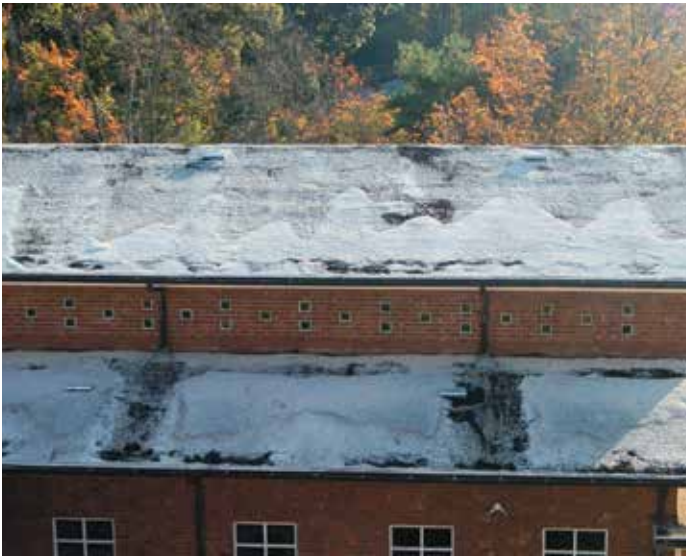
**Figure 11.** Downslope migration of bituminous flood coat and aggregate surfacing. The softening point of the bitumen was incompatible with the roof slope.

**Downslope migration of old built-up roofs:** **Figure 11** illustrates downslope migration of bituminous flood coat and aggregate surfacing. The softening point of the bitumen was incompatible with the roof slope. Five decades ago, this behavior was known as slippage, and all manner of construction disputes grew from it. The seasoned reader may recollect a practice known as back nailing, the purpose of which was to control downslope creep of bituminous roofing materials. The slow-acting load being applied here is simple gravity.

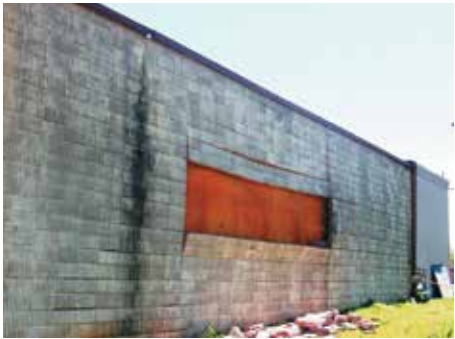
**Figure 12.** Unit masonry slumped vertically and eventually kicked out of plane. Decades in the making, it originated from a substandard connection to the backup plane.

**Unit masonry walls (usually but not always brick):** **Figure 12** is an example of unit masonry that had slumped vertically and eventually kicked out of plane. Probably

decades in the making, it originated from a substandard connection to the back-up plane. Bow and sweep observed in basement walls are often accompanied by water seepage. The perception by some property owners is that wall cracks are getting worse with time, and they may well be. Proprietary movement gauges are available to evaluate whether or not cracks are indeed widening. Cracks that are deemed to be "dynamic" should be closely scrutinized, with emphasis on remedial measures.
