A Tale of Two Masonry Facade Rehabilitations: When Preservation Standards, Codes, and Client Expectations Are at Odds

By Edward Gerns, RA, LEED AP, and Rachel Will, PE

This paper was originally presented at the 2021 IIBEC International Convention and Trade Show.

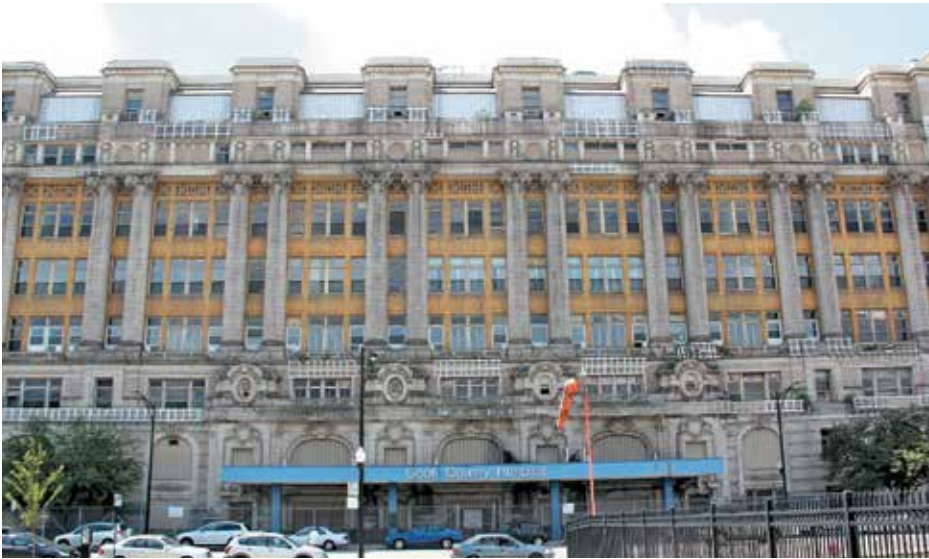
Figure 2. *Old Cook County Hospital north facade before redevelopment (circa 2012).*

The Old Cook County Hospital was closed in 2002, and maintenance of the exterior enclosure before that was limited. Additionally, the building stood vacant and unconditioned until 2018, with little effort made to limit air and water infiltration. Temporarily stabilization of portions of the exterior facade had been installed throughout the period of vacancy to minimize hazards to public safety. Unfortunately, the previous stabilization interventions did not provide weather protection for the interior or substrate portions for the structural support and anchorages (Fig. 2).

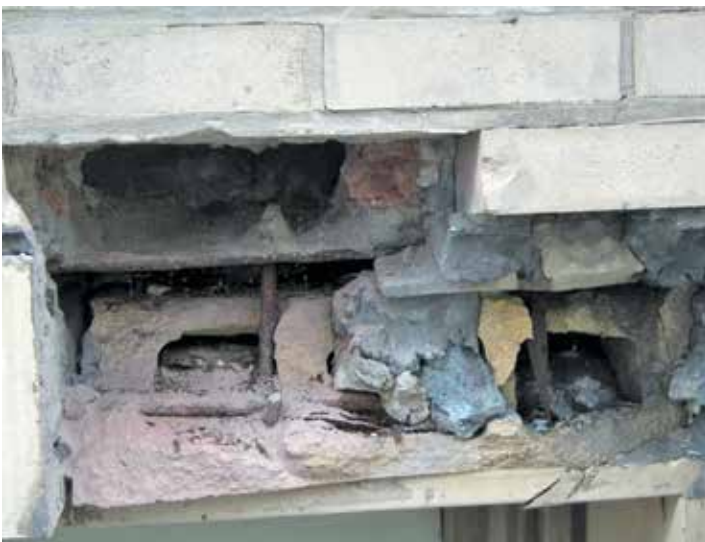
Figure 3. *Distressed terra-cotta window head unit caused by corrosion of steel anchorages and support at Old Cook County Hospital as viewed during the 2011 Phase 1 assessment.*

Generally, the investigation revealed that the majority of terra-cotta and brick exhibited deterioration consistent with a cladding material that has been in service for more than 100 years and minimally maintained due to vacancy of the building for the last 15 years and lack of appropriate funding. As expected, distress and deterioration were most pronounced at high-exposure area locations, with unrestricted water infiltration resulting in corrosion of supporting steel. These areas included the third-floor terra-cotta gutter, projecting balconies, hung terra-cotta elements, and parapets (Fig. 3).

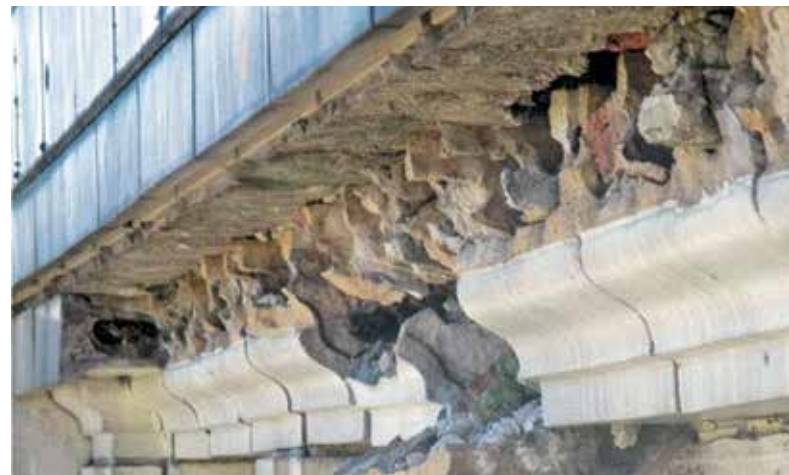
Figure 4. *Distressed terra-cotta window on seventh-floor head units below a previously replaced cornice at Old Cook County Hospital, as viewed during the 2016 Phase 2 assessment. The distress was attributed to corrosion of steel anchorages associated with the poor detailing of the retrofit.*

In addition, distress was occurring at locations of previous incompatible or poorly designed repairs and stabilization efforts, such as the terra-cotta cornice at the seventh floor. The cornice had been previously removed and replaced with a terra-cotta flat spandrel and poor

detailing relative to historic sensitivity and water management. The removal process included cutting steel elements flush with the plane of the wall and installing brick and poor-quality replacement terra-cotta around the existing steel. Water management considerations were not taken into account with the detail, thus allowing excessive water infiltration and subsequent corrosion of the supporting steel of the facade components below the repair area (Fig. 4). This approach provided a short-term solution to falling material, but poor detailing resulted in additional water infiltration into the “repaired” wall areas and subsequent development of distress and deterioration.

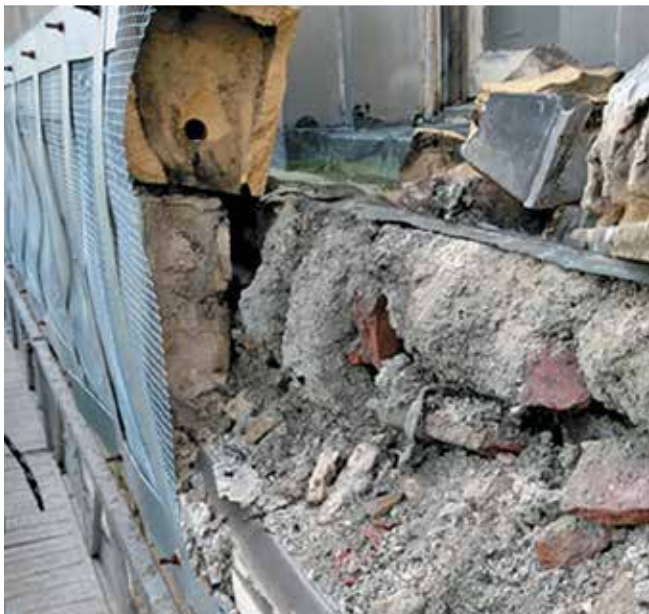
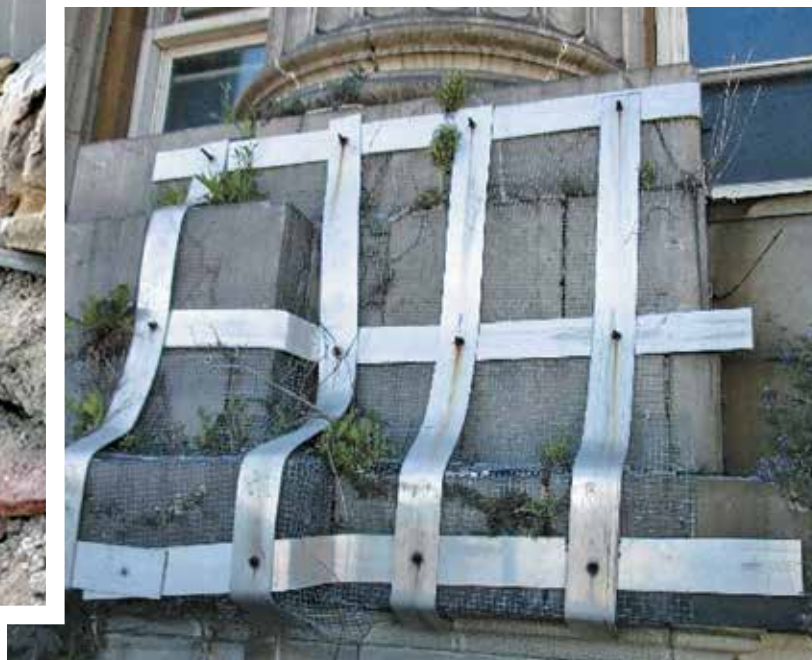
Figure 5. View of distress at the terra-cotta masonry exacerbated by previous stabilization efforts, with corroding fasteners causing cracking and spalling of the terra-cotta units.

Some of the additional distress to the brick and terra-cotta was caused by the previous installation of temporary stabilization without sensitivity for eventual restoration of the building. The stainless-steel straps and mesh were installed with ferrous anchors and through the face of the terra-cotta units and brick elements, rather than through mortar joints or other means to limit distress to the masonry units. Corrosion of the ferrous anchors for the stabilization resulted in excessive cracking and spalling of many of the terra-cotta units and brick masonry that could otherwise have been salvaged (Fig. 5).

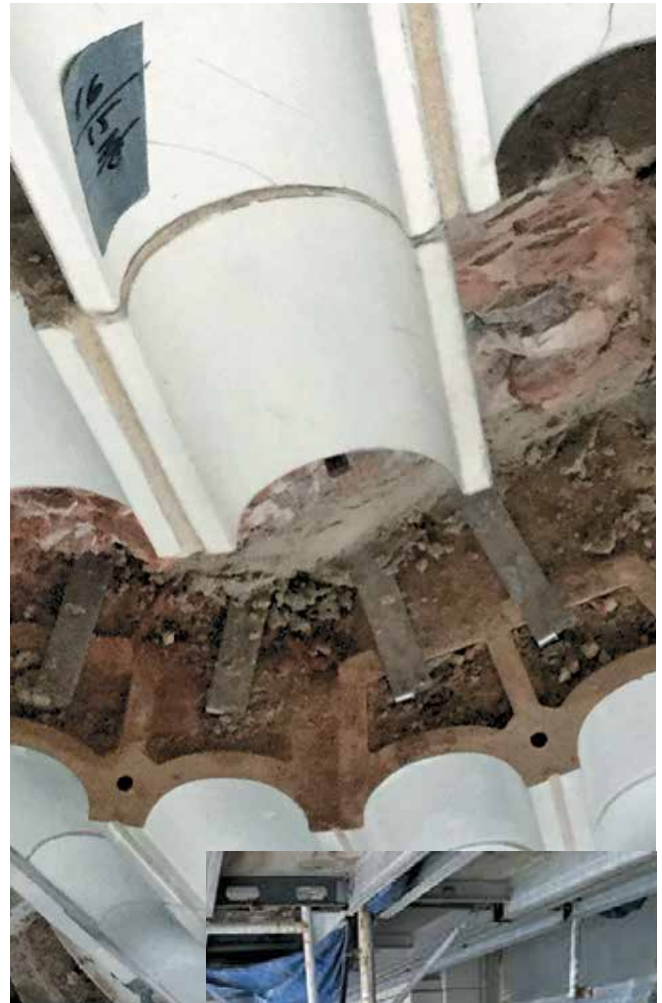
Figure 6. Installation of terra-cotta units at monumental columns at the north facade during rehabilitation of the Old Cook County Hospital in 2019.

- Brick, stone, and terra-cotta masonry were repaired or replaced on all facades. The brick, stone, and terra-cotta units that were deteriorated beyond repair were replaced in kind. This part of the project also included the removal and rebuilding of select areas with salvaged units. Approximately 10,000 ft² of brick were removed and replaced or reinstalled. Granite units were replaced at the base of the building as necessary. Approximately 4000 terra-cotta units were removed and replaced. Approximately 10,000 additional units were removed and reinstalled as part of the repairs to address the underlying steel (Fig. 6).

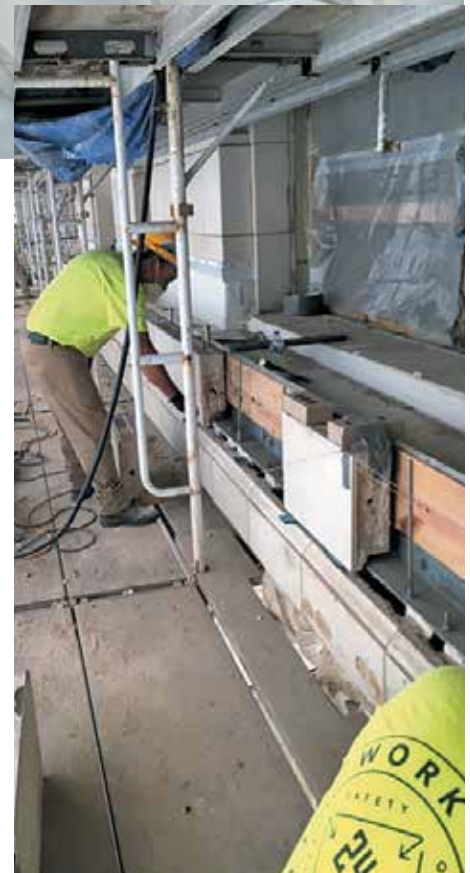
Figure 7. Reconstruction of the third-floor gutter and installation of terra-cotta units at the north, east, and west facades during rehabilitation of the Old Cook County Hospital in 2018–2019.

- The terra-cotta gutter at the third floor of the building was reconstructed on the north, east, west, and south return facades. This included replacing steel shelf angle and all anchorages, replacing deteriorated terra-cotta with new replacement terra-cotta, reinstallation of salvaged terra-cotta, and installation of a new gutter liner (Fig. 7).

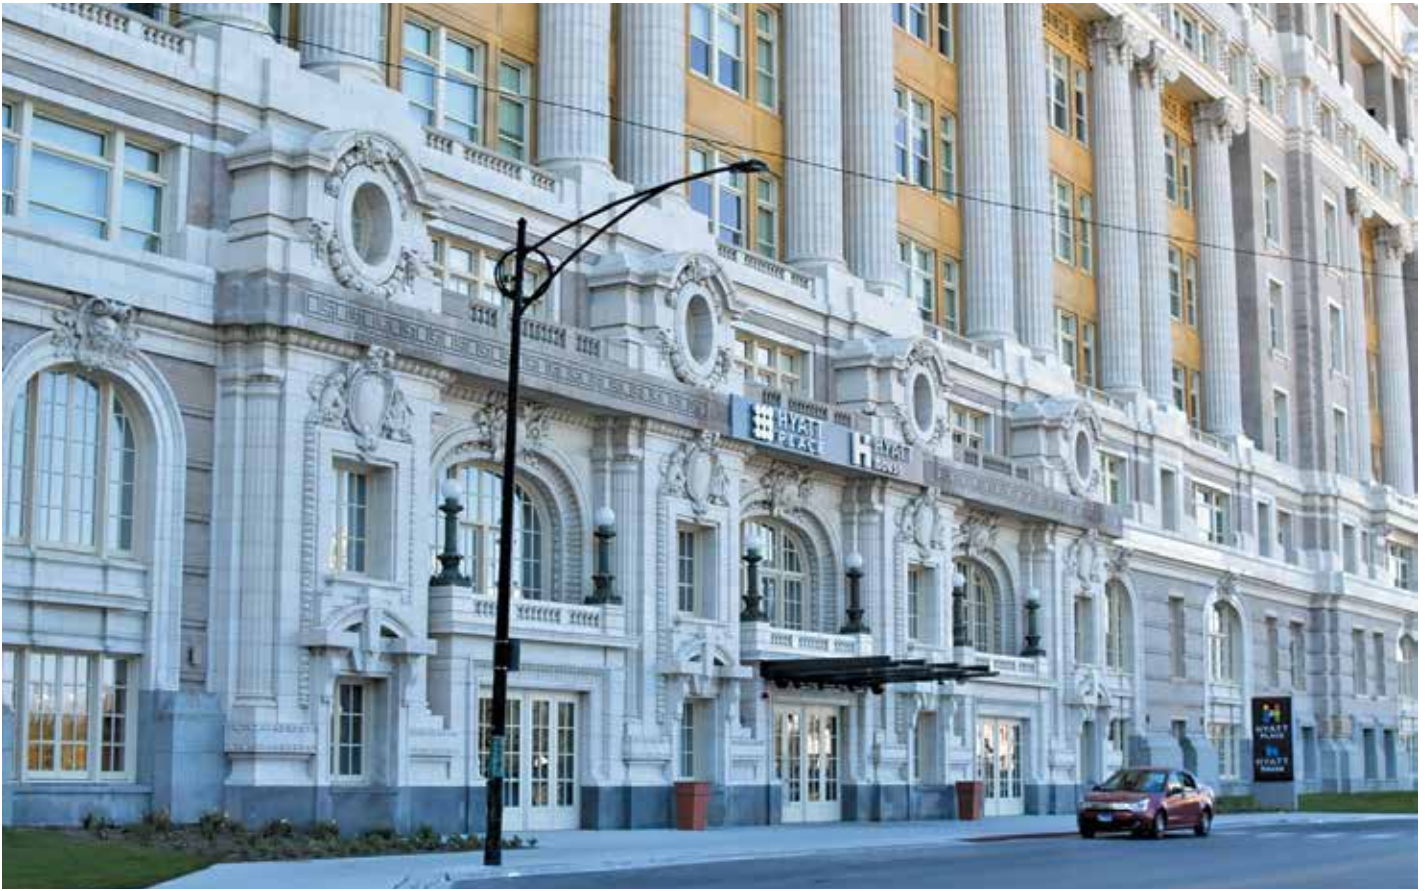
Figure 8. Overall view of the main entrance on the north facade following completion of the Old Cook County Hospital rehabilitation. Note the restored monumental windows and the salvaged and reinstalled the terra-cotta lanterns.

- The existing brick, terra-cotta, and stone masonry were cleaned with a two-part chemical cleaning system on the north, south, and west facades (Fig. 8).
- Nonhistoric metal paneling at the former pavilion locations and nonhistoric 1959 infill on the south facade were removed, and new metal panels and windows were installed in these areas.

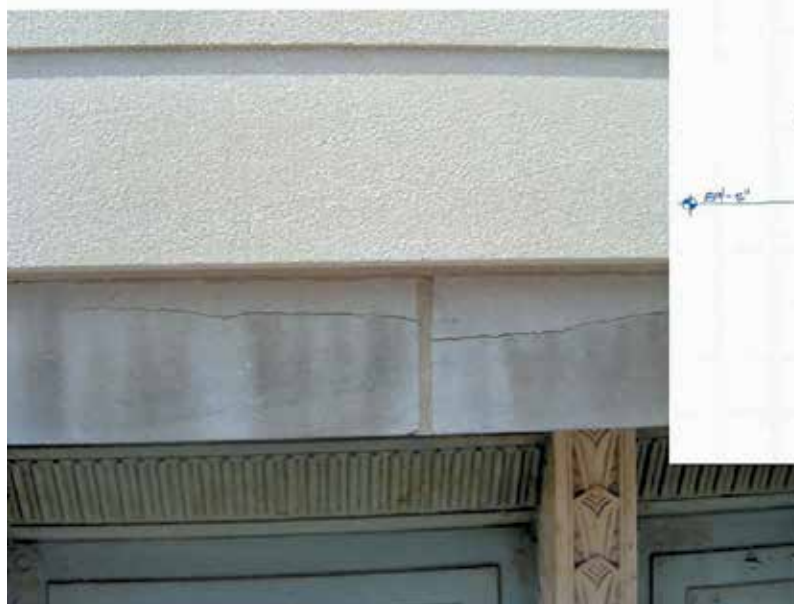
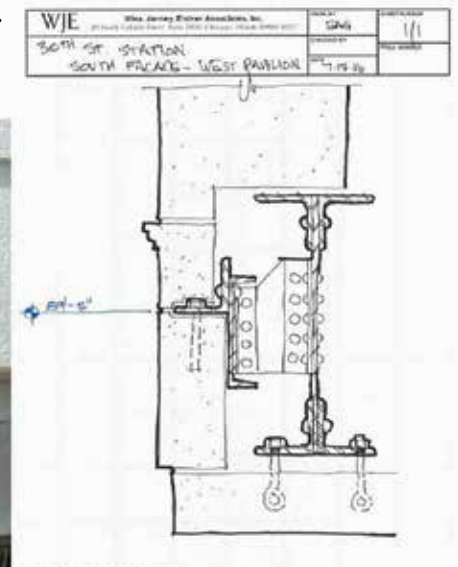
Figure 10. Typical cracked condition at the limestone soffit units at 30th Street Station, including field sketch of the existing condition.

- Spalls, displacements, and cracking of limestone at shelf angle locations were repaired. This repair included removing the limestone units that bear on the shelf angle. The existing shelf angle was cleaned and painted with a corrosion-inhibiting system, or the angle was replaced if the corrosion resulted in significant loss of cross-sectional area. For shelf angles that remained in situ, the mortar joint below the horizontal leg of the angle was ground out to provide access to the bottom side of the horizontal leg of the shelf angle. Replacement limestone units, or the existing limestone, were installed on the repaired or replaced shelf angle with stainless-steel lateral anchorage. The angles were protected by applying both a corrosion-inhibiting coating as well as a flexible membrane flashing (Fig. 10).

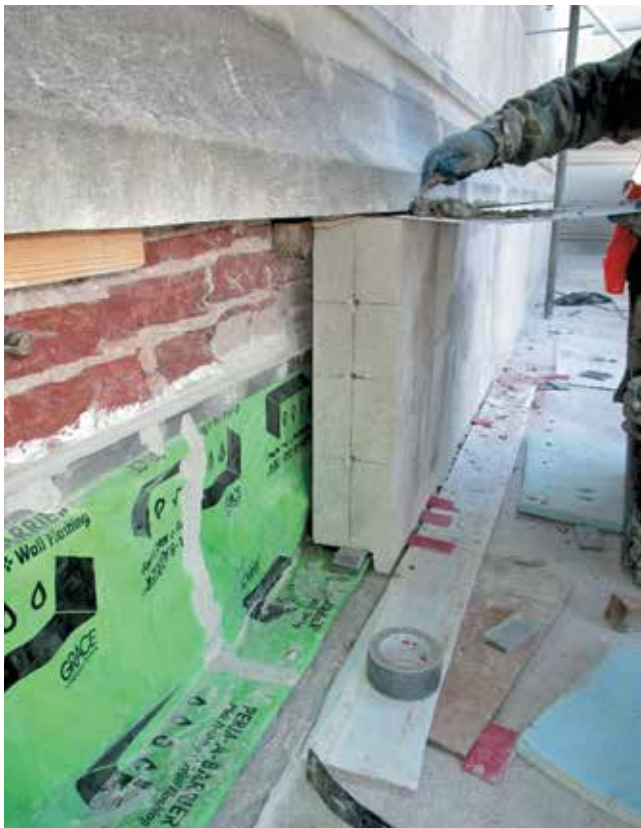
Figure 11. Installation of replacement stone at shelf angle location at 30th Street Station.

- Cracked limestone soffits were repaired by removing the limestone units set on the shelf angle before removing the units that were hung from the steel structure above. The existing shelf angle and exposed areas of the supporting steel were treated as previously discussed, and a new unit was installed supported by stainless-steel anchors (Fig. 11).

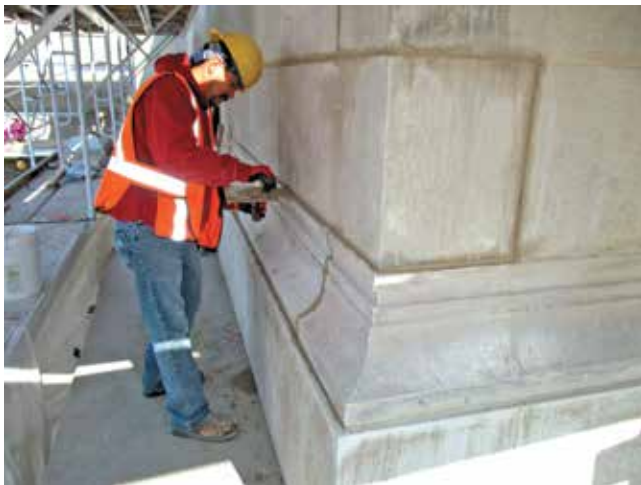
Figure 12. Repointing effort at the limestone at 30th Street Station.

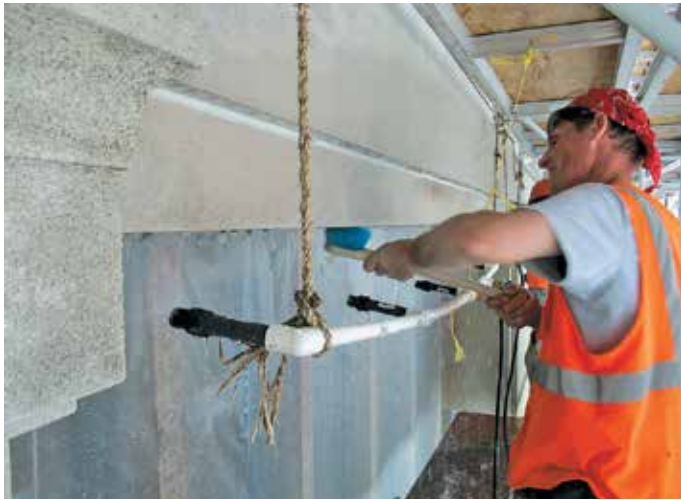
Figure 13. Water-misting cleaning at the limestone soffits at the main facades of 30th Street Station.

- The limestone was cleaned using a water-misting system in combination with biocide treatment to minimize accelerated limestone deterioration and improve the appearance of the building's primary public facades (Fig. 13).
- Inclusions in the limestone are being monitored as part of the ongoing maintenance of the facade. No repairs or treatments of the inclusions are determined to be necessary until a crack or spall has manifested.

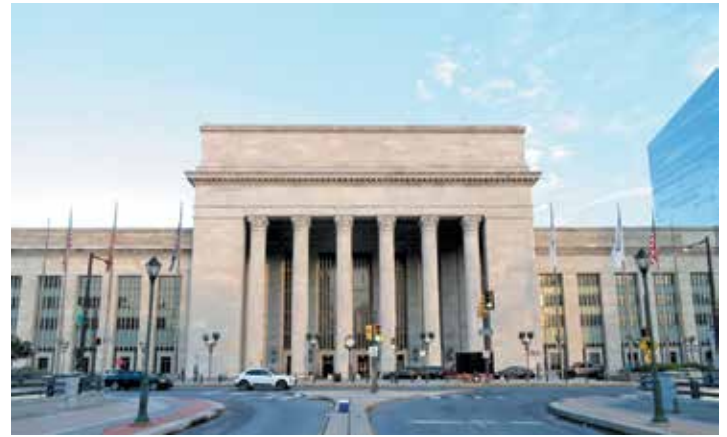
Figure 14. Overall view of completed rehabilitation of the east facade of 30th Street Station in 2018.

Initially, Amtrak requested that the facade restoration work be phased based on priority because funding potential was not known and would frequently vary based on emergency needs at other Amtrak facilities. Funding finally became available in 2012, more than seven years after the documents were prepared. A follow-up inspection was performed to update and reprioritize the repairs as necessary. Based on the conditions observed during the follow-up inspection, numerous conditions that had been considered medium priority in 2005 were reprioritized to high priority in 2012. In addition, some of the conditions that had previously been classified as high priority had deteriorated to a point that sidewalk protection was recommended and installed around the majority of the publicly accessible areas of the exterior of the station (Fig. 14).
