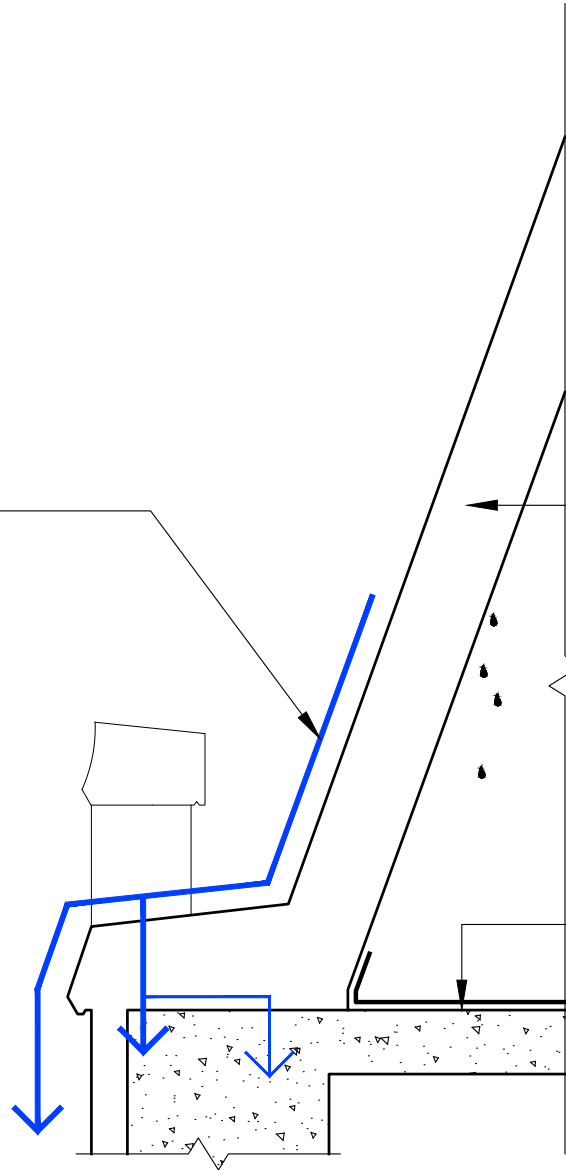
EXISTING RAIN AND SNOW
MANAGEMENT ENCOURAGED
WATER ENTRY INTO THE
WALL SYSTEM AT THE
SCUPPER OPENINGS
THEREBY CAUSING
MASONRY DEGRADATION

EXISTING LEAKING
WOOD FRAMED SPIRE

NO DRAINAGE PROVISIONS
UNDER EXISTING SPIRE

EXISTING SPIRE / ROOF CONDITION
