Technical Advisory  
Fiber-Cement Siding: Inherent Issues Affecting  
Performance – 17-2019

- TITLE:** Fiber-Cement Siding: Inherent Issues Affecting Performance
- DESIGNATION:** IIBEC-TA-017-2019
- OBJECTIVE:** To provide an informative advisory regarding performance issues that may be encountered with fiber-cement siding installed on a building.

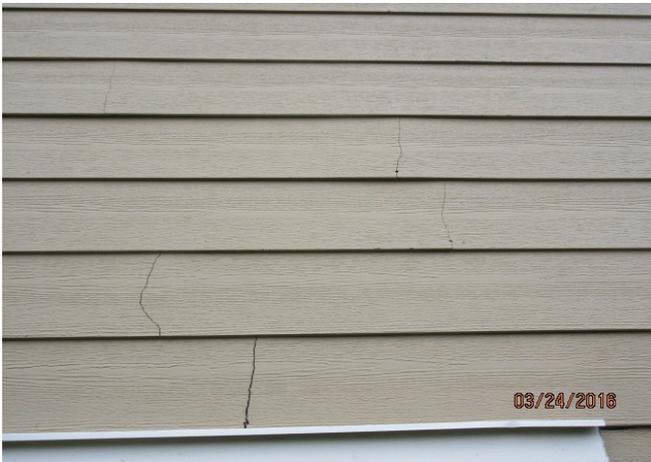
Figure 1 – Cracks in fiber-cement siding.

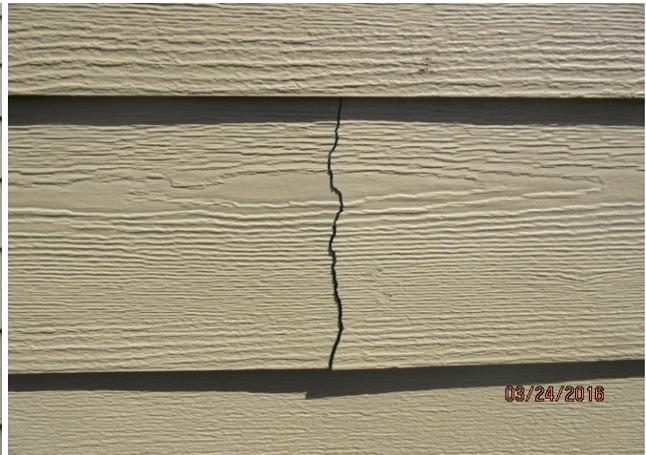
Figure 2 – Close-up view of crack in fiber-cement siding.

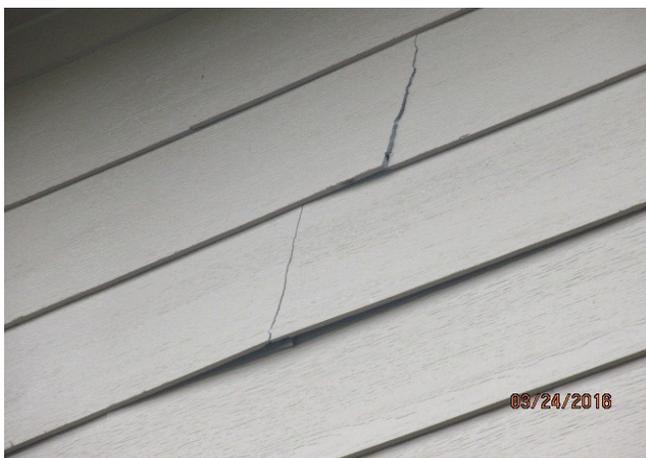
Figure 3 – Cracks and “warping” in fiber-cement siding.

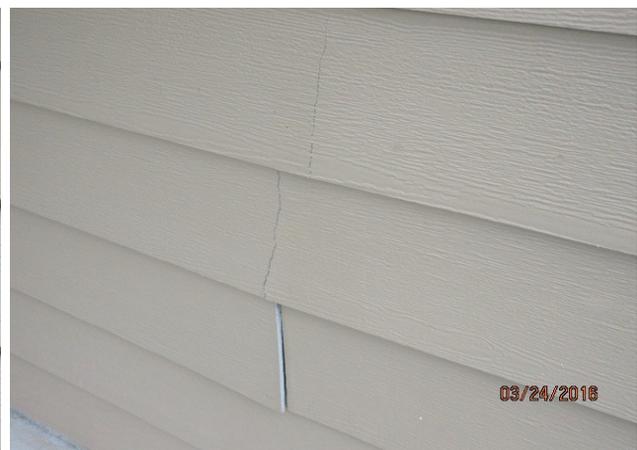
Figure 4 – Cracks and “warping” (open joint) in fiber-cement siding.

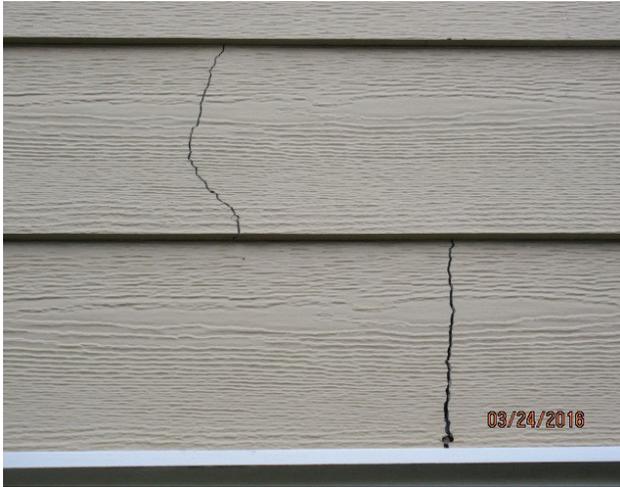
Figure 5 – Close-up view of cracks in fiber-cement siding.

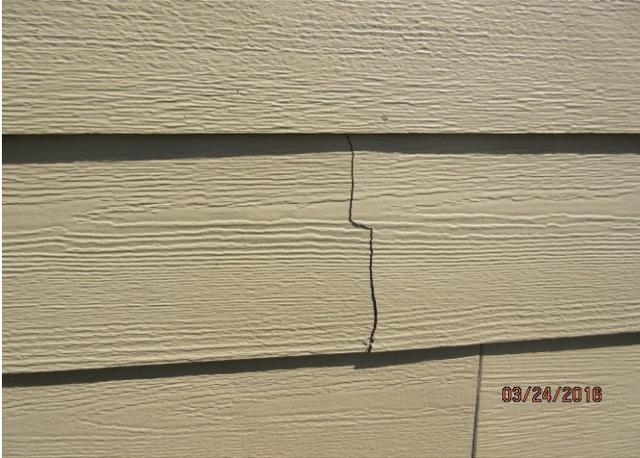
Figure 6 – Close-up view of cracks in fiber-cement siding.

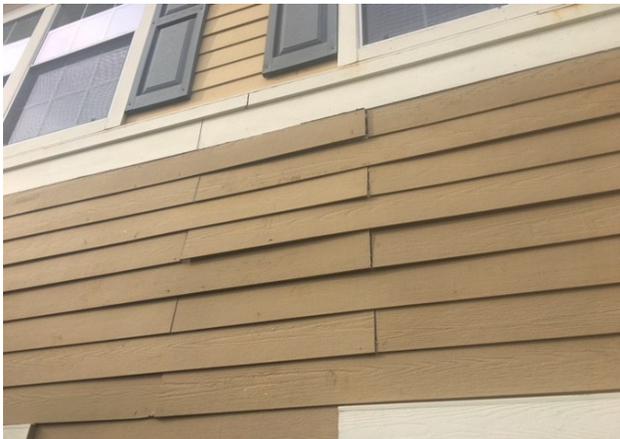
Figure 7 – Warped fiber-cement siding panels and opened butt joints between panels.

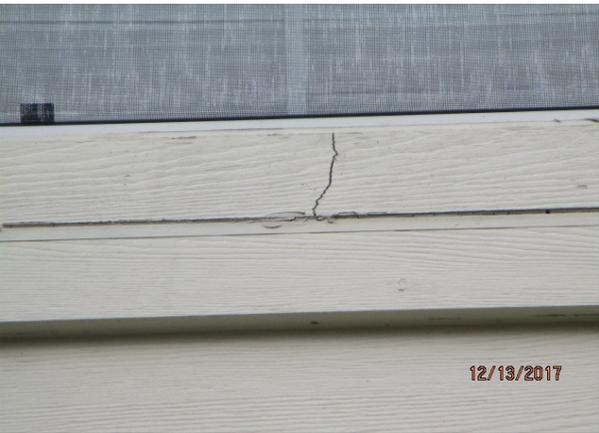
Figure 8 – Crack in fiber-cement trim.

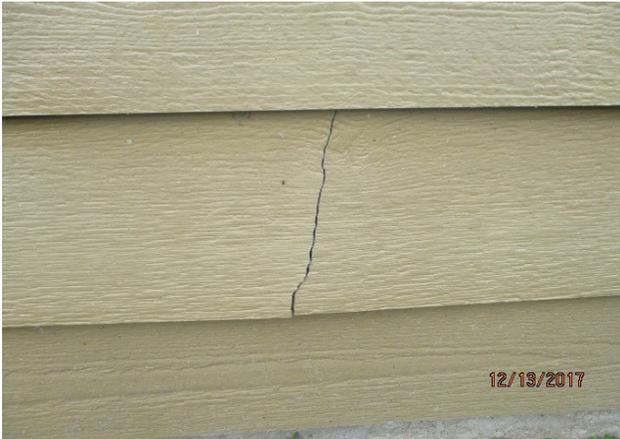
Figure 9 – Close-up view of crack in fiber-cement siding.

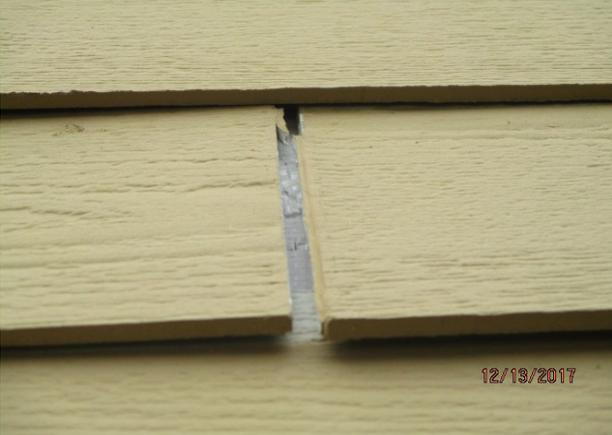
Figure 10 – Close-up view of open butt joint in fiber-cement siding.
