Children's Health Skybridges

Condition Assessment and Water Intrusion Investigation

FINAL REPORT

August 7, 2020
WJE No. 2020.2158.0

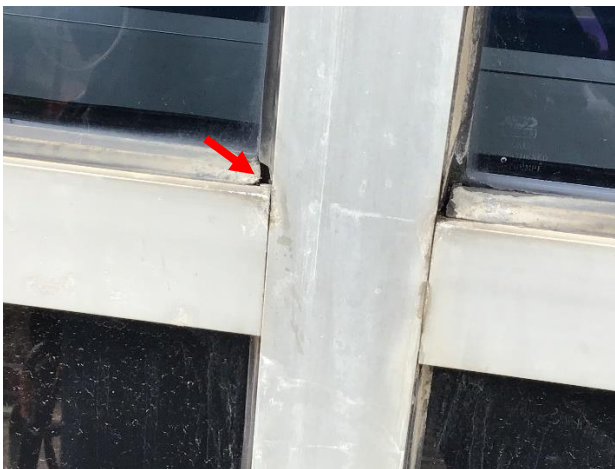
- Gasket shrinkage (between approximately 1/8 inch to 1/2 inch) was observed at several of the window lites on the south facade (Figure 6 and Figure 7). Little to no gasket shrinkage was observed on the north facade.

Figure 6. Gasket shrinkage at horizontal mullion.

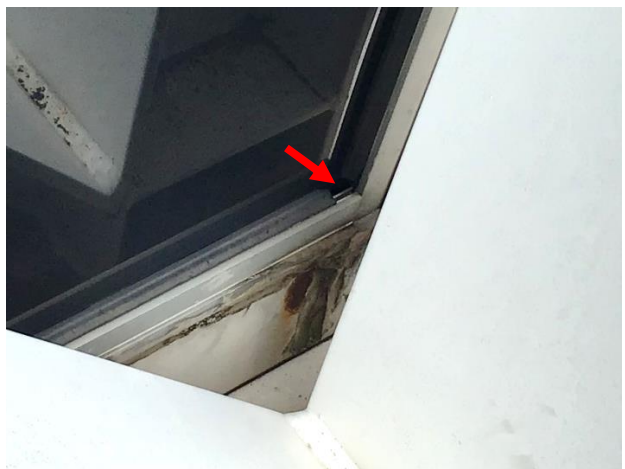
Figure 7. Gasket shrinkage at sill of window wall.

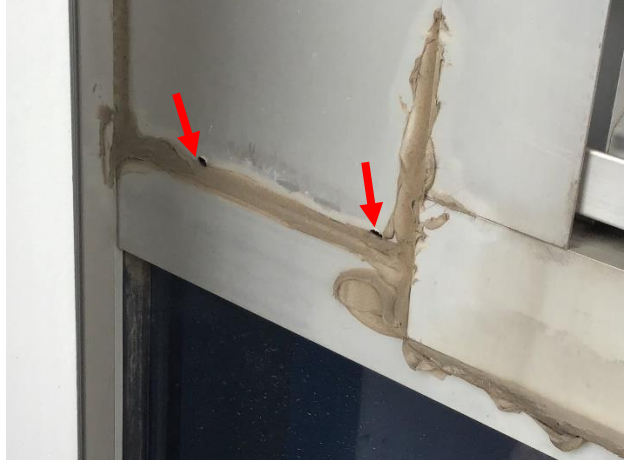
- At the east louver within the window wall, weep holes were observed at the bottom of the west infill panel (Figure 9). No other weeps were observed within the other infill panels.

Figure 9. Weep holes observed at bottom on infill panel adjacent to east louver on the south facade.

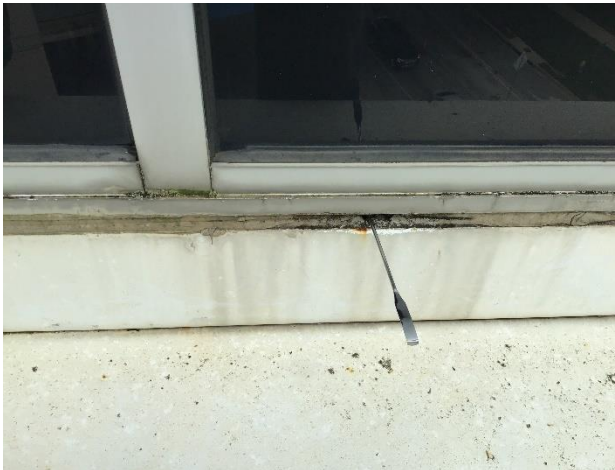
- Weeps were observed within the perimeter sealant joint along the sill of the window wall (Figure 10 and Figure 11). Weeps appear to be drilled through the sill receiver but were not consistently spaced. Dirt build-up and organic growth was present along the sealant joint around the weep holes. Similar dirt build-up and organic growth was observed along the upper edge of the sill receiver. Continuity of the sealant joint behind the steel columns at bents could not be verified.

Figure 10. Dirt build-up and organic growth around weep in perimeter sealant joint at sill and along top edge of sill receiver. Photo shows probe inserted into weep hole within sill receiver.

The presence of dirt build-up and mildew along the sill receiver and around the weeps at Skybridges A and B may indicate that the sill receiver does not drain efficiently, and that water may build up within the system. WJE was not able to determine if any staining or water intrusion has occurred on the interior of the sill receiver since the base of the window wall is covered by a short wall. No distress was observed on the interior drywall finishes and no water intrusion was observed with the infrared camera at the base of the wall during spray testing of the window walls at Skybridges A and B. WJE understands that the flooring, which runs up the base of the wall to act as a base moulding, was recently replaced which may have covered up any drywall distress or water staining at the base of the wall.

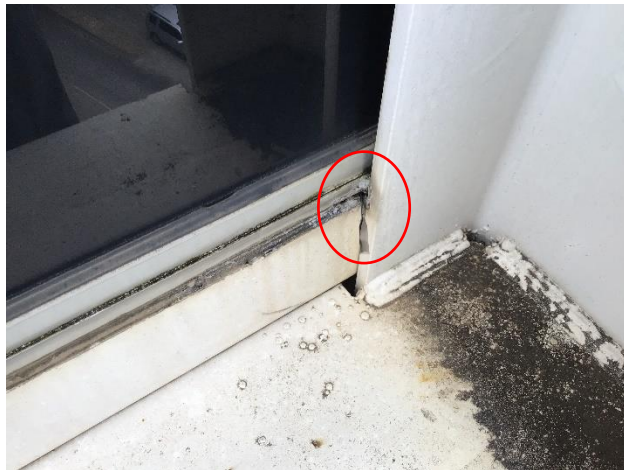
Figure 11. Dirt build-up and organic growth around weep in perimeter sealant joint at sill and along top edge of sill receiver. Photo shows probe inserted into weep behind steel column. Condition of sealant joint behind column could not be observed.

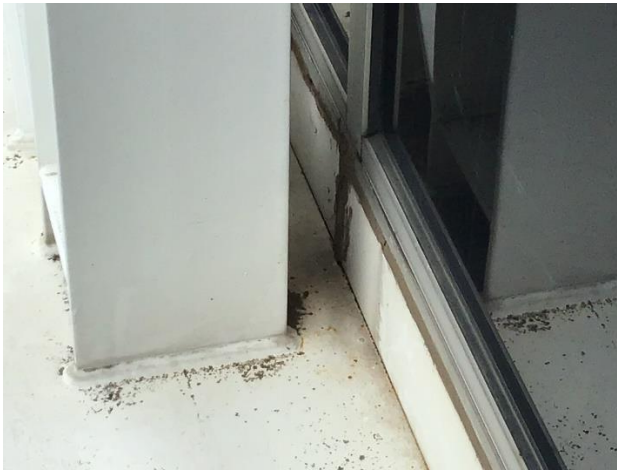
- Sealant was observed to be inconsistently applied at the butt joints in the perimeter steel plates at the floor slab (Figure 12 and Figure 13). Corrosion was observed at some of the joints on the north facade where the sealant was discontinuous (Figure 13).

Figure 12. Butt joint in perimeter steel plate for the floor slab. Sealant inconsistently applied at joint.

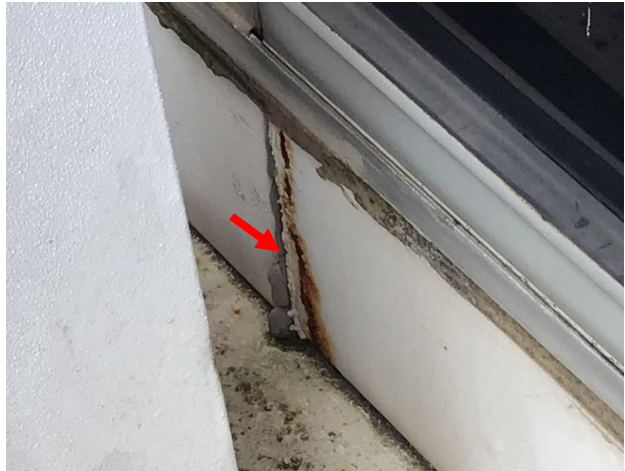
Figure 13. Corrosion at butt joint in the perimeter steel plate for the floor slab.

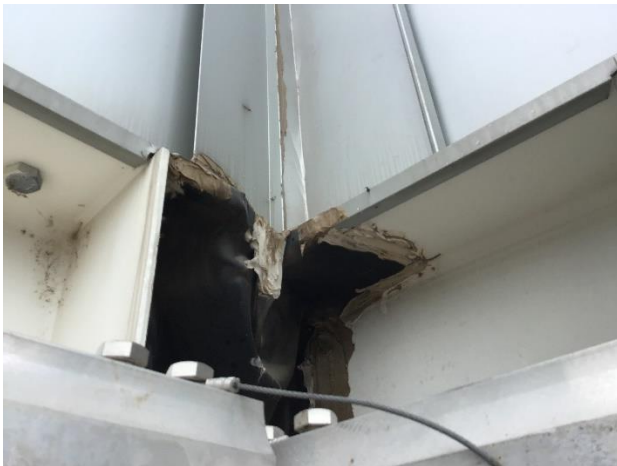
- A black flexible sheet membrane was observed at the intersection of the steel wide flange beams for Skybridges A and B (Figure 14). It is unknown to WJE whether this was part of the original construction or a remedial attempt. Two different applications of sealant were observed around the perimeter of the membrane. Sealant deterioration ("alligatoring") was observed within the lighter colored sealant (Figure 15).

Figure 14. Black flexible membrane at steel beam intersection for Skybridges A and B.

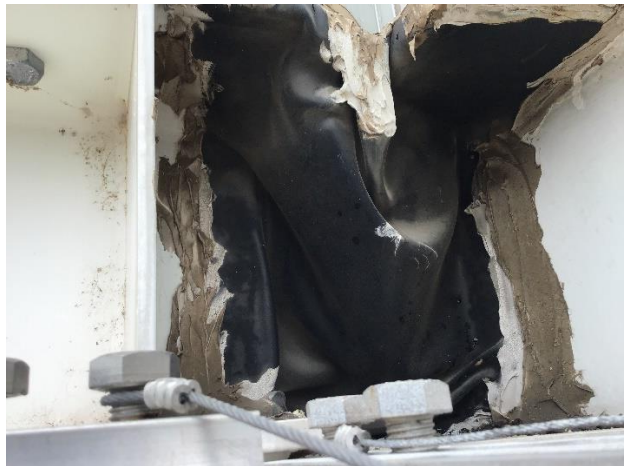
Figure 15. Two different applications of sealant were observed. Sealant deterioration ("alligatoring") was observed within the underlying whiter sealant.

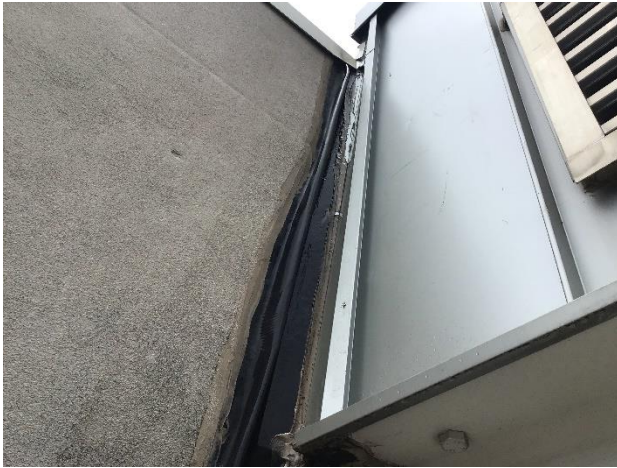
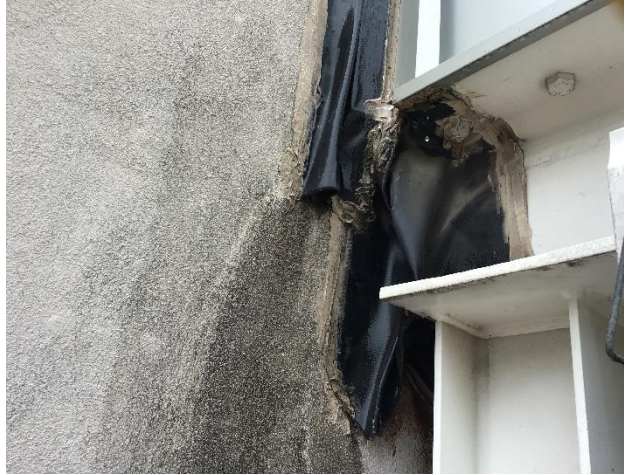
- Black flexible sheet membrane was observed along the south vertical termination of the metal wall panels and the cladding of the Bright Building (Figure 16 and Figure 17). The sealant was observed to be poorly installed and smeared along the edges of the membrane.

Figure 16. Black flexible membrane at west termination of skybridge. Edges of membrane sealed with sealant.

Figure 17. Black flexible membrane at west termination of skybridge. Edges of membrane sealed with sealant.

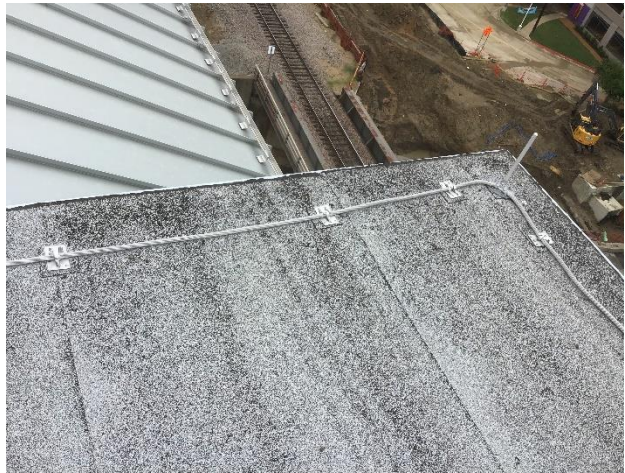
- The gabled metal panel roof transitions to a low slope modified bitumen roofing at each end of the skybridge (Figure 18). Signs of aging, including granule loss and alligator cracking, were observed throughout the modified bitumen roof membrane (Figure 19).

Figure 19. Typical granule loss observed at the roof membrane at the low-slope roof areas.

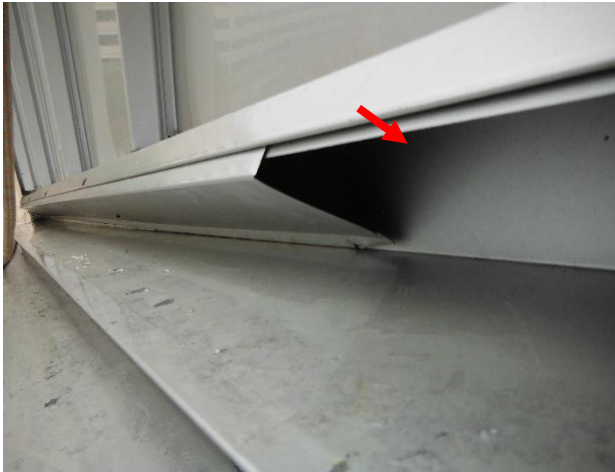
- A piece of counterflashing was observed to be missing at the west sidewall metal panel roof transition (Figure 20). Insulation and framing were visible behind the section of missing counterflashing (Figure 21).

Figure 20. Section of missing counterflashing along sidewall roof transition.

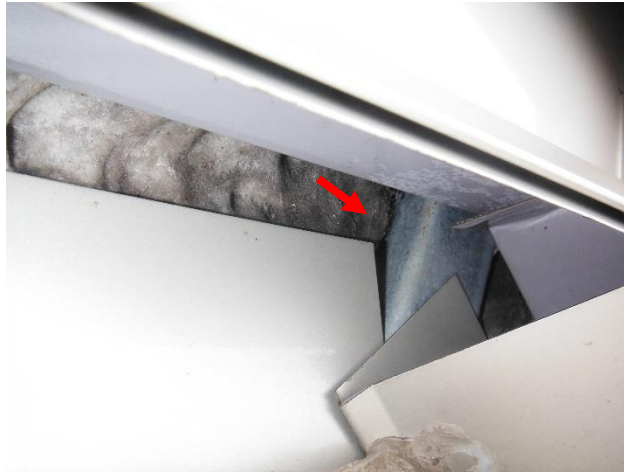
Figure 21. Insulation and framing observed behind section of missing counterflashing.

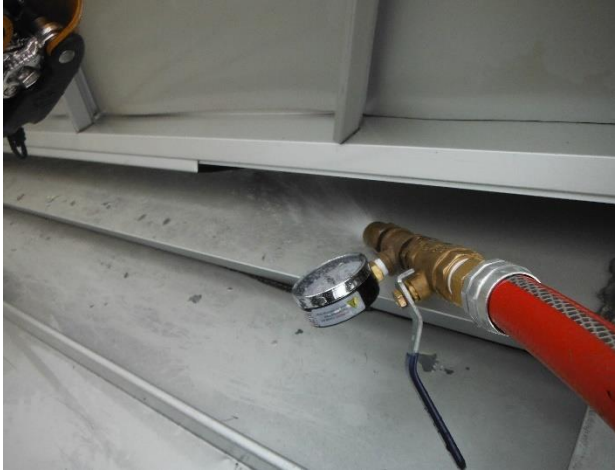
Location 1 included the sidewall transition between the gabled metal panel roof and the vertical metal sidewall panels. As noted above, a piece of sidewall counterflashing was observed to be missing near the ridge (Figure 20). Staining was observed on the interior framing components below this transition indicative of previous water intrusion (Figure 4). WJE used a spray nozzle to test along the sidewall transition at both sides of the gable. WJE started at the eave and sprayed up to the ridge. Water intrusion was observed below both sides of the gable when testing near the upper half of the sidewall transitions where the counterflashing was missing (Figure 22 through Figure 25). Water was observed on the interior running off of the ends of the steel deck flutes and also out from behind the interior drywall at the exterior walls. No additional water intrusion was observed when testing the adjacent metal roof panels, wall panels, or coping metal along this sidewall transition.

Figure 22. Water spray testing sidewall transition with missing counterflashing along south half of gabled roof. Water intrusion observed after 2 minutes.

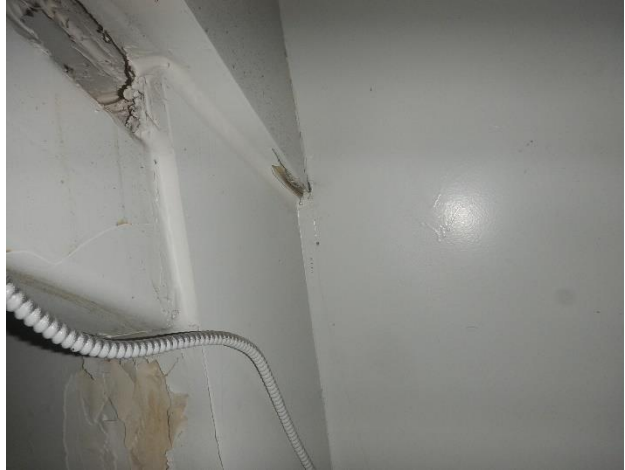
Figure 23. Water intrusion running out from behind drywall at south exterior wall when testing sidewall transition above.

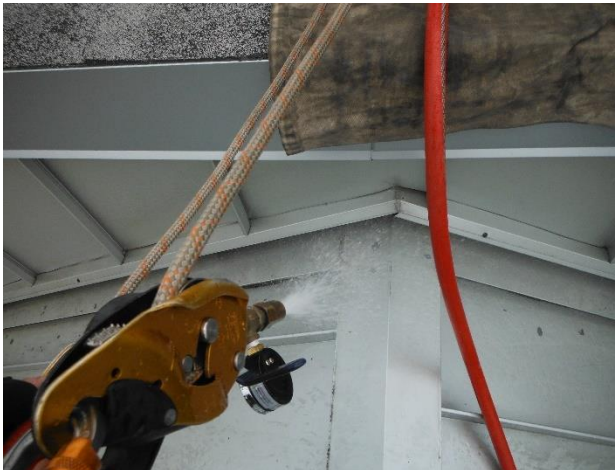
Figure 24. Water spray testing sidewall transition with missing counterflashing near ridge. Water intrusion observed after 5 minutes.

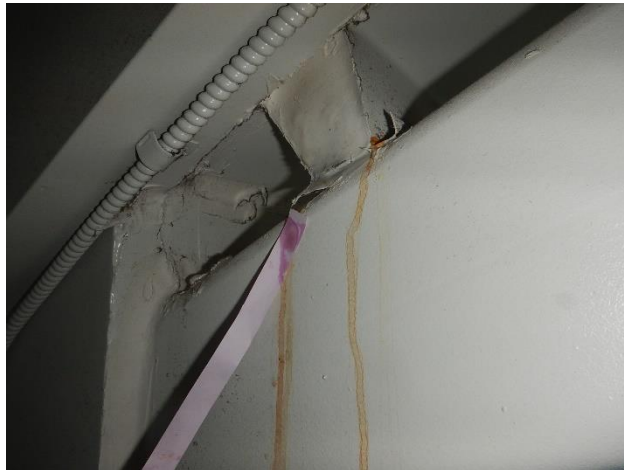
Figure 25. Water running out of metal deck flutes directly below sidewall transition.

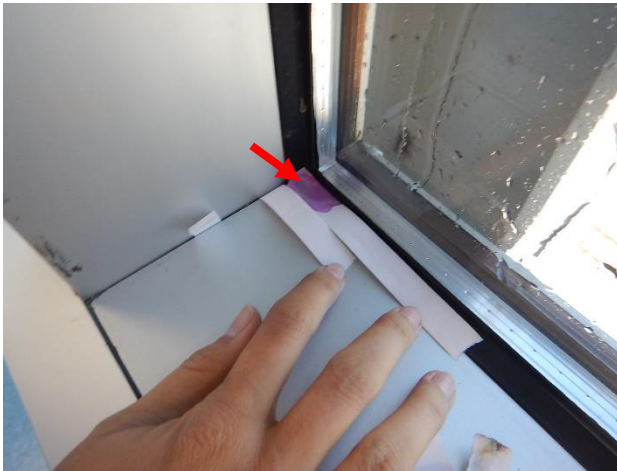
Figure 28. Water intrusion observed at gasket intersection at horizontal mullion below the test area.

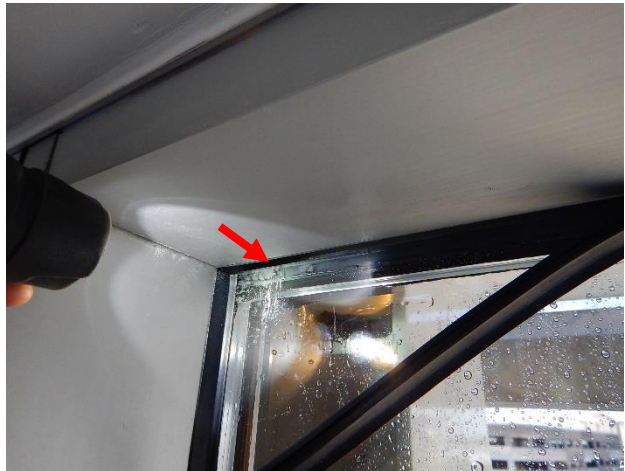
Figure 29. Removal of interior head gasket revealed that the top of the glass was in line with the daylight opening of the frame.

Water intrusion was observed during spray testing of the head framing of two vision lites at Skybridge A. Removal of an interior head gasket revealed that the top of the glass lite was not properly positioned up into the glazing pocket. This may be a result of improper installation of setting blocks or improperly sized glazing for the opening. As a result, some of the head gaskets may not have a tight seal against the glass. During our spray testing, water was infiltrating past the head gasket and was able to migrate over the top of the glass lite and onto the interior gaskets. This water travelled down the back of the interior gasket at the jamb and out of the glazing pocket at the discontinuous intersection of the vertical and horizontal interior gaskets. This source of water intrusion is typically prevented by sealing the intersection of the interior gaskets; this was not observed at these window walls. Given the overhang above the window heads created by the steel beams and a lack of previously reported water intrusion at windows, water intrusion at these gasket intersections would not be common during a typical rain event. In addition, if water intrusion did occur, only a small amount of water would be expected to pool on the mullion and would not likely warrant remediation efforts.

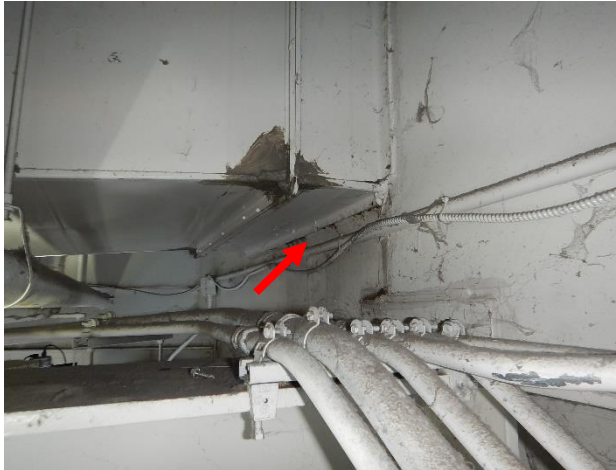
- Water stains were observed below a louver in the metal wall panels on the west facade near the Purple Garage (Figure 30). Water stains were also observed below the louvers within the window wall on the west facade (Figure 31).

Figure 30. Water staining observed below intersection of duct work and exterior wall behind louver within the metal wall panels on the west facade.

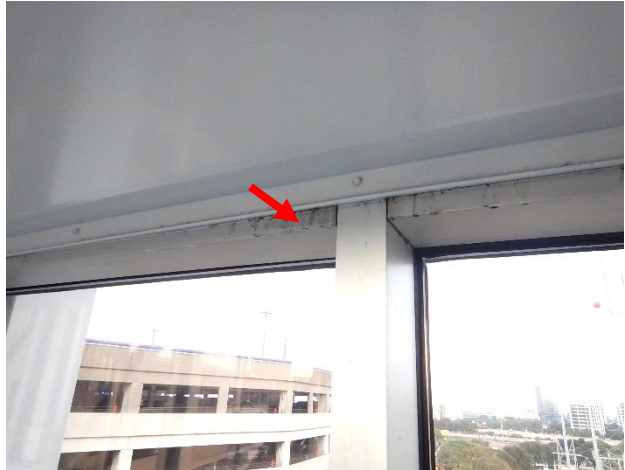
Figure 31. Water stains below louvers within window wall.

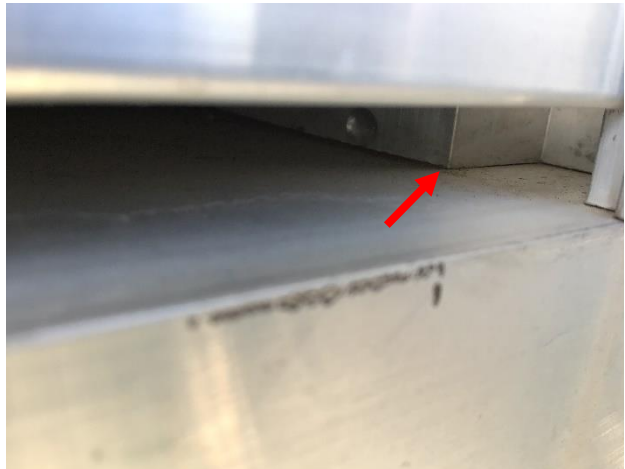
- Observations behind the louver grille showed an internal joint along the base of the louver that appeared unsealed (Figure 32 and Figure 33).

Figure 33. Open joint observed inside louver.

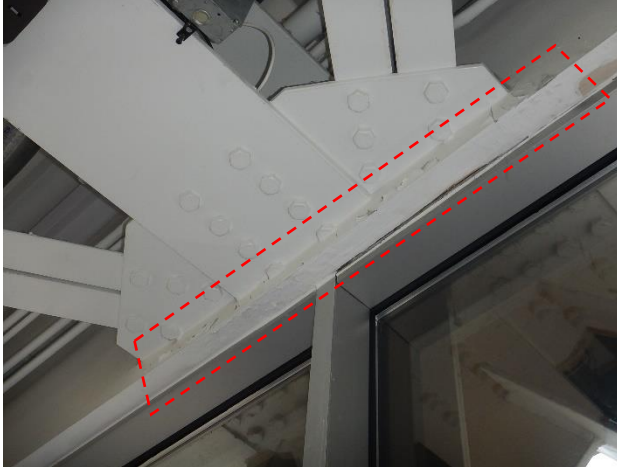
- Water staining was observed above the head of a window in line with the west steel column of the northern bent (Figure 34). Sheet metal cap flashings were observed at the top of these columns that were cut into the standing seam roof panels. Some of these cap flashings were observed to be sealed along the top and sides; however, the majority were not, including this location where water staining

Figure 34. Interior water staining below sheet metal cap on north end of the west facade.

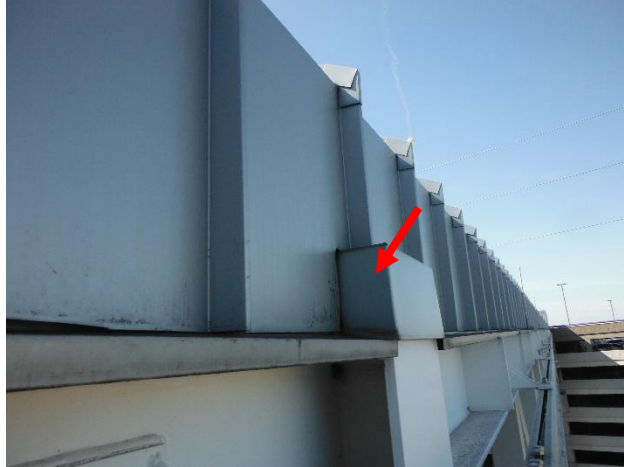
was observed below (Figure 35). No other issues were observed within the standing seam roof panels at this location.

Figure 35. Sheet metal cap above steel column. Perimeter of cap not sealed at this location.

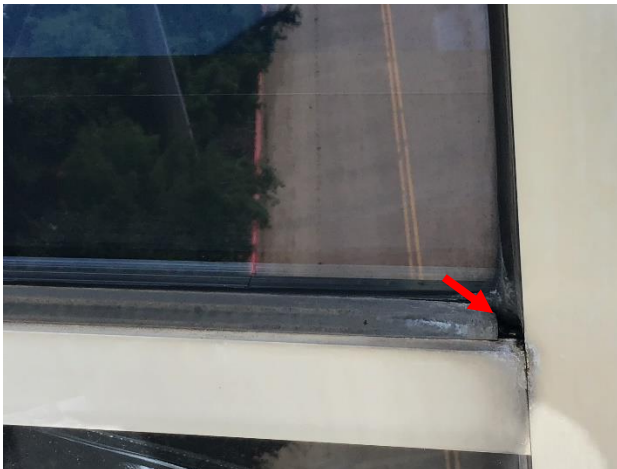
- Gasket shrinkage was observed on the east and west window walls in multiple locations (Figure 36).
- A missing sealant joint was observed around the perimeter of an inset operable window frame near the center of the skybridge on the west facade (Figure 37).

Figure 36. Gasket shrinkage on east facade.

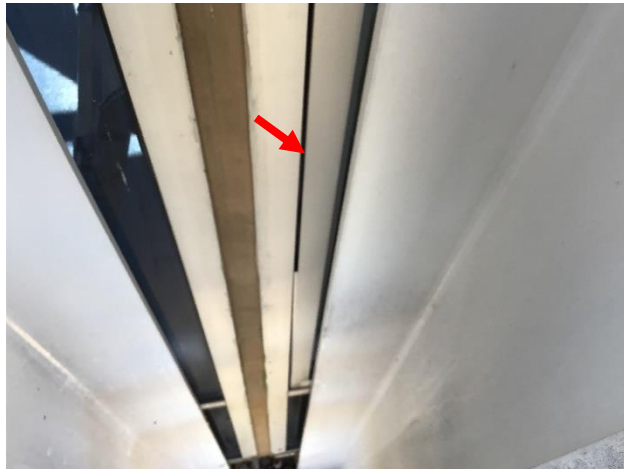
Figure 37. Unsealed joint between window wall frame and inset operable window frame.

In addition to the spandrel and vision lites of glass within the window wall, louvers and operable windows were also glazed into the window framing. The condition of the louvers is addressed in a subsequent section. The operable windows were installed in order to gain access to the specialty rail system on the outside of the skybridges. No issues were observed regarding the internal water management of the operable frames, and no evidence of water staining or water intrusion was observed. However, a missing sealant joint was observed around the perimeter of one of the inset operable window frames on the west facade of Skybridge B.

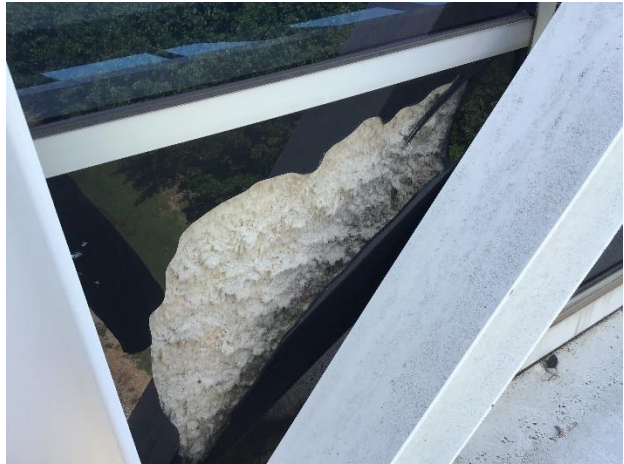
- One of the spandrel lites on the east facade was observed to be shattered with portions of the glass missing (Figure 38 and Figure 39). The lite was located above the railroad track. Spandrel insulation was observed behind the broken lite.

Figure 39. Broken spandrel lite on east facade above rail road track.

At two locations on the east facade of Skybridge B, deficiencies were observed in the IGUs including a broken spandrel lite and a failed IGU seal. Failures within the perimeter seal of an IGU will allow moisture vapor within the airspace resulting in the fogged/hazy appearance observed onsite.

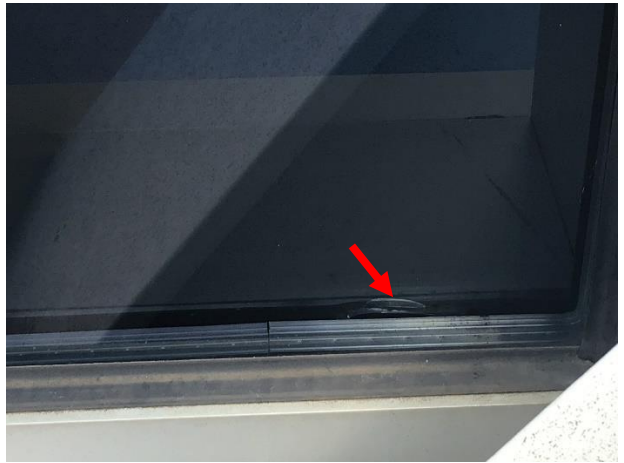
- Evidence of a failed perimeter seal within one of the insulated glass units (IGUs) was observed on the east facade (Figure 40 and Figure 41).

Figure 41. Deficiency observed within perimeter IGU seal.

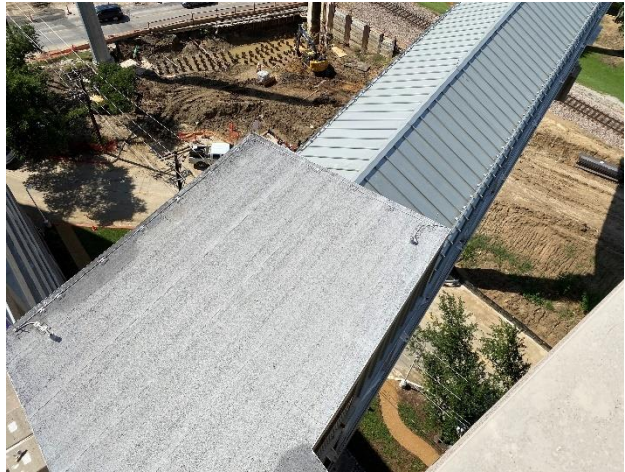
- Similar issues regarding the perimeter sealant joint along the sill at Skybridge A were also observed at Skybridge B.
- No missing counterflashing or other visible deficiencies were observed in the sidewall roof transitions at either end of the skybridge (Figure 42).
- The modified roof membrane at the low slope roofs on both sides of Skybridge B showed similar signs of aging as those on Skybridge A (Figure 43).

Figure 43. Low-slope roof at south end of Skybridge B.

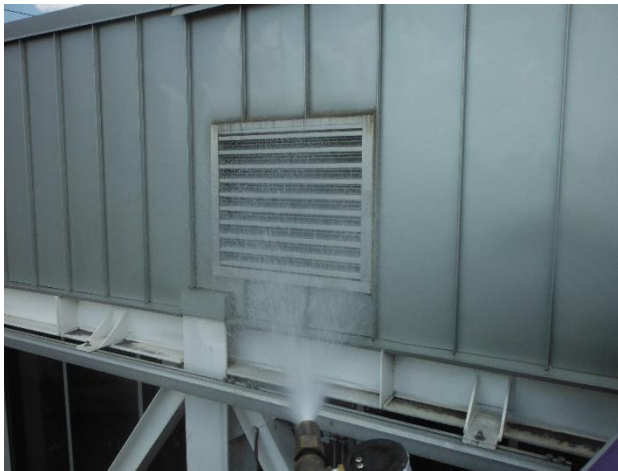
Figure 48. Water spray testing perpendicular to the west facade louver near the Purple Garage. Water intrusion observed after 2 minutes.

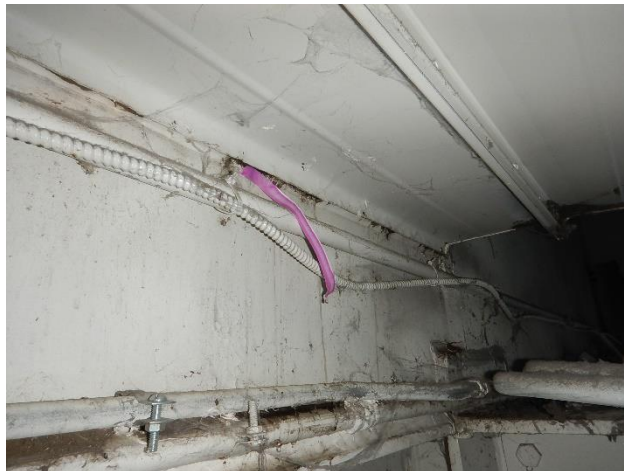
Figure 49. Water intrusion observed running out of the bottom joint between the louver duct work and the wall.

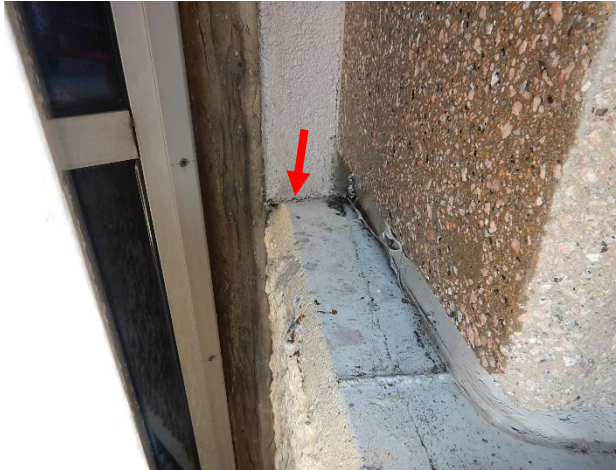
WJE tested the vertical expansion joint on the west facade that separates the skybridge and the Purple Garage. Prior to testing, staining was observed on the precast panel adjacent to the joint. WJE started testing with a spray nozzle at the bottom of the joint and proceeded upward. Water intrusion was observed within 2 minutes when spraying near the mid-height of the joint at a ledge in the adjacent precast panel (Figure 50 and Figure 51).

Figure 50. Vertical expansion joint between the skybridge and the Purple Garage. Water intrusion observed when spray testing the adjacent precast ledge after approximately 2 minutes.

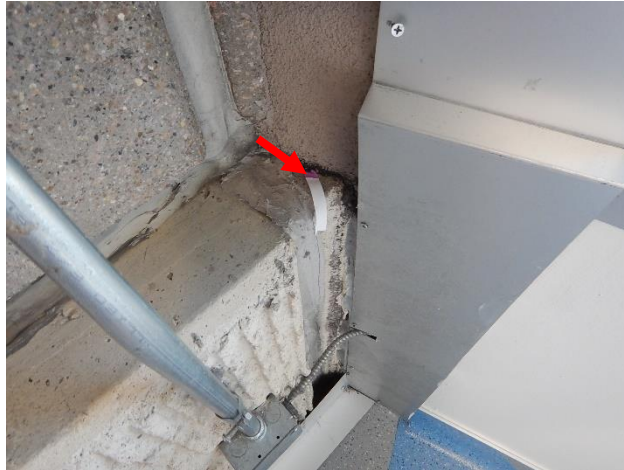
Figure 51. Water intrusion observed on top of precast ledge.

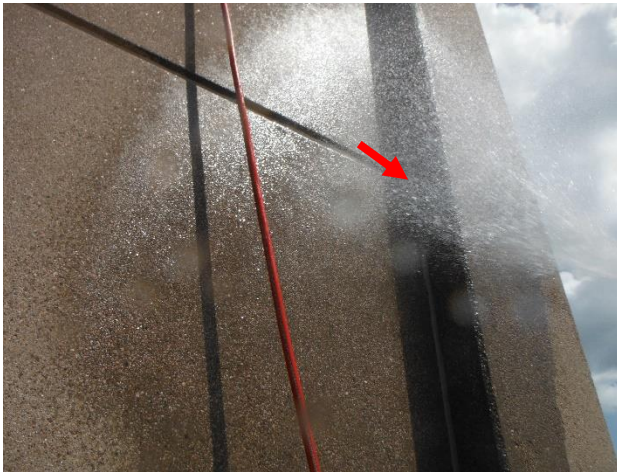
Figure 54. Water spray testing vertical sealant joint with adhesive failure above roof-to-wall transition at the elevator tower. Water intrusion observed after 4 minutes.

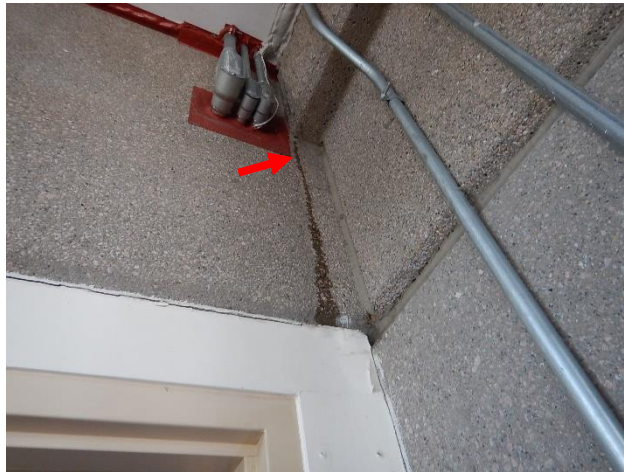
Figure 55. Water intrusion observed running down precast panel within the skybridge below roof-to-wall transition at the Purple Garage elevator tower.

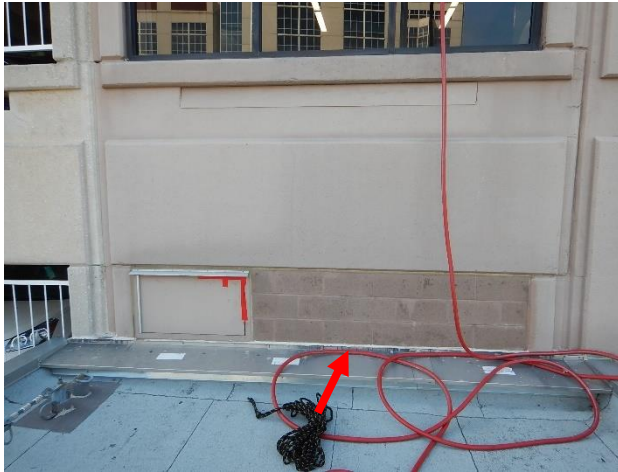
- Deteriorated sealants with cohesive and adhesive failures were observed along the expansion joint flashing at the roof-to-wall transition where the skybridge meets the Green Garage (Figure 60 and Figure 61). Multiple layers of remedial sealant were observed along this joint.

Figure 60. Roof-to-transition at the Green Garage. Metal expansion joint flashing sealed to precast panels and CMU infill (arrow).

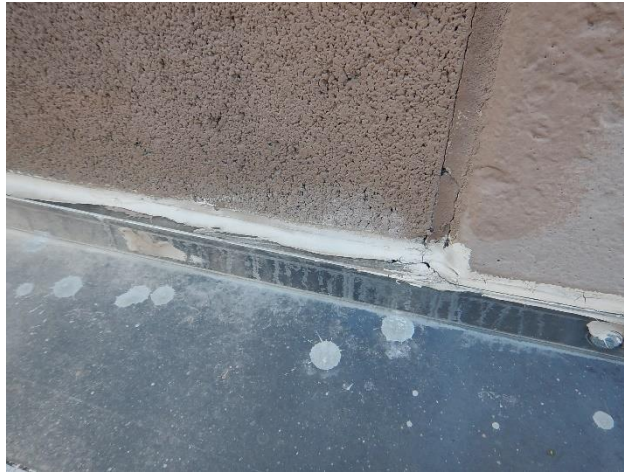
Figure 61. Deteriorated remedial sealant joint along top of expansion joint flashing.

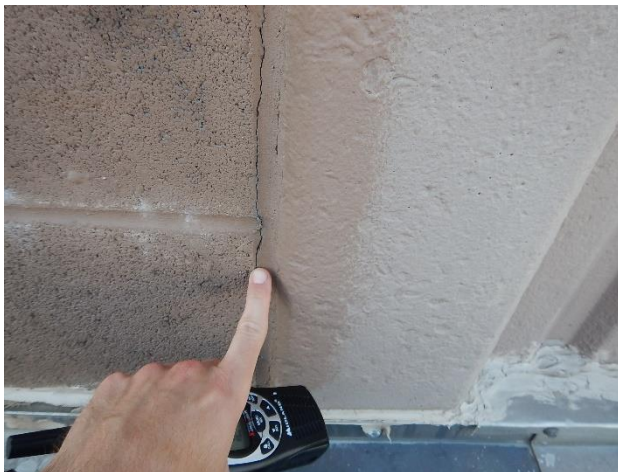
- The CMU infill directly above the expansion joint flashing was observed to be coated. Cracks/separations were observed within the mortar joints of the CMU that propagated through the exterior coating (Figure 62). Efflorescence and water stains were observed on the back of the CMU (Figure 63).

Figure 62. Separation/cracking of mortar joint within CMU infill above roof flashing.

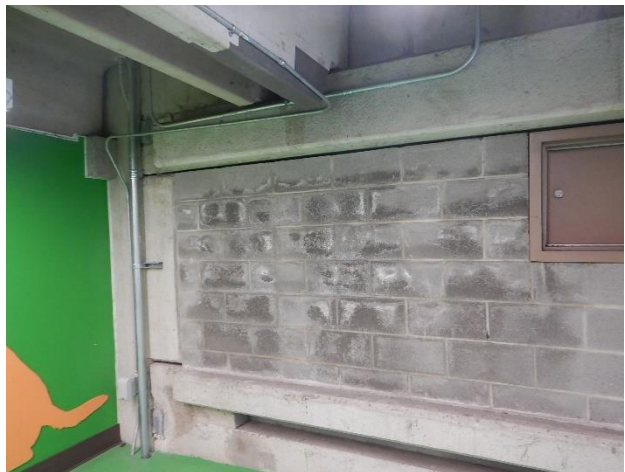
Figure 63. Efflorescence and water staining on back of CMU infill.

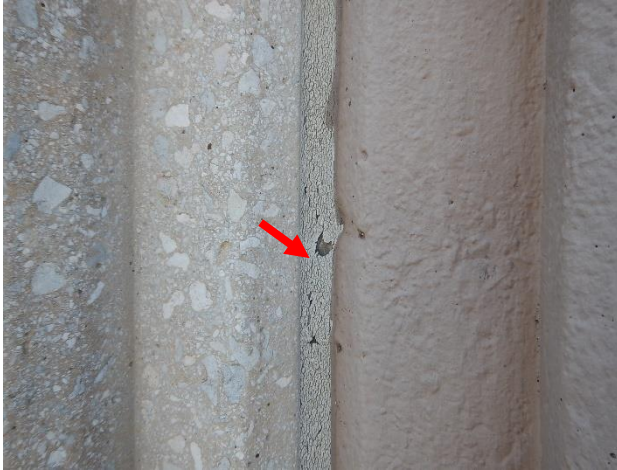
- Additional deficiencies/discontinuities were observed within the precast-to-precast and window perimeter sealant joints higher up the precast wall for the Green Garage (Figure 64 and Figure 65).

Figure 64. Cohesive failures of precast-to-precast sealant joint.

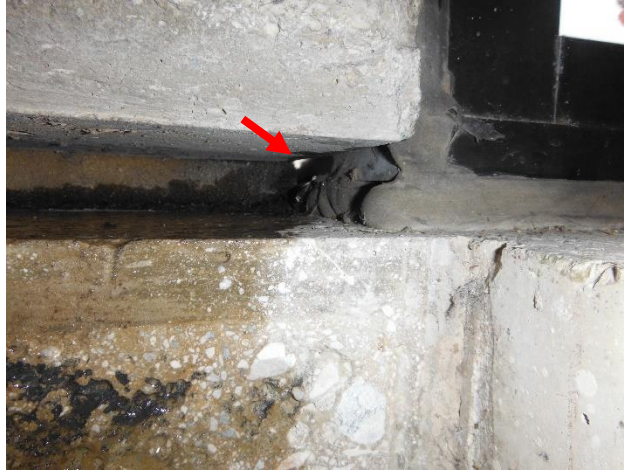
Figure 65. Daylight observed at corner of 2nd floor window sill above the roof-to-wall transition of the skybridge.

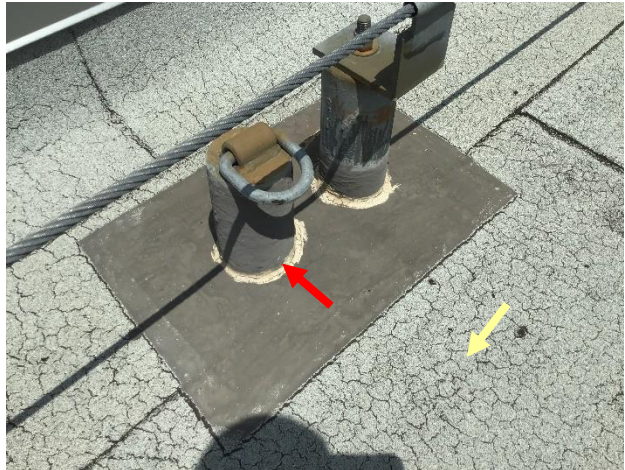
- Granule loss and alligator cracking was observed within the modified bitumen roof membrane (Figure 66 and Figure 67). Various roof sealants were also observed to be deteriorated.

Figure 67. Alligator cracking of roof membrane from UV exposure (yellow arrow). Sealant deterioration observed around tie back anchors (red arrow).

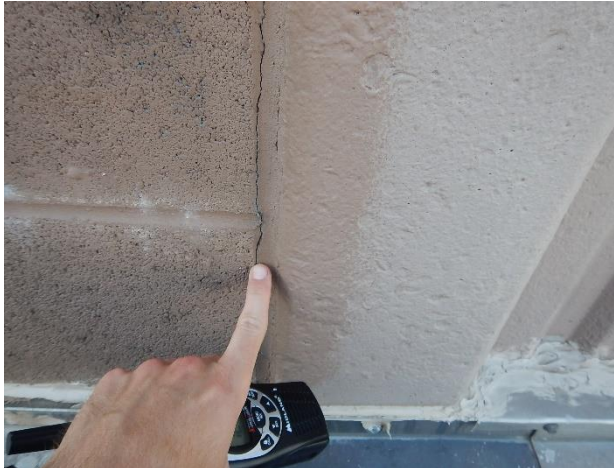
painted CMU infill wall directly above the metal roof-to-wall flashing. Further diagnostic testing revealed that water was primarily migrating through separations in the mortar joints. Water was observed running out below the south vertical joint between the precast and the CMU. Water pooled on the garage floor and migrated into a core hole for a conduit penetration within the concrete slab.

Figure 68. Separation/cracks were tested within the CMU infill above the roof-to-wall transition.

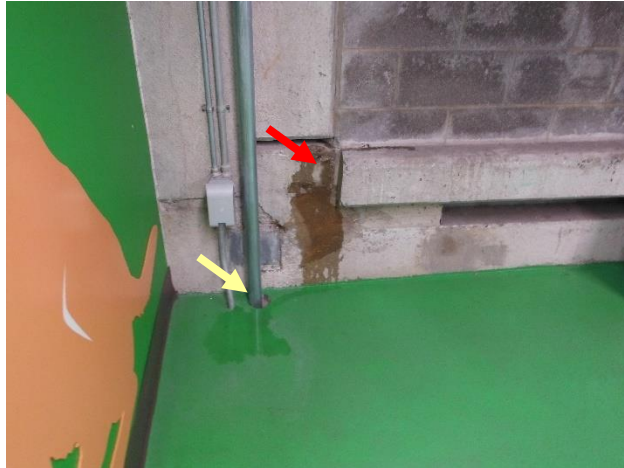
Figure 69. Water intrusion (red arrow) observed when spraying cracks/separations within the CMU infill above the roof-to-wall transition. Water migrated down through conduit penetrations within the garage floor (yellow arrow).

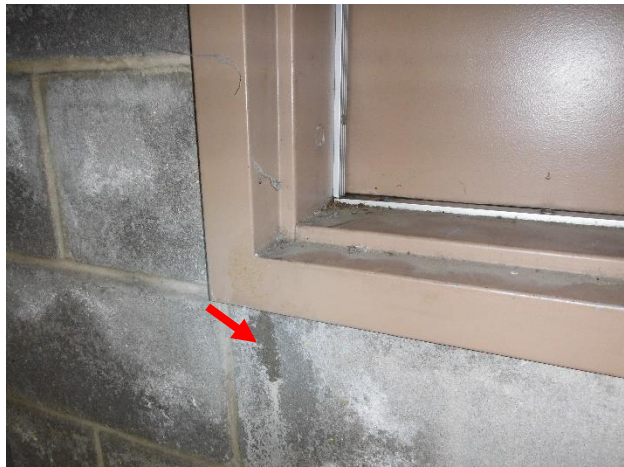
Water intrusion was also observed when spraying the small metal access door to the skybridge roof (Figure 70). Water was observed running down the CMU below the door jamb after approximately 30 seconds of testing (Figure 71).

Figure 71. Water intrusion observed after 30 seconds of testing the metal access door.

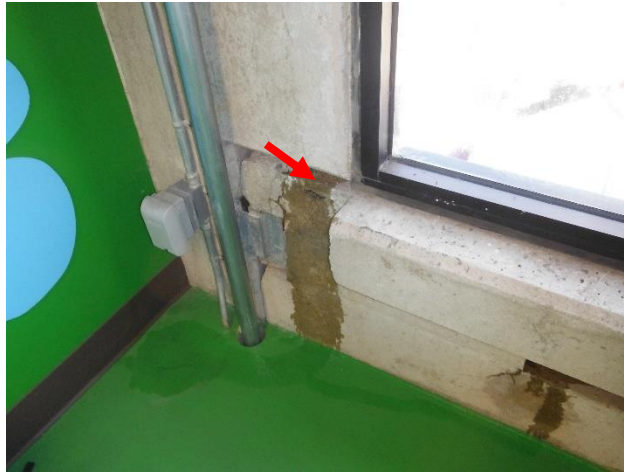
WJE continued testing up the garage wall above the skybridge roof. Water intrusion was immediately observed when testing the perimeter of the punched window on the second floor of the garage (Figure 72 and Figure 73). Discontinuities within the perimeter sealant joint allowed water intrusion.

Figure 73. Immediate water intrusion observed due to large discontinuity in perimeter sealant at the corner of the window.

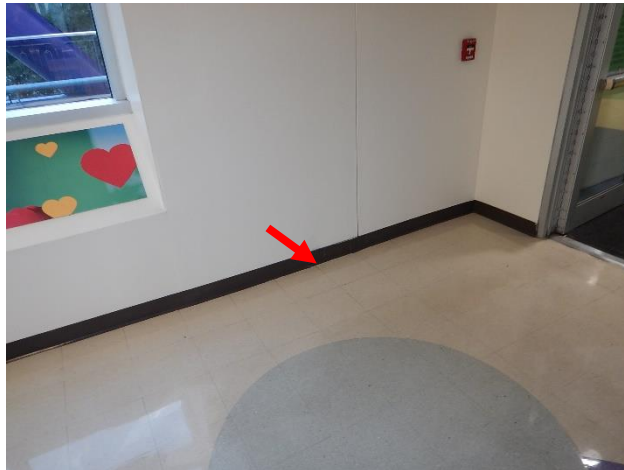
WJE used a spray rack to test the window wall on the north facade of the skybridge behind the location of interior drywall distress at the base of the wall. At this location, the window wall is covered with framing and interior drywall. No interior drywall was able to be removed at the time of our testing. WJE started testing by spraying the middle of the curtain wall. No water intrusion was observed after 45 minutes. WJE moved the spray rack up to test the upper half of the curtain wall and perimeter head sealant joint (Figure 74). Water intrusion was observed after 10 minutes pooling along the base of the wall (Figure 75).

Figure 75. Water intrusion observed at base of wall behind windows.
