June 19, 2018

MH Ref: 8170089.01

Re: Building Envelope Condition Assessment
Graham-Terry Apartments, 2020 Terry Avenue, Seattle, WA

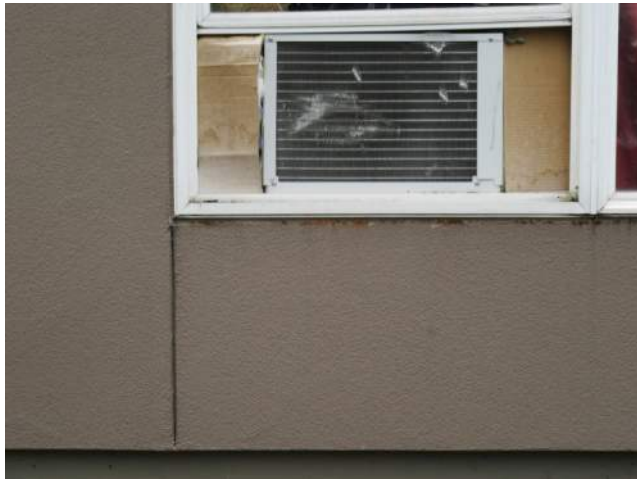
Photo No. A17.

Extent of rust and staining along window sill at south side of window group in Photo No. A14.

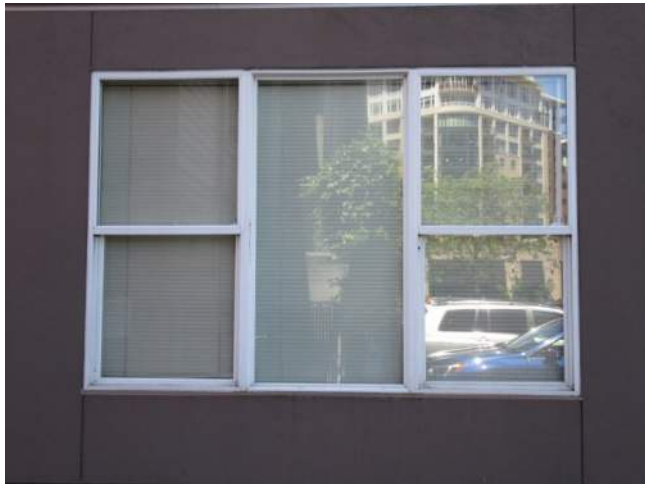
Photo No. A18.

Window of Unit 320 in 2018 with new sealant installed along sill.

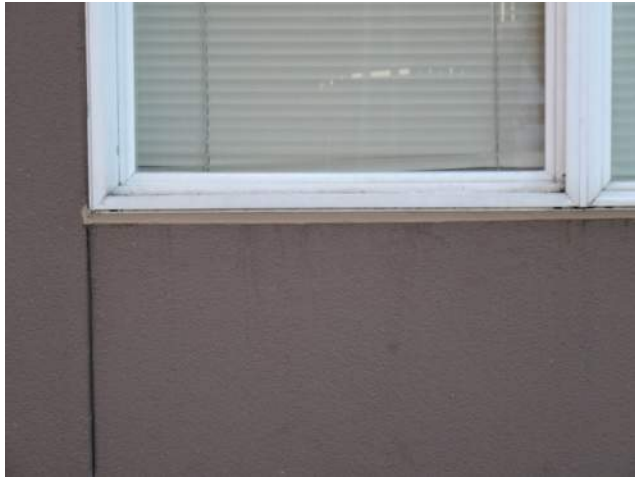
Photo No. A19.

Evidence of rust and staining diminished at Unit 320 in 2018 after installation of new sealant (compare with Photo No. A15).

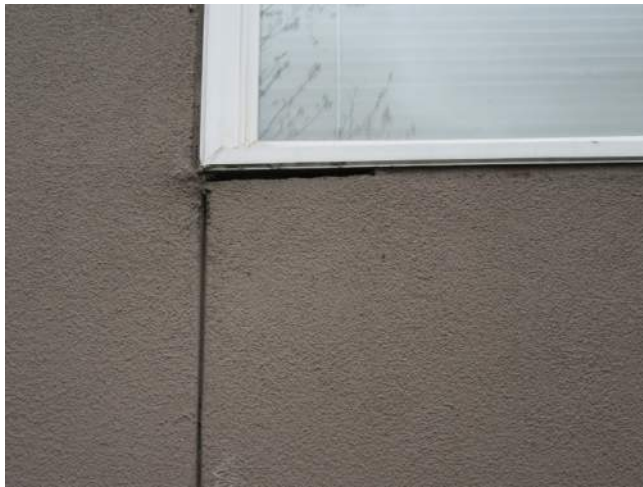
Window frames were typically sealed along their perimeter, but a few were observed as missing some sealant at the window sill; see Photo No. A20. Fully sealed window opening perimeters are typical of face-sealed cladding systems; however, it is not a recommended practice by MH. In addition, a number of window frames have developed breaks or cracks (see Photos No. A35 through A37).

Missing sealant joint at portion of window sill opening at Unit 325 (in 2017).

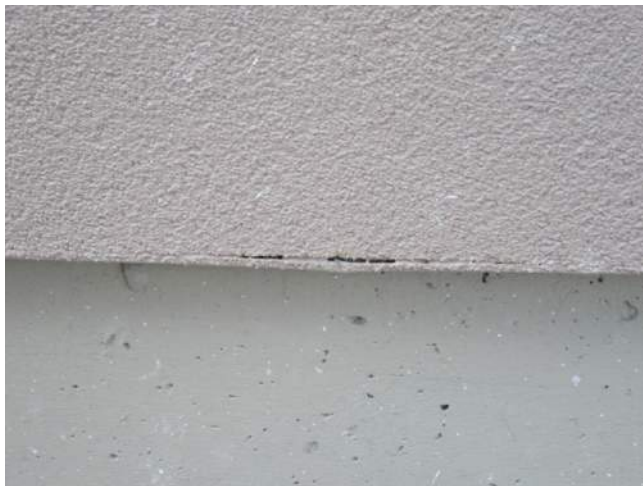
Photo No. A21.

J-molding separating from stucco cladding along bottom edge of cladding.

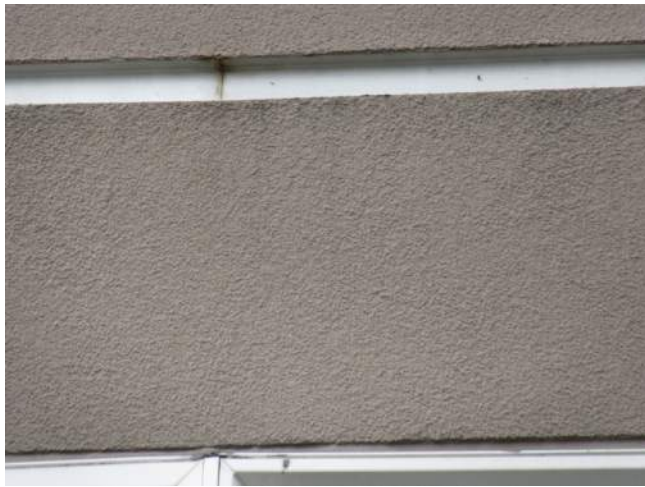
Photo No. A25.

Corrosion at butt joint of sheet metal reveal and rust along bottom of stucco cladding at top edge of reveal.

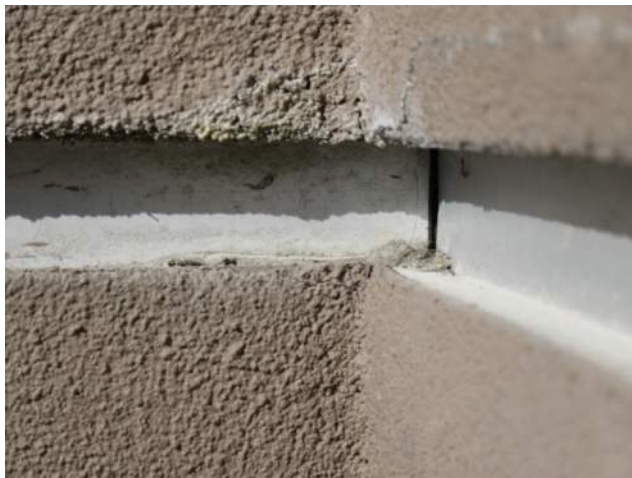
Photo No. A26.

Visibly open gap at corner intersection of sheet metal reveal (Level 6).

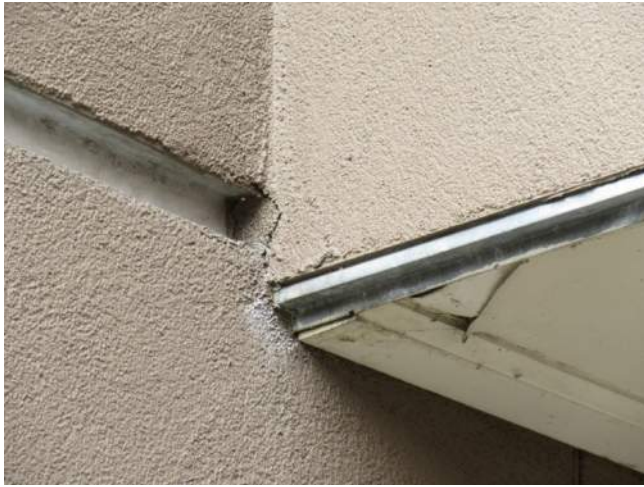
Photo No. A28.

The stucco cladding has a series of extruded metal reveals generally located at the floor level between the upper stories. The reveals are installed with butt joints between individual prefabricated pieces, which results in a series of gaps that allow some water penetration through the stucco cladding, which has allowed some minor corrosion to occur at the reveal butt joints (see Photo No. A25). Some of the gaps are visibly open (see Photo No. A26) and occasionally the butt joints have resulted in a hole in the lower horizontal flange of the joint (see Photo No. A27). In addition, where the extruded metal reveal terminates at a building corner, a visibly open crack has developed and the exterior finish of the adjacent soffit is peeling (see Photo No. A28).

Crack in stucco cladding at corner intersection and delamination of finish surface of overhanging soffit.

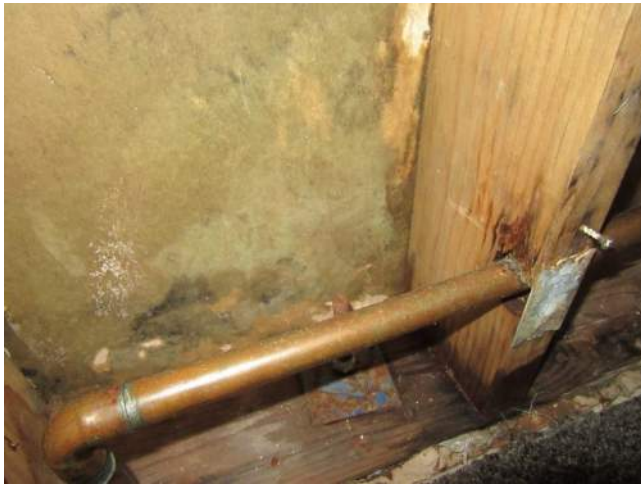
Photo No. A29.

Although no staining of the exterior gypsum sheathing was observed at the exterior surface at Level 6, water staining and some physical deterioration was evident on the interior surfaces at Unit 724 and Unit 624 (see Photos No. A29 and A30). Refer to Appendix B for the 2018 exploratory openings at the exterior walls.

Exploratory opening (7 April 2017) in east wall of Unit 724 with physically damaged gypsum sheathing and wet wood framing.

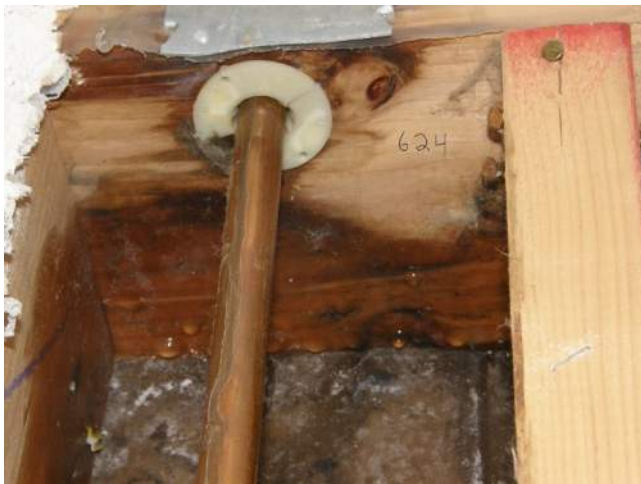
Photo No. A30.

Exploratory opening (30 March 2017) in east wall of Unit 624 with visibly wet wood framing and gypsum board sheathing (photo by Brian Huff).

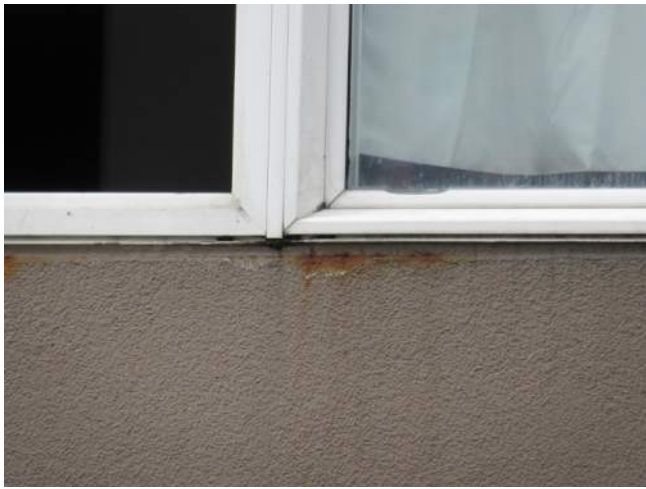
Photo No. A35.

Break in window sill frame; also rust and staining at stucco coating below window.

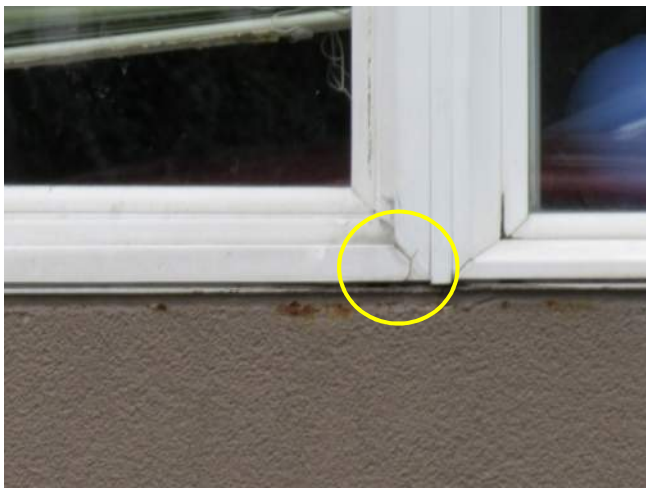
Photo No. A36.

Crack in window frame at sill/jamb juncture.

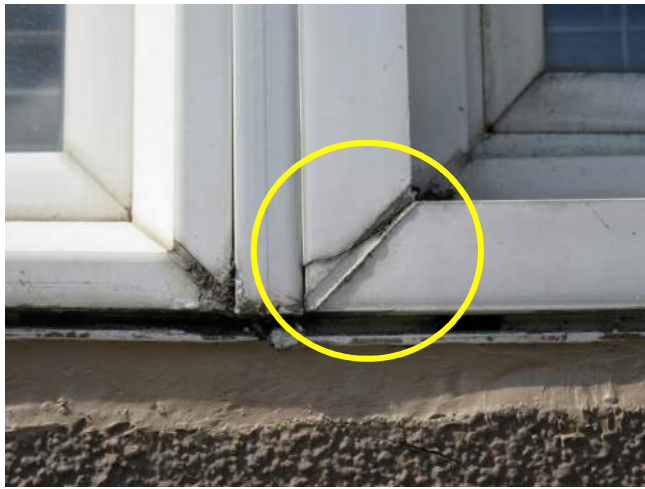
Photo No. A37.

Crack in window frame at sill/jamb juncture.

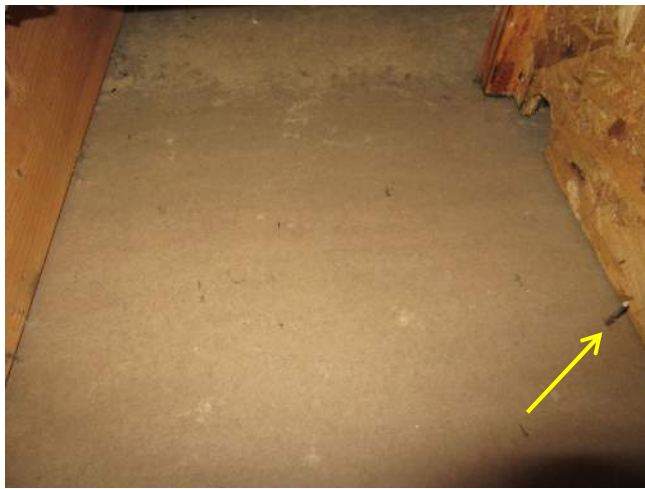
Photo No. A38.

Fastener penetration through exterior gypsum sheathing at Unit 724, with rust evident where the fastener penetrates the sheathing.

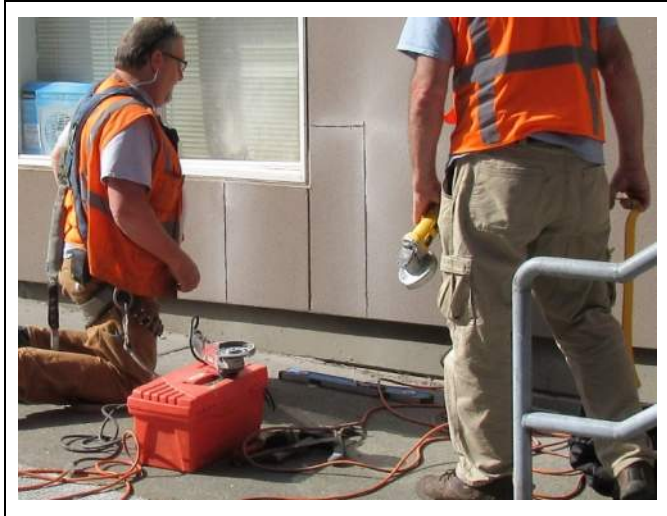
Photo No. B2.

Initial size of exploratory opening at window sill/jamb and stucco control joint.

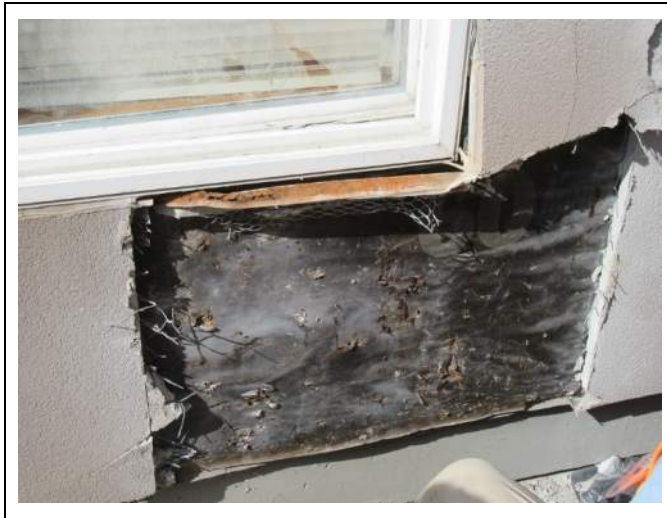
Photo No. B3.

Stucco cladding removed, showing asphaltic building paper with minor wrinkling.

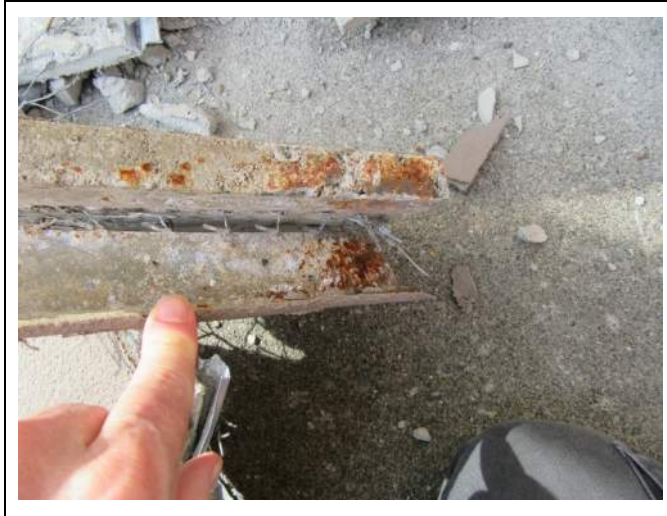
Photo No. B5.

Close-up view of the stucco control joint screed with rust increasing towards bottom of stucco cladding.

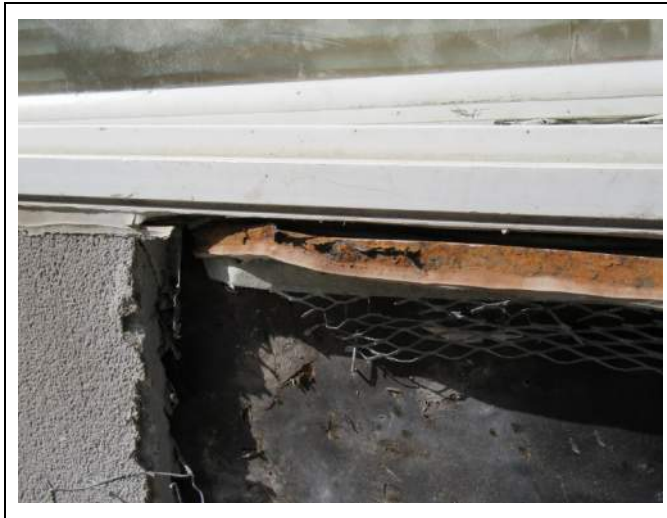
Photo No. B6.

Close-up of rust observed at the stucco screed at the window sill.

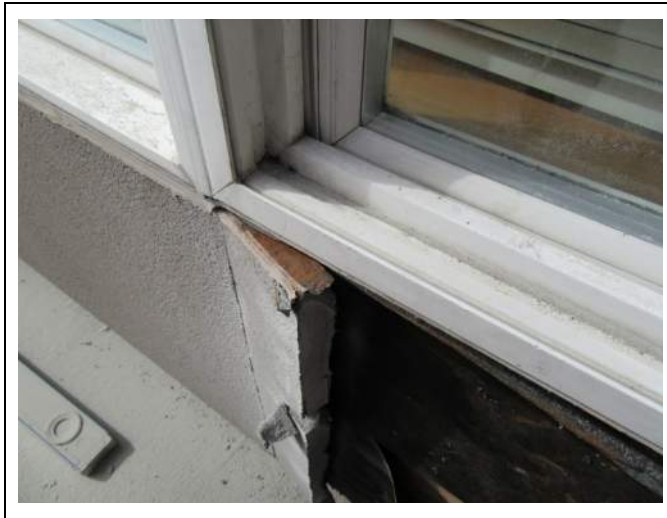
Photo No. B9.

Close-up of rust observed behind sealant joint at window sill.

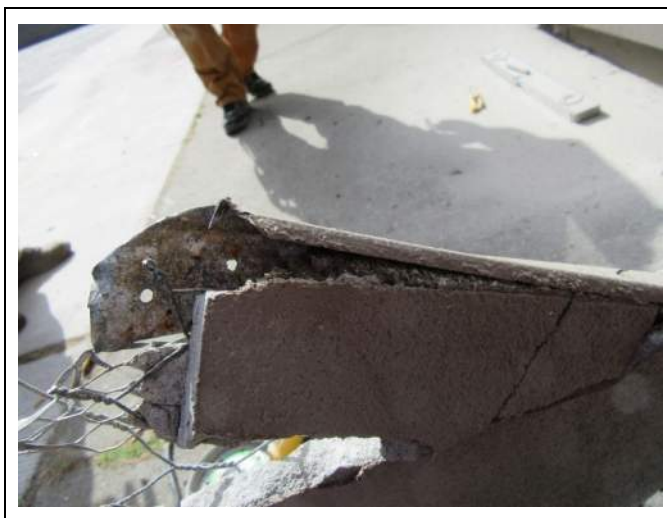
Photo No. B10.

Close-up of rust observed in the J-molding of extended exploratory opening.

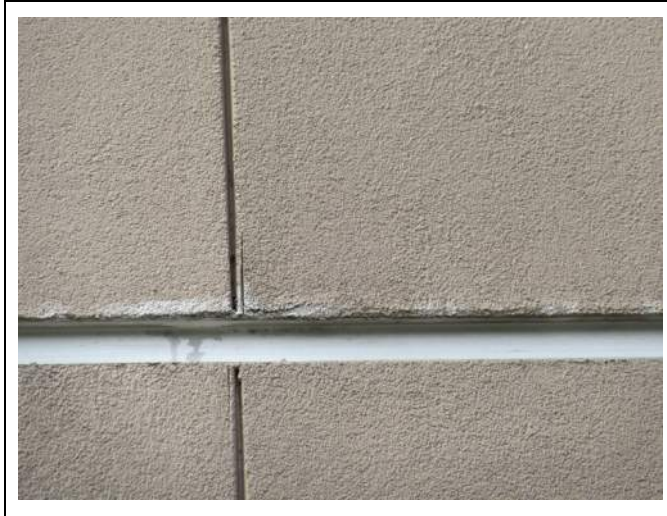
Photo No. B12.

View exploratory opening area with the exterior stucco layer removed; minor separation of stucco screeds from stucco at control joints.

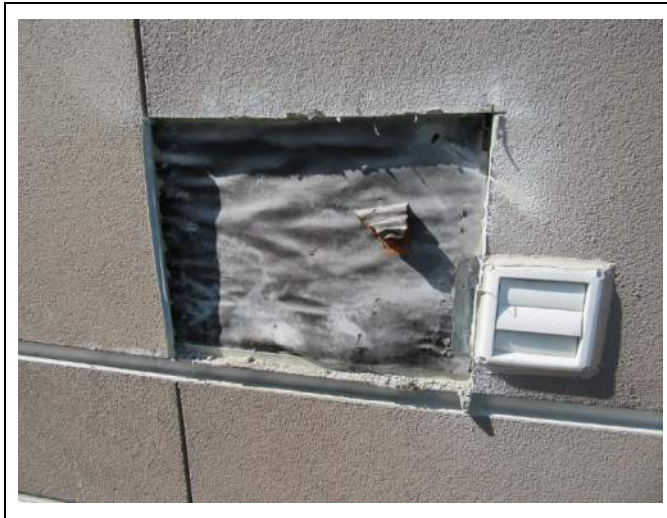
Photo No. B13.

Stucco cladding removed, showing asphaltic building paper with minor wrinkling.

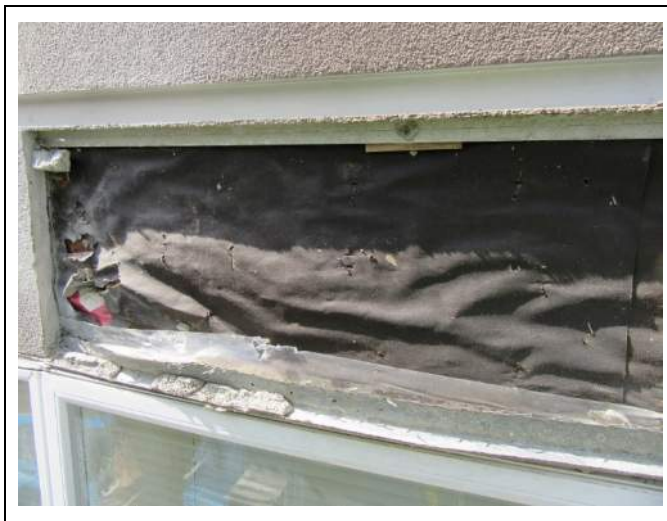
Photo No. B20.

Stucco cladding removed, showing asphaltic building paper with minor wrinkling.

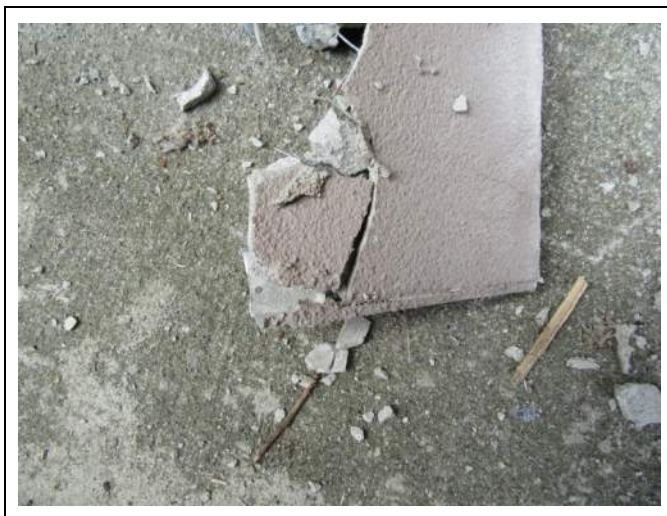
Photo No. B27.

Cracking at stucco adjacent to exploratory opening. Rusting of J-molding can be seen through the exterior crack.

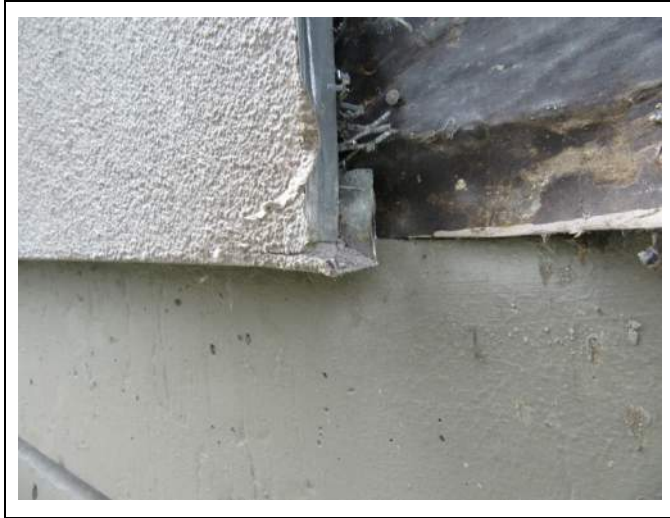
Photo No. B28.

Rust at stucco screed of the vertical control joint.

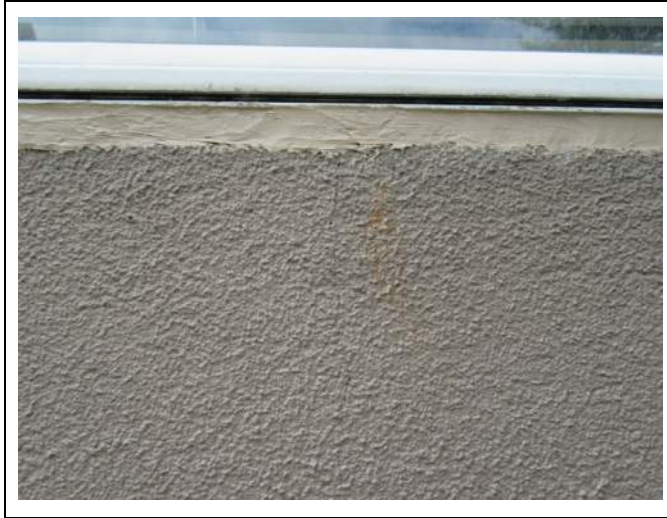
Photo No. B30.

- Condition of stucco cladding: Surface cracks observed at center the exploratory opening area (see Photo B30) and stucco cladding had efflorescence at its bottom edge (see Photo B31). Stucco had expanded metal lath, indicative of a repair location as the other exploratory openings had a hexagonal-pattern wire lath. Small amounts of rust were observed at the horizontal stucco screeds

Top edge of the exploratory opening with hairline crack visible.

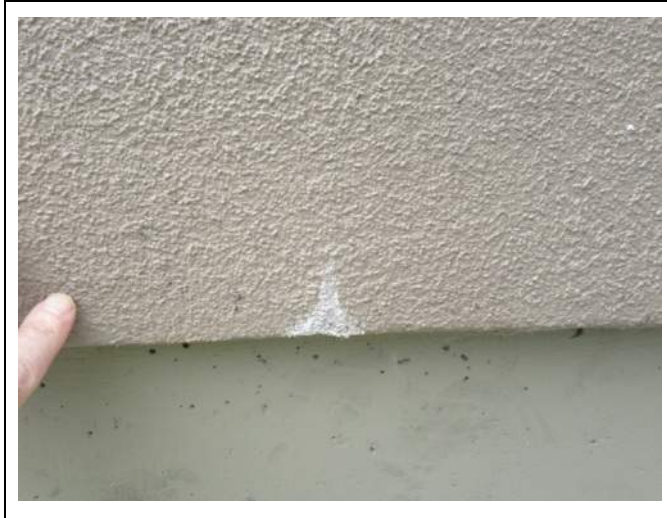
Photo No. B31.

Bottom edge of the exploratory opening with minor efflorescence.

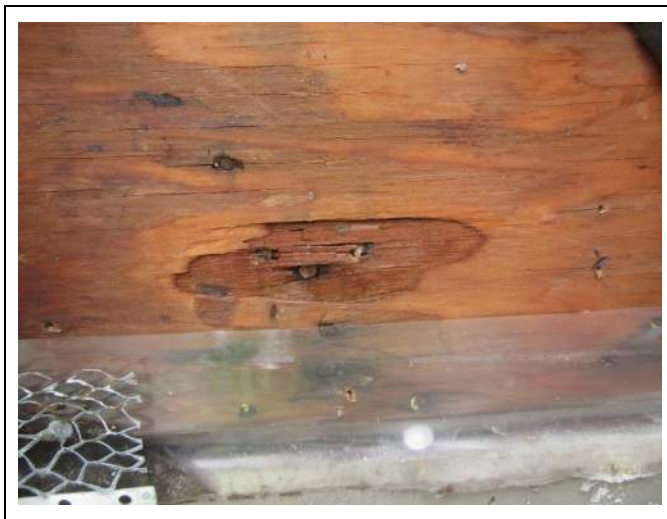
Photo No. B32.

View of exterior plywood sheathing with water stains and some minor surface deterioration.

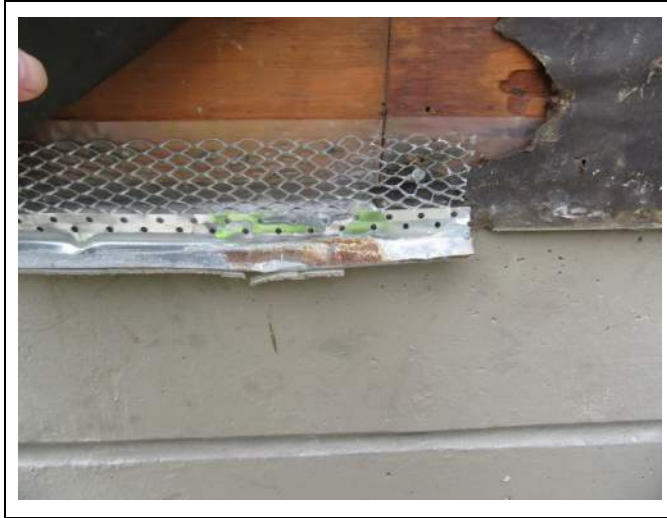
Photo No. B33.

Small area of corrosion at location of efflorescence at bottom of exploratory opening.

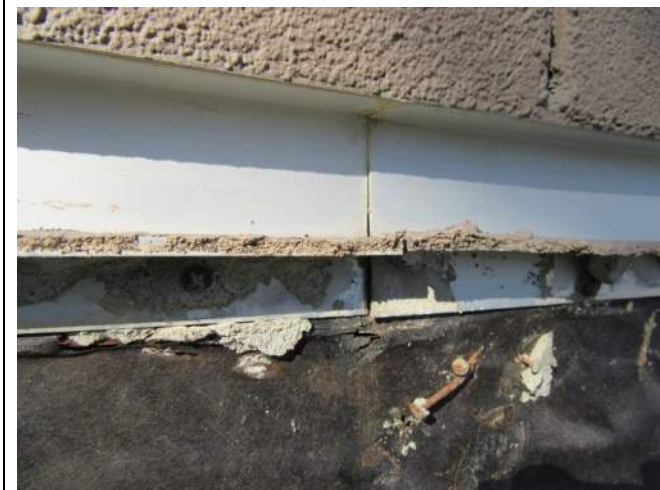
Photo No. B38.

Sheet metal reveal with minor corrosion at butt joint of nailing flange. Nails below reveal have rust at nail-heads and shanks.

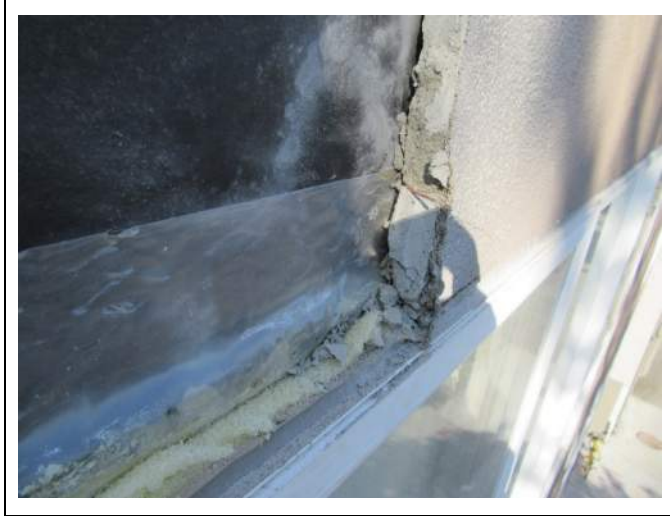
Photo No. B39.

Minor corrosion at exposed fragment of stucco lath.

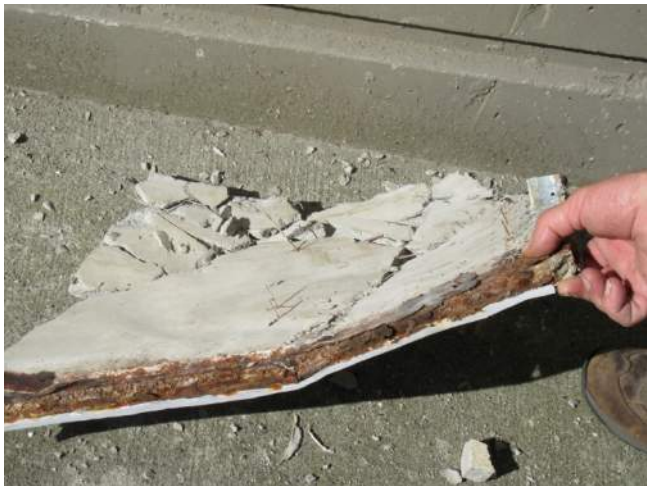
Photo No. B45.

Rust at metal screed of stucco cladding along bottom of exploratory opening.

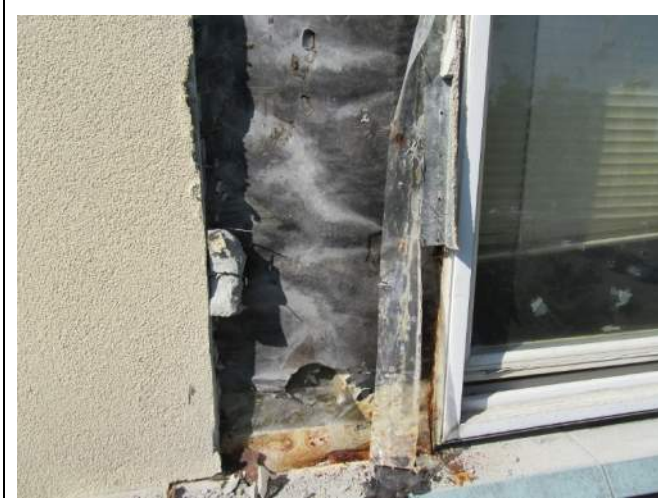
Photo No. B48.

Stucco cladding removed, showing asphaltic building paper with minor wrinkling.

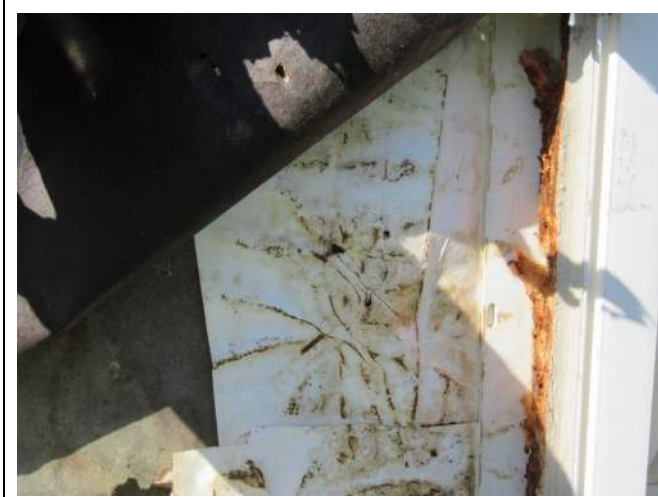
Photo No. B49.

Self-adhesive membrane flashing at window jamb installed behind nailing flange with rust stains at sealant joint.

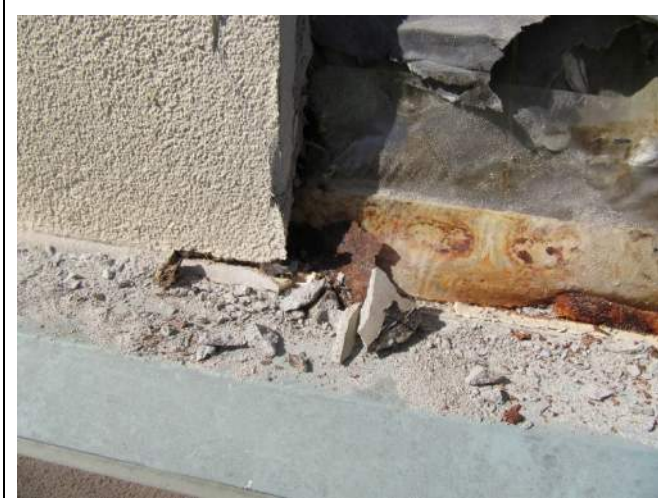
Photo No. B51.

Rust stains at vertical flange of horizontal building cornice.

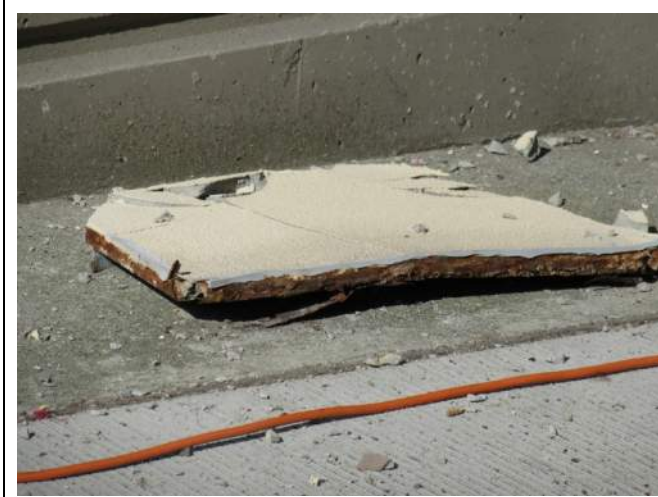
Photo No. B52.

Extensive corrosion visible at stucco screeds at edges of exploratory opening.

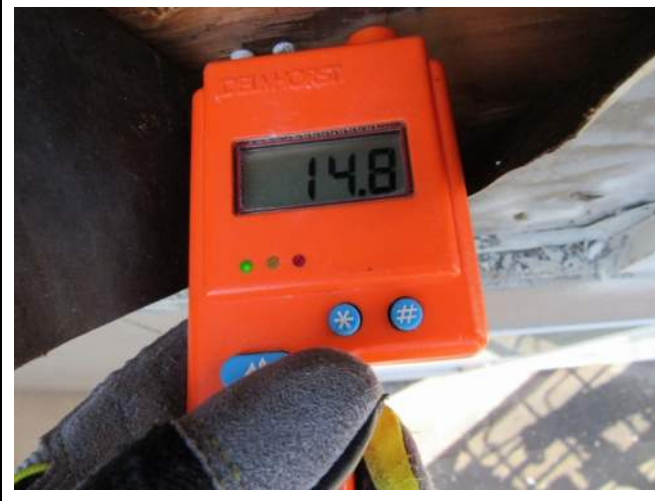
Photo No. B56.

Moisture reading of 14.8% at location of dark water stain visible in Photo No. B55.

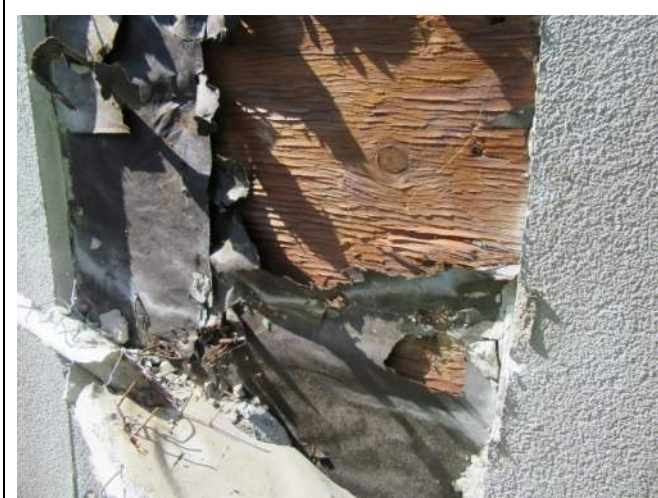
Photo No. B60.

Loss of asphaltic building paper (WRB) with removal of stucco cladding. Visible deterioration of outside veneer of plywood sheathing.

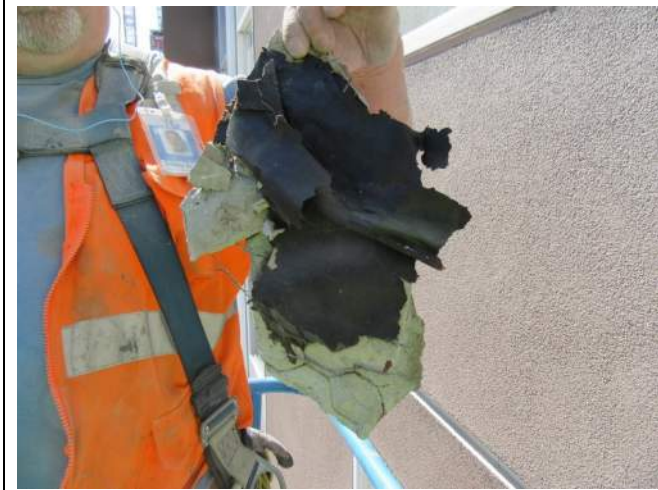
Photo No. B61.

Asphaltic building paper adhered to back of removed stucco cladding.

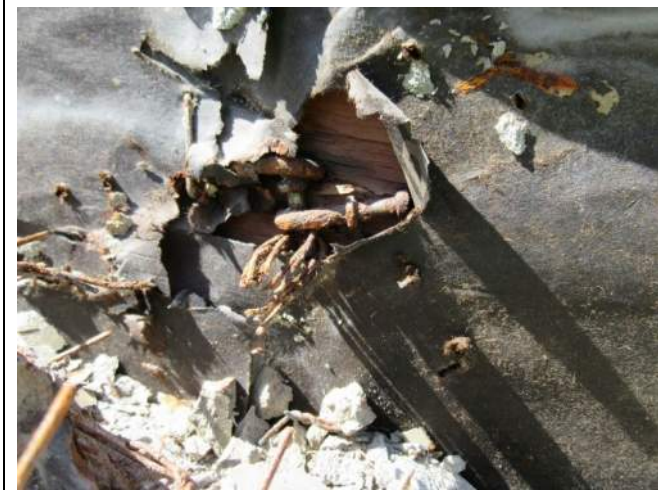
Photo No. B62.

Close-up view of vestigial rusted end of tie-wire attached to the wall structure.

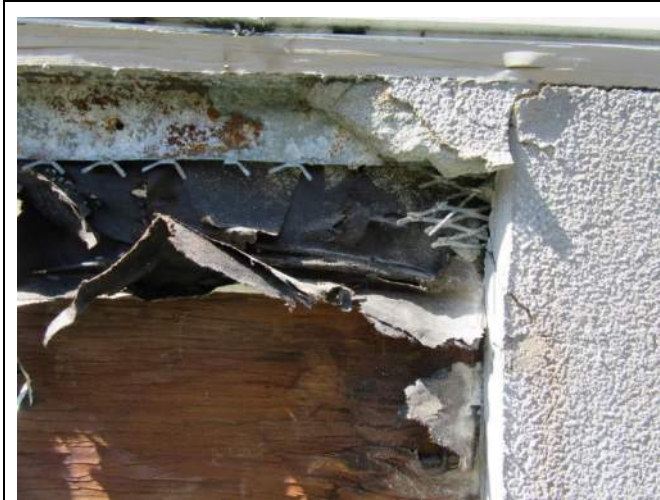
Photo No. B63.

Minor corrosion visible on stucco screed at window sill and rust staining on surface of stucco coating.

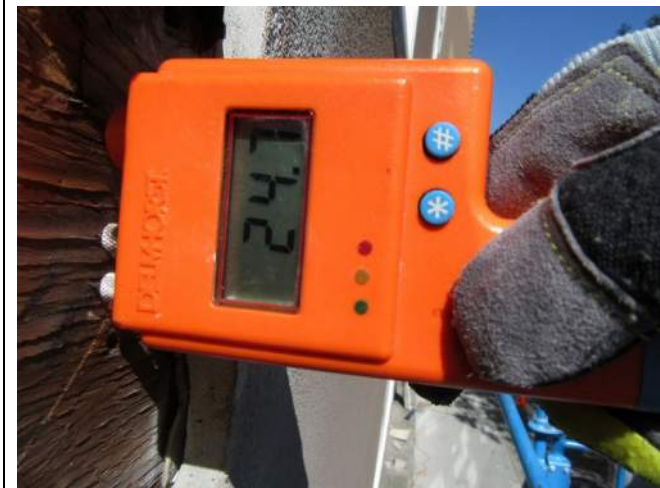
Photo No. B64.

Moisture reading of 24.7% at location of dark water stain visible in Photo No. B55.

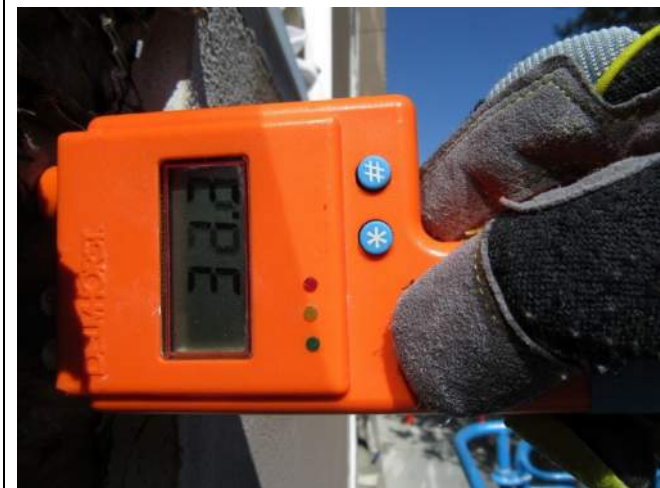
Photo No. B65.

Moisture reading of 31.3% at upper corner of plywood sheathing visible in Photo No. B63.

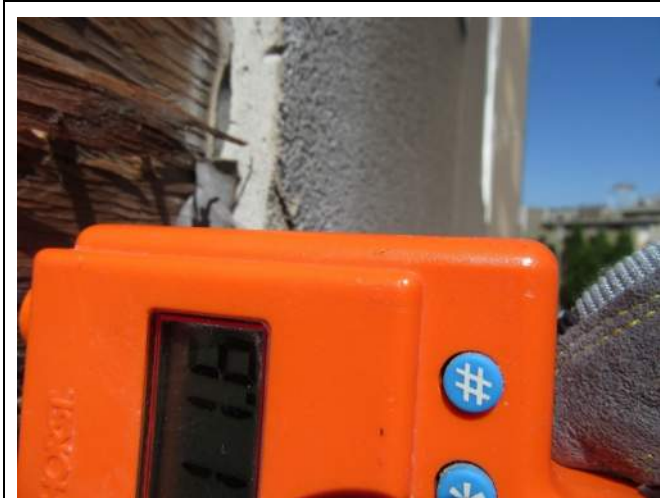
Photo No. B66.

Moisture reading of 11.8% at location south of plywood location visible in Photo No. B64.

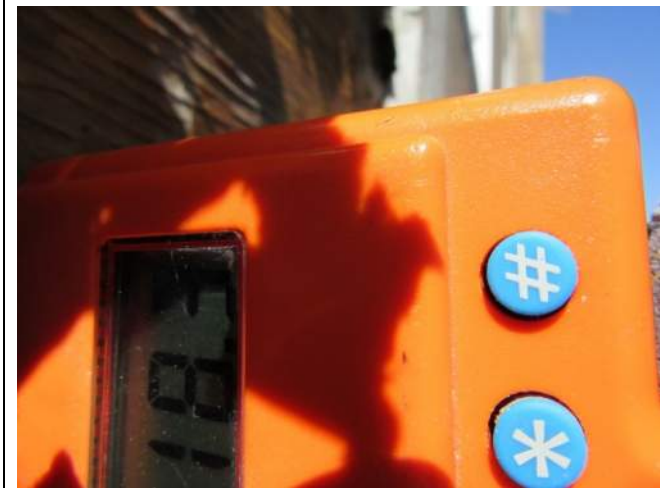
Photo No. B67.

Moisture reading of 18.3% at location of plywood slightly above location of Photo No. B66.
