BUILDING ENVELOPE COMMISSIONING REPORT

Report Date: July 21, 2022
Project Name: Winooski School BECx
Project Number: 21-21-162
Date of Visit: July 19, 2022
Purpose: First Instance Tests - ASTM E 1186 (Fog Testing)

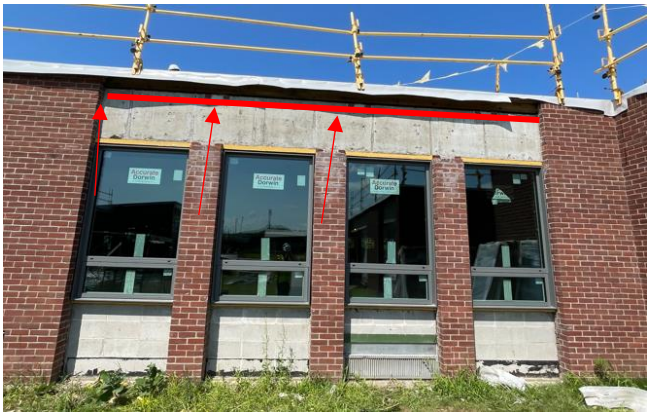
Location:	East Elevation Area D
Location Description:	Wall to Roof Transition at Spray Foam Section
Test Type:	Pressurized fog at 60+ pascals of pressure (impingement)
<p>Results: In the area above the window, no leaks were observed due to the spray foam making a good seal to the metal deck. However at the I-joists the spray foam wasn't able to make an effective seal. As a result fog was found to leak out at every I-joist transition where it meets the wall to roof. We recommend that the I-joists are spot sealed with can foam to address the air leakage through and around them.</p>

<p>The tested transition is outlined above. The red arrows call out the specific locations where fog was observed to escape.</p>
<p>The arrow above points to an I-joist which the can foam does not fully seal around. We recommend the I-joist voids are filled with can foam to help decrease the air leakage.</p>

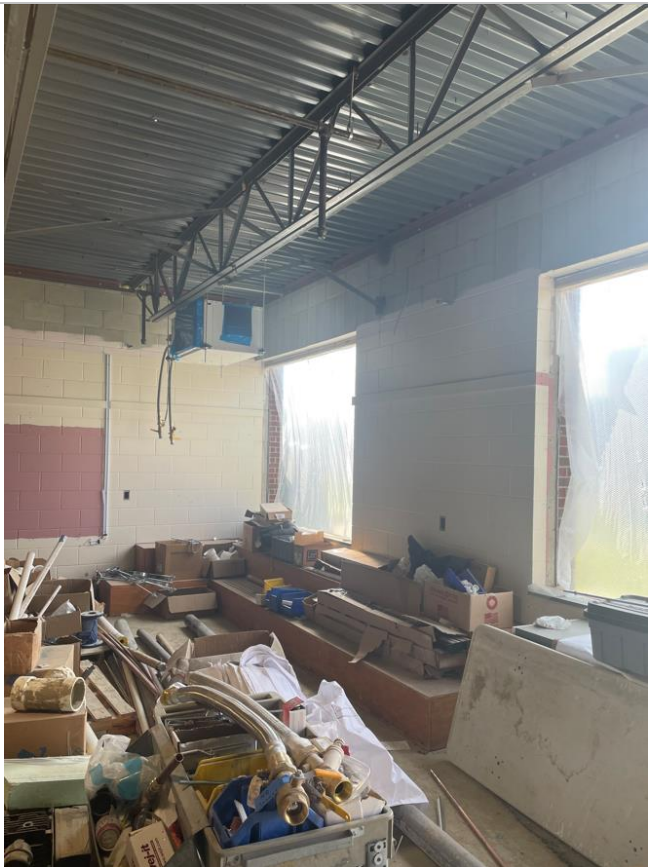
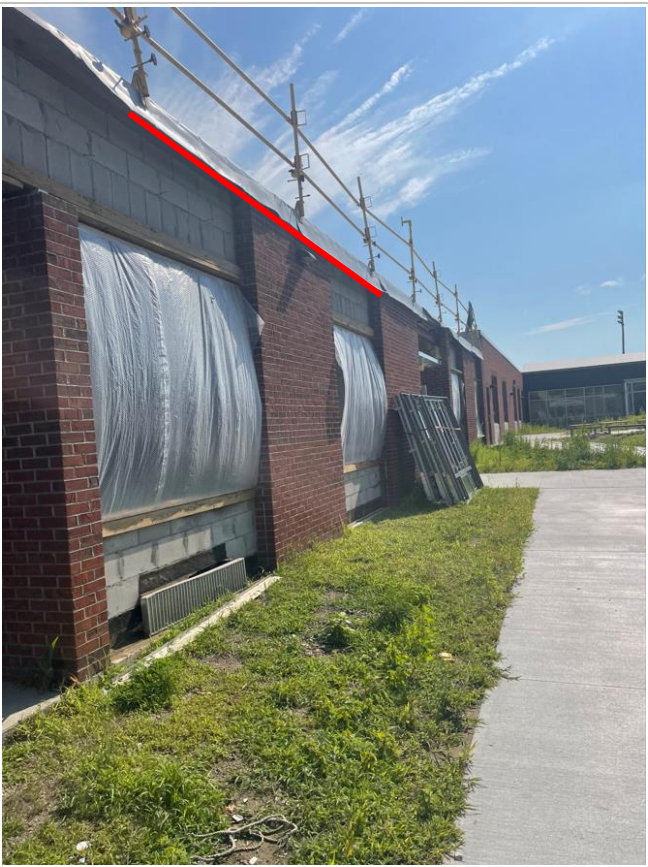
Location:	South Courtyard Elevation in Area D
Location Description:	Wall to Roof Transition
Test Type:	Pressurized fog at 60+ pascals of pressure (impingement)
Results: This area leaked heavily as there is no defined air barrier in the detail. We recommend a change order is submitted in order to get the approval for spray foam to seal the wall to roof transition. BVH also recommends sealing the roof membrane or the exterior brick/CMU to prevent air from leaking out at the flutes above the deck. This is because the flutes of the metal deck here are perpendicular to the wall whereas at the previous vintage the flutes are parallel.

The tested transition is outlined above.	The tested transition is outlined above in red.

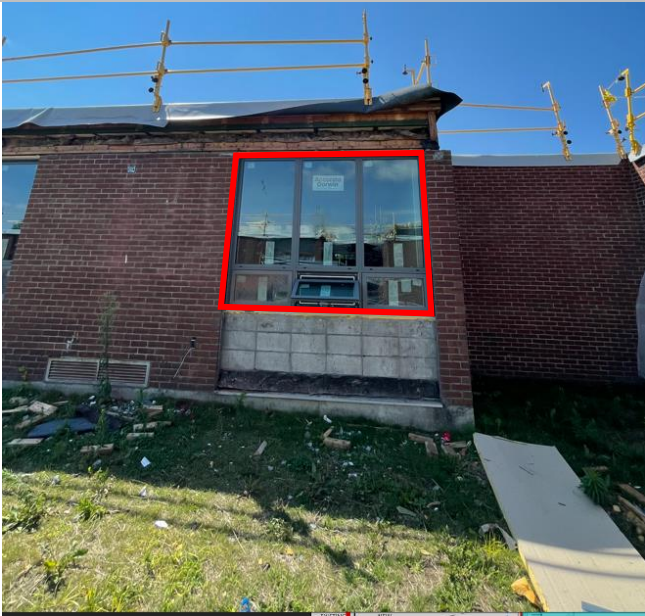
Location:	North Courtyard Elevation in Area D
Location Description:	Window to Rough Opening and the Window
Test Type:	Pressurized fog at 60+ pascals of pressure (impingement)
Results: This transition produced no leaks during testing. Continue to construct this detail in the same manner with the same quality of work. The window was also found to perform well.

The tested transition is outlined above.

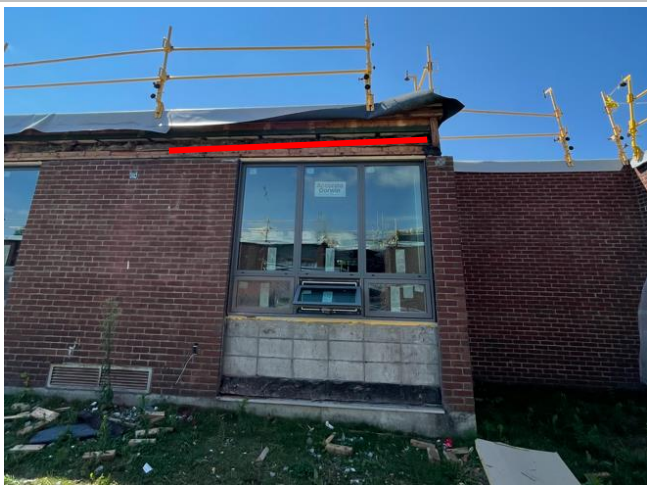
Results: This transition leaked heavily one because it was incomplete, and two because the spray foam only travels up the wall to the bottom of the wall to roof transition beam. With the tectum being porous, air is easily able to leak out here. We recommend to continue work adhering to the 1-A510.2 detail and SKA-28 as these will complete an airtight transition. This will greatly improve the performance of this transition.

The tested transition is outlined above.

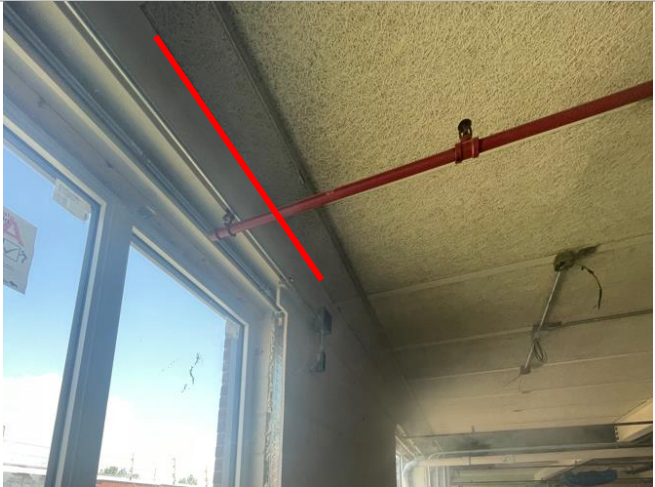
The tested transition is outlined above.

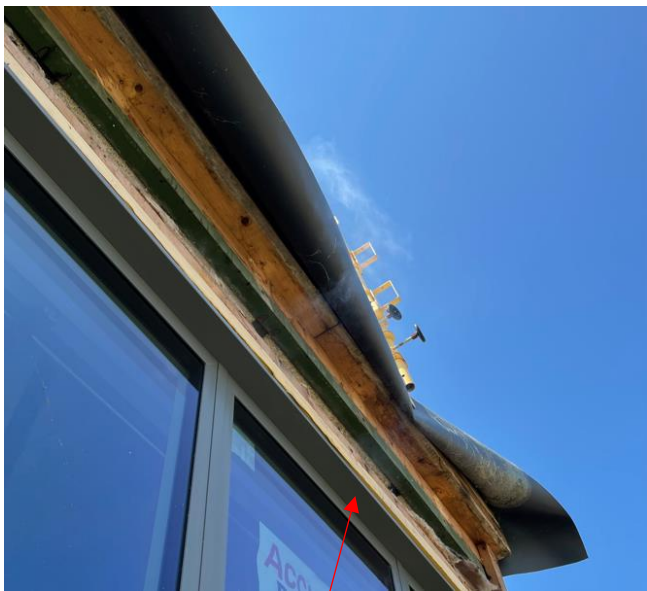
Close up image showing fog escaping the transition during the testing.

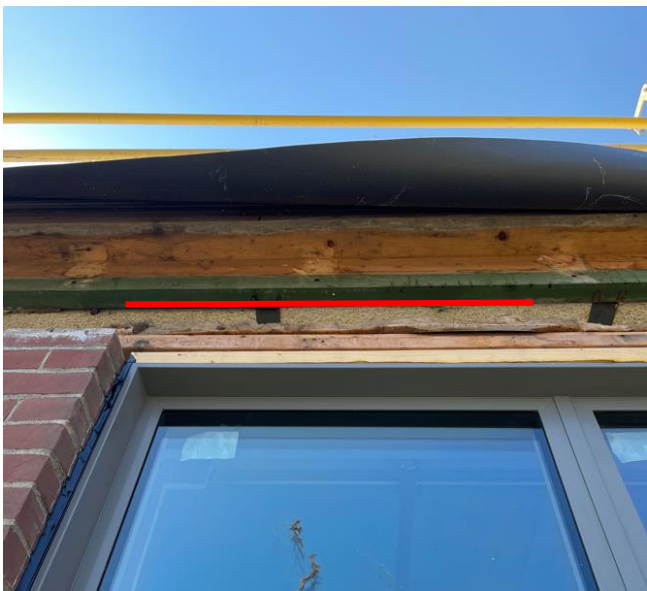
Close up image showing another location where fog was observed to escape during testing.

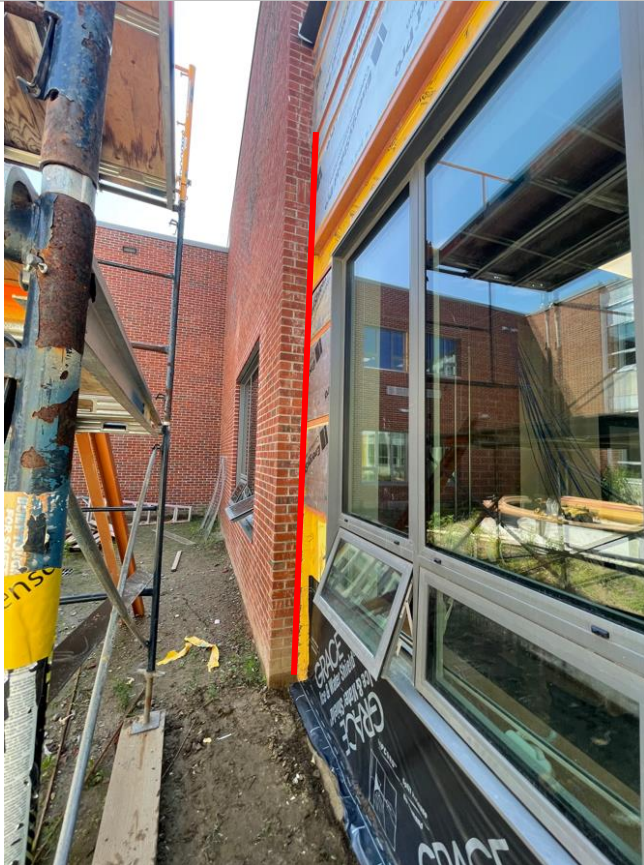
Location:	North Courtyard Elevation in Where Area E and Area D Meet
Location Description:	New to Existing Transition
Test Type:	Pressurized fog at 60+ pascals of pressure (impingement)
Results: During testing fog was observed to leak through fish mouth openings in the transition membrane. We recommend that the insulation is removed so the transition membrane can be sealed with an additional layer of DensElement sealant.

The tested transition is outlined above.

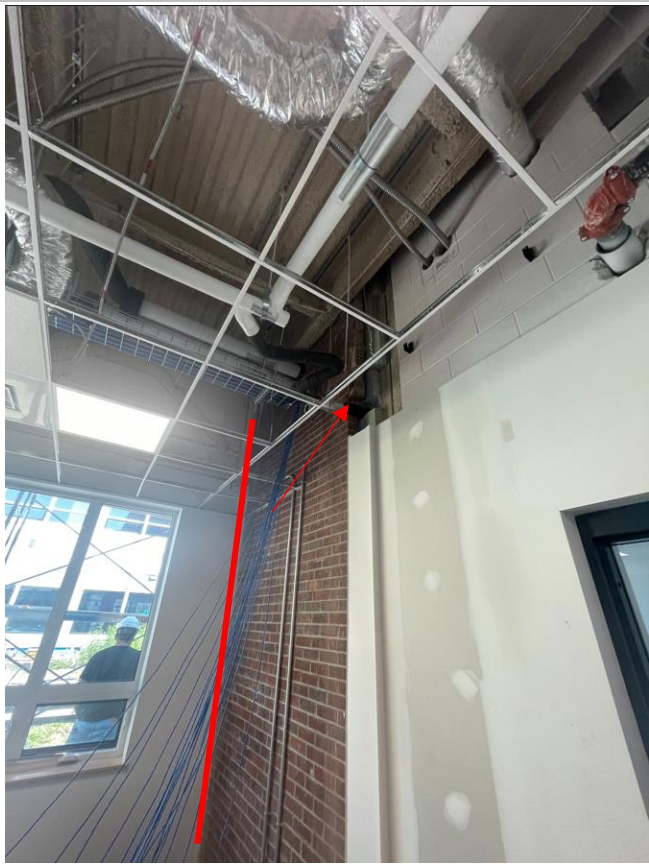
The tested transition is outlined above. Pointed to above is an air bypass through the existing layers which is described in the next table.

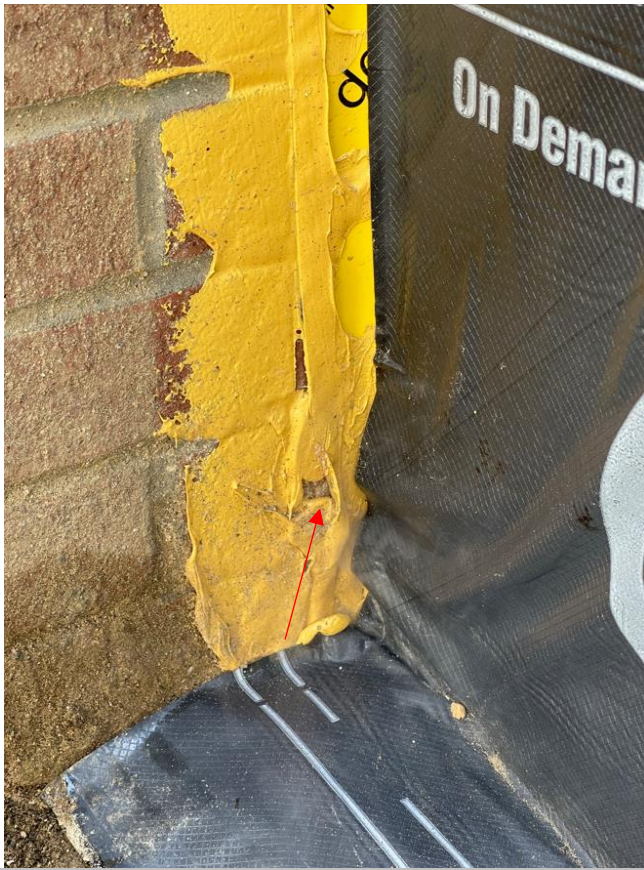
Close up image showing fog escaping the transition during the testing. These openings in the transition membrane should be sealed with more fluid applied.

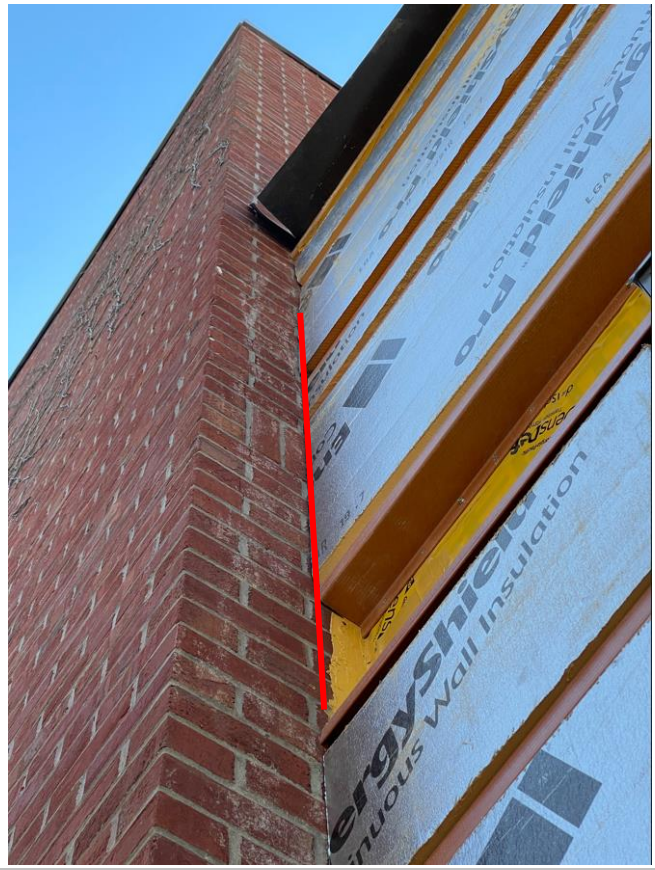
Close up image showing another location where fog was observed to escape during testing. This insulation should be removed so that the transition membrane can be sealed with additional fluid applied.

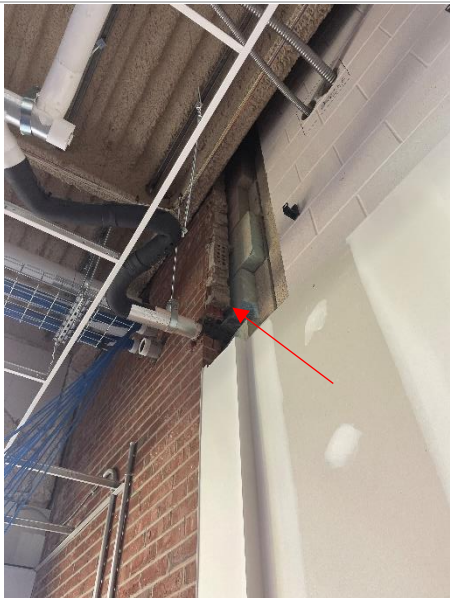
Location:	North Courtyard Elevation in Where Area E and Area D Meet
Location Description:	New to Existing Transition
Test Type:	Pressurized fog at 60+ pascals of pressure (impingement)
Results: While inspecting the building, the existing construction at this location was found to have an air space behind the brick. This air space acts as a path for air to leak out of the building. BVH recommends this space is filled with can foam where the existing brick was cut. This will help to decrease the buildings air leakage.

The arrow above points to the air space which leads to outside, We recommend this is filled with can foam along the entire height. Some of the drywall will need to be removed to do this.

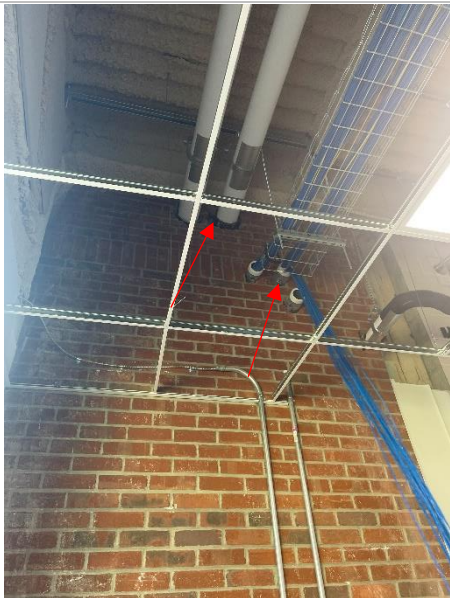
The arrows above point to some penetrations through the brick wall which should be sealed from both sides, as they enter the air space.

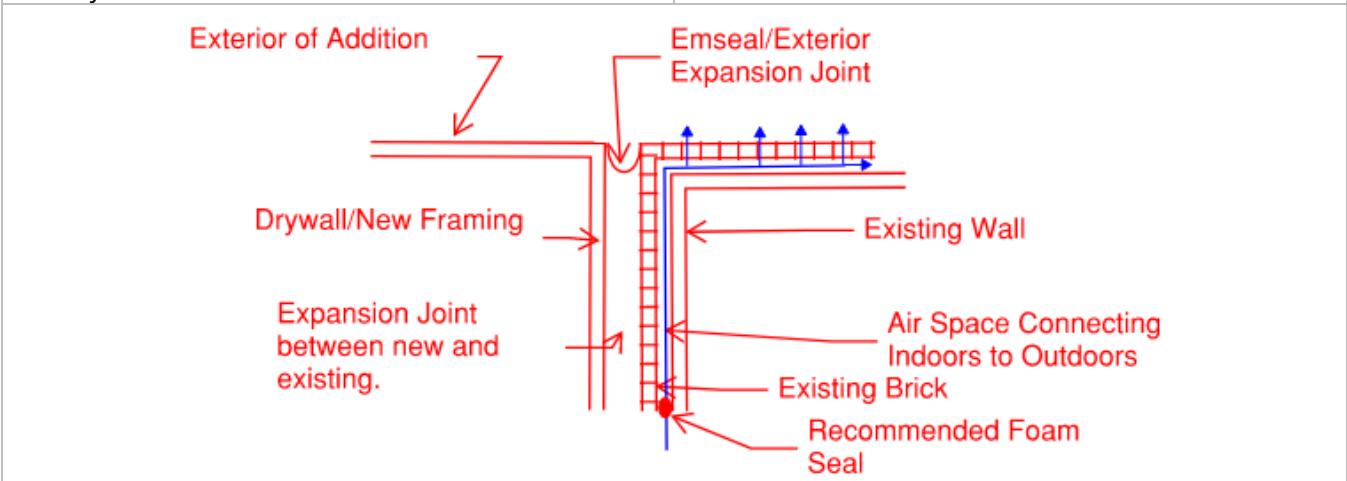
Diagram above is slightly different from what is actually constructed, but it shows how conditioned air (represented by the blue line) can travel into the cavity and out through the existing wall at weep holes, mortar joints, etc.
