BUILDING ENVELOPE COMMISSIONING REPORT

| Project Name | Winooski School - Building Envelope Commissioning |
| Project Number | 21-20-162 |
| Purpose | First Instance Tests - ASTM E 1186 (Fog Testing) |

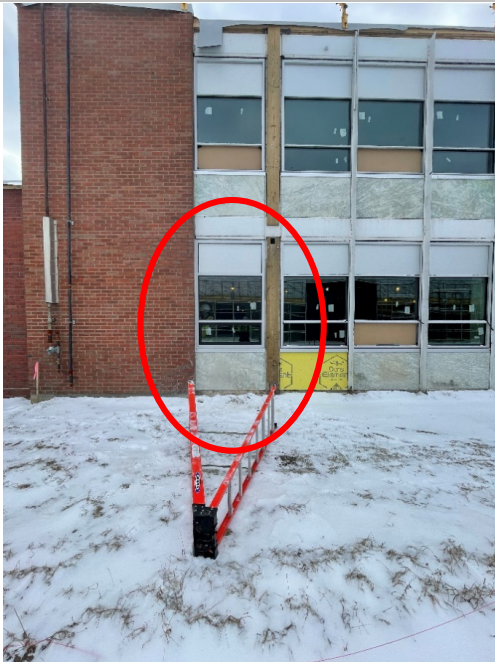
| Results: We tested a new curtain wall placed into existing construction and found a small leak through a void in the caulking. Overall the curtain wall performed well. BVH spoke with SAG prior to leaving the job and they will address the void by using additional caulk. | |
| Curtain wall tested | Small void in caulking at corner of operable window |

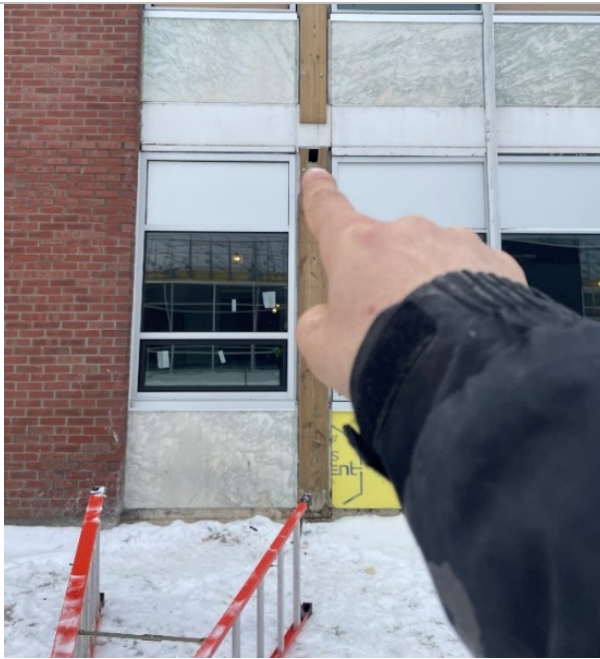
Hole in wood covering over concrete column.
What is the plan for addressing this - can foam?

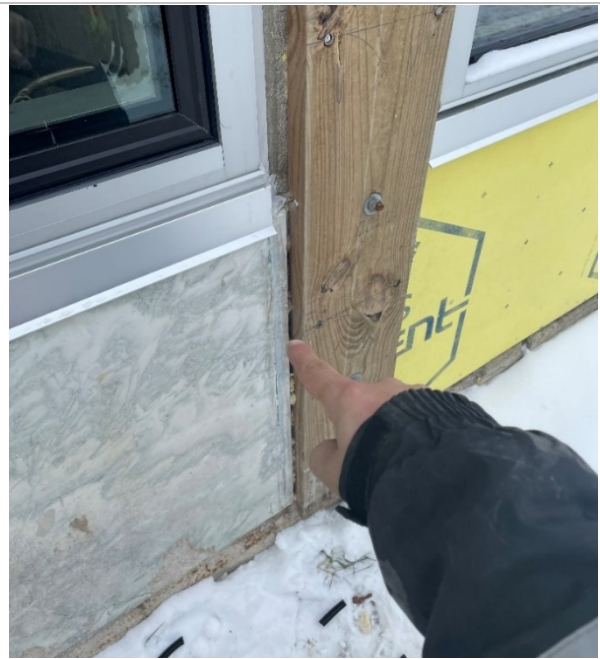
Break in the air seal along the granite transition.
This transition leaked heavily.

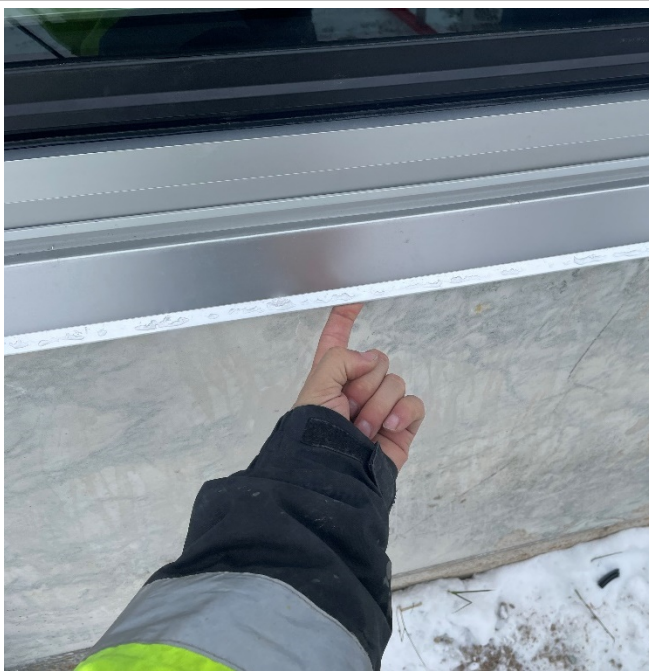
Fog leaked heavily underneath the sill flashing.
The sill flashing is sealed to the wood buck;
however, the wood buck does not appear to be
sealed to the exterior granite.

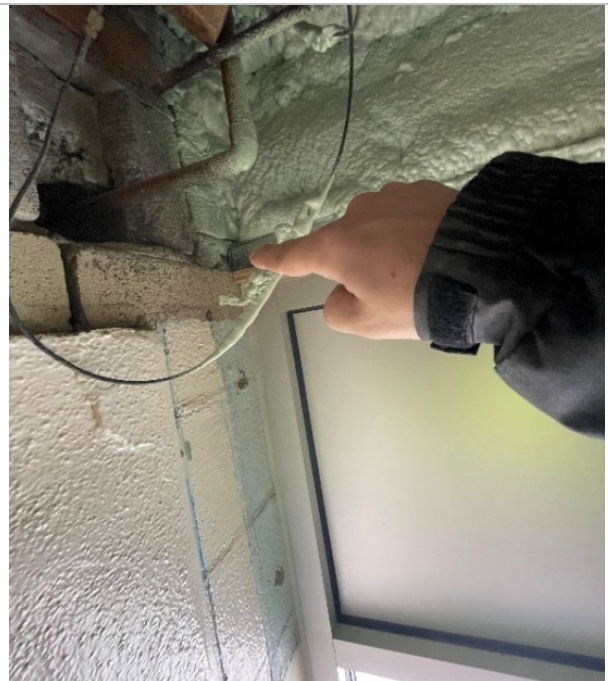
Heavy leakage at top corners of the curtain wall.
From the right angle, daylight is visible through this. Caulk can be added from inside to the area pointed at above. Same leakage occurred at the opposite side of the head as well.

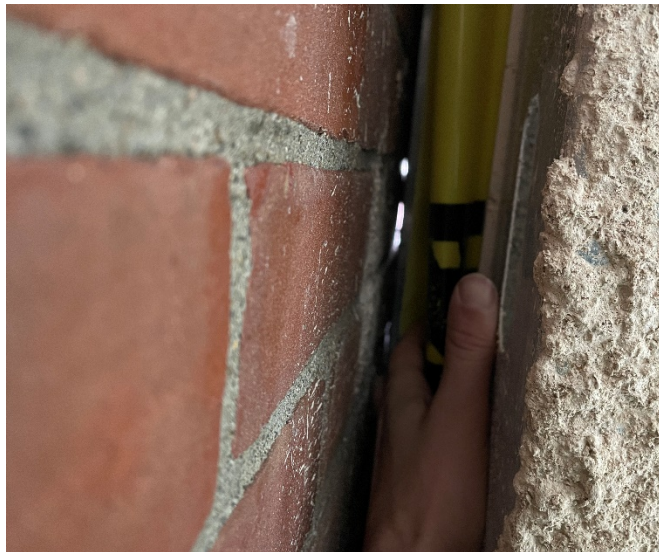
Results: The Stego Wrap on the expansion joint we tested was not sealed to the brick. An exterior cover is blocking from the outside; the only access appears to be from the inside unless the cover is removed. Sealing the Stego Wrap to the brick with caulk/DensDefy Liquid Sealant should address the leaks.

Daylight can be seen shining through where the Stego Wrap is not sealed to the brick.

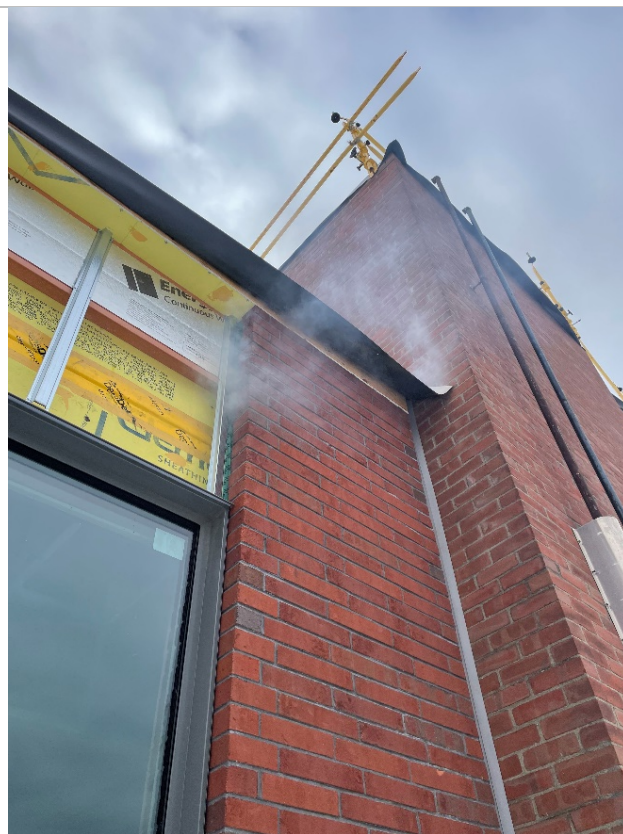
Fog can be seen leaking out heavily here. The roof-to-wall transition is not sealed yet either, which accounts for some of the air leakage above.

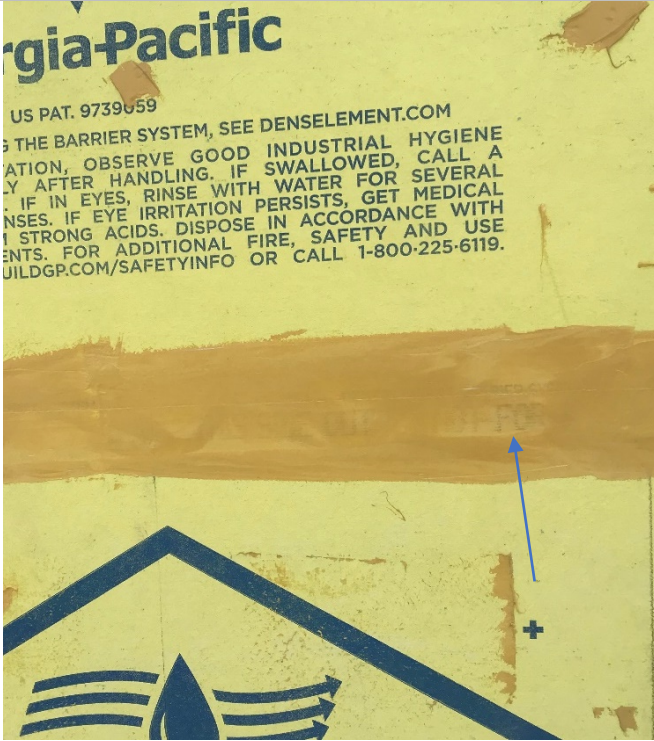
| Results: We also looked at sealed joints in the DensElement. The majority are sealed well, but there are a few areas that appear to need additional sealant. The lettering on the DensElement sheathing is visible through some of the sealant, implying that the sealant is thin in some areas. BVH recommends inspecting the joints and adding additional sealant as needed. | |
| DensElement applied thinly. The arrow points to some lettering visible through the sealant. | Location of visual inspection |

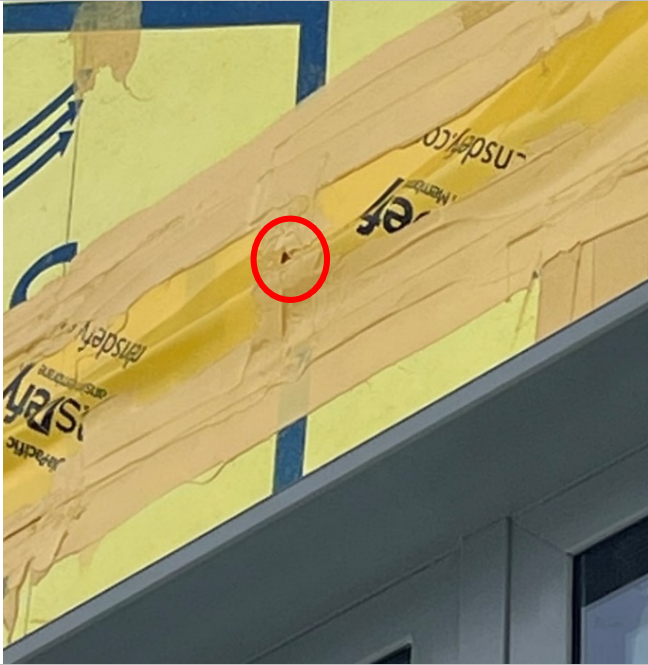
| Results: Overall the control joint is being air sealed well with liquid sealant and the transition membrane. BVH did observe one fish-mouth opening in a vertical seam which should have additional sealant added. BVH recommends inspecting the control joints as construction continues, looking for similar issues and address as needed. | |
| Fish-mouth opening in control joint is circled above. | Location of visual inspection |
