SEALANT, WATERPROOFING & RESTORATION INSTITUTE • WINTER 2022 • 44.1

**THE FRICK  
BUILDING  
CORNICE**

BY STEVE BENTZ

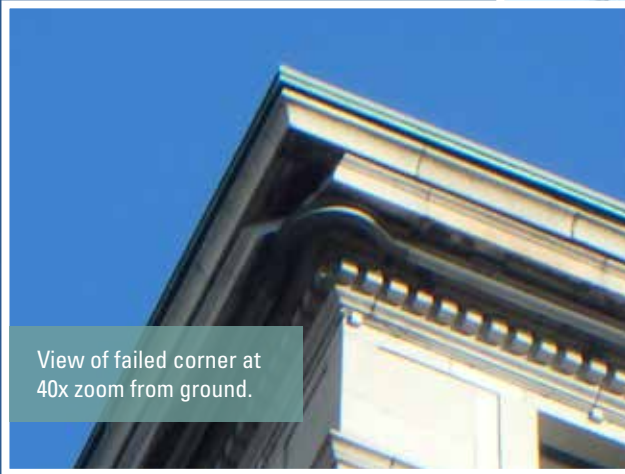
View of failed corner at 40x zoom from ground.

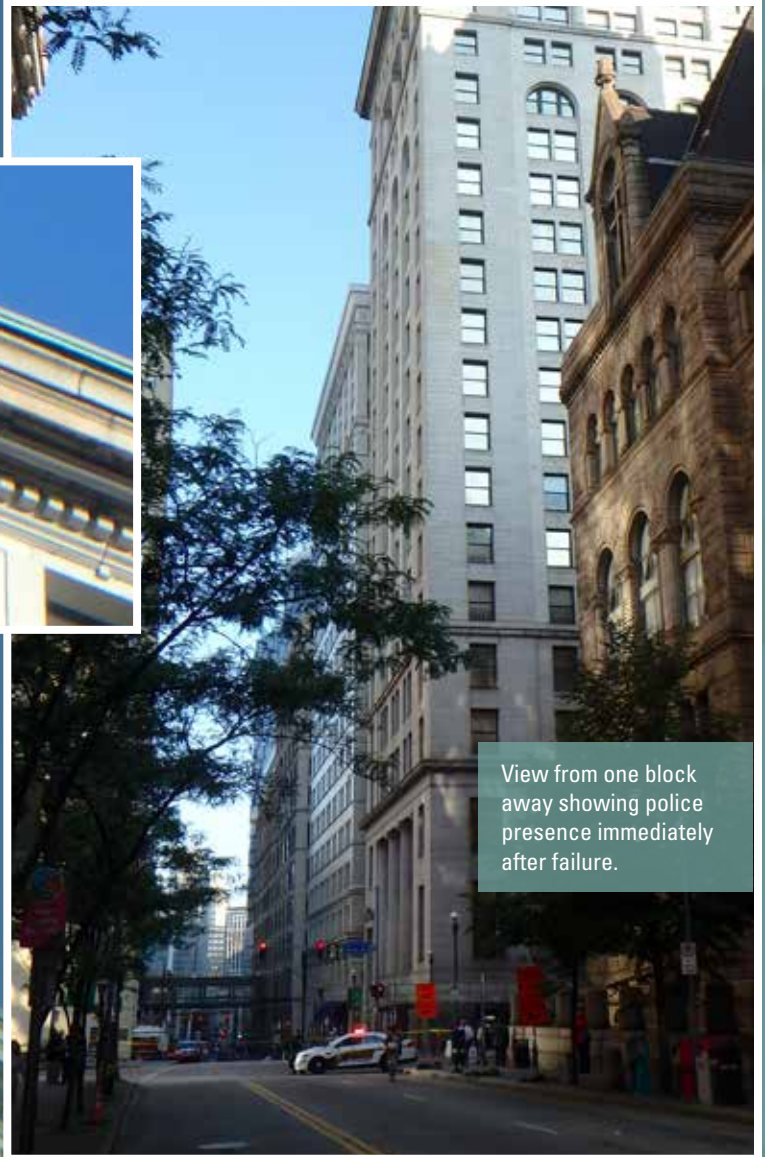
View from one block away showing police presence immediately after failure.

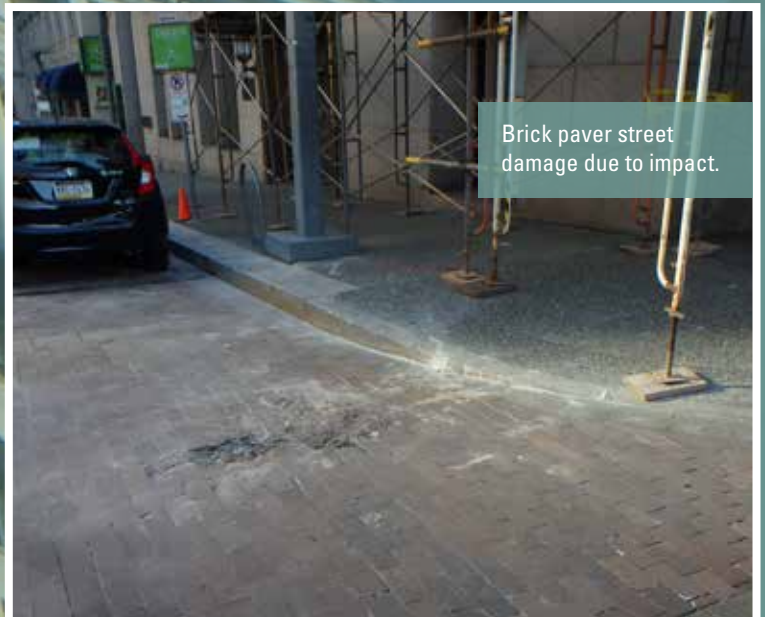
Brick paver street damage due to impact.

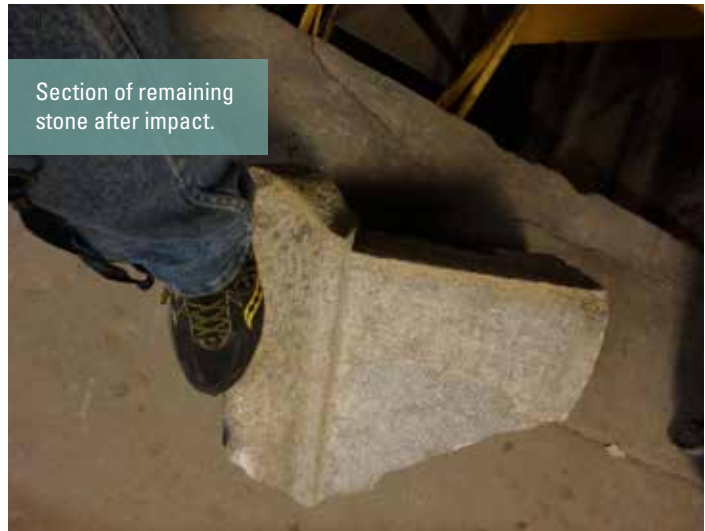
Section of remaining stone after impact.

the large stone to hang from the steel framing of the cornice. The actual stone was later found to be about 5-foot square in plan dimensions and about 2-foot thick; the section that fell was only the outermost edge. The paddle anchor had corroded, resulting in “rust jacking” which effectively split the stone along the line of the anchor

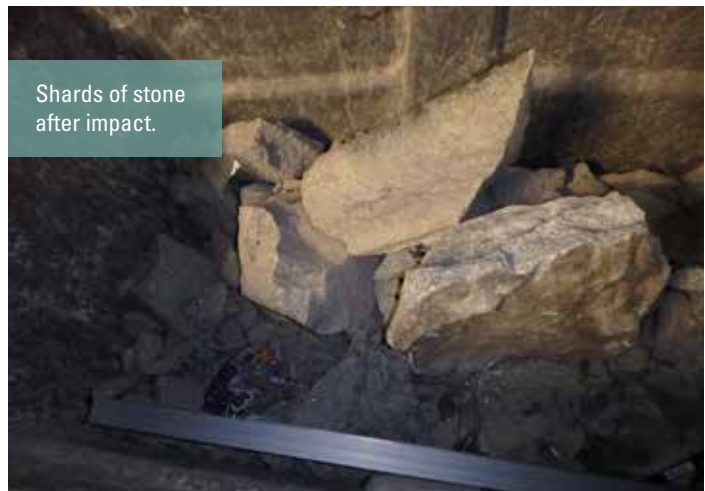
Shards of stone after impact.

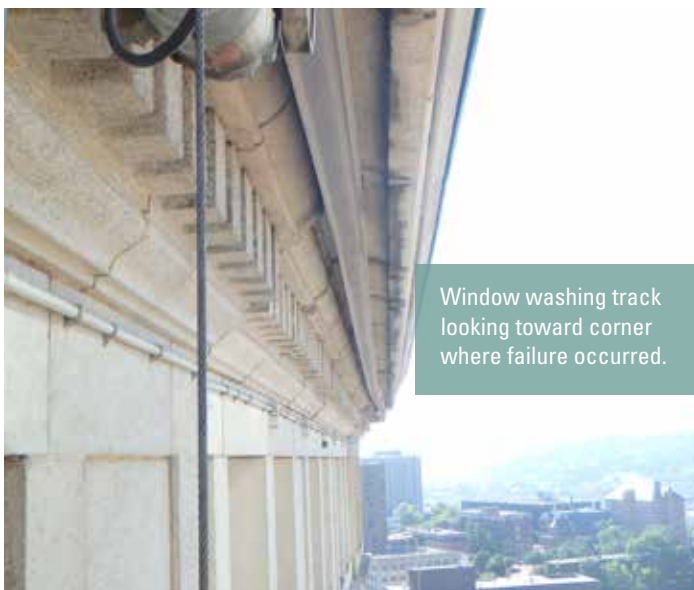
Window washing track looking toward corner where failure occurred.

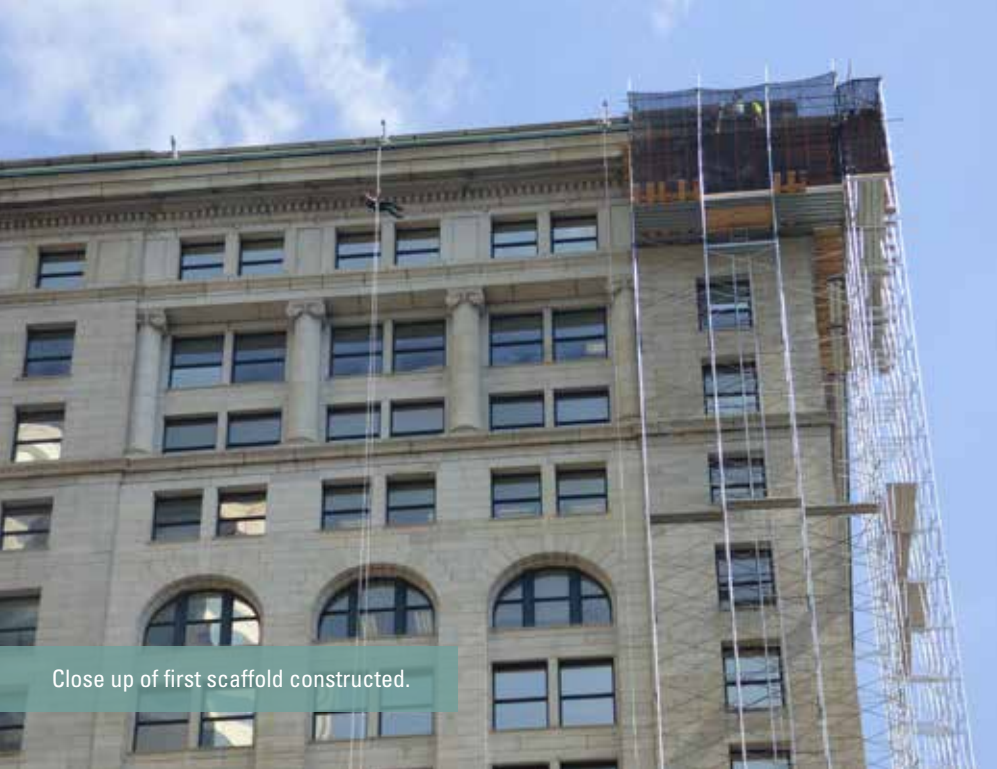
Close up of first scaffold constructed.

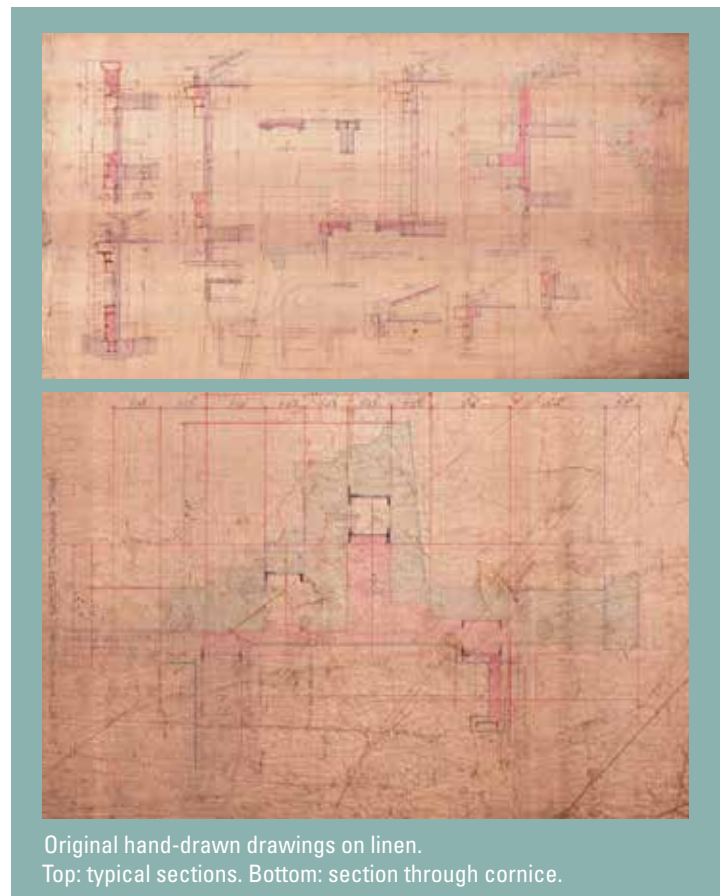
Original hand-drawn drawings on linen.  
Top: typical sections. Bottom: section through cornice.

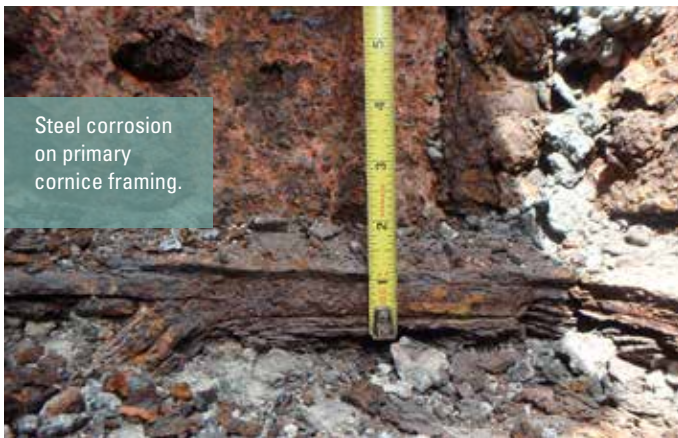
The drawings indicated that the cornice was supported by steel framing. As the layers were removed it became evident that the steel framing of the cornice had been buried in the cinder fill concrete from the original construction. This fill material was not shown on the drawings, and likely held water in contact with the steel and the paddle anchors for extended periods of time.

Steel corrosion on primary cornice framing.

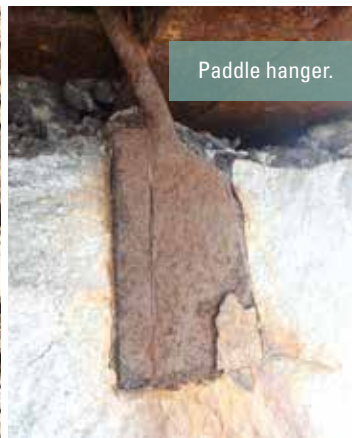
Paddle hanger.

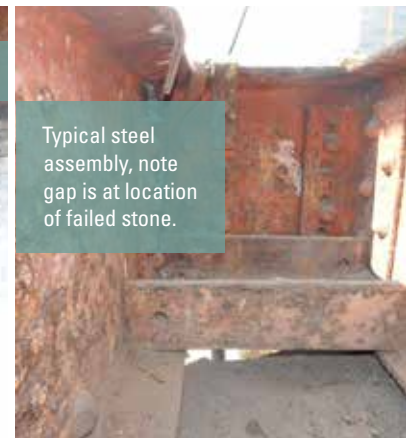
Typical steel assembly, note gap is at location of failed stone.

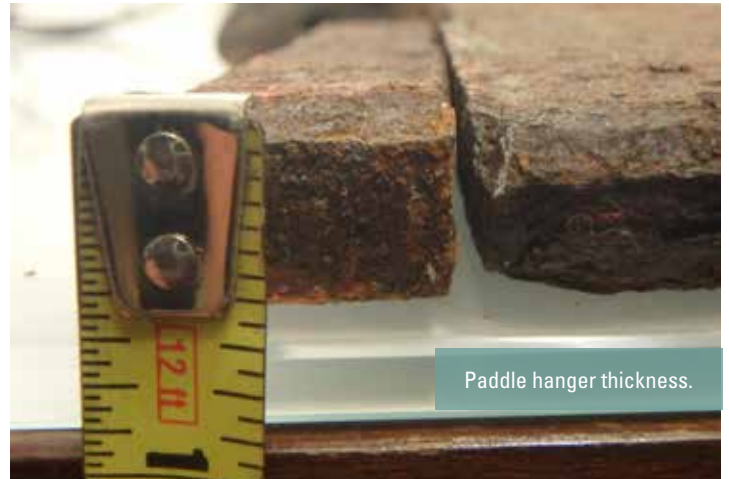
Paddle hanger thickness.

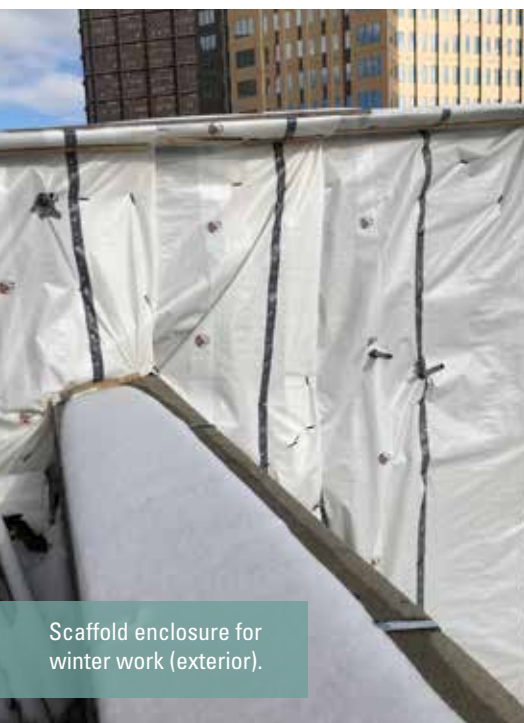
Scaffold enclosure for winter work (exterior).

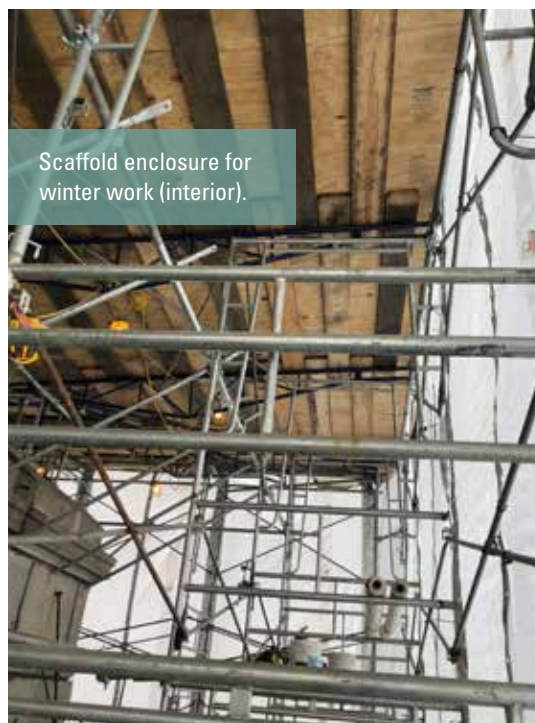
Scaffold enclosure for winter work (interior).

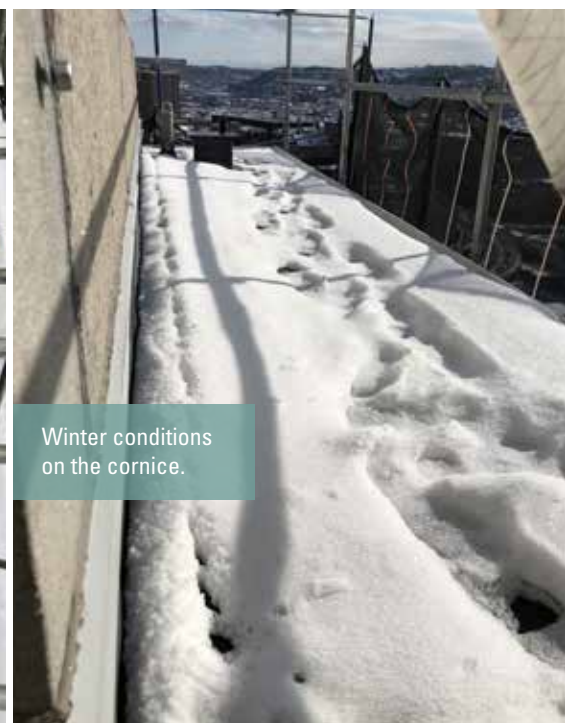
Winter conditions on the cornice.

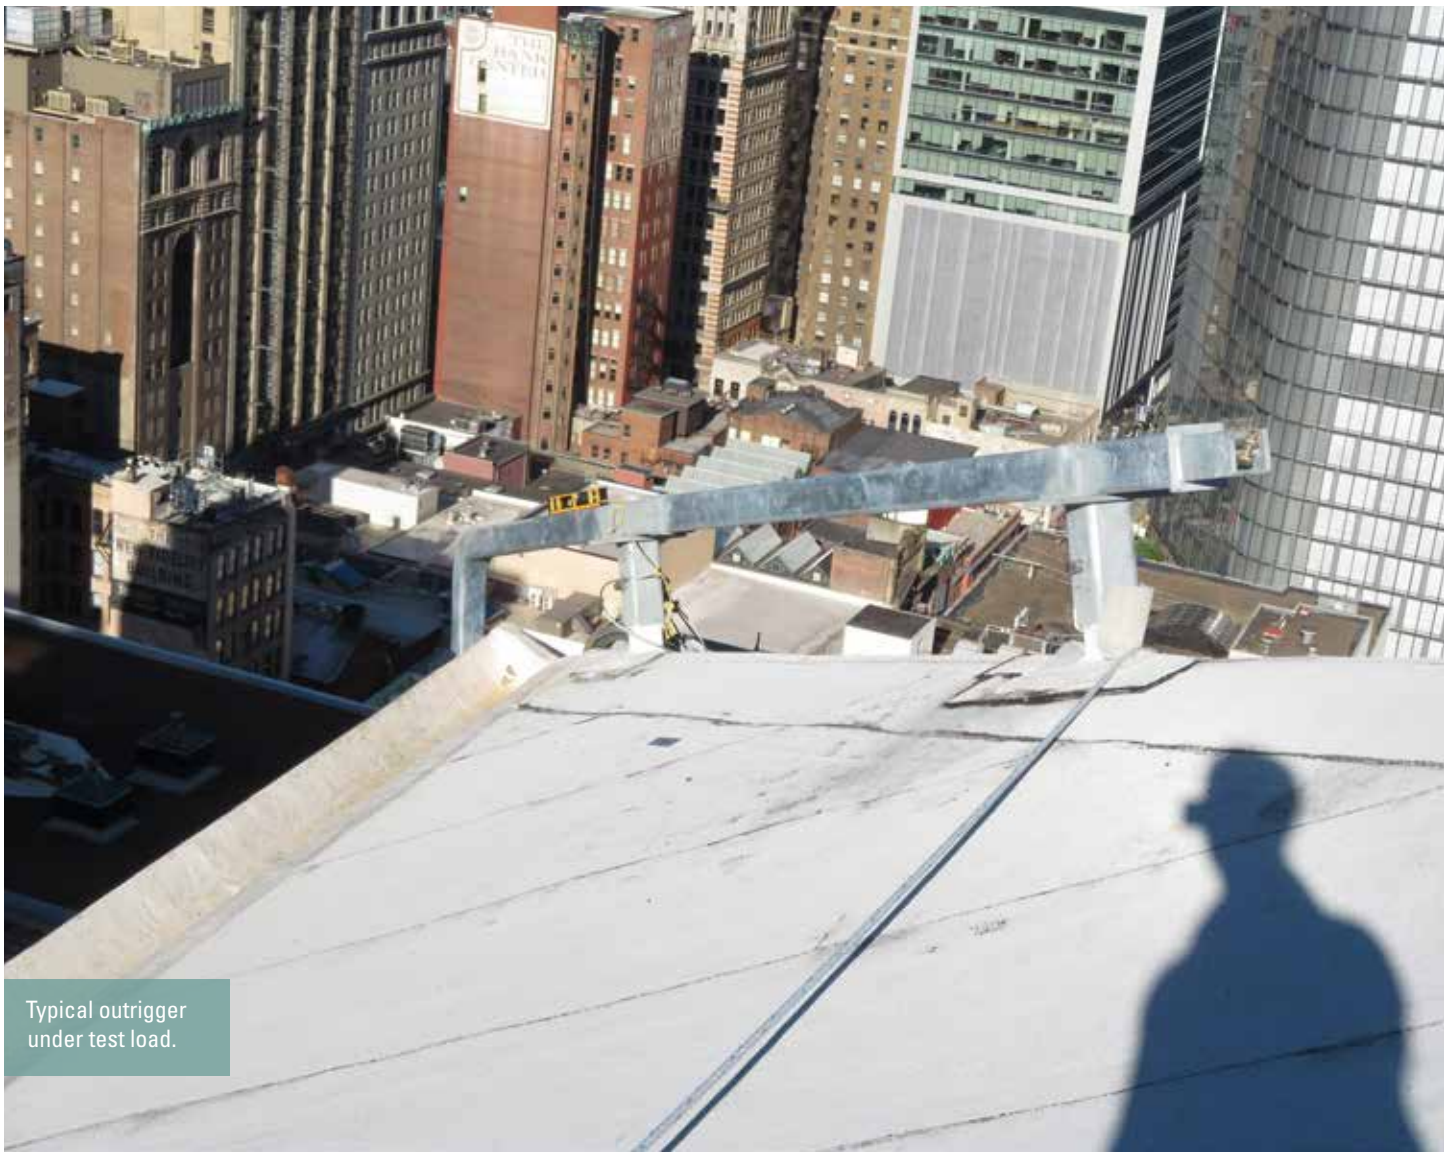
Typical outrigger  
under test load.
