MORRISON HERSHFIELD

Address: 2020 Terry Ave.,
Seattle, WA

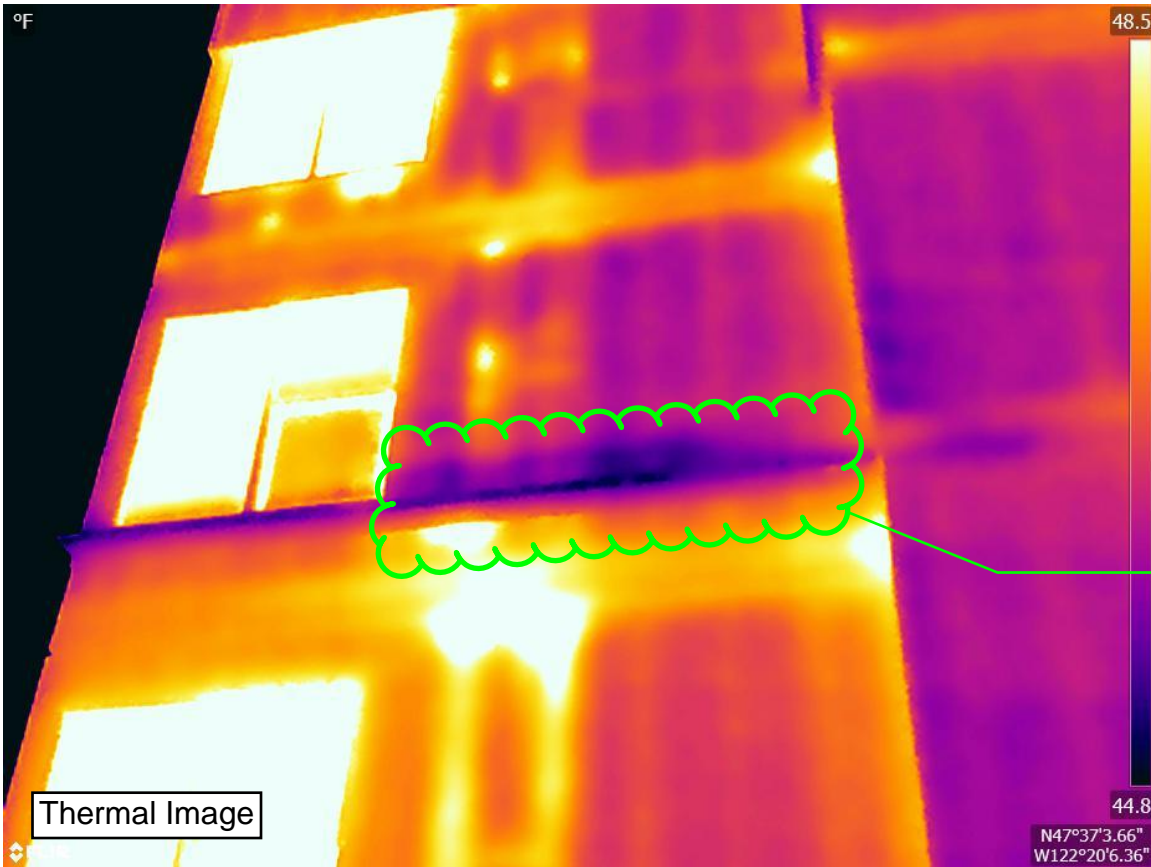
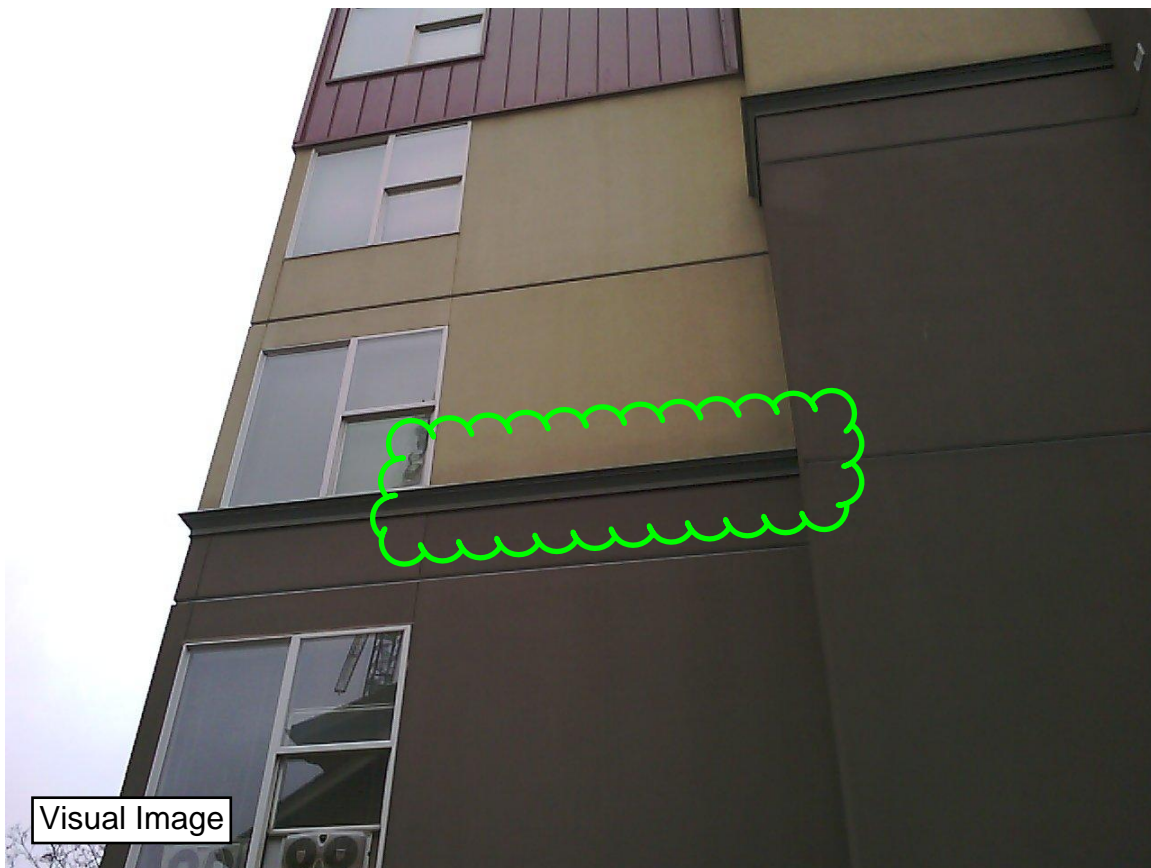
Observation #1

Location: East Wing, East
Elevation, South Corner,
Level 5

Thermal Anomaly potentially
indicating higher moisture
content in stucco layer above
architectural trim relative to
adjacent areas.

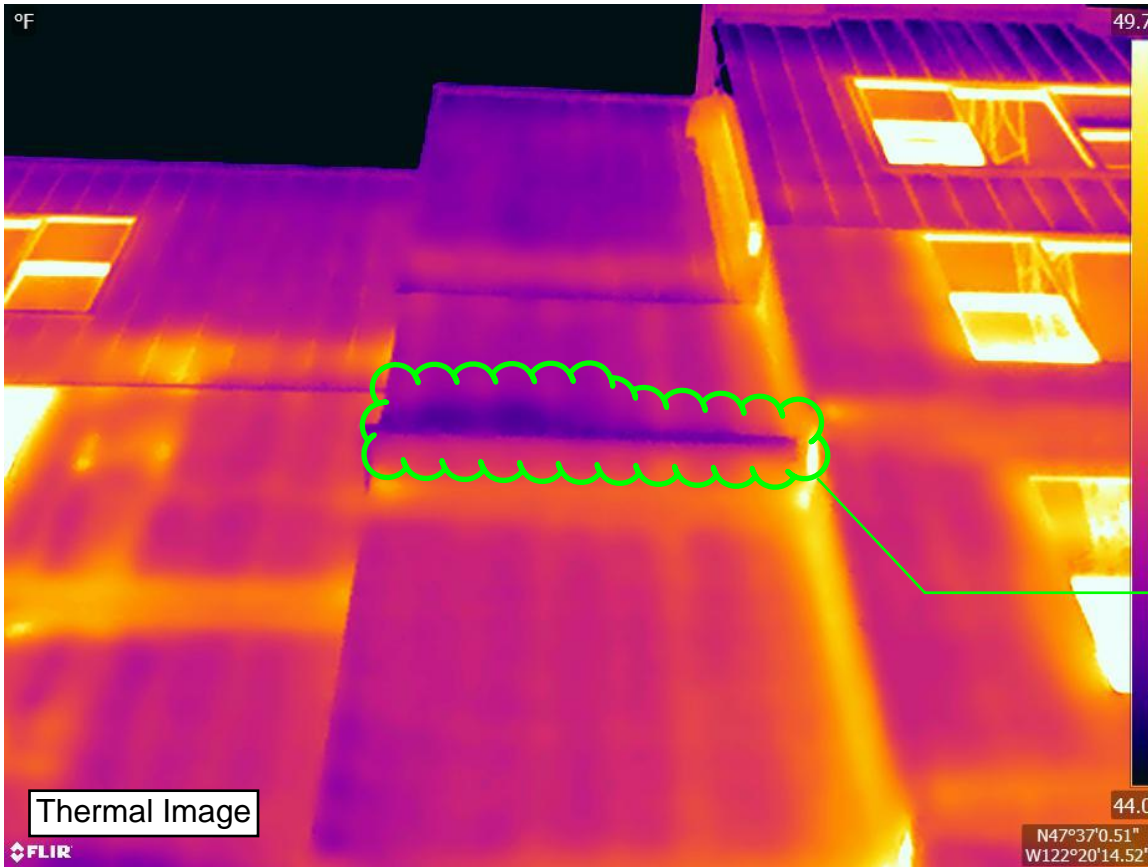
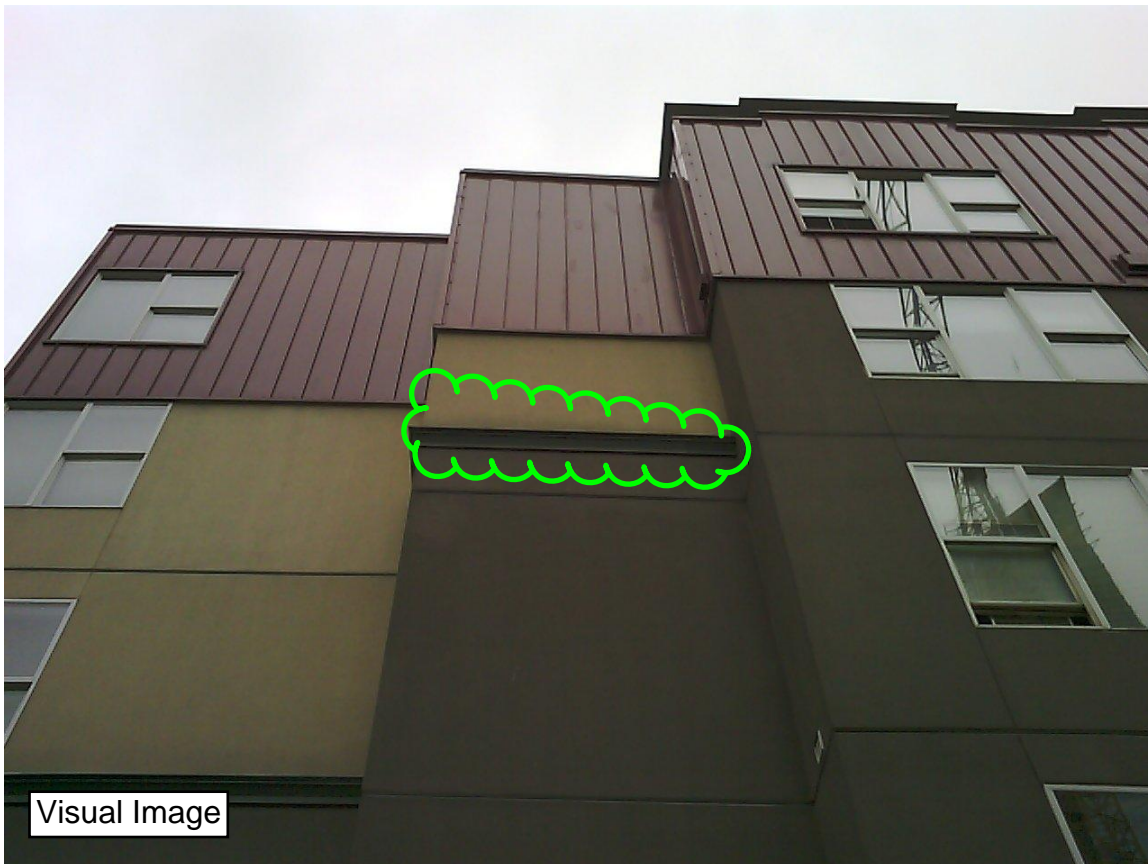
Observation #2

Location: East Wing, East
Elevation, Level 6

Thermal anomaly potentially
indicating higher moisture
content in stucco layer above
architectural trim relative to
adjacent areas.

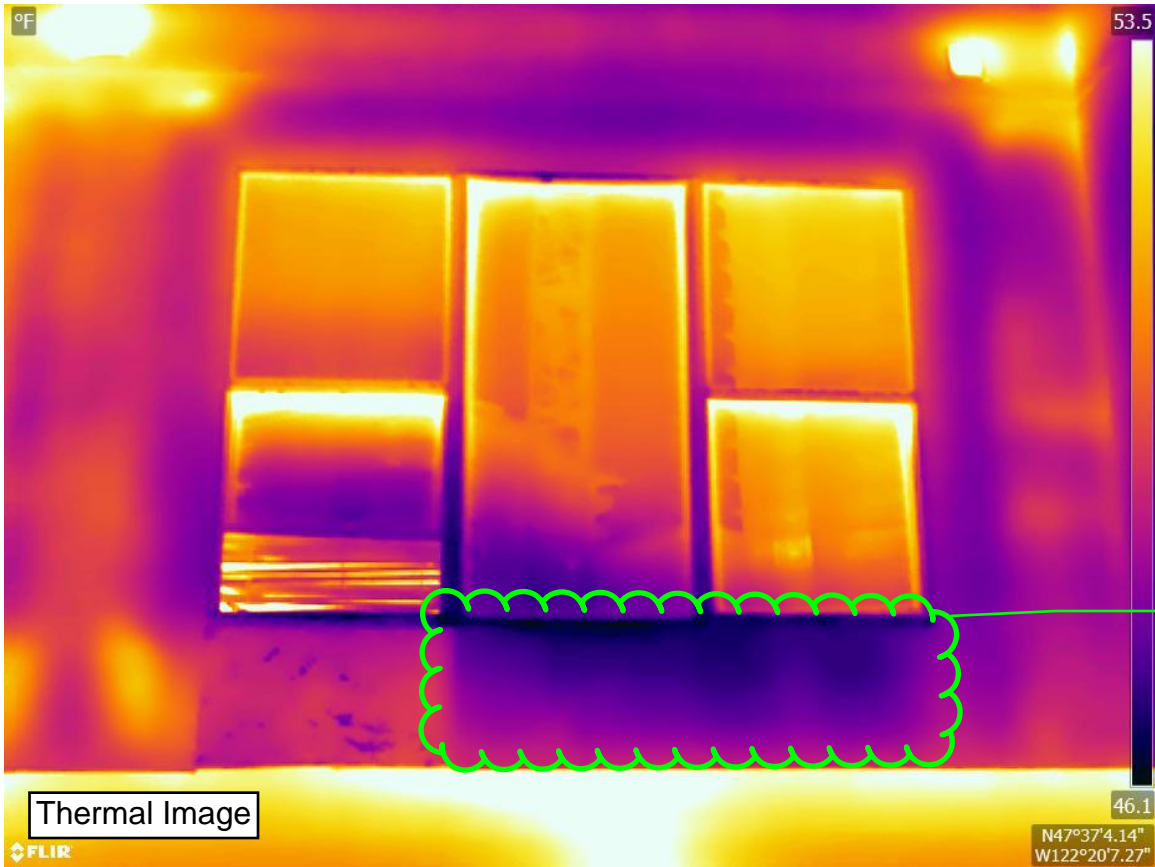
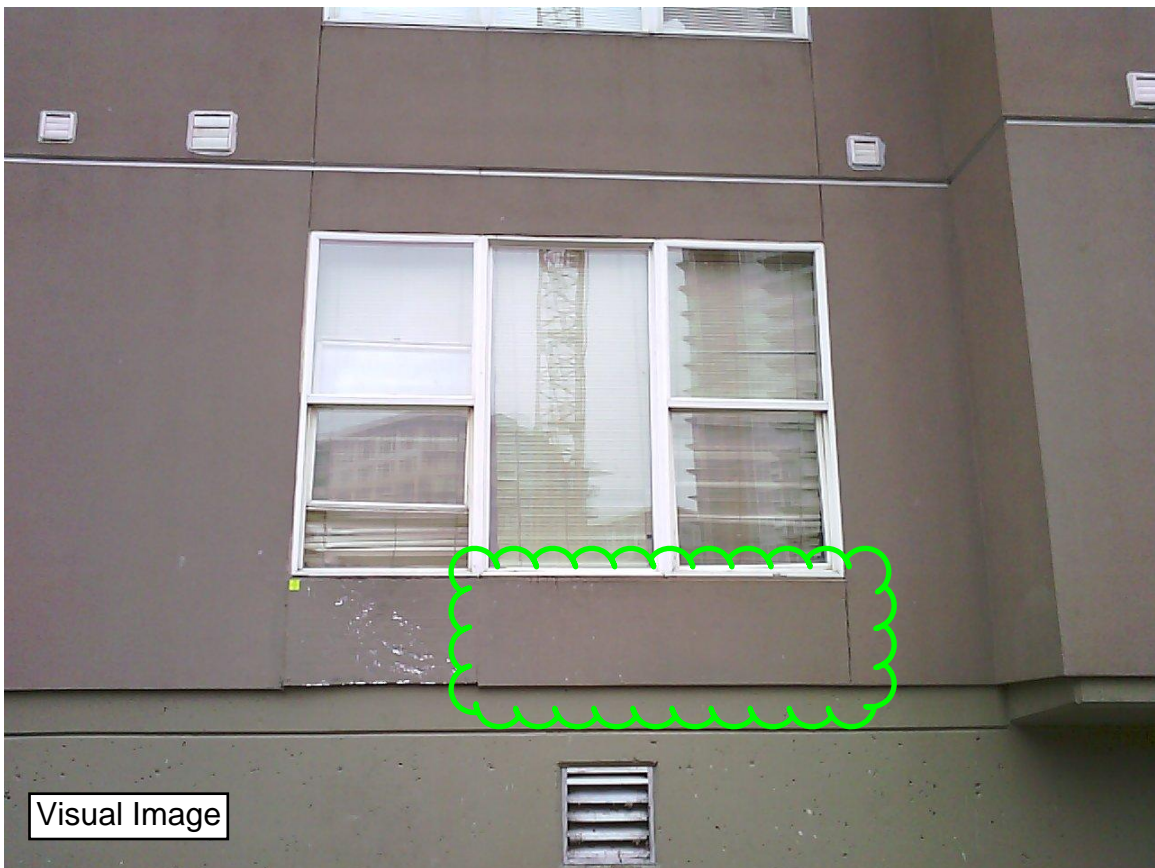
Observation #3

Location: East Wing, East
Elevation, Level 3

Thermal anomaly potentially
indicating higher moisture
content in stucco layer below
window sill relative to
adjacent areas.

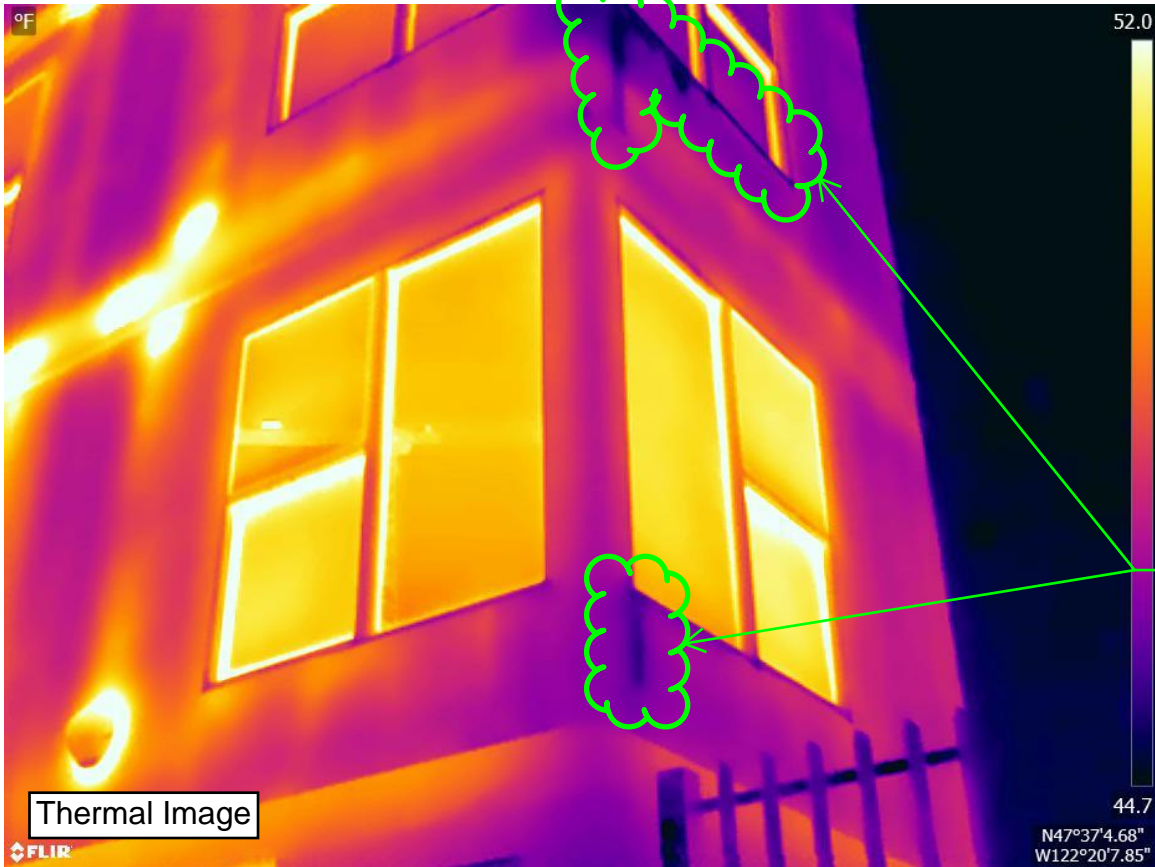
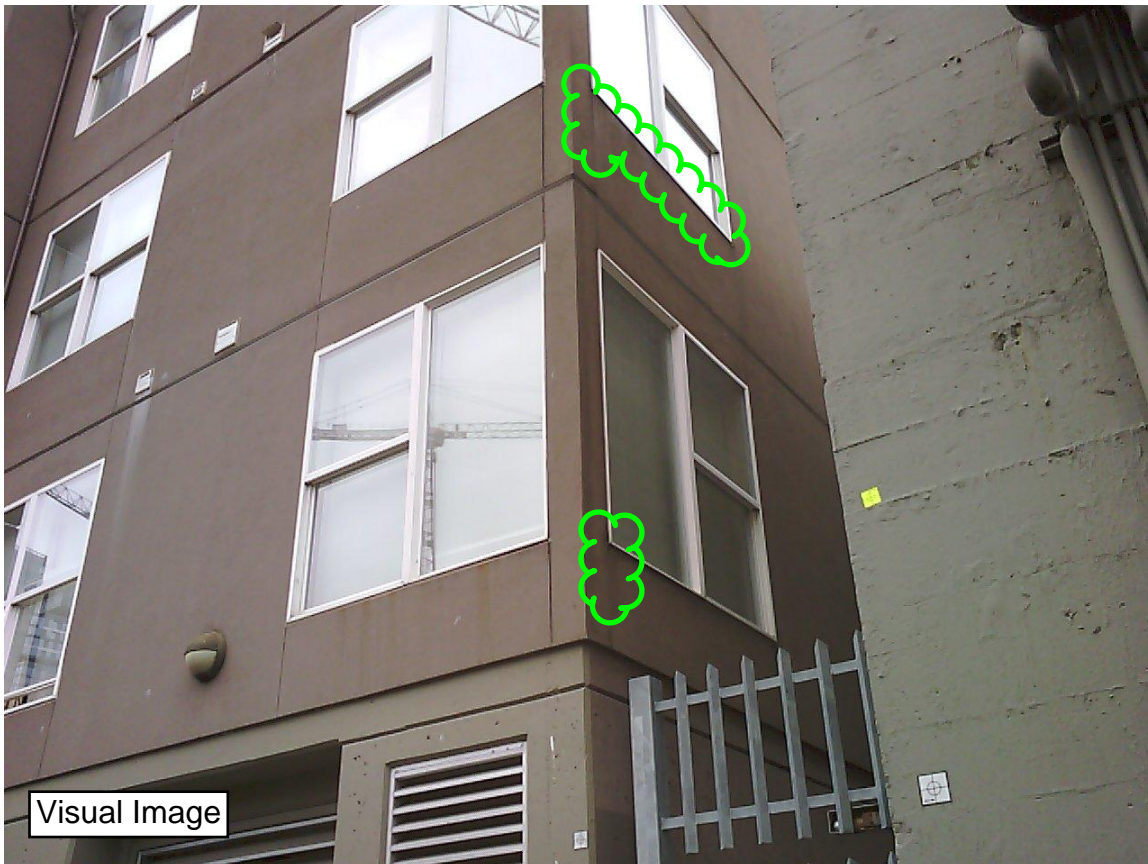
Observation #4

Location: East Wing, North
Elevation, East Corner,
Levels 3 and 4

Thermal anomalies
potentially indicating higher
moisture content in stucco
layer below window sill
relative to adjacent areas.

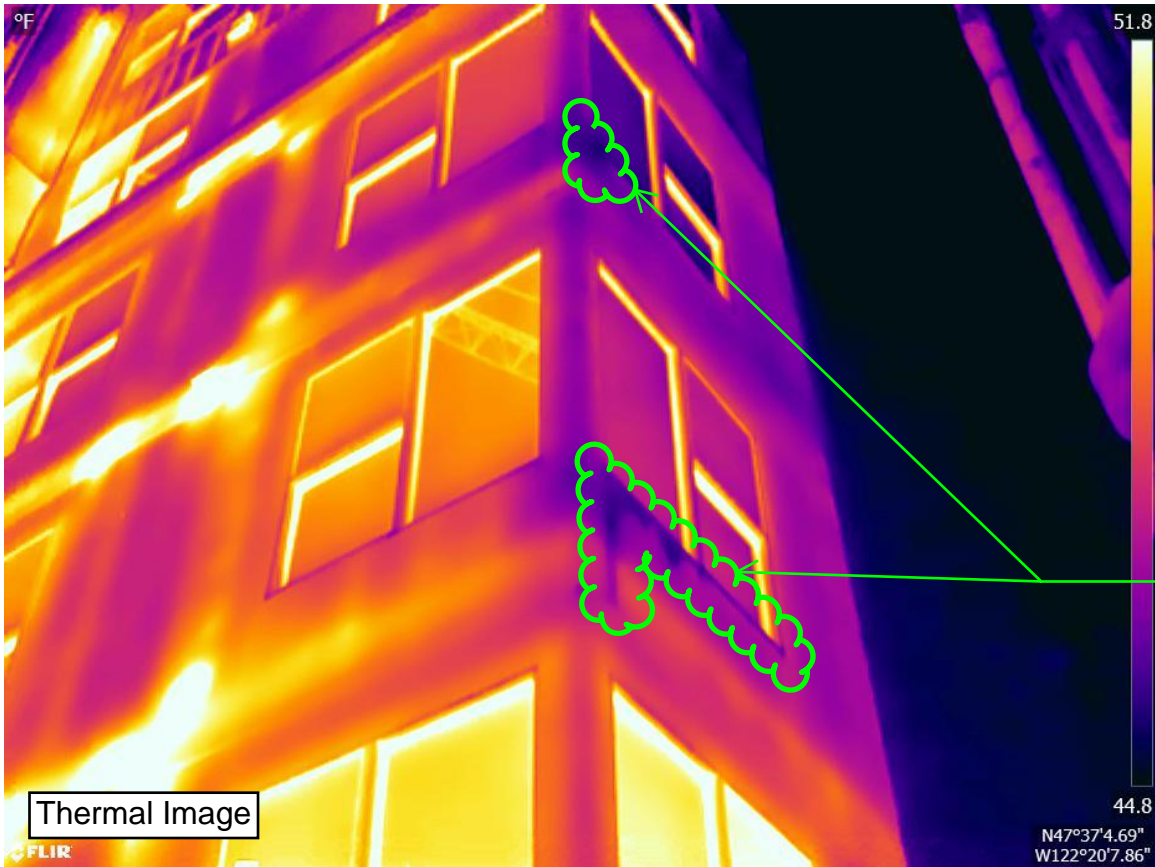
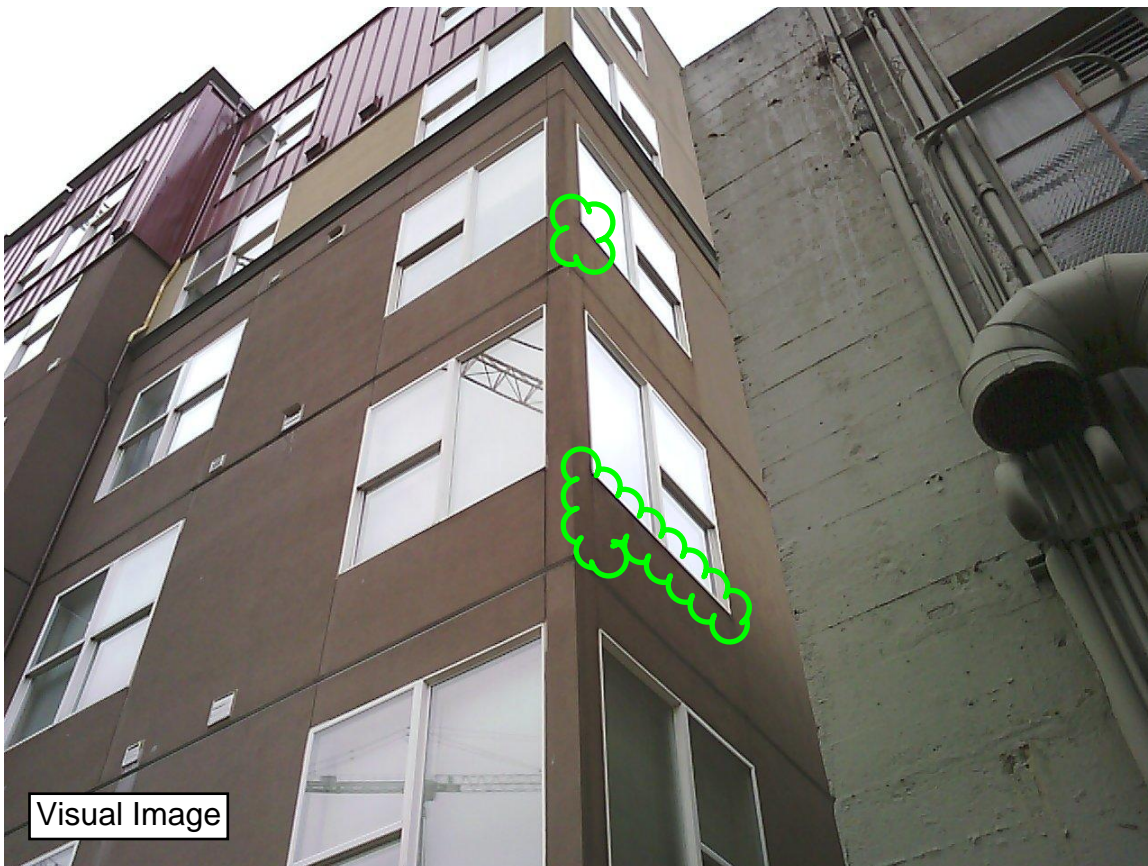
Observation #5

Location: East Wing, North
Elevation, East Corner,
Levels 4 and 5

Thermal anomalies potentially
indicating higher moisture
content in stucco layer below
window sill relative to
adjacent areas.

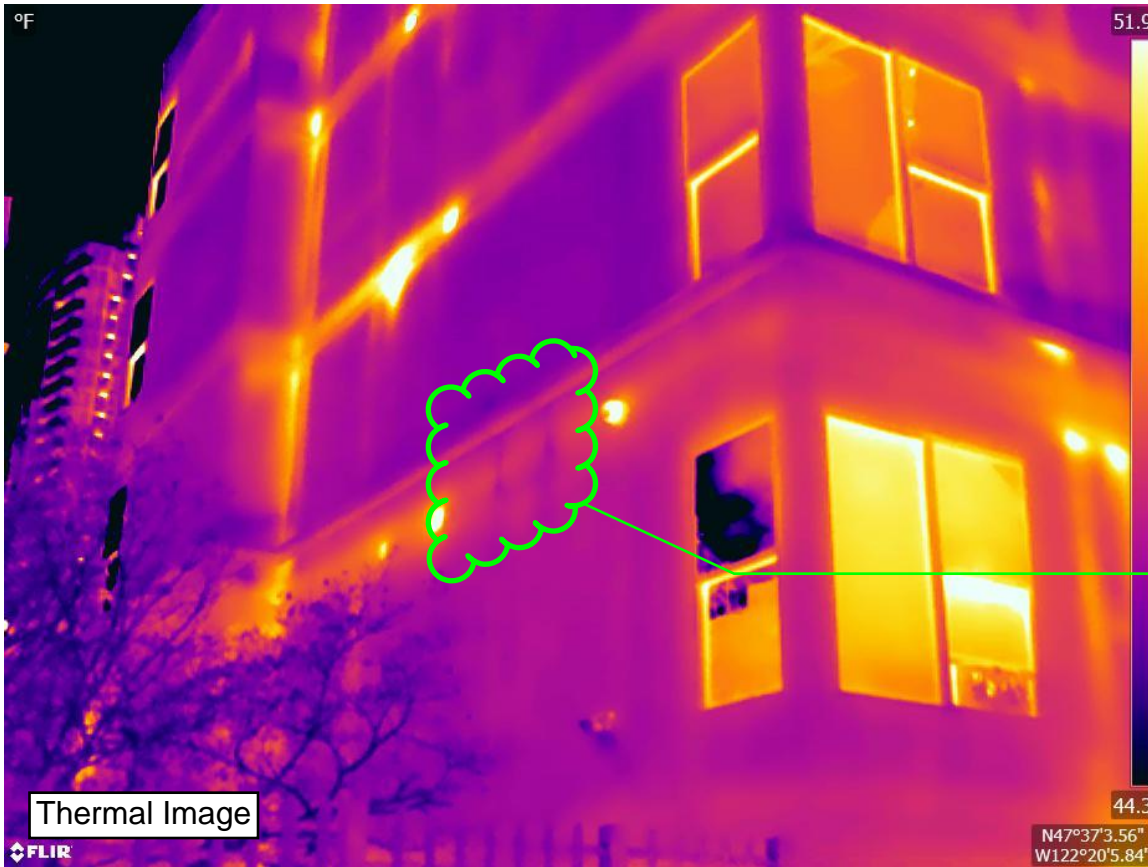
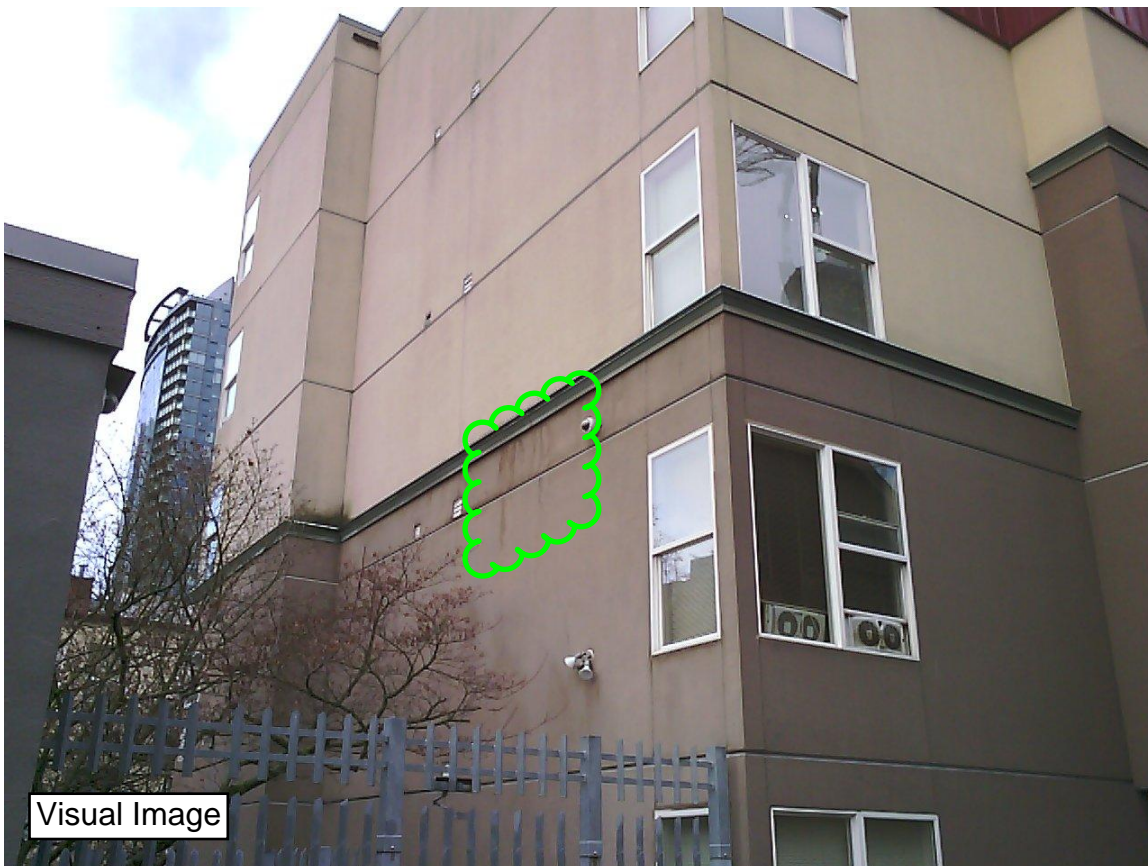
Observation #6

Location: East Wing, South
Elevation, East Corner,
Level 4

Thermal anomaly potentially
indicating higher moisture
content in stucco layer below
architectural trim relative to
adjacent areas.

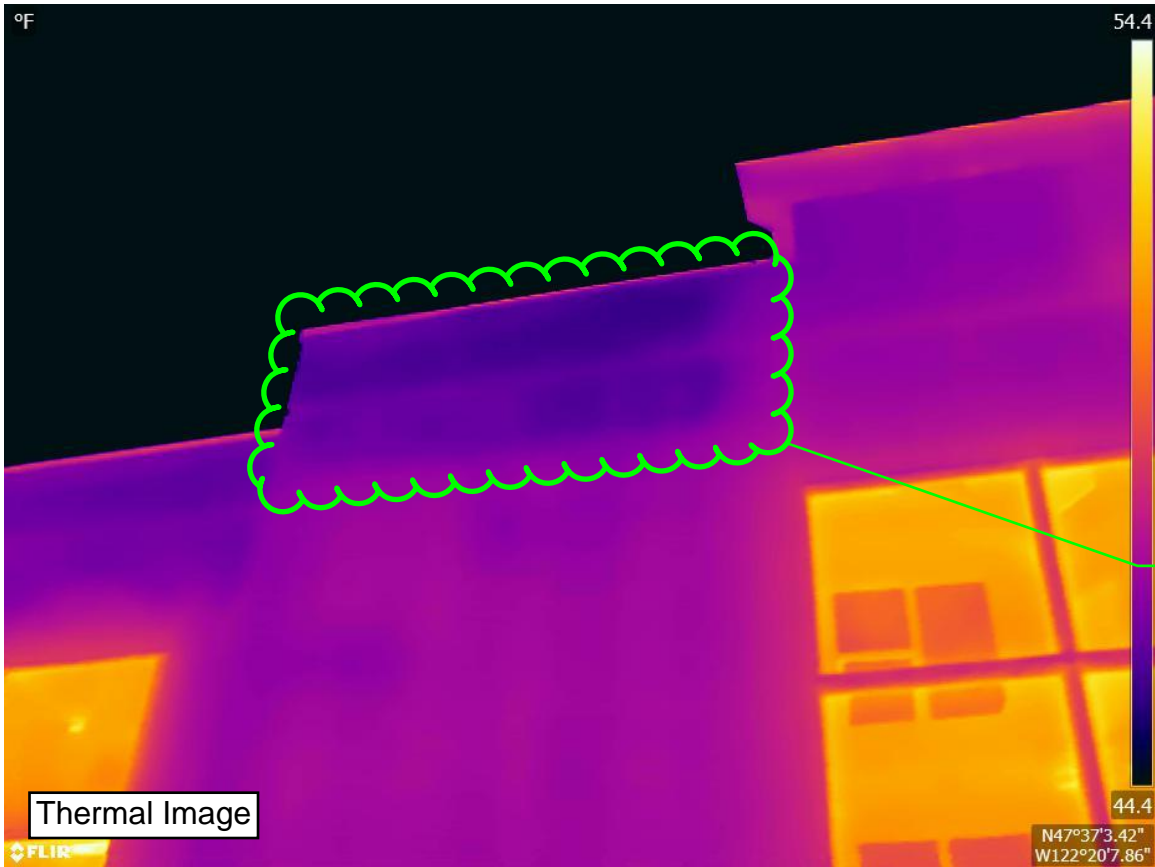
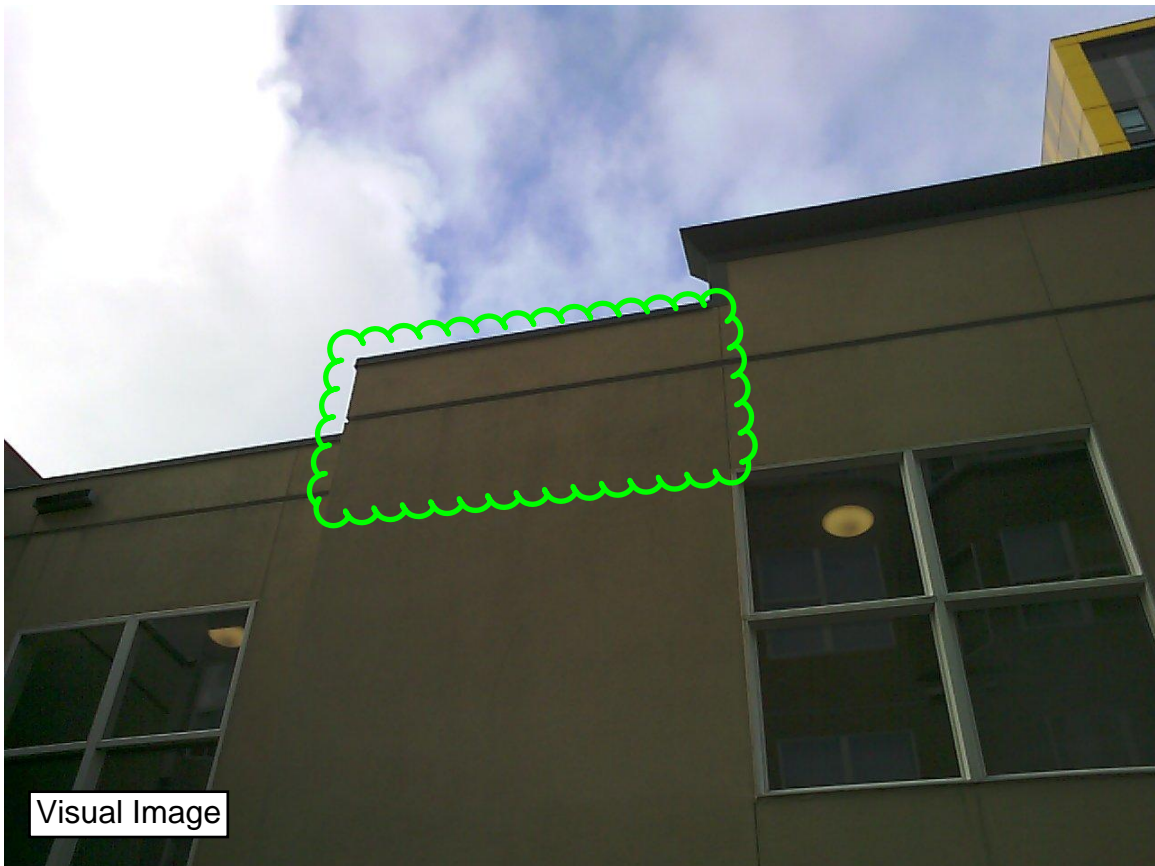
Observation #7

Location: West Wing, East
Elevation, Roof Level (South
Courtyard)

Thermal anomaly potentially
indicating higher moisture
content in stucco layer below
roof parapet relative to
adjacent areas.

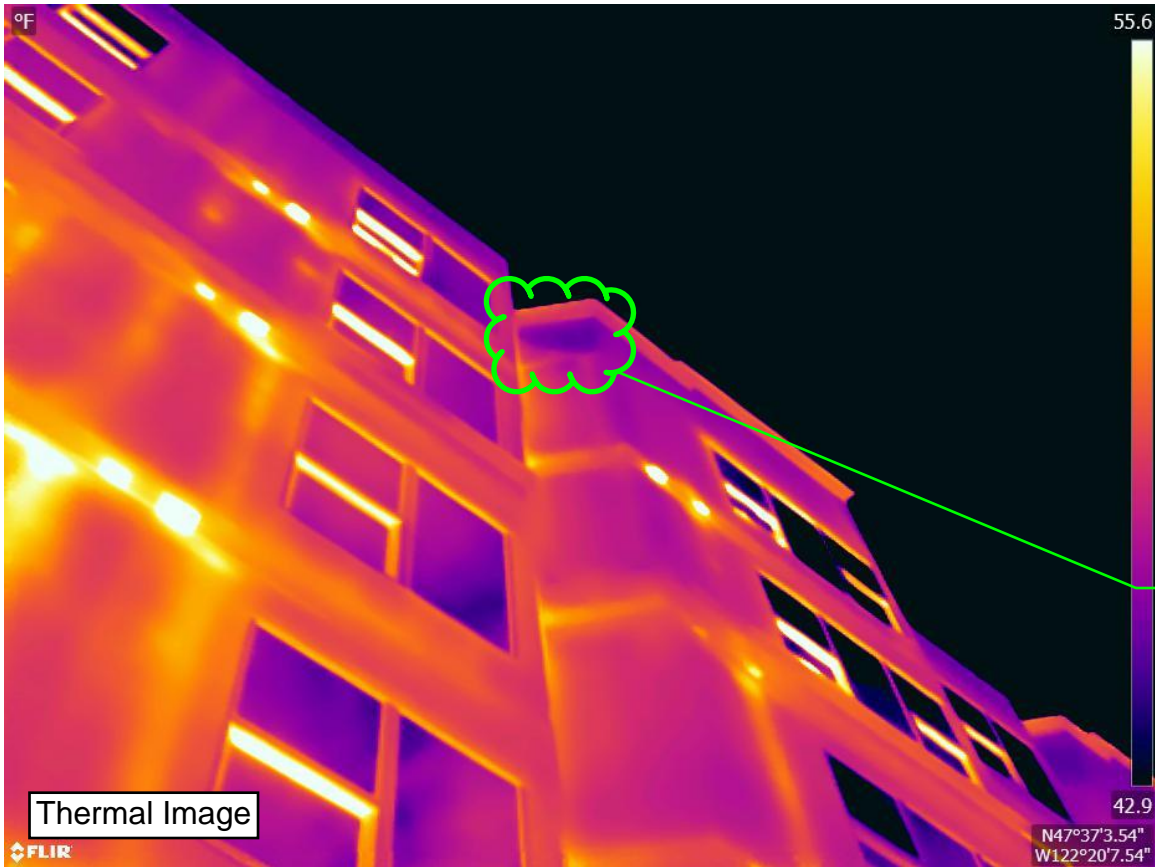
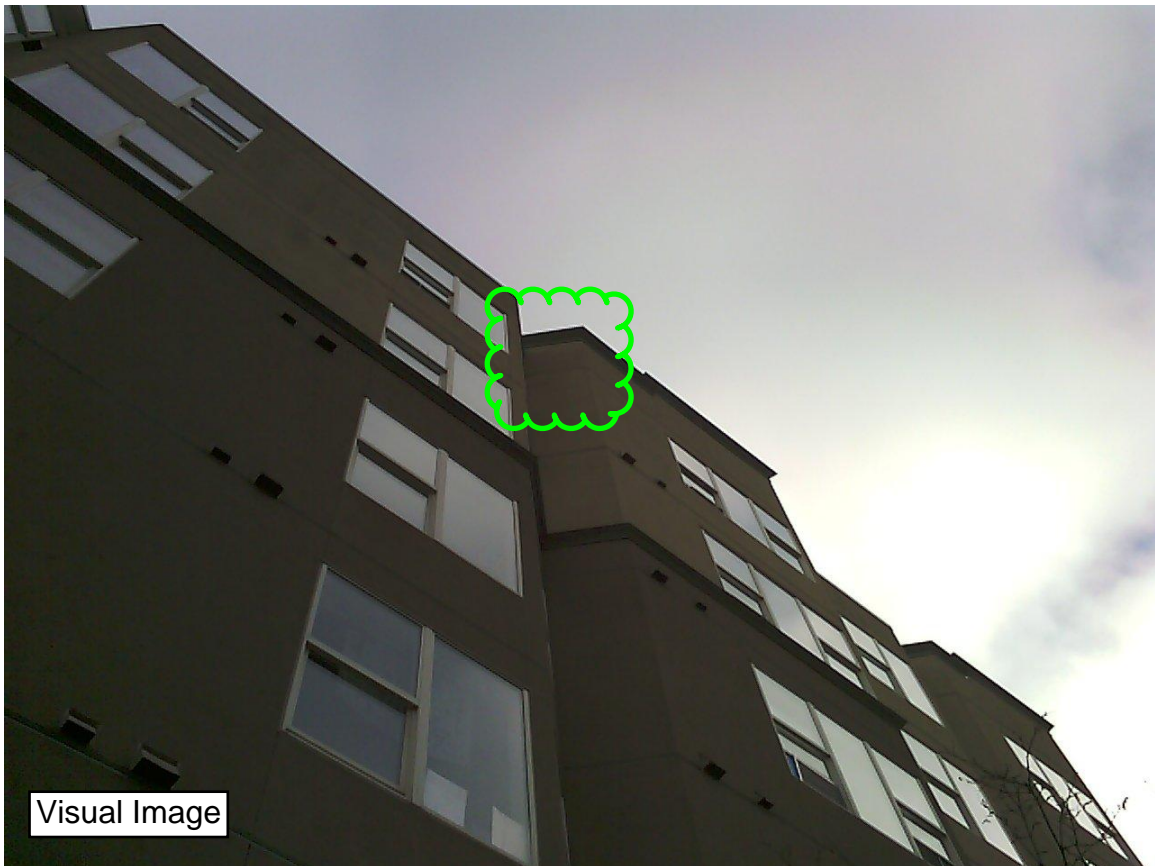
Observation #8

Location: East Wing, West
Elevation, Roof Level (South
Courtyard)

Thermal anomaly potentially
indicating higher moisture
content in stucco layer below
roof parapet relative to
adjacent areas.

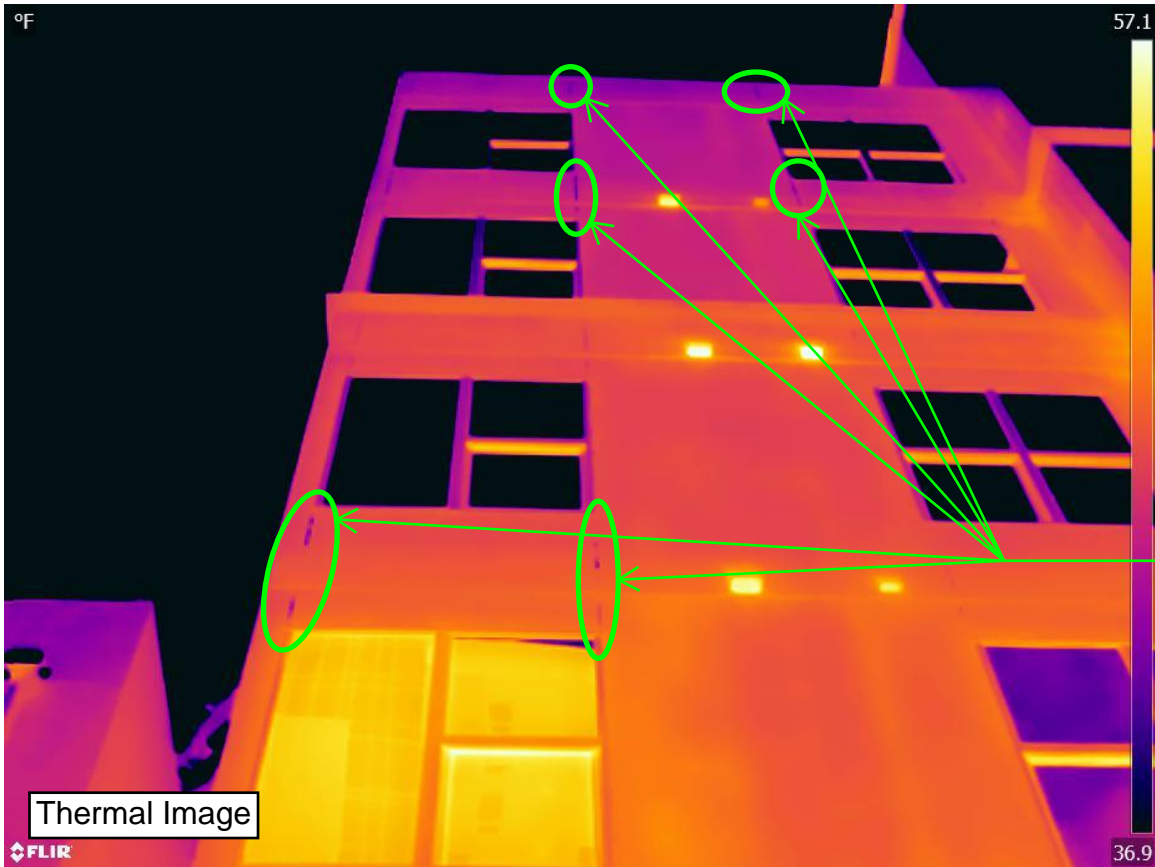
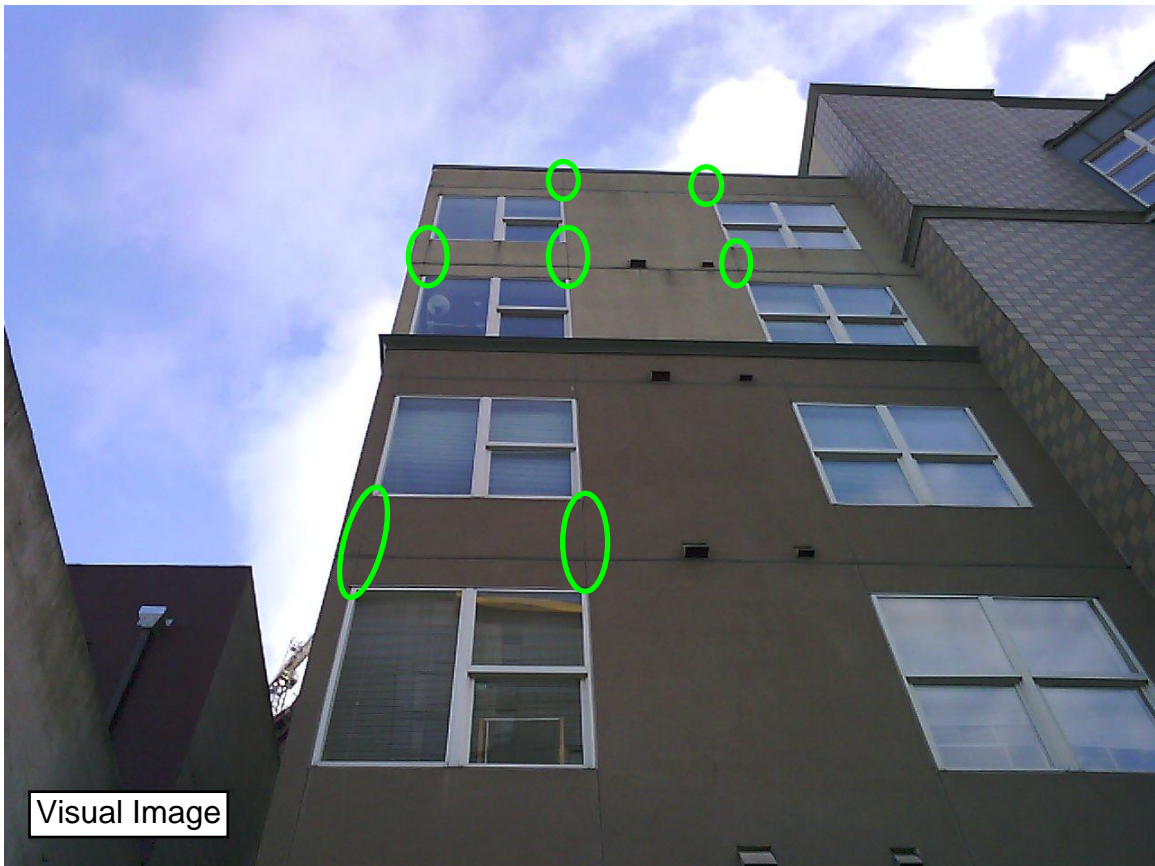
Observation #9

Location: East Wing, West
Elevation, Level 4 to Roof
Level (North Courtyard)

Thermal anomalies potentially
indicating higher moisture
content in stucco layer at
vertical control joints relative
to other vertical control joints.

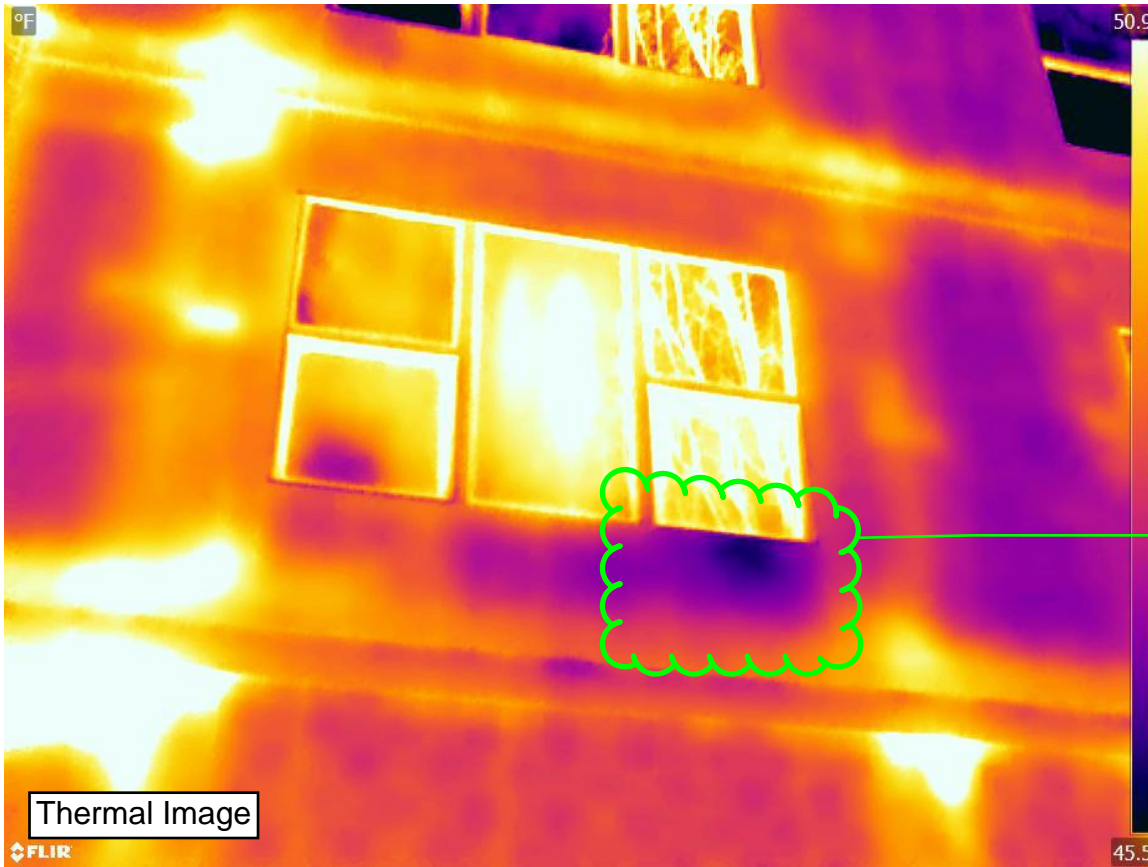
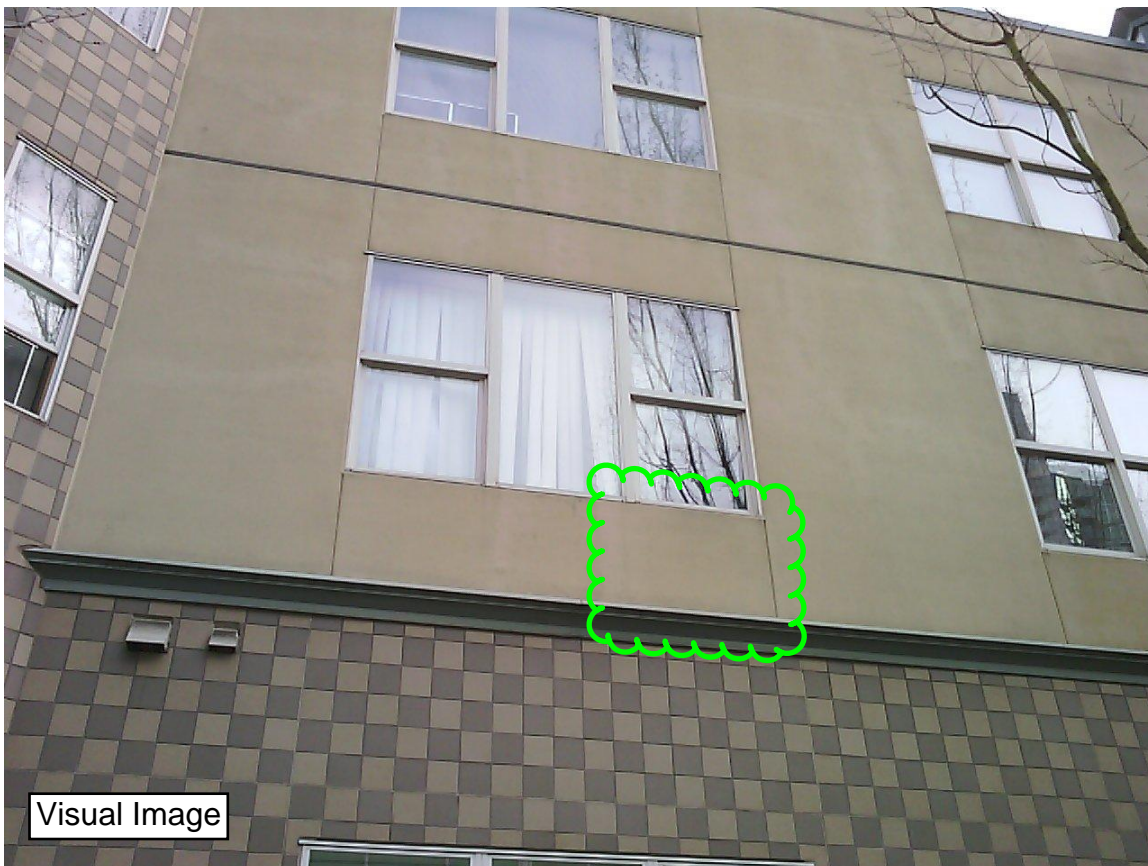
Observation #10

Location: West Wing, West
Elevation, Level 2

Thermal anomaly potentially
indicating higher moisture
content in stucco layer below
window sill relative to
adjacent areas.

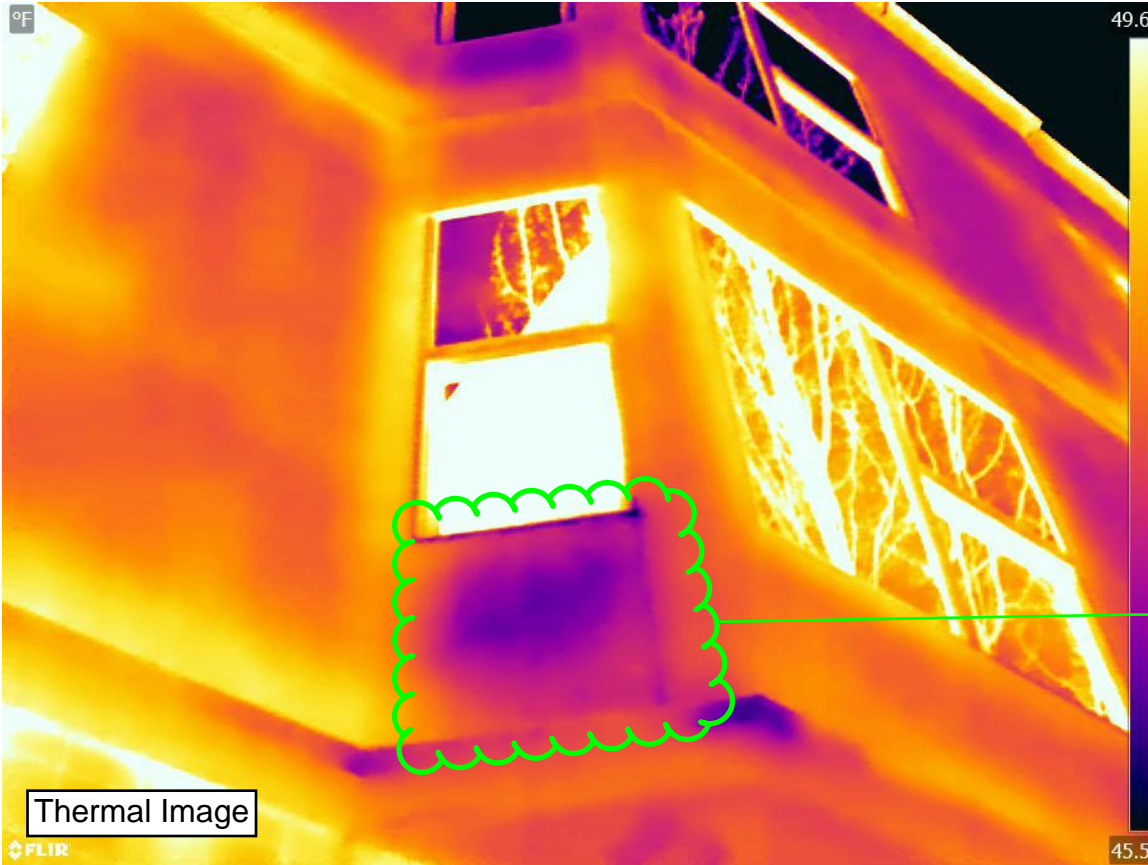
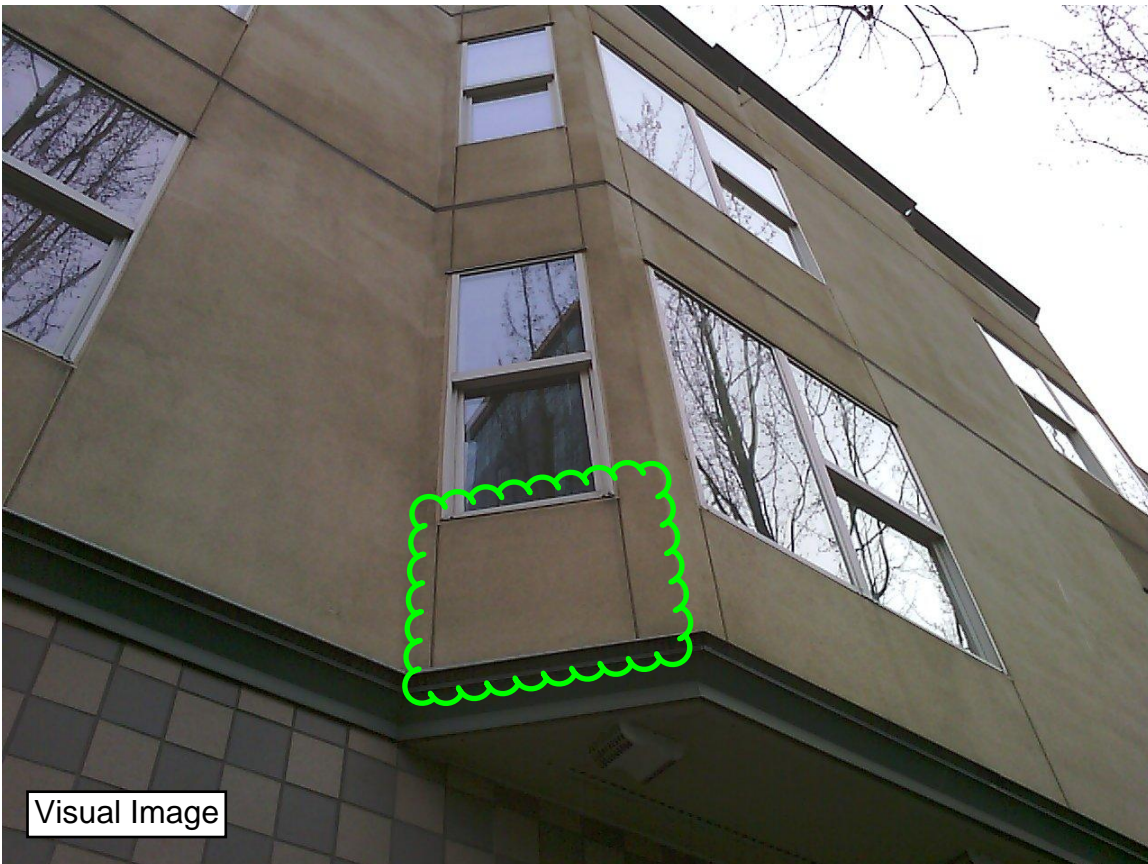
Observation #11

Location: West Wing, West
Elevation, Level 2

Thermal anomaly
potentially indicating
higher moisture content in
stucco layer below window
sill relative to adjacent
areas.
