SITE VISIT REPORT No. 1 | May 2, 2022

Ramova Theater

Facade Repairs

REPORT DATE	May 6, 2022	WJE PROJECT NO.	2020.1161.1
REPORTED BY	Amanda Marshall	WJE PROJECT MGR.	Rachel Will
OWNER/ CLIENT	Dan O'Riley O'Riley Office 1516 South Wabash Avenue, Unit 1002Chicago, Illinois 60605	CONTRACTOR/ PROJECT NO.	James McHugh Construction (McHugh)
PRESENT AT SITE	Amanda Marshall (WJE) Eamonn Connolly (McHugh) Dan O'Riley (O'Riley Office) Vatsal Desai (Baum Revision)	DISTRIBUTION	Rachel Will (WJE) Nicole Declat (WJE) Amanda Marshall (WJE) Jennifer Gee (McHugh) Eamonn Connolly (McHugh) Dan O'Riley (O'Riley Office) Vatsal Desai (Baum Revision)

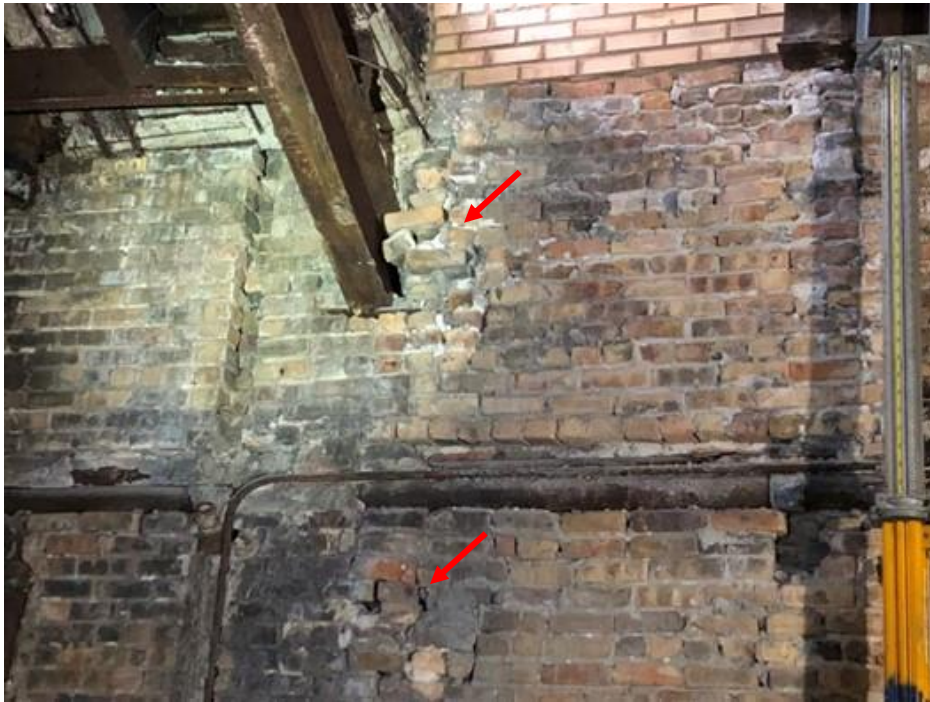
Item No.	Description	Action Required by
1	<p>Embedded Steel: WJE reviewed the condition of the brick masonry at areas adjacent to embedded steel elements, such as girders, conduit, and drain leaders. WJE observed deteriorated mortar joints, cracked and displaced brick masonry adjacent to embedded steel (Figure 1).</p> <p><i>Action: MBB to sound areas of brick masonry adjacent to existing embedded steel. MBB will remove and replace unsound masonry. MBB to notify WJE if large repair areas or multi-wythe repairs are required.</i></p>	MBB

Figure 1. View of distressed masonry adjacent to embedded steel (arrows)

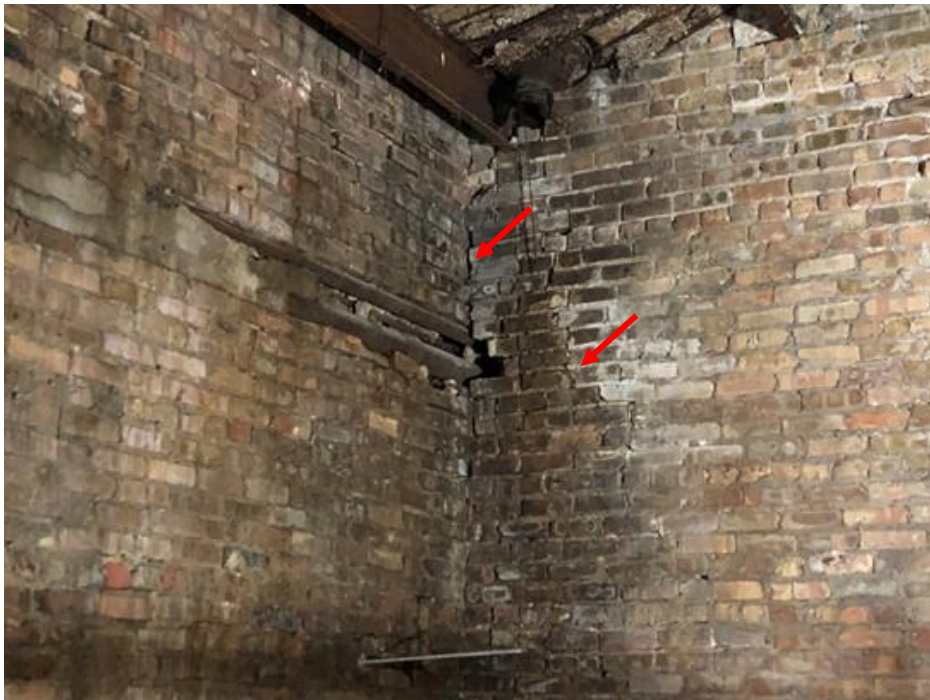
Item No.	Description	Action Required by
2	<p>Interior Masonry at Southwest Corner: WJE reviewed the masonry at the interior side of the exterior wall at the southwest corner of the building. WJE observed a stepped crack of approximately 1/16 inch wide extending vertically from the roof deck to the head of the new door opening at the ground floor (Figure 2).</p> <p><i>Action: McHugh will verify if the existing roof drain leader will be used after roof repairs take place. MBB to sound the full height of the corner. MBB will remove and replace unsound masonry. MBB to notify WJE if large repair areas or multi-wythe repairs are needed.</i></p>	McHugh/ MBB
3	<p>Center Pier at West Wall: WJE reviewed the center pier at the interior side of the west exterior wall. WJE observed vertical cracks of approximately 1/8 inch wide, deteriorated mortar joints, efflorescence, and outward displacement of the brick masonry, as well as corrosion of the steel column (Figure 3). Cracked and displaced brick masonry was concentrated at the lower 5 feet of the pier, and deteriorated mortar joints and isolated efflorescence the full height of the pier (Figure 4).</p> <p><i>Action: McHugh or MBB will remove the lower 5 feet of brick masonry that surrounds the column and remove corrosion scale from the surface of the column, and paint. MBB to notify WJE and McHugh of loss of cross-sectional area of the steel. MBB and McHugh to notify WJE when brick has been removed and steel cleaned and painted for review or if additional brick masonry needs to be removed.</i></p>	McHugh/ MBB

Figure 2. View of cracking at southwest corner (arrows)

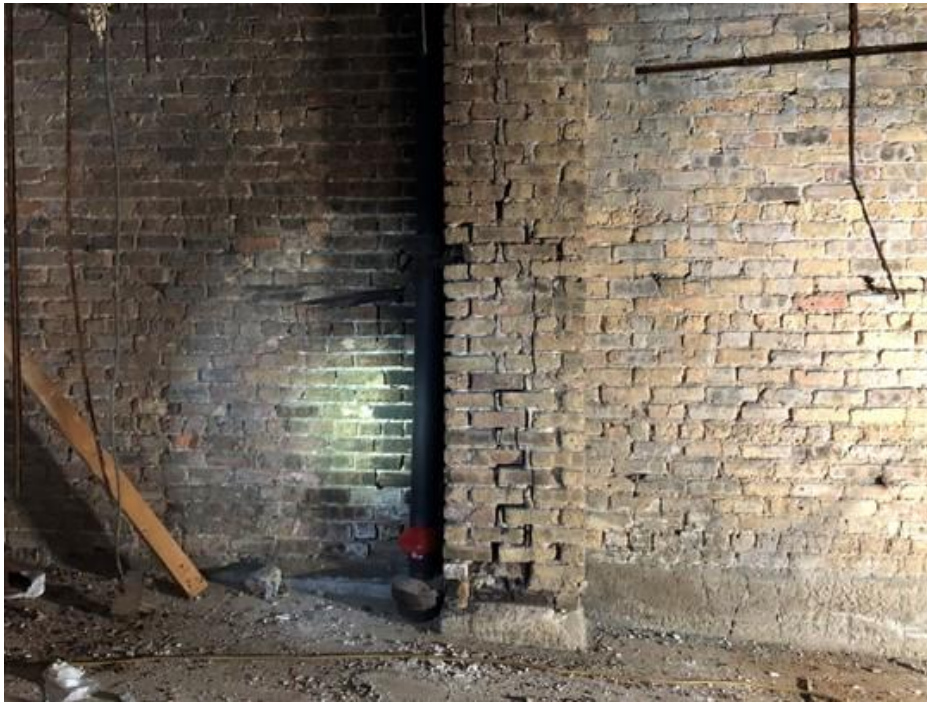
Figure 3. View of distress at the lower 5 feet of the center pier

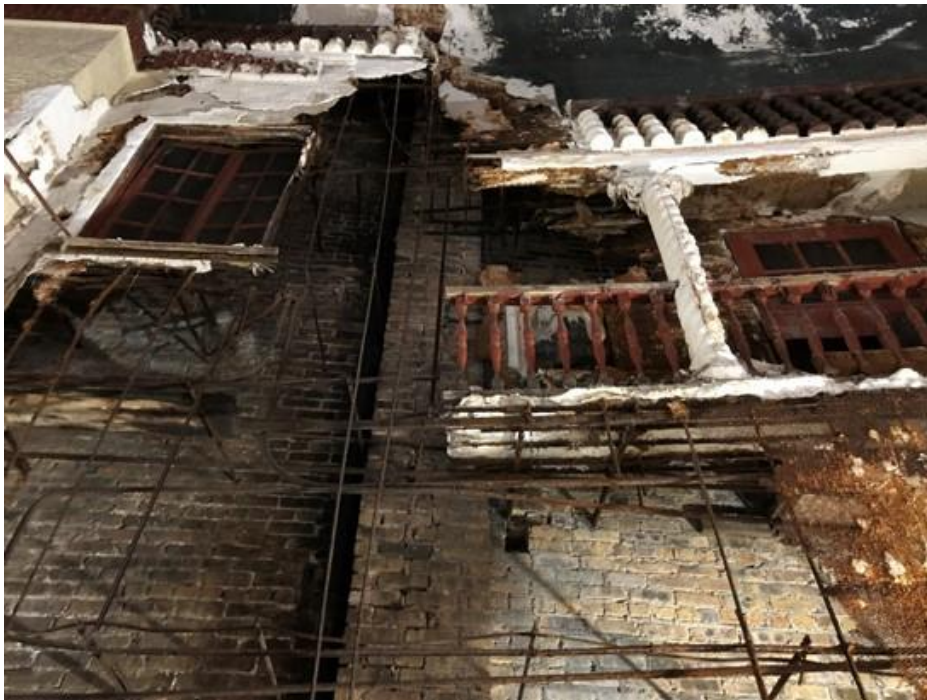
Figure 4. View of upper portion of the center pier

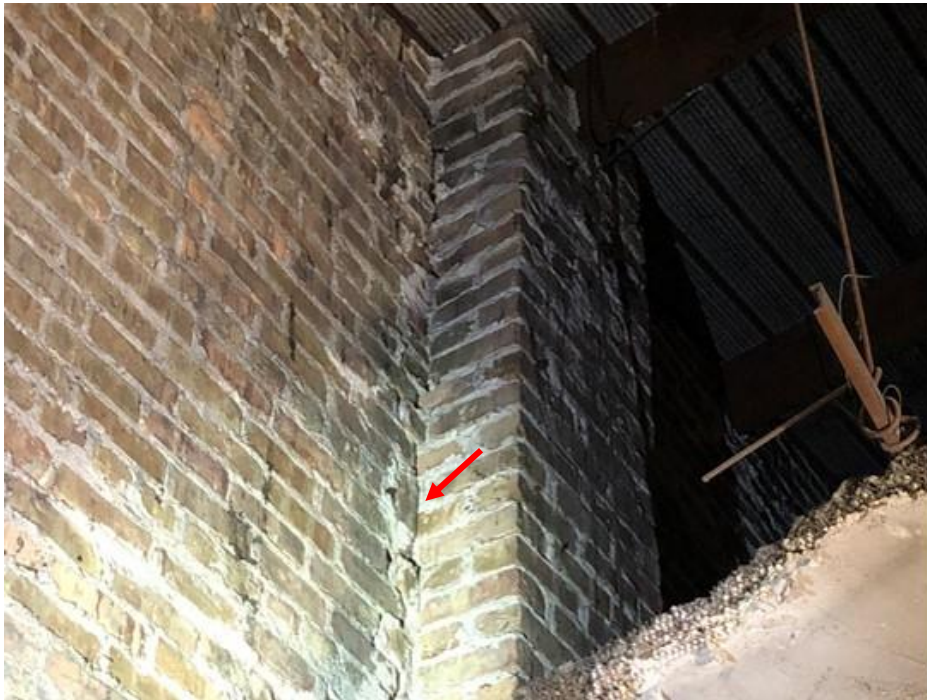
4	<p>South Pier at West Wall: WJE reviewed the southernmost pier at the interior side of the west exterior wall. WJE observed that a narrow (1/32 inch wide) gap was present at the wall to pier interface (Figure 5). WJE determined that no repairs are necessary at the pier.</p>	N/A
5	<p>North and South Facade Repointing: WJE reviewed the repointing work in progress being completed by MBB. Areas on the north and south facade are being repointed per WJE's drawings and field inspections (Figure 6).</p>	N/A
6	<p>New Steel Lintels: MBB reported that three new steel lintels were ordered for new door openings on the south facade of the building. MBB noted that the new steel lintels are not Hot-Dip Galvanized lintels, as specified in WJE's project bid documents.</p> <p><i>Action: In addition to the shop primer, MBB to apply two coats of Tnemec Series 135 coating to all new steel lintels that are not Hot-Dip Galvanized.</i></p>	MBB

Figure 5. View of gap at pier to wall interface at south pier (arrow)

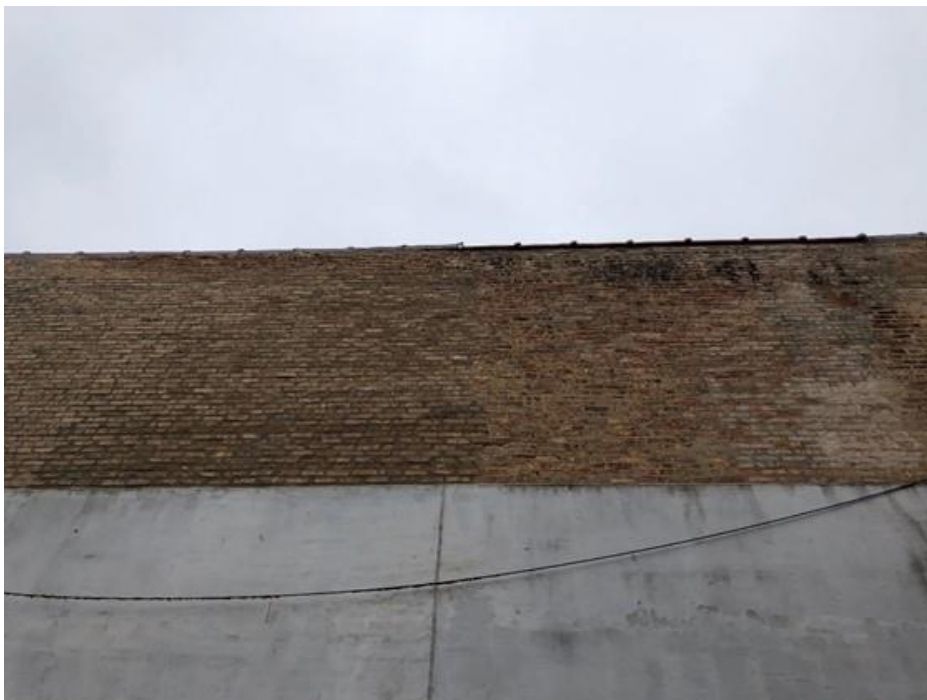
Figure 6. View of south facade

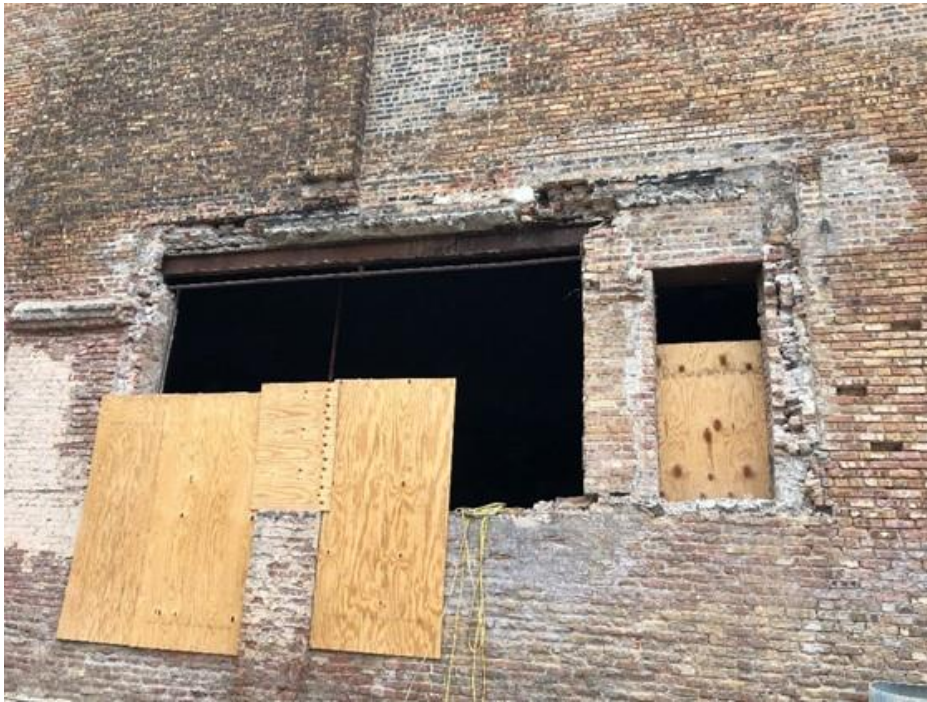
Item No.	Description	Action Required by
7	<p>New Masonry Infill at North Theater Facade: WJE reviewed the wall opening at the north facade of the theater (Figure 7), where Alpine had removed the projecting bay. WJE, McHugh, Baum, and O'Riley discussed options for infilling the opening at the masonry wall. Baum noted that fragments of concrete and rebar from the demolished theater projecting bay remained above the opening.</p> <p><i>Action: Alpine to remove the remaining concrete roof slab and rebar from the previous projection. WJE, McHugh, Baum, and O'Riley will discuss repair options at the next on-site meeting. It is anticipated the infill will consist of multi-wythe masonry (four wythe header bonded brick masonry or brick and CMU toothed into the surrounding existing brick masonry).</i></p>	WJE/ Baum/ McHugh/ O'Riley/ Alpine
8	<p>Bridgeport News Building Corbeled Chimney: WJE reviewed the corbeled masonry chimney at the west end of the Bridgeport News Building. The outer 8 to 10 inches of the chimney is supporting an existing steel beam to remain (Figure 8). WJE, McHugh, Baum, and O'Riley discussed in-situ repair options for the beam and the chimney.</p> <p><i>Action: McHugh will review and document the bearing condition of the beam and the masonry to confirm that the corbeled masonry is a chimney. WJE, McHugh, Baum, and O'Riley will discuss repair options at the next on-site meeting following completion of McHugh's initial assessment.</i></p>	WJE/ Baum/ McHugh/ O'Riley

Figure 7. View of openings at north facade of theater

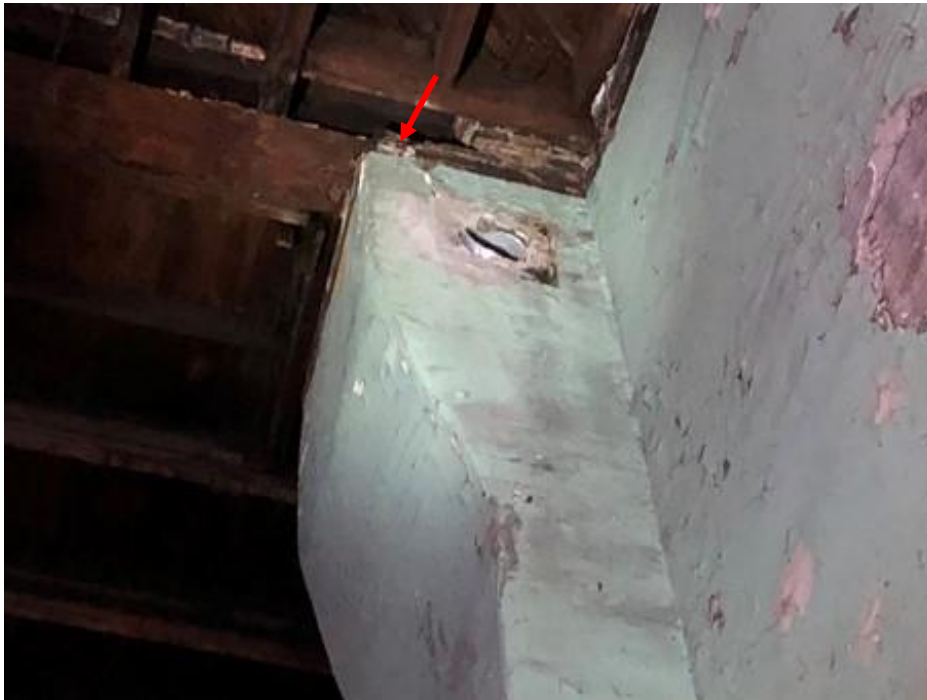
Figure 8. View of steel beam bearing on corbeled masonry chimney (arrow)

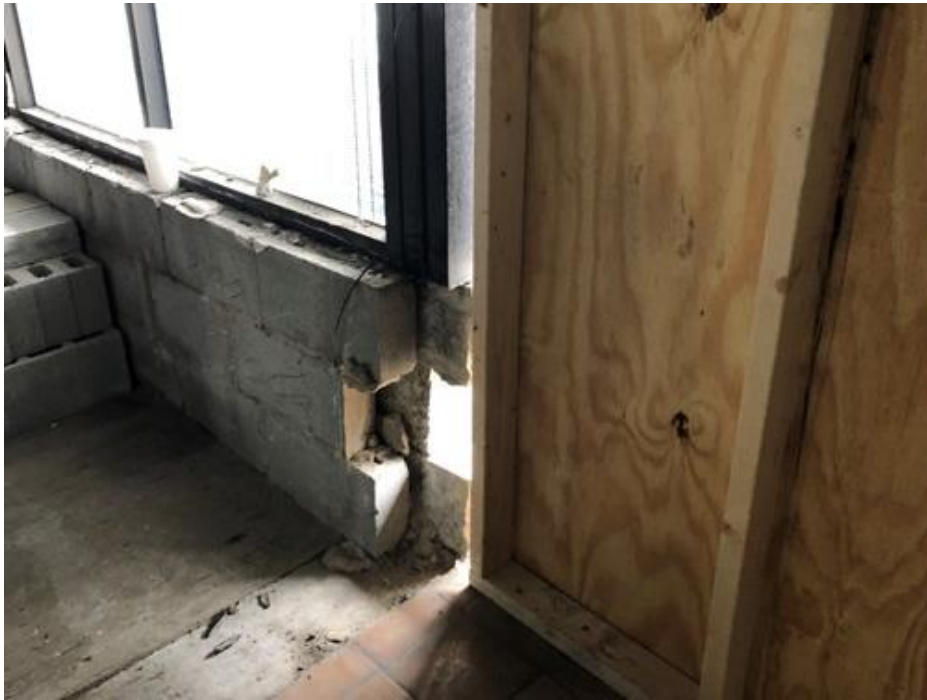
9	<p>New Limestone Knee Wall at Bridgeport News Building: WJE reviewed the area at the east facade of the Bridgeport News Building where an existing storefront door system had been removed to accommodate a new limestone knee wall with a concrete block backup and a new storefront window system (Figure 9). McHugh noted that the existing tile floor will be removed prior to installation of the new limestone wall system. McHugh reported that the new wall would not be flashed or waterproofed. WJE has prepared the proposed detail for the construction of the limestone clad knee wall including the installation of flashing and waterproofing membrane, as well as anchors and interface detailing for the new wall with the existing wall (Figure 10).</p>	WJE

Figure 9. View of opening for new limestone knee wall
