Report: E 1105 & E 783 Testing

MN12033300 (610)
Kellen Research Building

9.6.2023

PROJECT NAME: KELLEN RESEARCH BUILDING
PROJECT NUMBER: MN12033300 (610)
LOCATION: ROCHESTER, MN

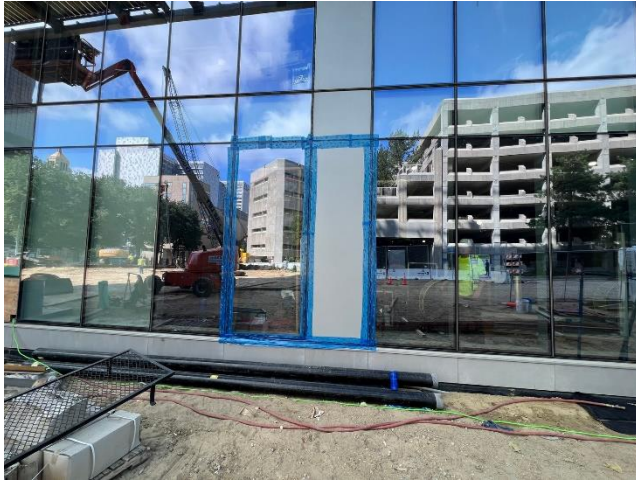
Photo 1 – Specimen 4, masked.

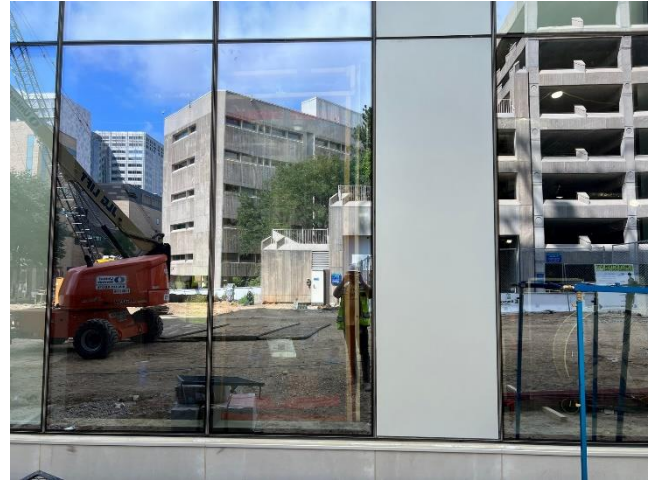
Photo 2 - Specimen 4 – No masking.

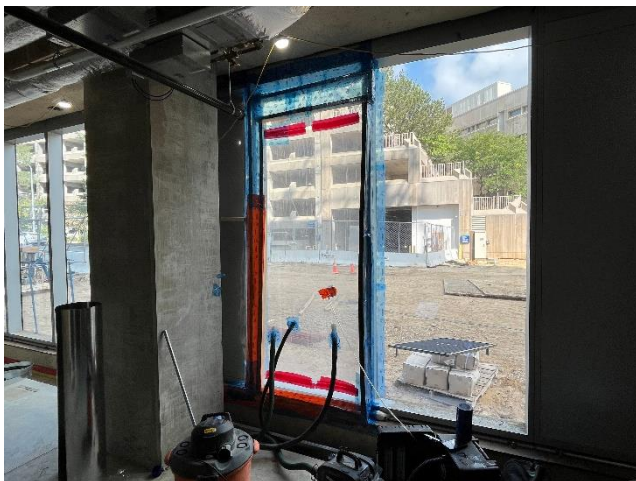
Photo 3 – Specimen 4, interior view of test chamber.

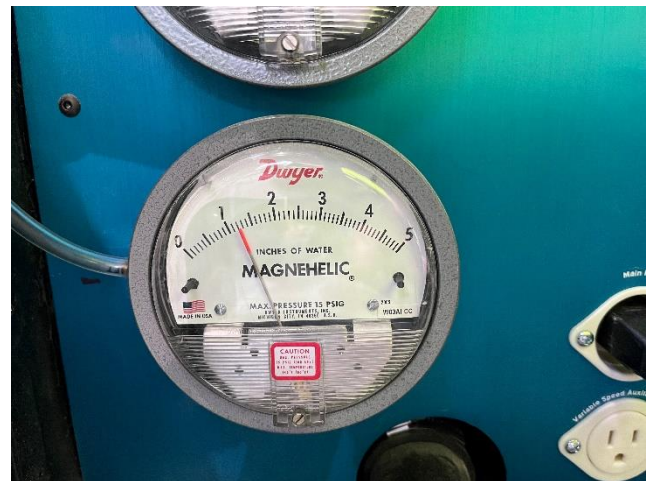
Photo 4 – Specimen 4 – Interior test chamber pressure at 1.2 in Aq.

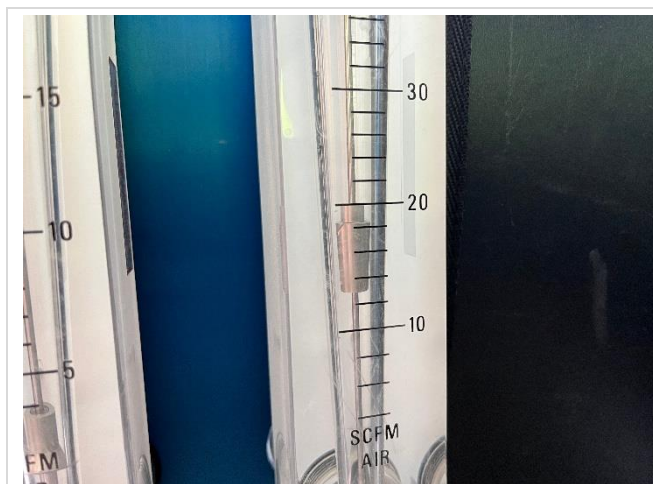
Photo 5 – Specimen 4 airflow reading at 18 CFM, masked.

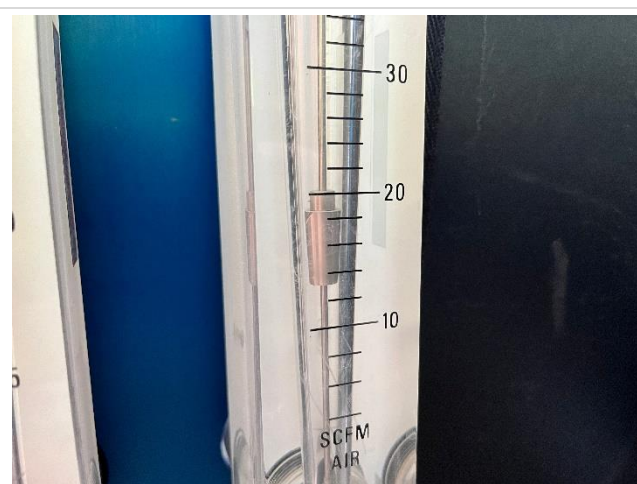
Photo 6 – Specimen 4 airflow reading at 18 CFM, no masking.

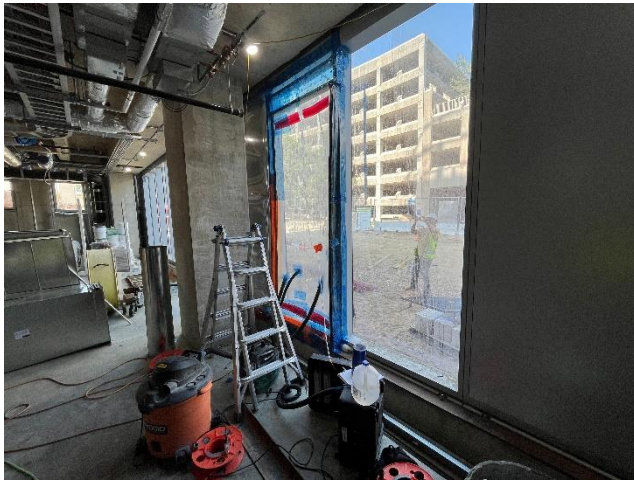
Photo 7 – Specimen 4, interior chamber setup.

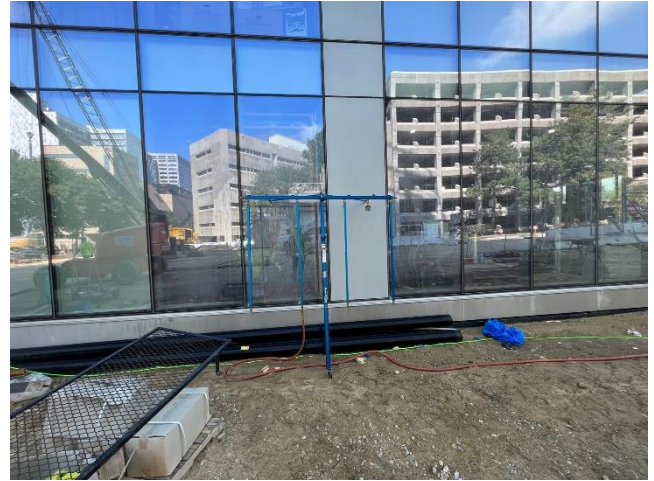
Photo 8 – Specimen 4, spray rack positioning at bottom of test area.

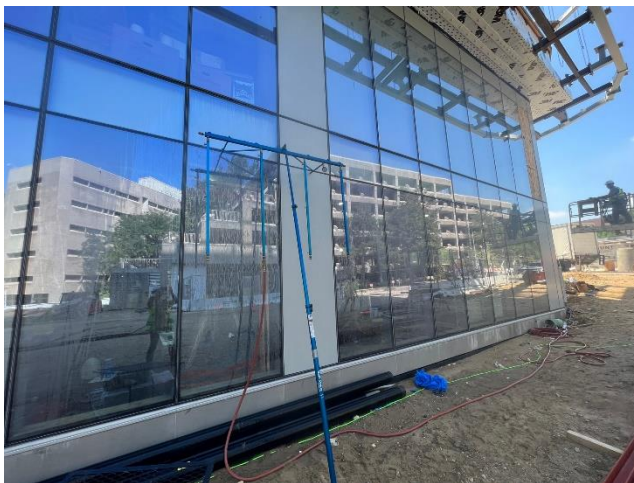
Photo 9 – Specimen 4, spray rack positioning at top of test area.

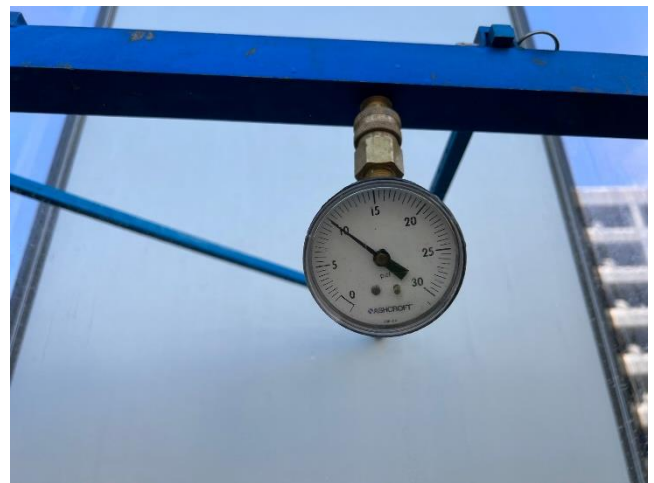
Photo 10 – Specimen 4, spray rack pressure at 10 psi.

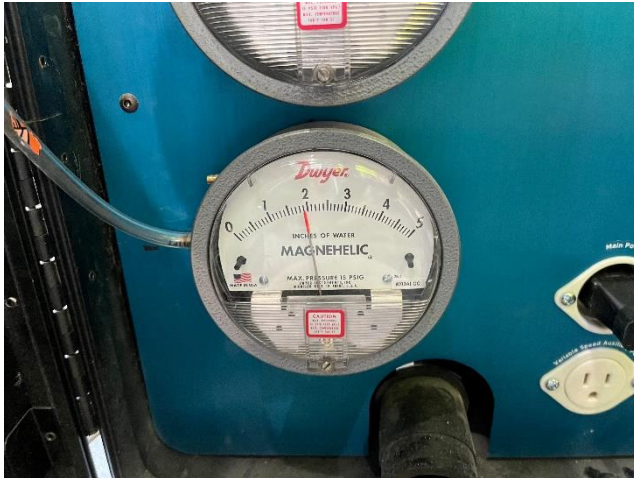
Photo 11 – Specimen 4, interior chamber pressure at 1.9 in Aq.

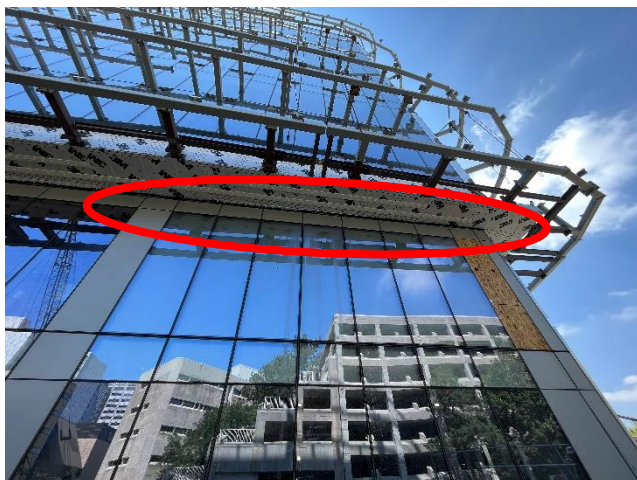
Photo 12 – Test Specimen 5 test area.

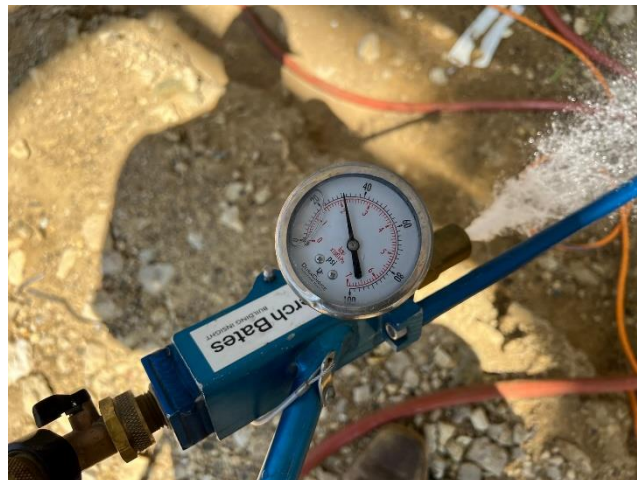
Photo 13 – Typical spray wand water pressure at 30 psi.

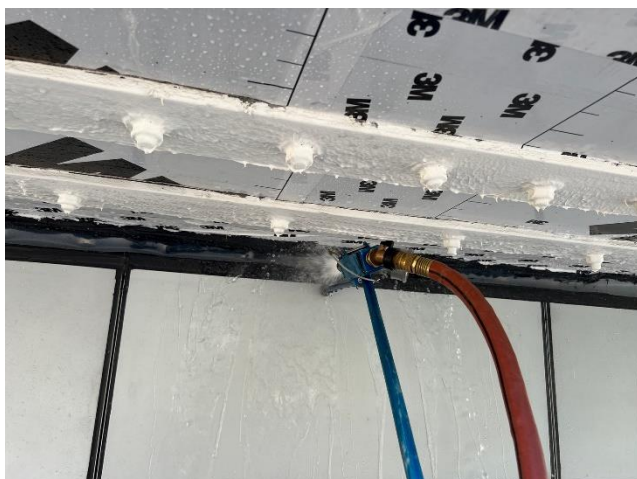
Photo 14 – Typical water spray application at Specimen 5.

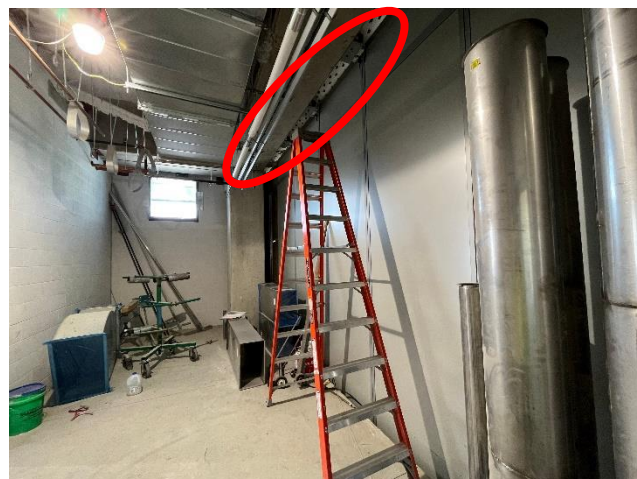
Photo 15 – Interior view of test area for Specimen 5.

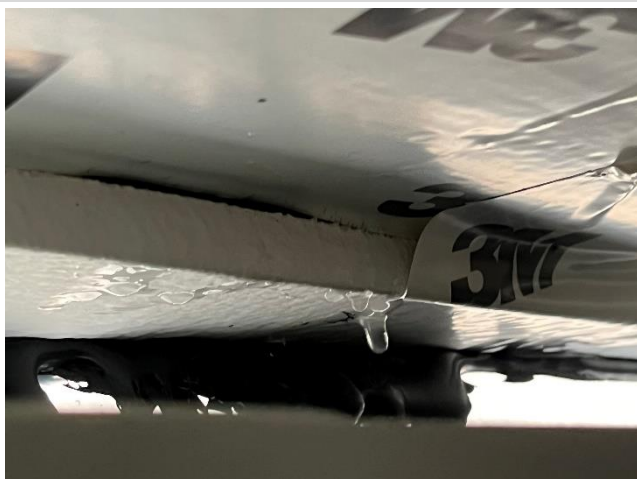
Photo 16 – View of moisture intrusion observed at interior.

While water spray was applied to the transition detailing between the Level -1MGU-8 Unitized Curtain Wall assembly the Level 2 soffit, moisture intrusion was observed at the interior of the building and accumulated on top of the horizontal mullion framing. Lerch Bates interior view was limited due to construction build-out, so moisture intrusion was observed through photos and videos captured during testing (refer to Photo 16 which shows interior moisture intrusion and water accumulation on horizontal mullion).

Lerch Bates recommends the air barrier installer reviews detailing at this condition to confirm continuity of the air/weather barrier including sealant applications and proper detailing around steel plates (which appeared to bridge between the seal at this location). Recommend retesting the test area after repairs have been completed.

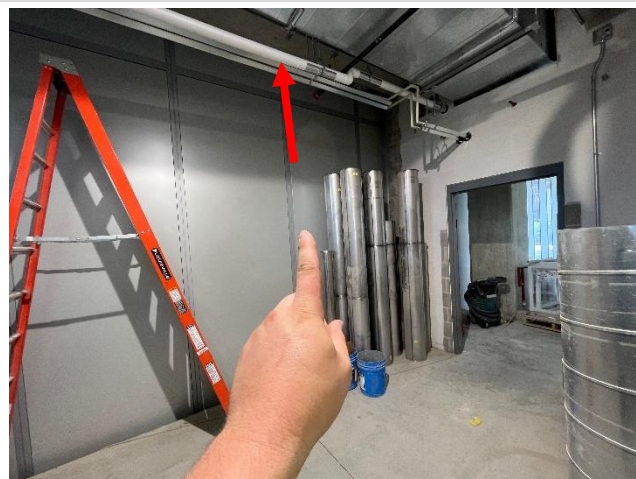
Photo 17 – Interior view of moisture intrusion location (red arrow – on top of horizontal mullion).

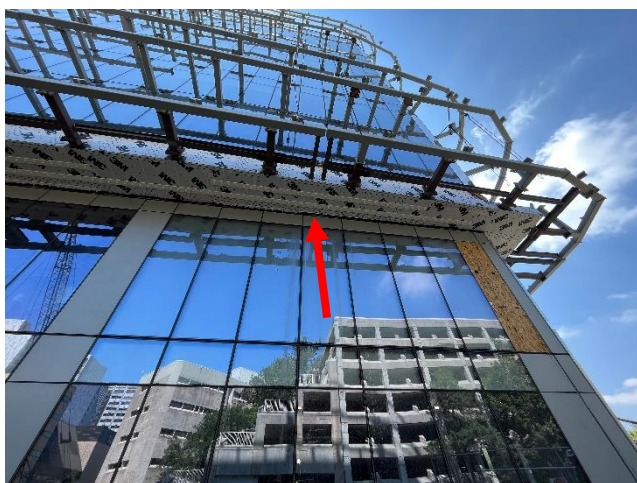
Photo 18 – Exterior view of where water application resulted in moisture intrusion.

After the moisture intrusion was initially observed, Lerch Bates re-applied moisture at general locations shown in Photos 18-20. There were various deficiencies/potential moisture infiltration paths within the weather barrier detailing membrane including fish mouths (Photos 19 & 20), general sealant applications and tooling along the edge of the boot flashing, sealing around steel plate bolts (Photo 20), and at a location where the self-adhered membrane detailing appeared to terminate along the steel plate (Photo 20 red arrow).

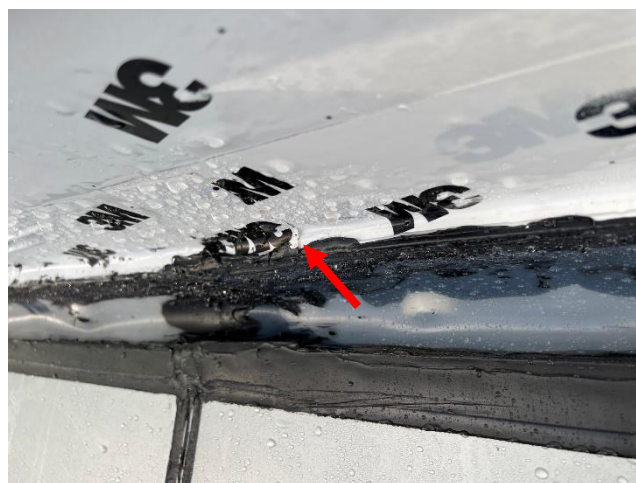
Photo 19 – Potential fish mouth deficiency within the 3M self-adhered flashing.

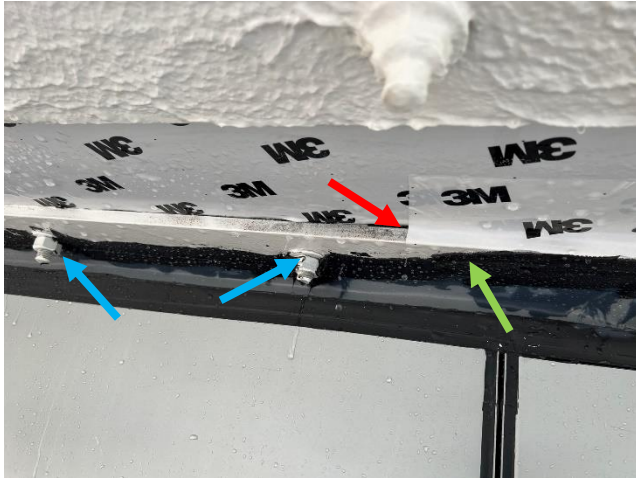
Photo 20 – Specimen 5, Potential moisture intrusion path locations (refer to “Results & Recommendations”).

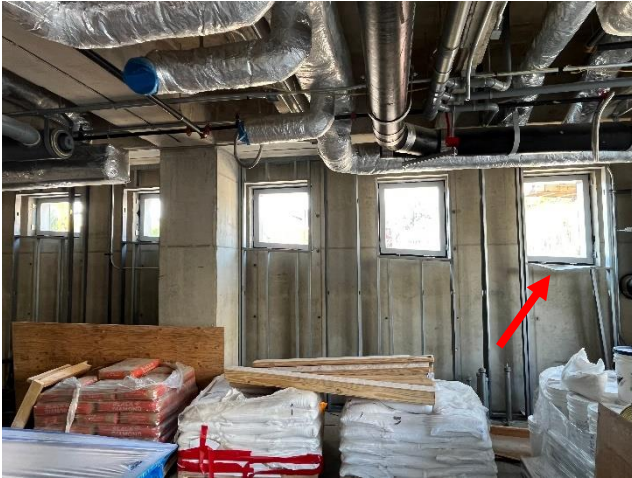
Photo 21 – Interior view of Specimen 6 location at north elevation, ground level.

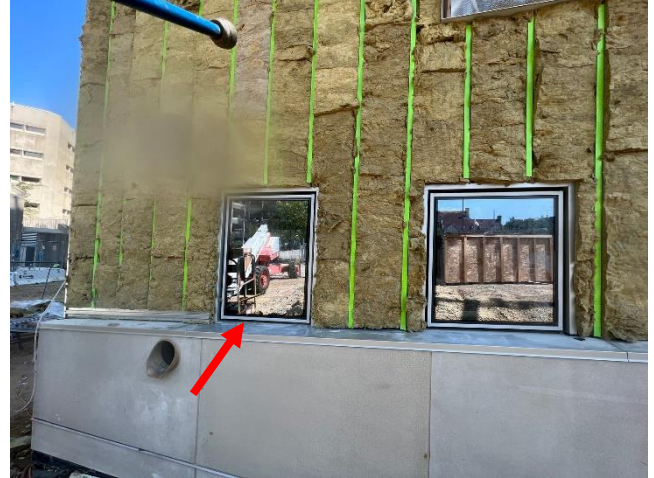
Photo 22 – Exterior view of Specimen 6.

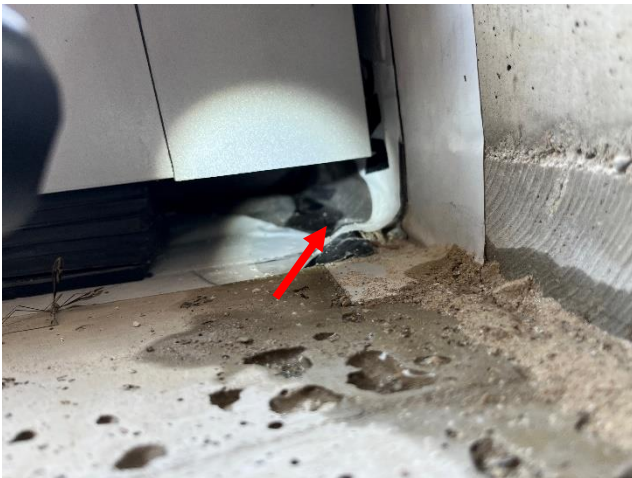
Photo 23 – View of Specimen 6 moisture intrusion at interior right sill/jamb interface.

It is Lerch Bates' opinion, based on a reasonable degree of engineering certainty, that the glazing system installed within the west elevation punched opening exhibited water penetration. The test specimen, therefore, failed the AAMA 501.2 test.

Light was visible through the framing joints indicating lack of sealant application within the framing of Specimens 6 and 7 and therefore inability to resist water infiltration. Lerch Bates recommends repairing the glazing systems

installed within the west elevation punched openings to provide intended system performance; retesting will confirm remediation effort have been successful.

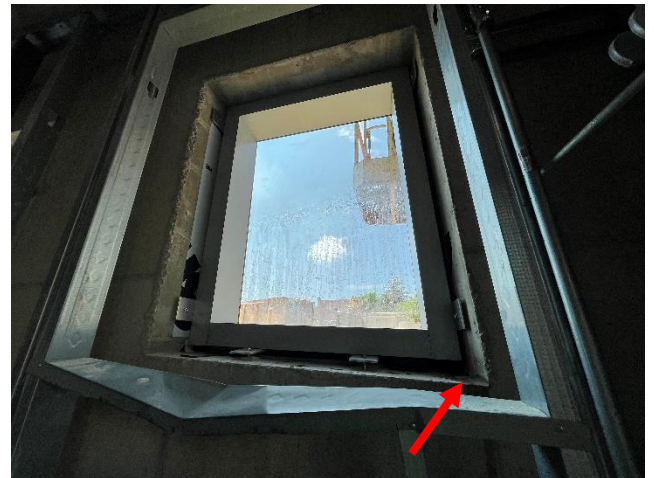
Photo 24 – Location of moisture intrusion, interior view.

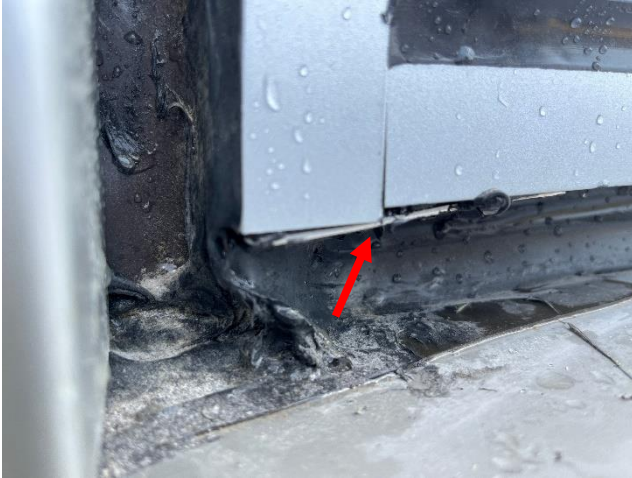
Photo 25 – Enlarged exterior view of moisture intrusion location.

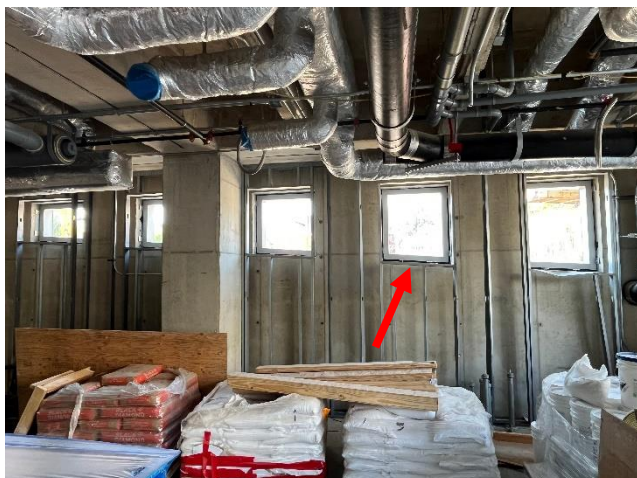
Photo 26 – Interior view of Specimen 6 location at north elevation, ground level.

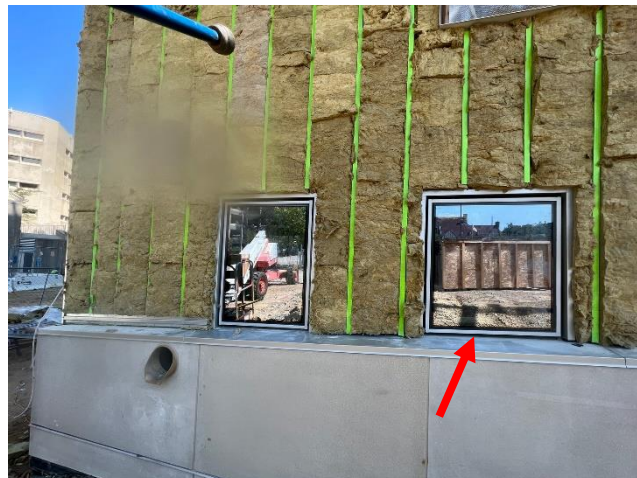
Photo 27 – Exterior view of Specimen 6.

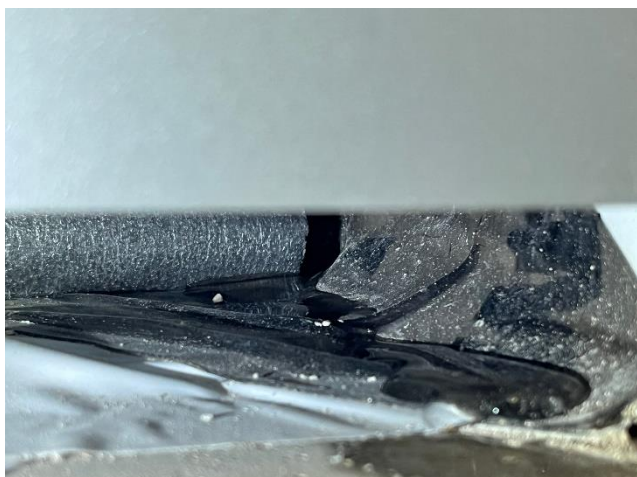
Photo 28 – View of Specimen 7 moisture intrusion at interior right sill/jamb interface.

It is Lerch Bates' opinion, based on a reasonable degree of engineering certainty, that the glazing system installed within the west elevation punched opening exhibited water penetration. The test specimen, therefore, failed the AAMA 501.2 test.

Note: Lerch Bates recommends reviewing all west elevation punched openings as it appears to be a systemic condition. Review of the issue with HDR will be undertaken and if in agreement, additional units will be tested to confirm punched openings meet project performance targets after MG McGrath has an opportunity to review and remediate units as necessary.

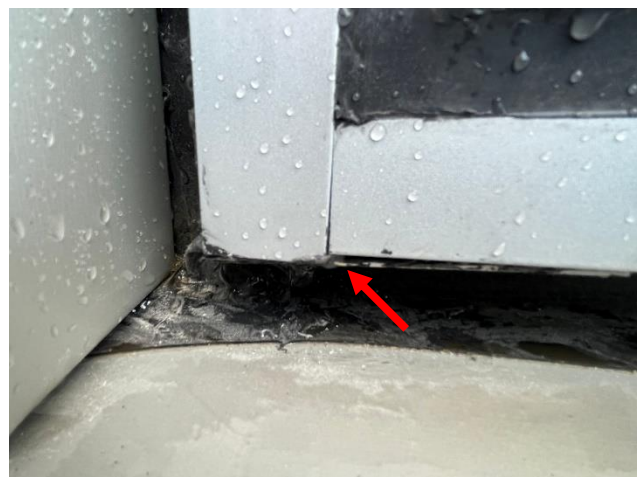
Photo 29 – Enlarged view from exterior.
