Condition Assessment

The following photographs were taken on 10/18/21 to document the in-service conditions at the reported leak locations.

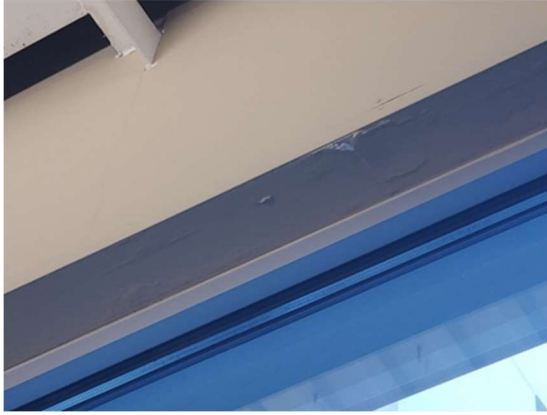
*Photo #1: Chipped paint on drywall along the top of the window rough opening at leak location #1.*

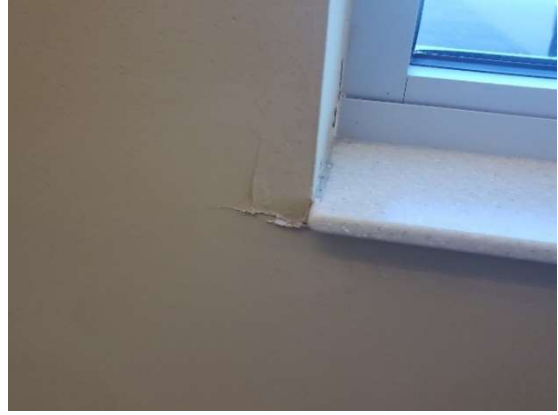
*Photo #2: Chipped paint on drywall at the bottom of the window jamb rough opening at leak location #1.*

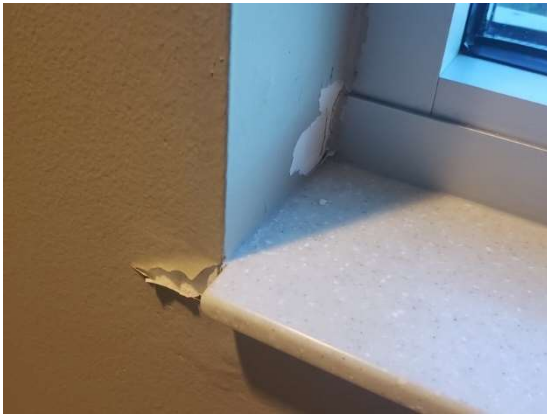
*Photo #3: Chipped paint on drywall at the bottom of the window jamb rough opening at leak location #2.*

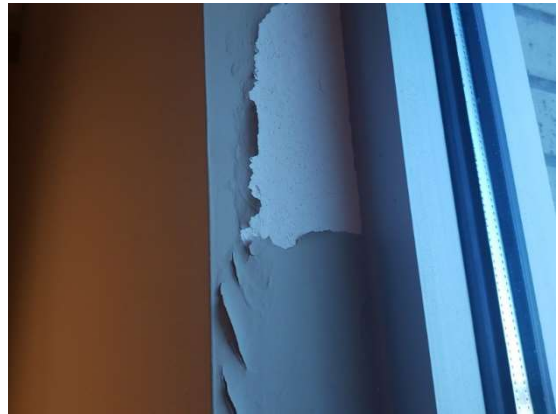
*Photo #4: Chipped paint on drywall along the window jamb rough opening at leak location #2.*

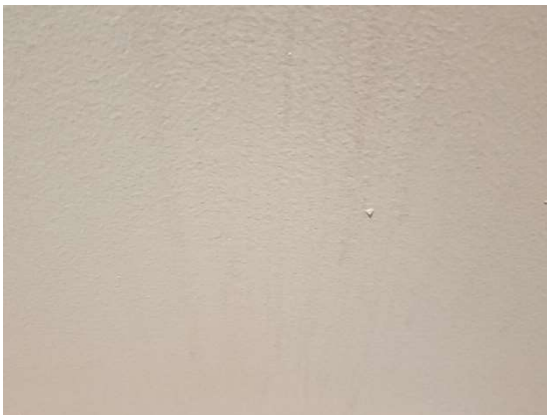
*Photo #5: Stains on the drywall directly below the window at leak location #2.*

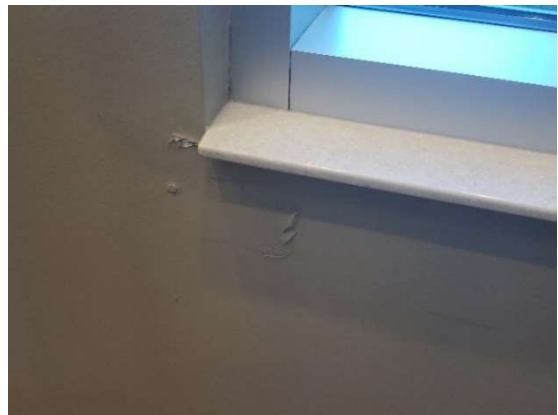
*Photo #6: Chipped paint on drywall at the bottom of the window jamb rough opening at leak location #3.*

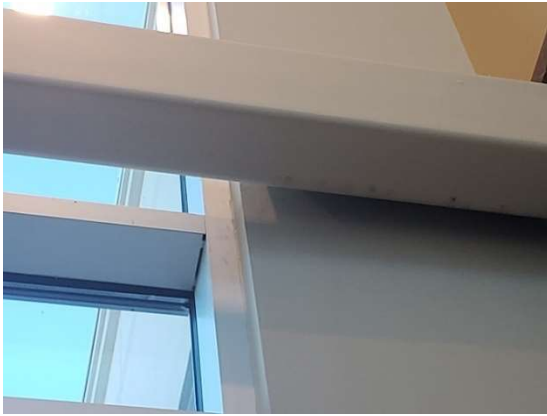
*Photo #7: Drip marks on the bottom side of the horizontal steel tubing at leak location #3.*

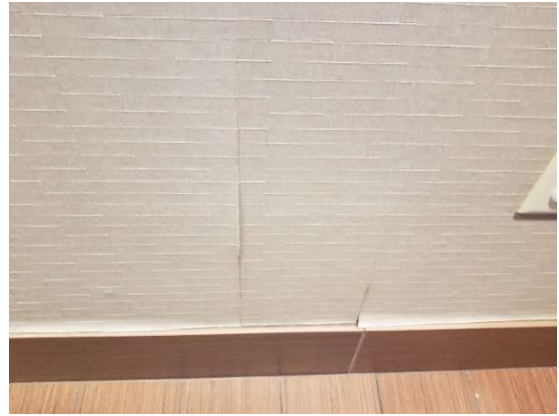
*Photo #8: Wallpaper peeling below the window at leak location #5.*

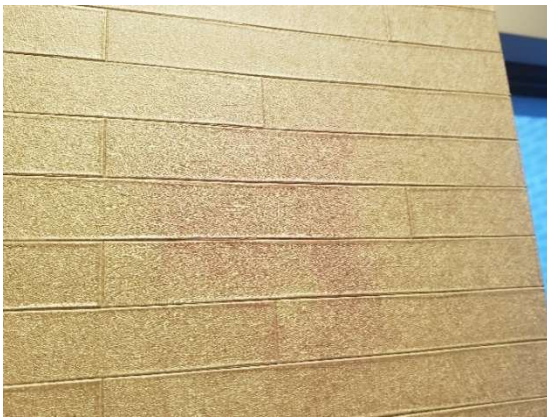
*Photo #9: Wallpaper discoloration adjacent to the window at leak location #5.*

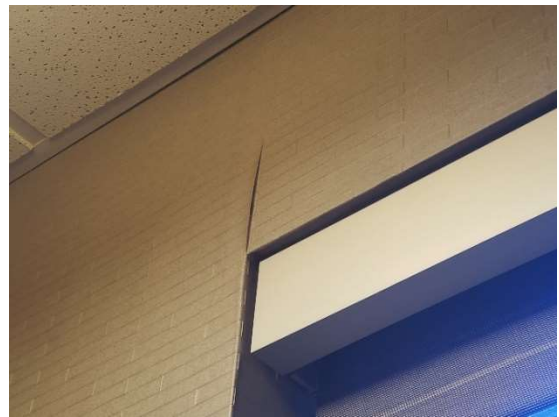
*Photo #10: Wallpaper peeling above the window at leak location #5.*

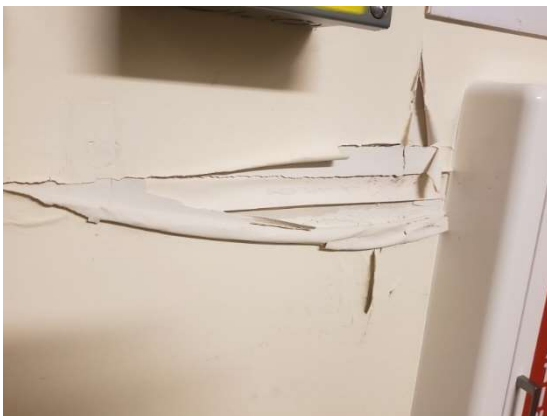
*Photo #11: Chipped/peeling paint on drywall at leak location #6.*

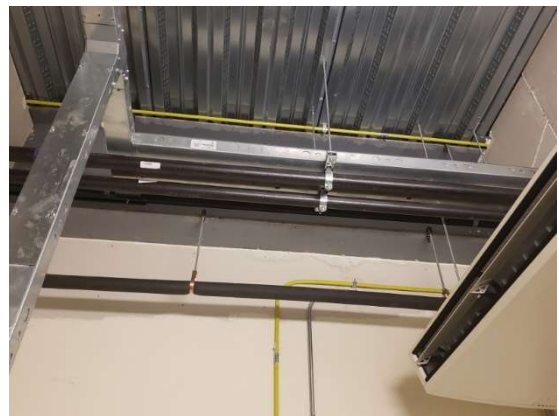
*Photo #12: Stains on drywall at leak location #6.*

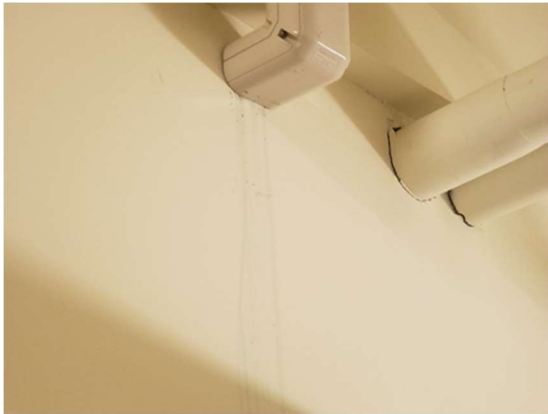
*Photo #13: Stains on drywall at leak location #7.*

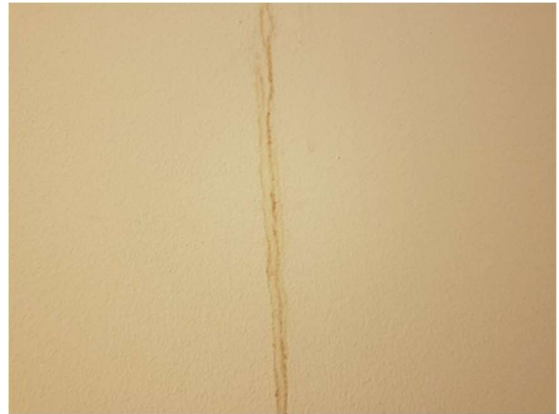
*Photo #14: Stains on drywall at leak location #8.*

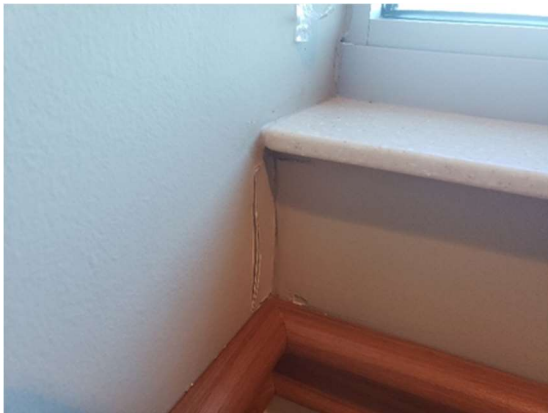
*Photo #15: Chipped paint on drywall at the bottom of the window jamb rough opening at leak location #9.*

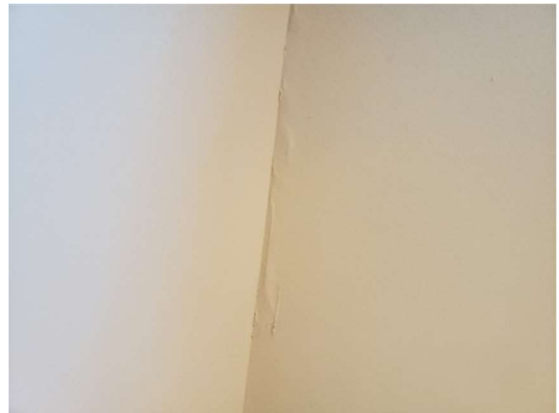
*Photo #16: Signs of drywall deterioration directly below the window at leak location #9.*

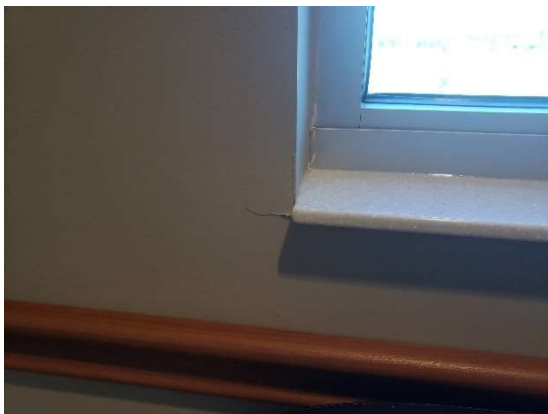
*Photo #17: Chipped paint on drywall at the bottom of the window jamb rough opening at leak location #10.*

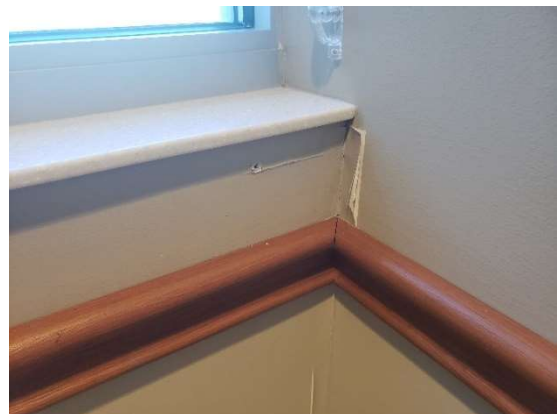
*Photo #18: Chipped paint on drywall at the bottom of the window jamb rough opening at leak location #10.*

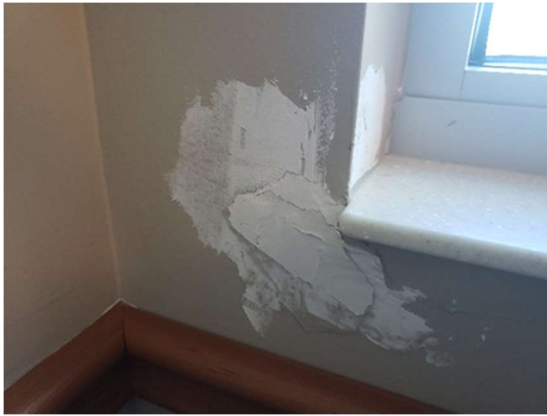
*Photo #19: Presumable drywall repair at the bottom of the window jamb rough opening at leak location #11.*

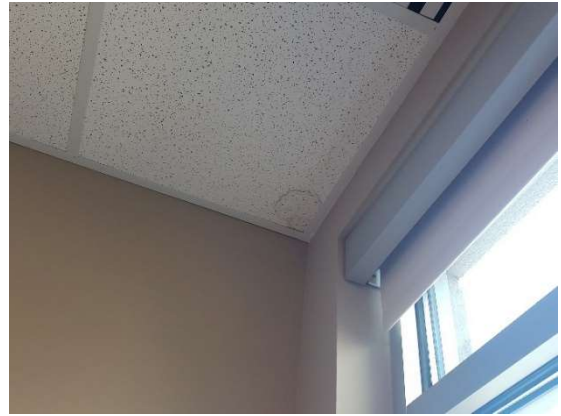
*Photo #20: Stain on the ceiling tile directly above the window at leak location #11.*

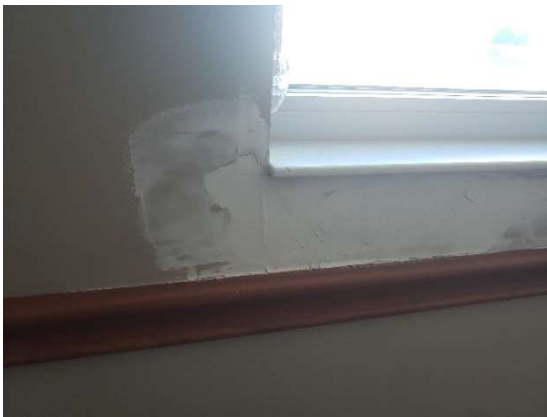
*Photo #21: Presumable drywall repair at the bottom of the window jamb rough opening at leak location #12.*

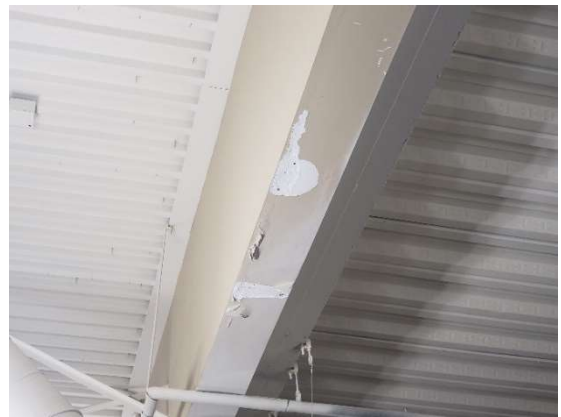
*Photo #22: Chipped paint on drywall along the spandrel beam at leak location #13.*

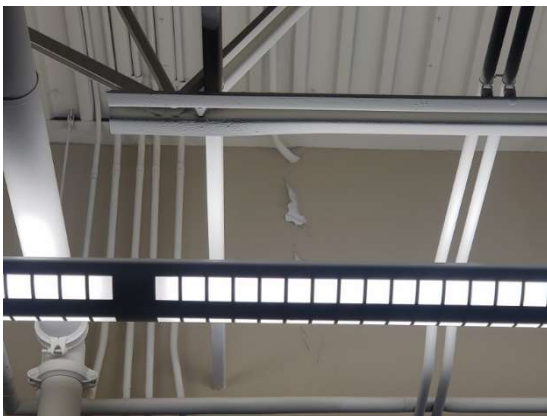
*Photo #23: Chipped/peeling paint on drywall at leak location #13.*

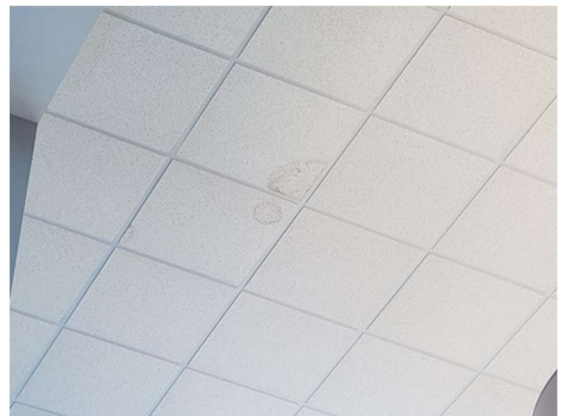
*Photo #24: Stains on the ceiling tiles at leak location #15.*

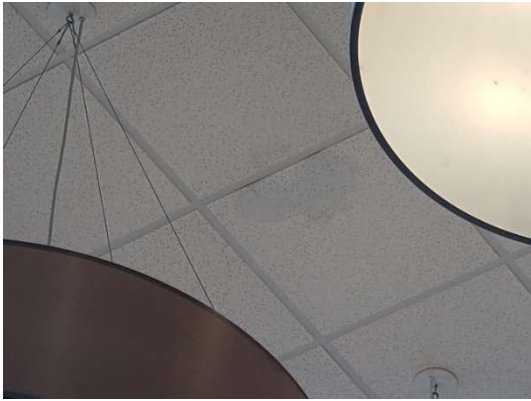
*Photo #25: Stains on the ceiling tiles at leak location #16.*

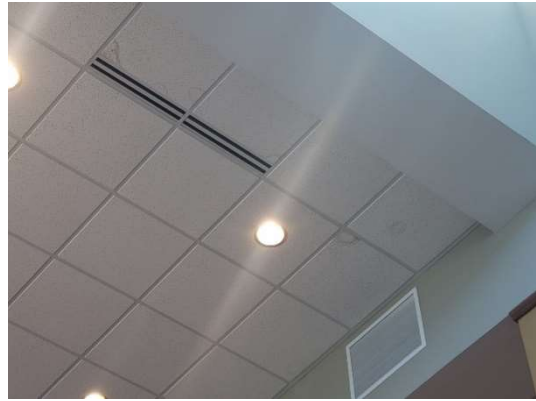
*Photo #26: Stains on the ceiling tiles at leak location #17.*

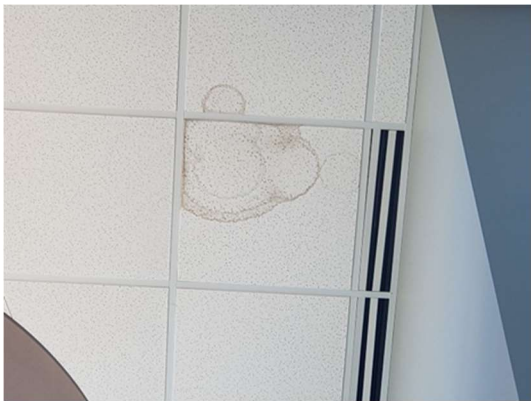
*Photo #27: Stains on the ceiling tiles at leak location #18.*

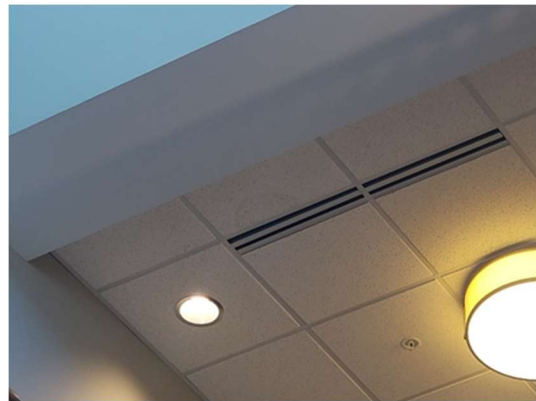
*Photo #28: Stains on the ceiling tiles at leak location #19.*

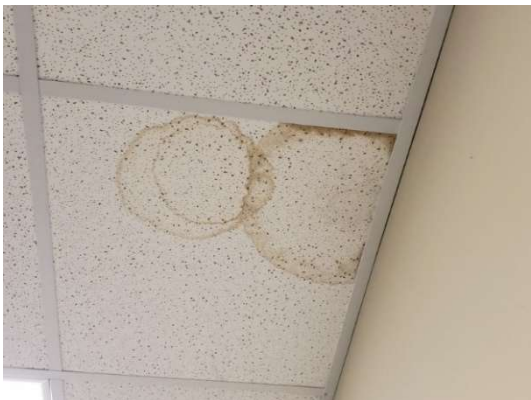
*Photo #29: Stains on the ceiling tile at leak location #20.*

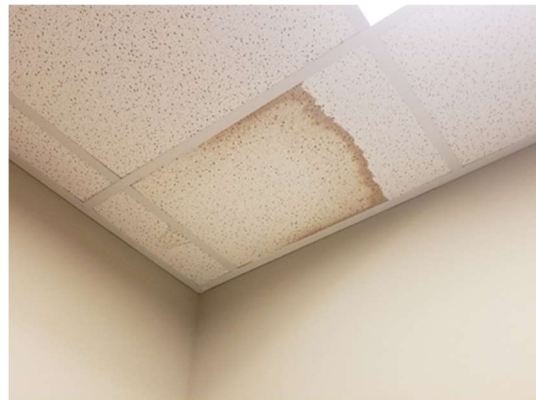
*Photo #30: Stains on the ceiling tiles at leak location #21.*

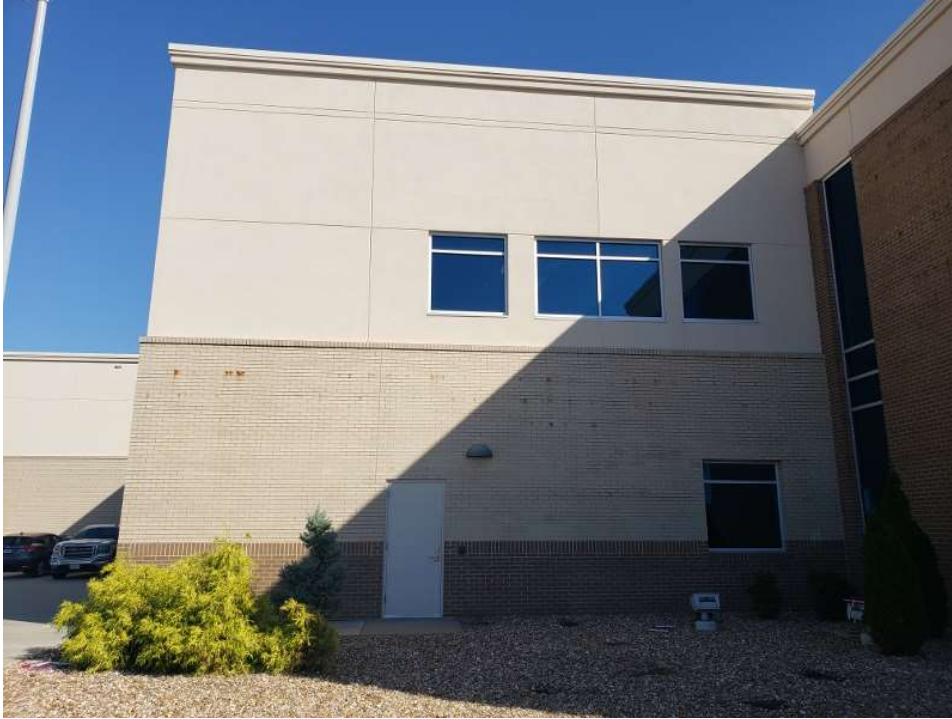
*Photo #74: View of orange/red staining and white residue on the brick (west elevation, north of lobby, 10/18/21).*

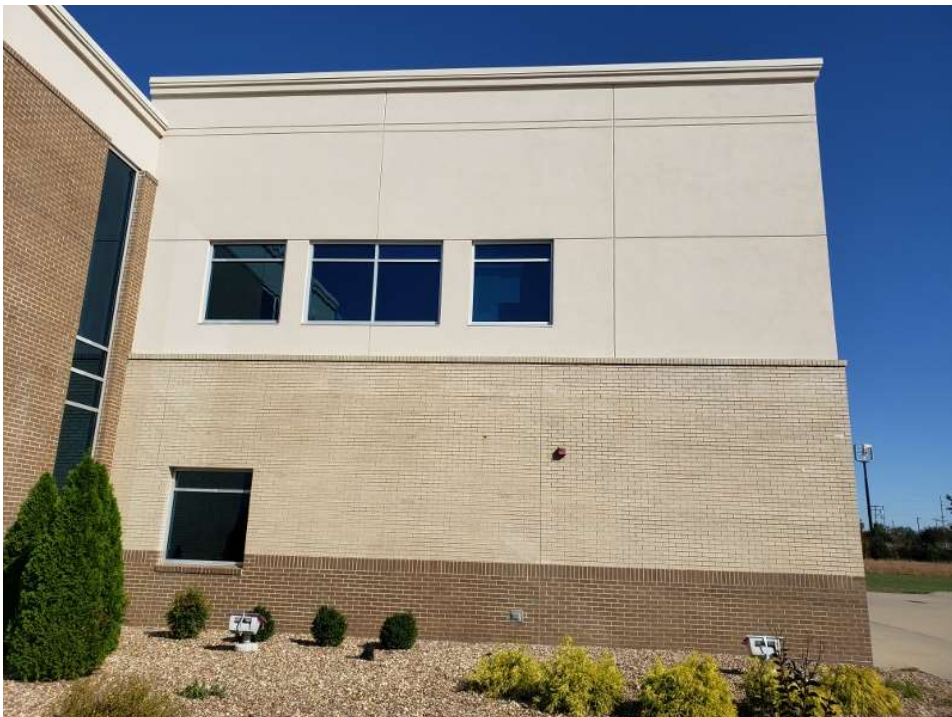
*Photo #75: View of orange/red staining and white residue on the brick (west elevation, south of lobby, 10/18/21).*

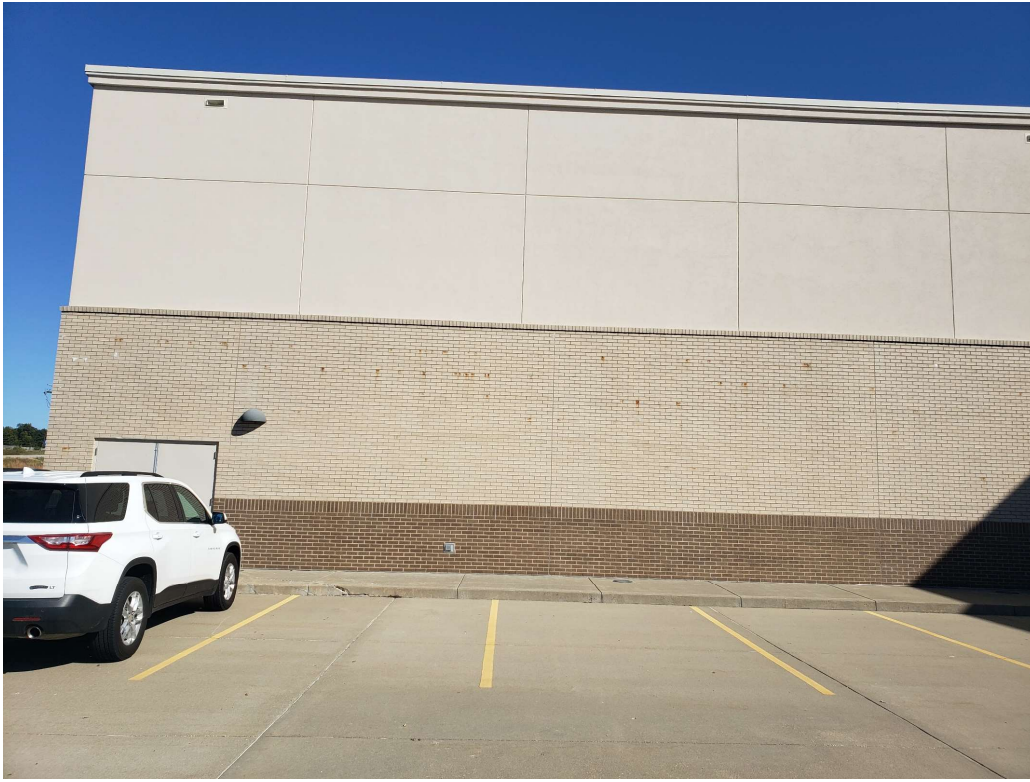
*Photo #76: View of orange/red staining and white residue on the brick (west elevation, gymnasium, 10/18/21).*

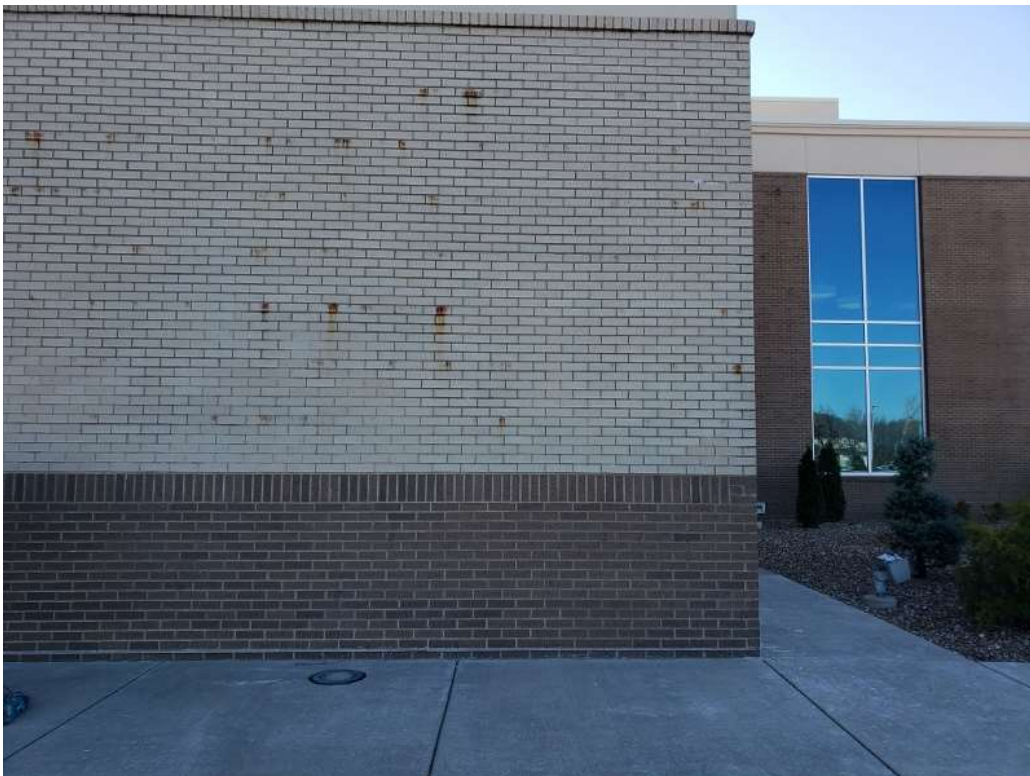
*Photo #77: View of orange/red staining and white residue on the brick (north elevation, stairwell, 1/12/22).*

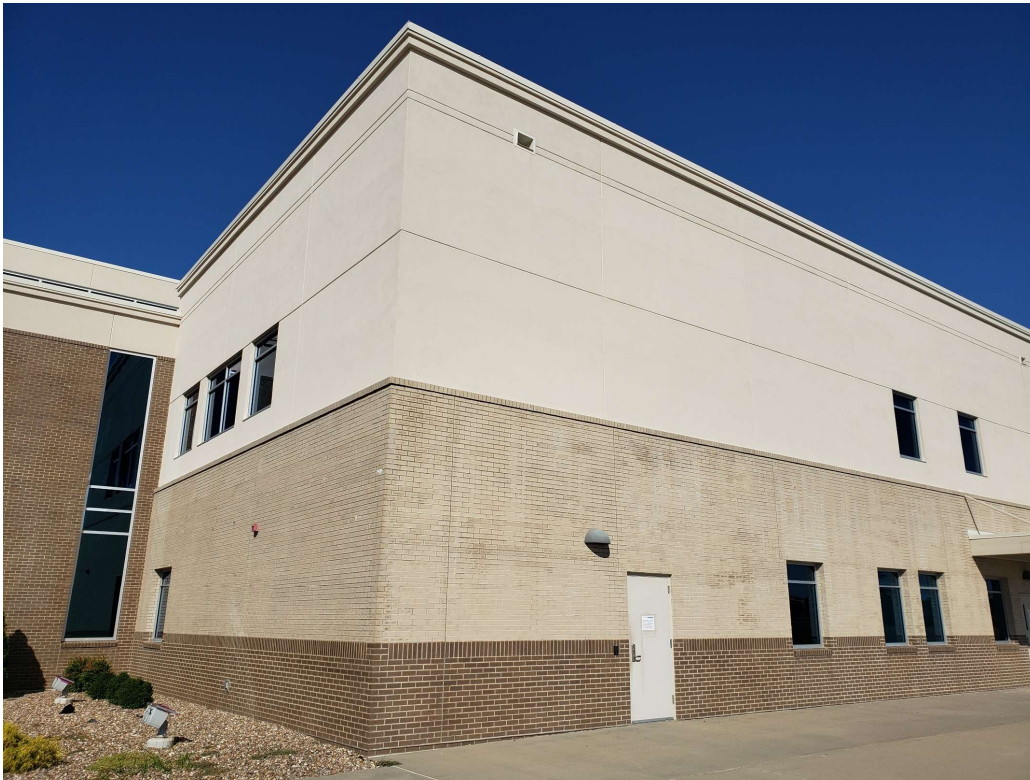
*Photo #78: View of orange/red staining, white residue, and discolored brick (southwest corner, 10/18/21).*

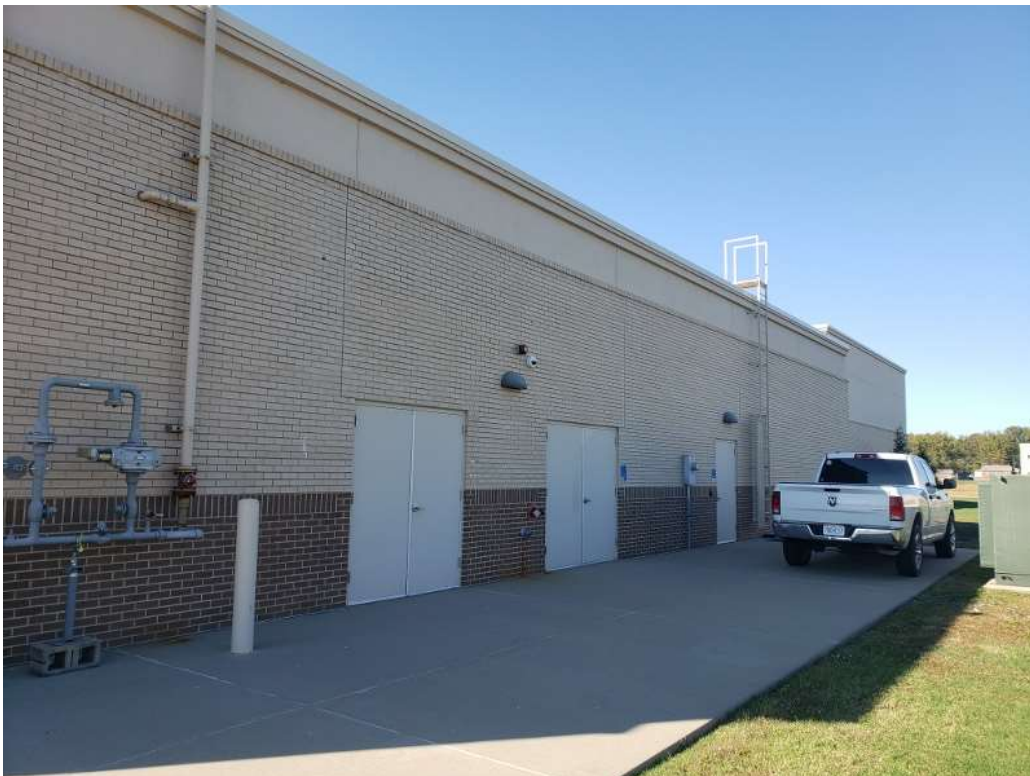
*Photo #79: View of orange/red staining and white residue on the brick (east elevation, 10/18/21).*

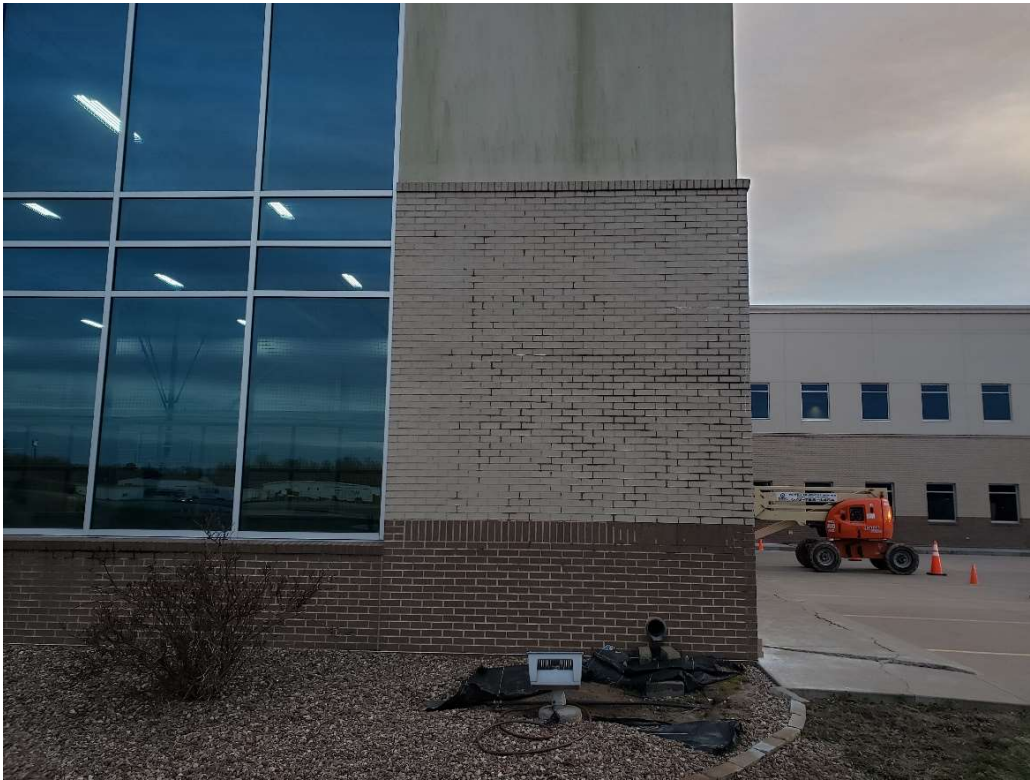
*Photo #80: View of dark residue on the mortar (north elevation, gymnasium, 1/12/22).*

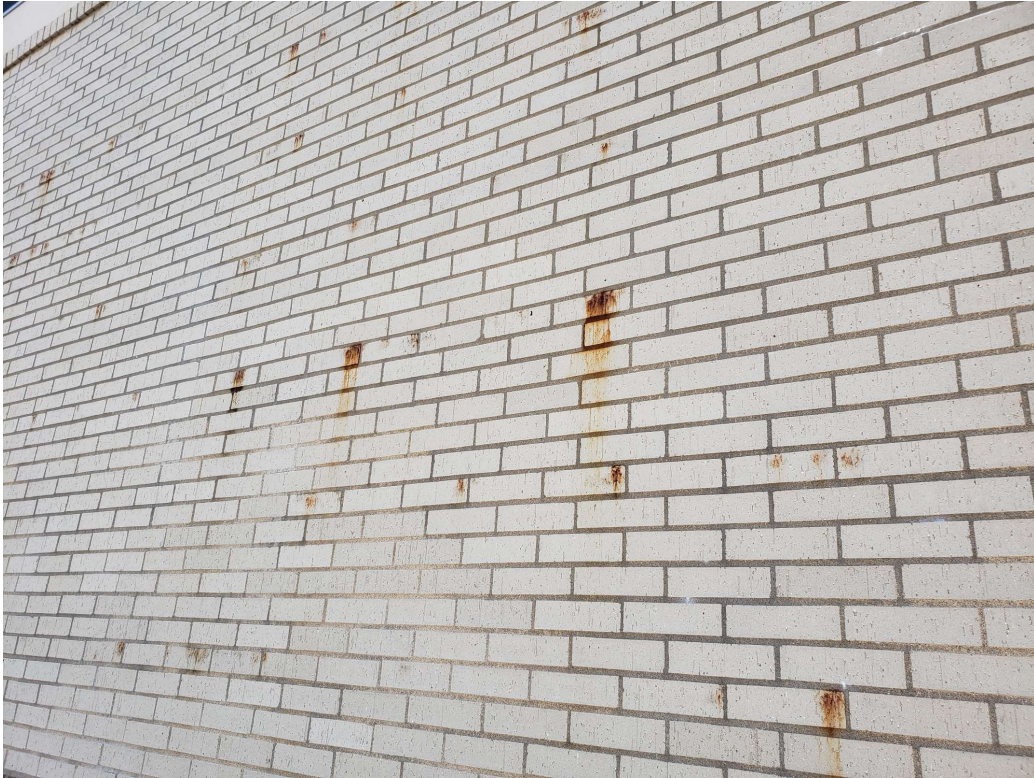
*Photo #82: Close-up view of orange/red staining on the brick (north elevation, stairwell, 10/18/21).*

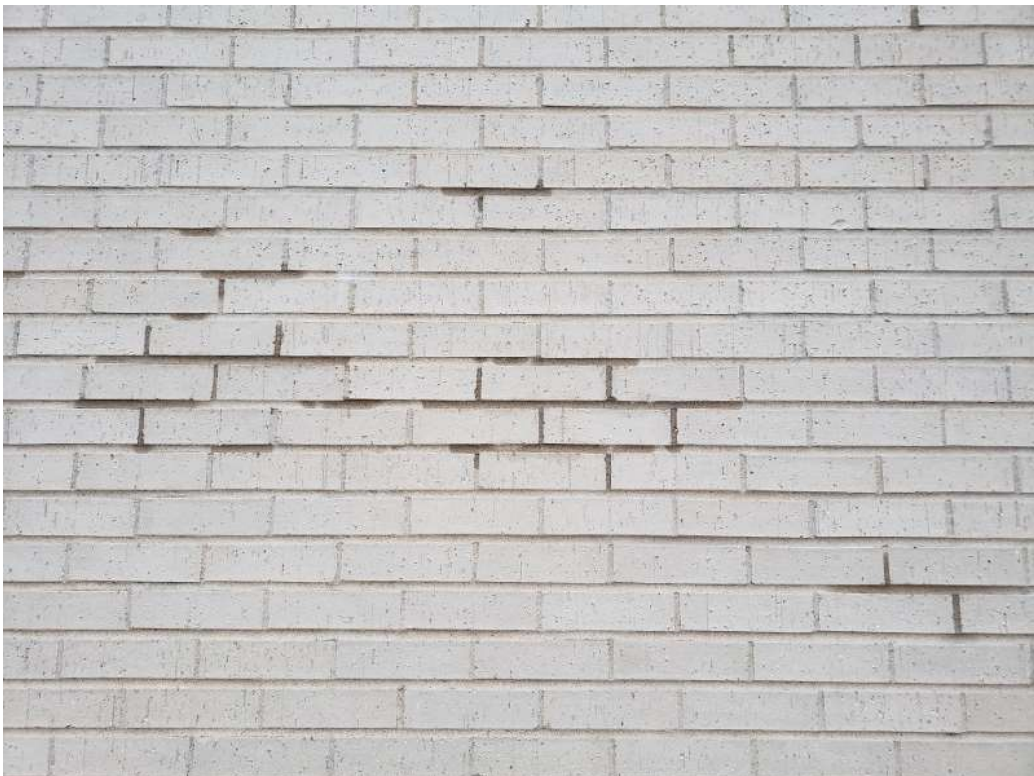
*Photo #83: Close-up view of mortar that appears to be wet (north elevation, gymnasium, 1/12/22).*

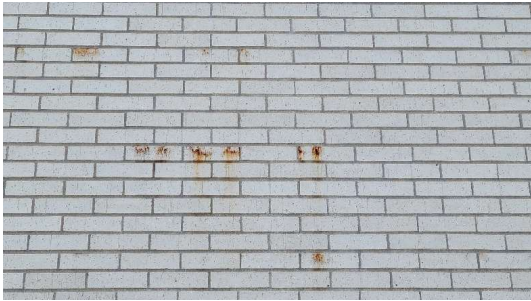
*Photo #84: Close-up view of orange/red staining on the brick (west elevation, gymnasium, 1/11/22).*

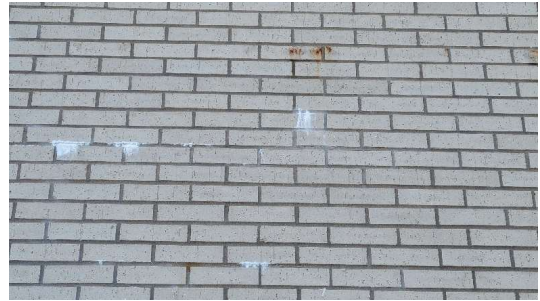
*Photo #85: Close-up view of orange/red staining and white residue on the brick (west elevation, gymnasium, 1/11/22).*

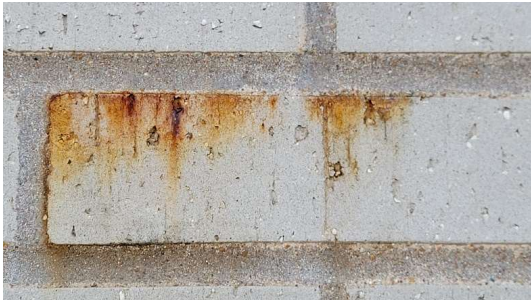
*Photo #86: Close-up view of orange/red staining on the brick (west elevation, gymnasium, 1/11/22).*

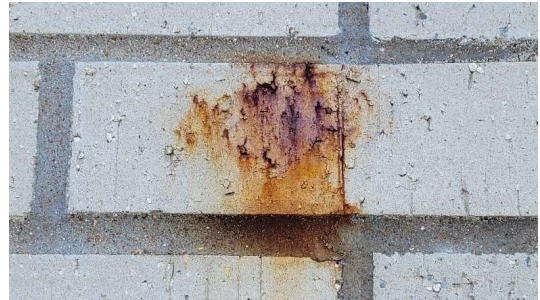
*Photo #89: Close-up view of orange/red staining on the brick (west elevation, gymnasium, 1/11/22).*

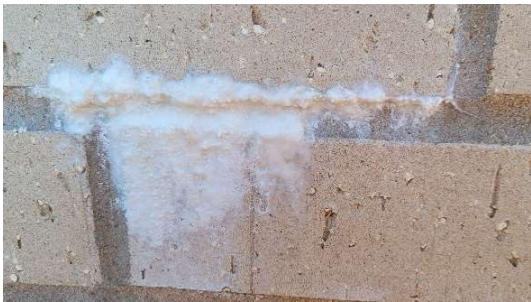
*Photo #87: Close-up view of white residue on the brick (west elevation, gymnasium, 1/11/22).*

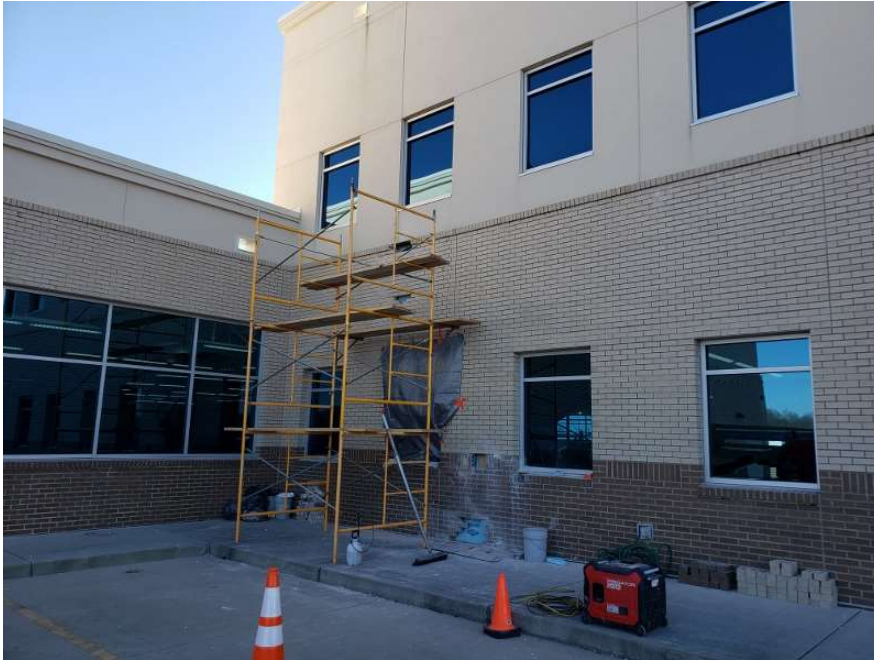
*Photo #98: View of exploratory opening locations (north elevation, fitness area, 1/12/22).*

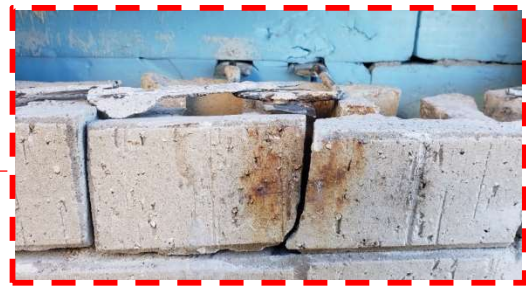
*Photo #101: View of as-built condition after removal of a few brick units (north elevation, fitness area, 1/10/22).*

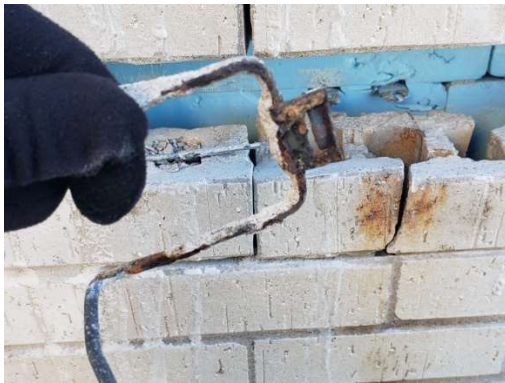
*Photo #102: Close-up view of corroded brick anchor tie (north elevation, fitness area, 1/10/22).*

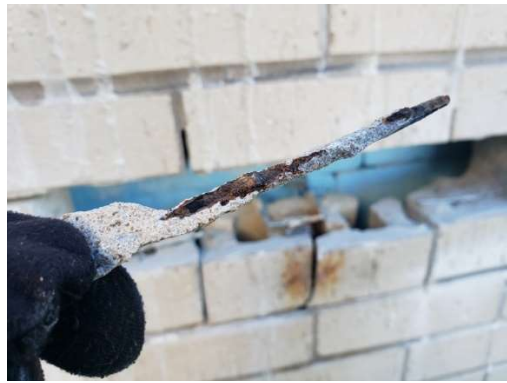
*Photo #103: Close-up view of corroded brick wire (north elevation, fitness area, 1/10/22)*

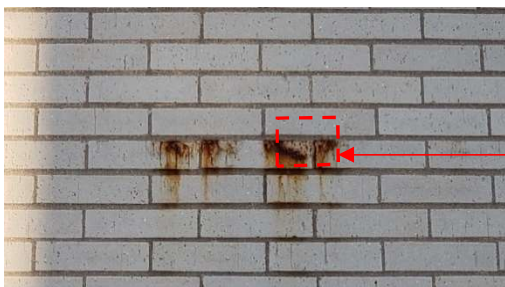
*Photo #104: View of rust stain on brick surface, prior to exploratory opening (west elevation, stairwell, 1/10/22).*

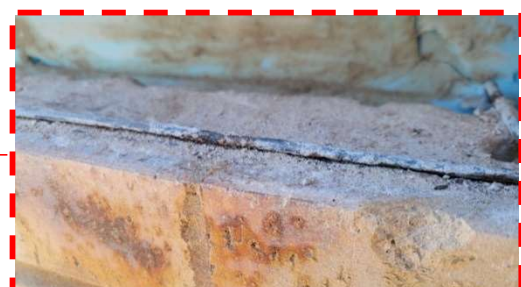
*Photo #105: Close-up view of corroded brick wire (west elevation, stairwell, 1/10/22).*

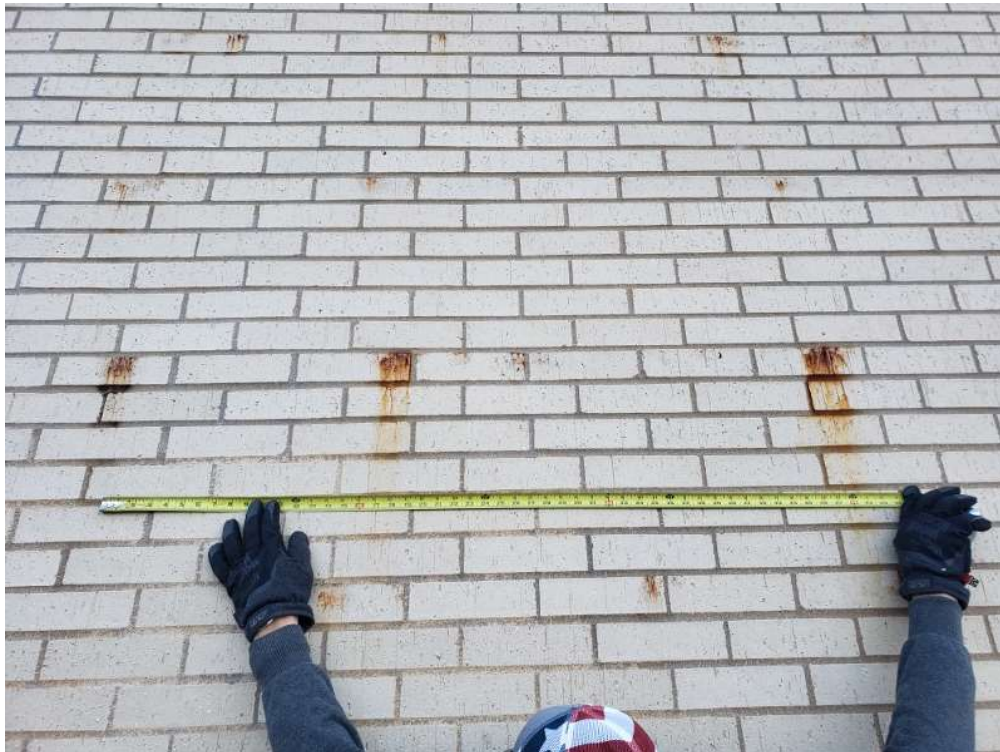
*Photo #106: Representative example of predominate rust stains at horizontal intervals of approximately 16" on-center (north elevation, stairwell, 1/12/22).*

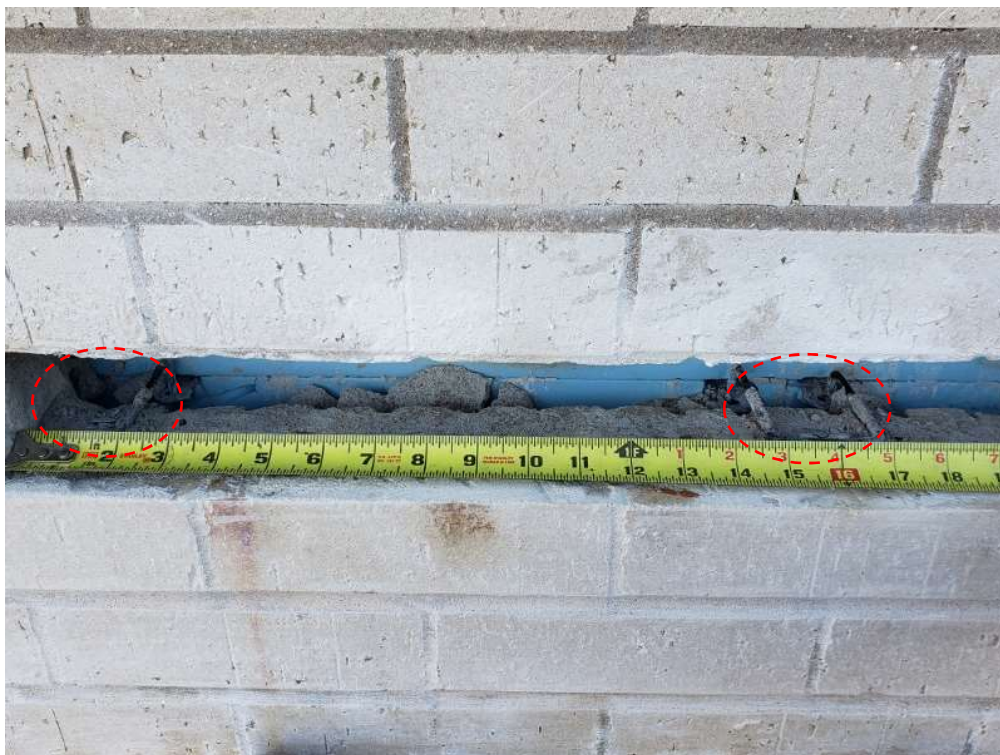
*Photo #107: Representative example of brick anchor tie horizontal spacing of approximately 16" on-center (west elevation, stairwell, 1/12/22).*

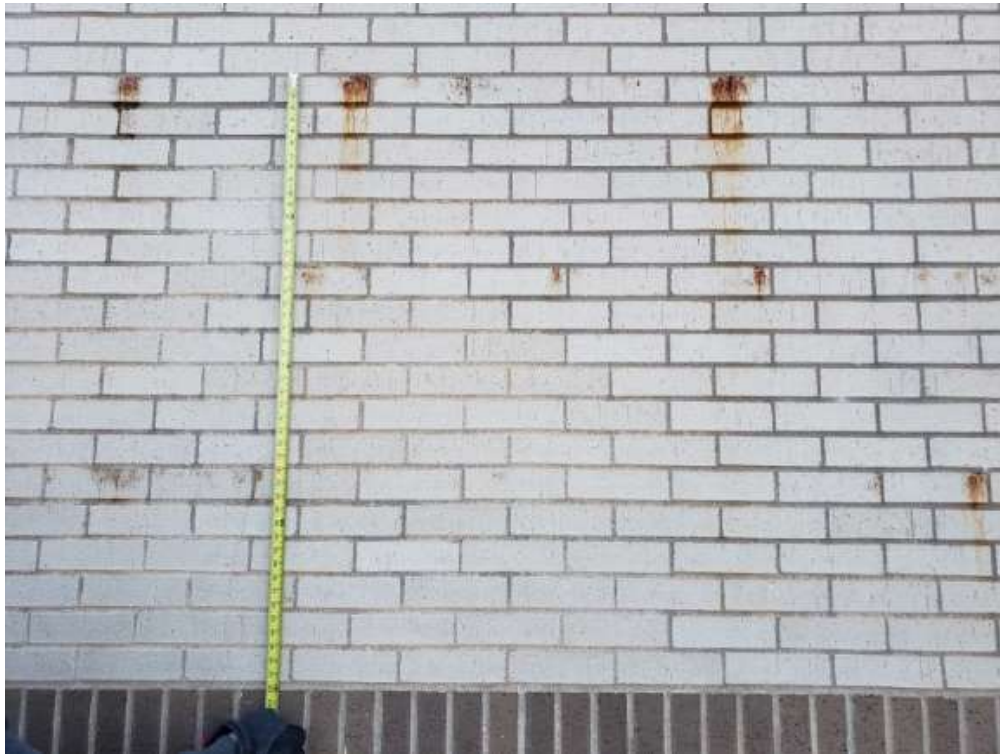
*Photo #108: Representative example of predominate rust stains at vertical intervals of approximately 16" on-center, which was 6 mortar bed joints (north elevation, stairwell, 1/12/22).*

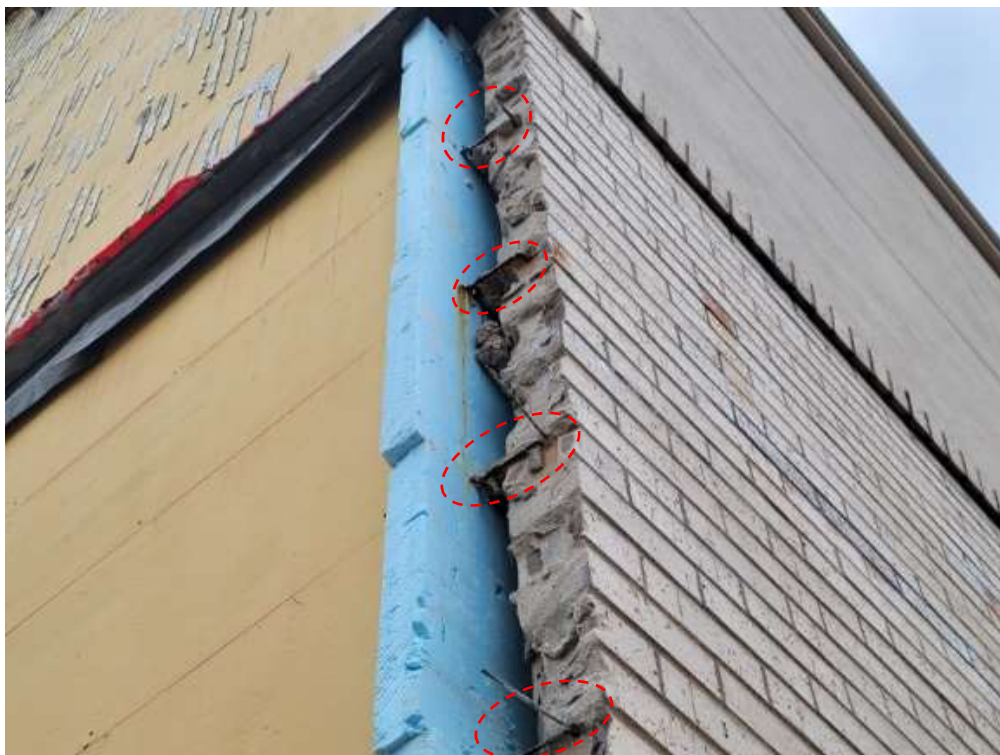
*Photo #109: Representative example of brick anchor tie and wire vertical spacing of approximately 16" on-center, which was 6 mortar bed joints (west elevation, stairwell, 7/19/23).*

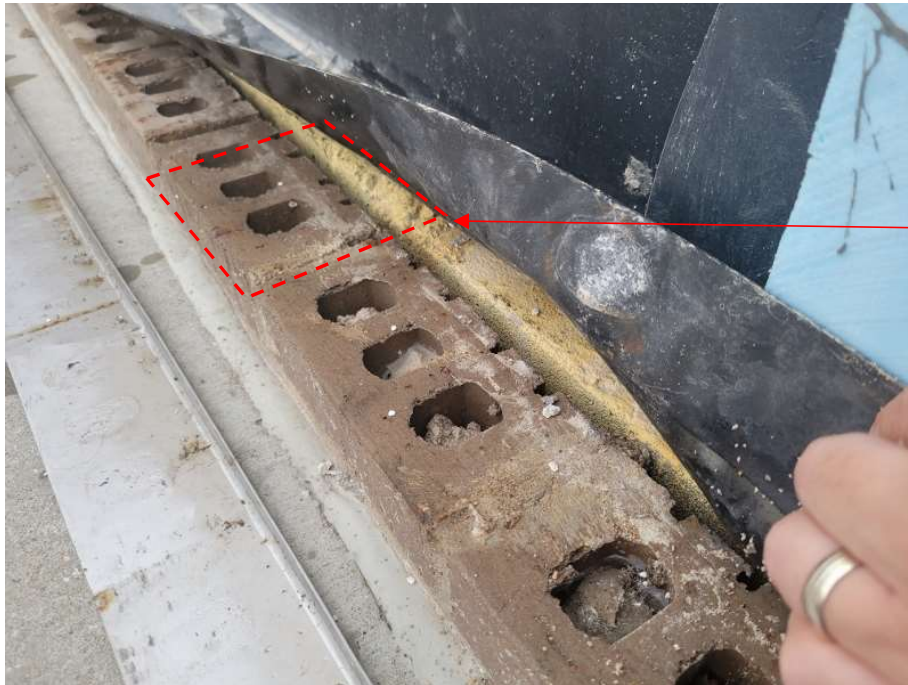
*Photo #114: View underneath unsealed flashing membrane at the base-of-wall condition (north elevation, stairwell, 7/19/23).*

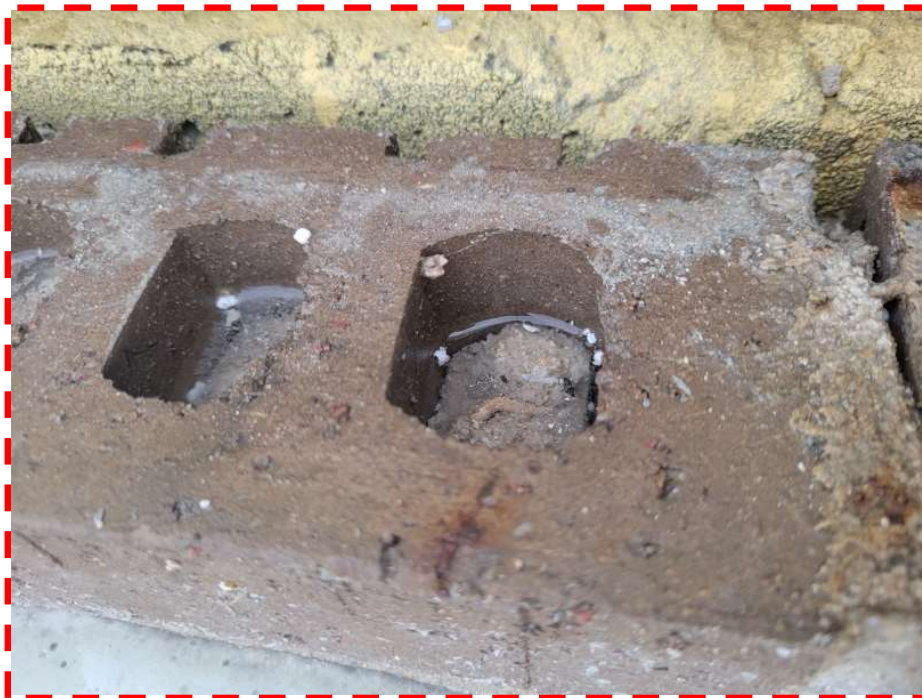
*Photo #115: Close-up view of water in brick cores at the base-of-wall condition (north elevation, stairwell, 7/19/23).*

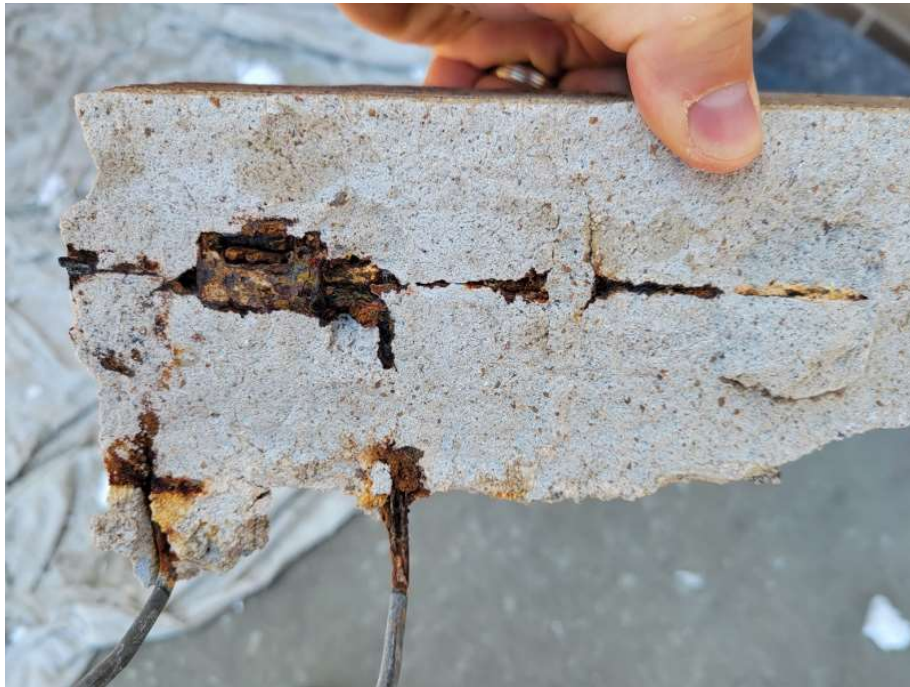
*Photo #116: Underside view of a brick unit with a corroded brick anchor tie and wire, embedded in the mortar (north elevation, fitness area, 6/26/23).*

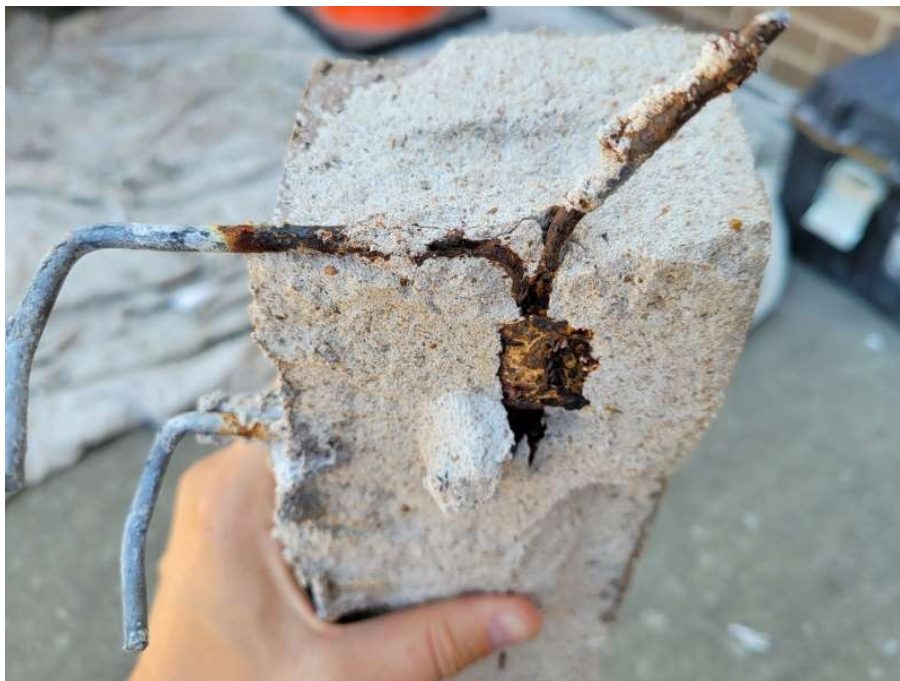
*Photo #117: Underside view of a brick unit with a corroded brick anchor tie and wire, embedded in the mortar (north elevation, fitness area, 6/26/23).*
