Condition Assessment

The following photographs were taken on 10/18/21 to document the in-service conditions at the reported leak locations.

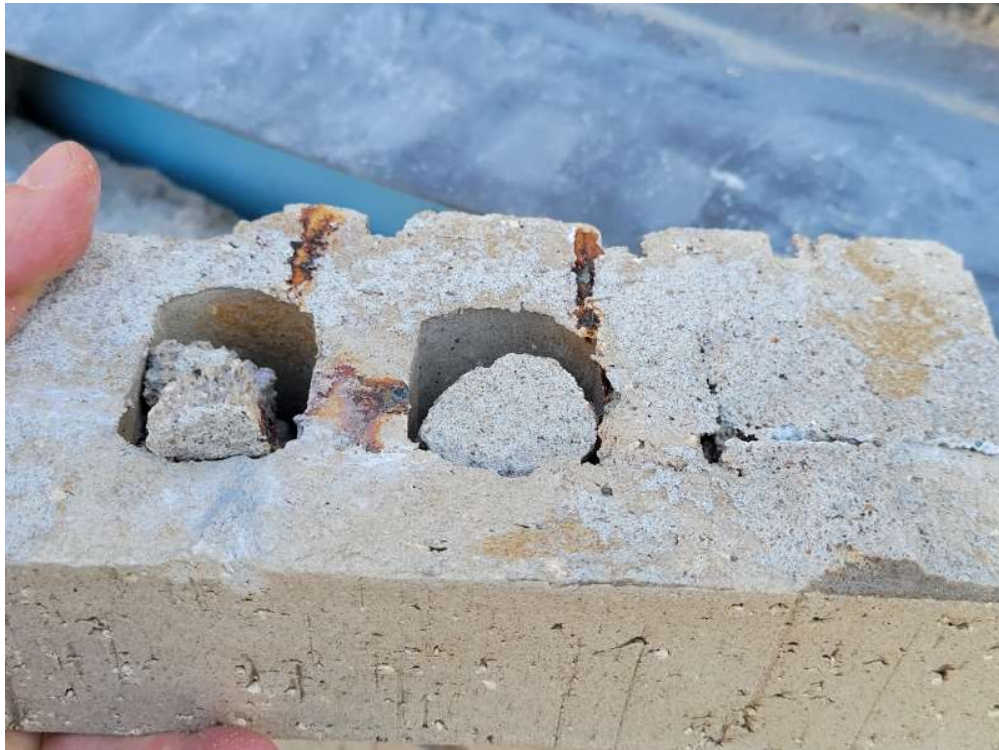
*Photo #118: Rust stains on the top side of a brick unit after removal of the brick anchor tie (north elevation, fitness area, 6/26/23).*

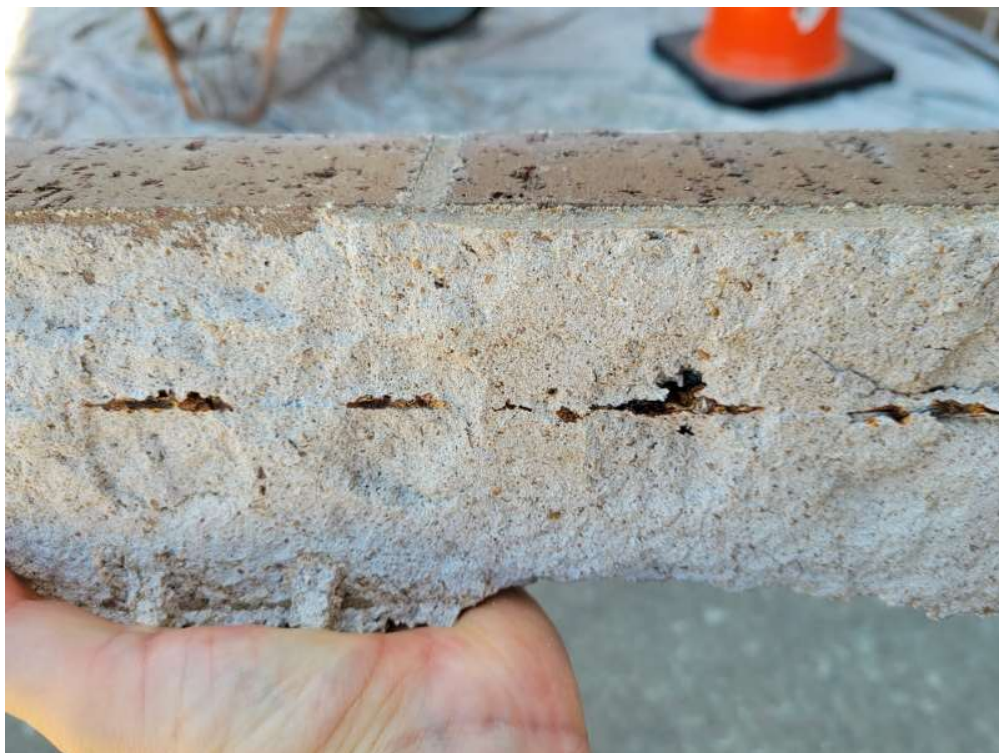
*Photo #119: Rust stains on the mortar along a wire (north elevation, fitness area, 6/26/23).*

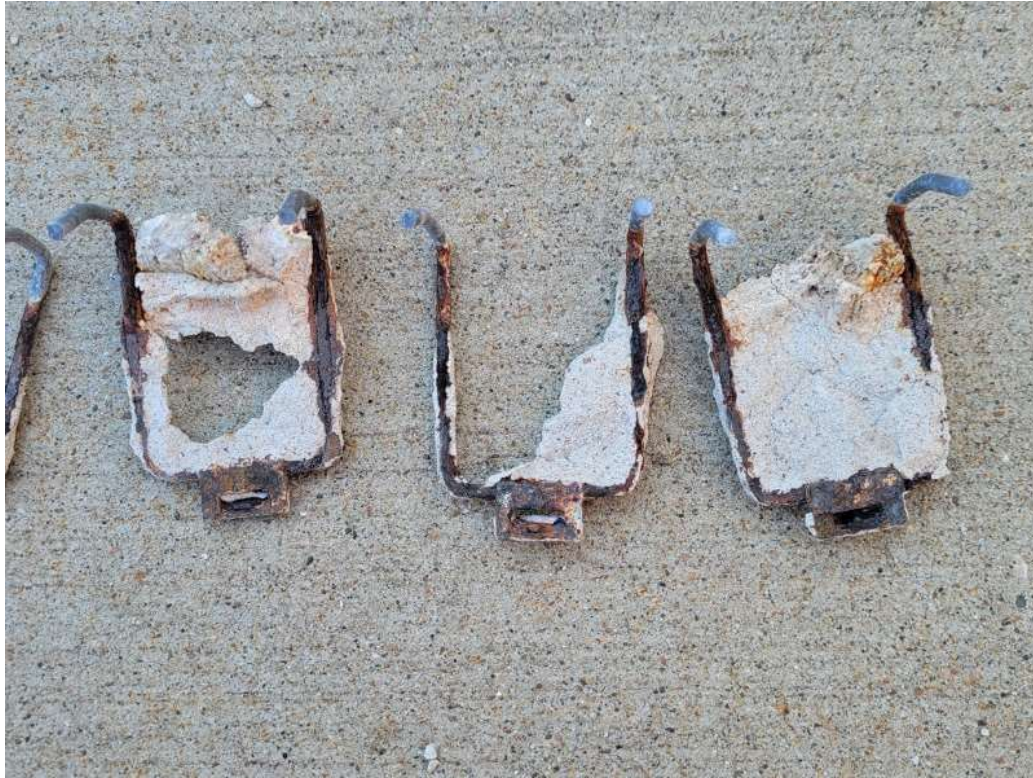
*Photo #120: View of rusted brick anchor ties after removal from the wall (north elevation, fitness area, 6/27/23).*

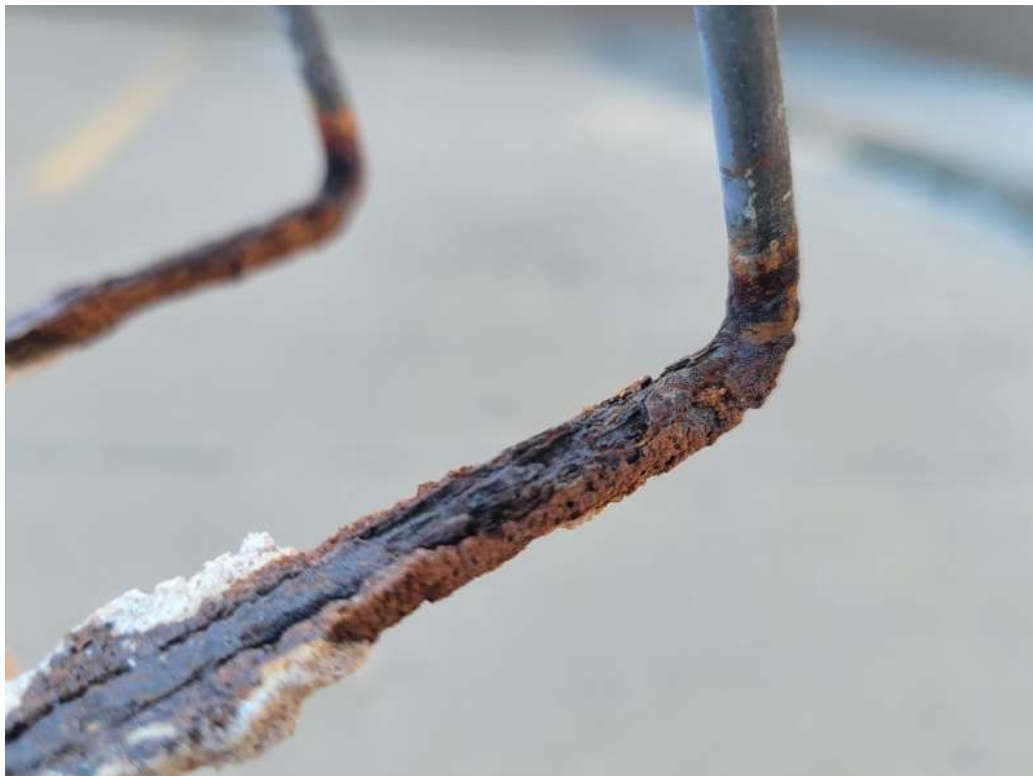
*Photo #121: Close-up view of a rusted brick anchor tie (north elevation, fitness area, 6/27/23).*

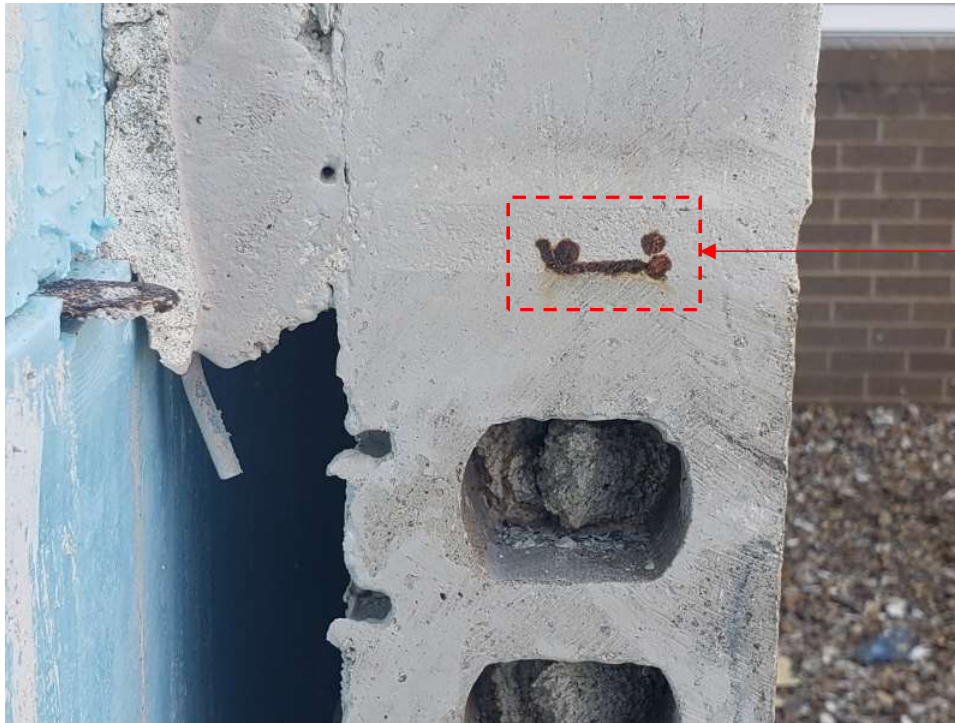
*Photo #122: View of a rusted brick anchor tie and wire, but no indication of staining on the brick surface (west elevation, hallway, 8/30/23).*

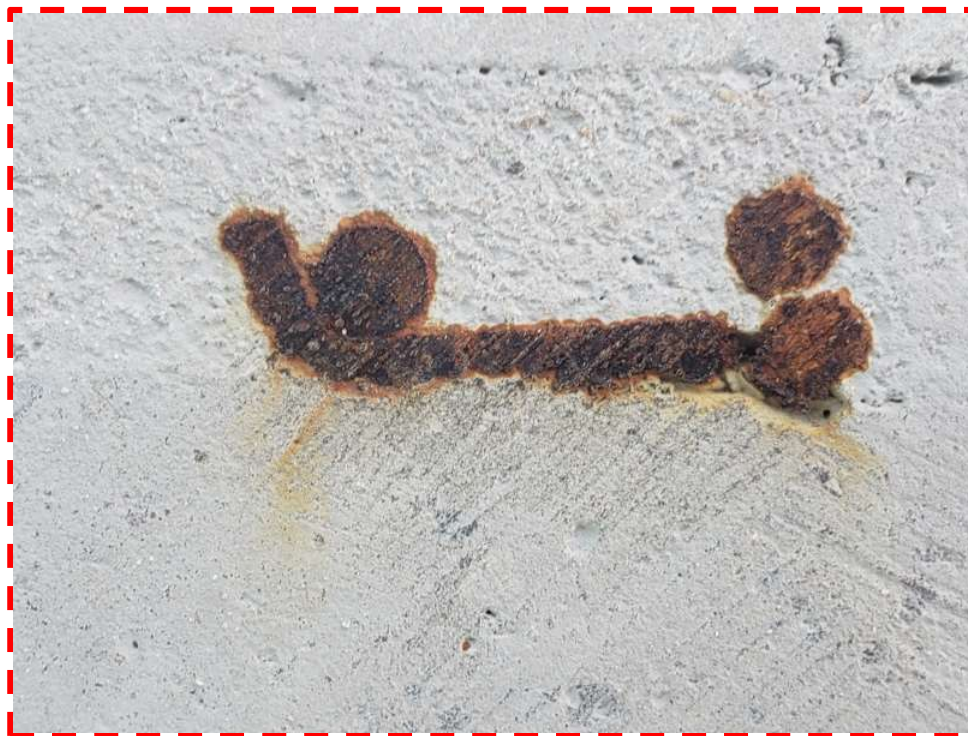
*Photo #123: Close-up view of a rusted brick anchor tie and wire (west elevation, hallway, 8/30/23).*

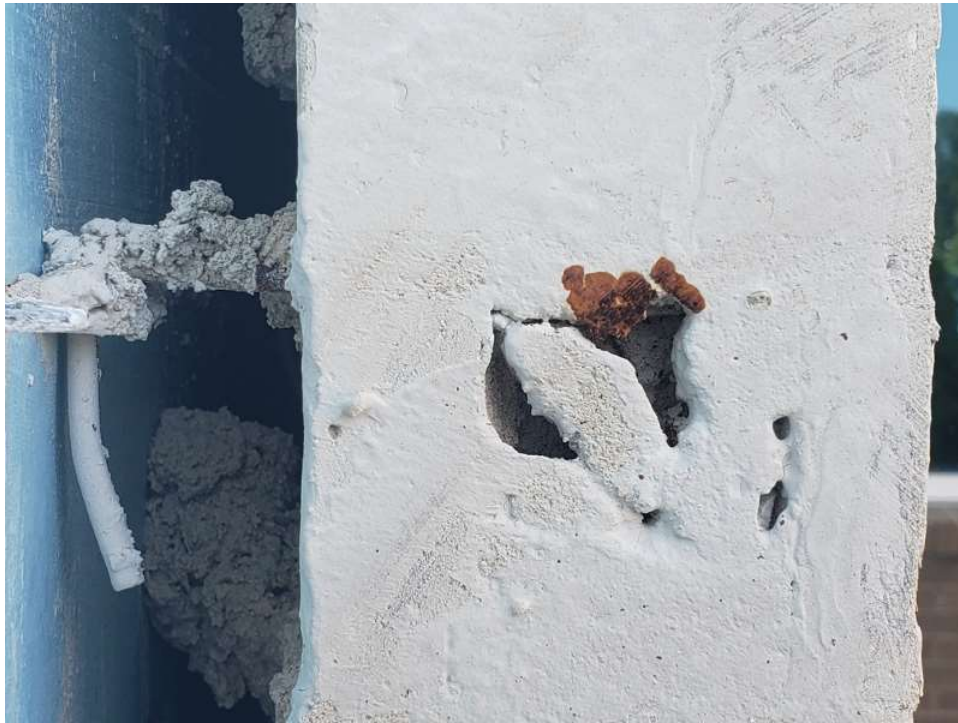
*Photo #124: View of a rusted brick anchor tie and wire, but no indication of staining on the brick surface (west elevation, hallway, 8/30/23).*

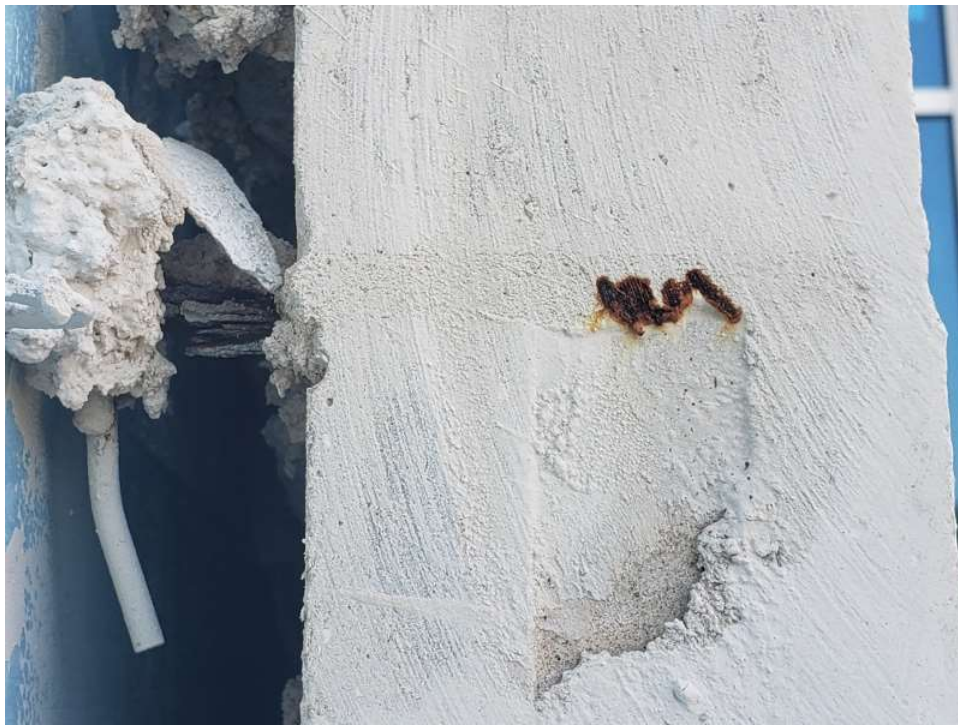
*Photo #125: View of a rusted brick anchor tie and wire, but no indication of staining on the brick surface (west elevation, hallway, 8/30/23).*

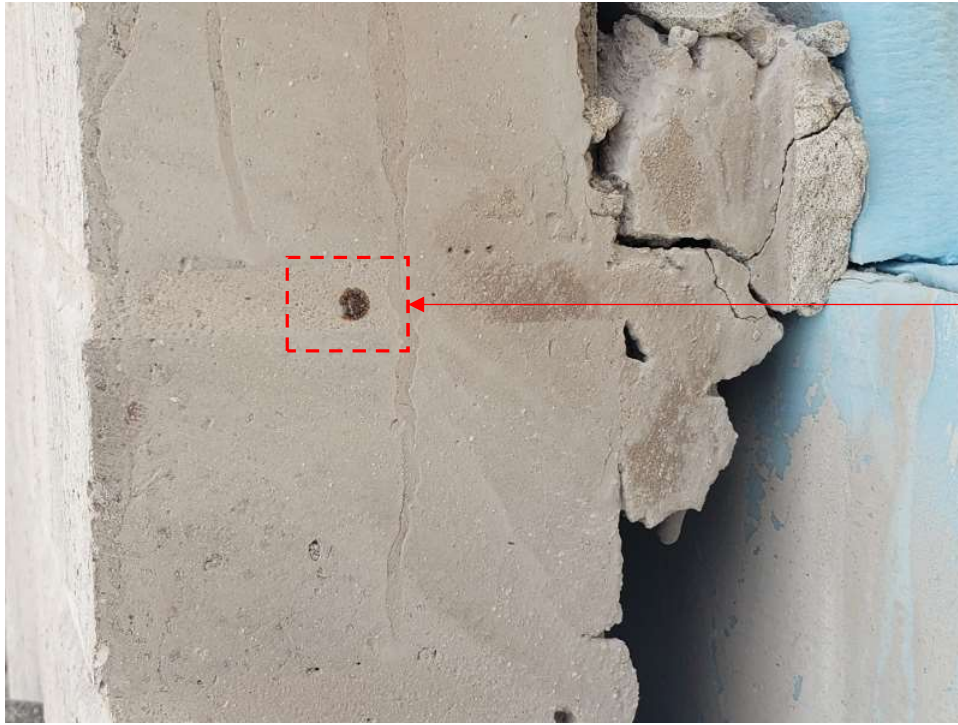
*Photo #126: View of a rusted brick wire, but no indication of staining on the brick surface (west elevation, stairwell, 8/30/23).*

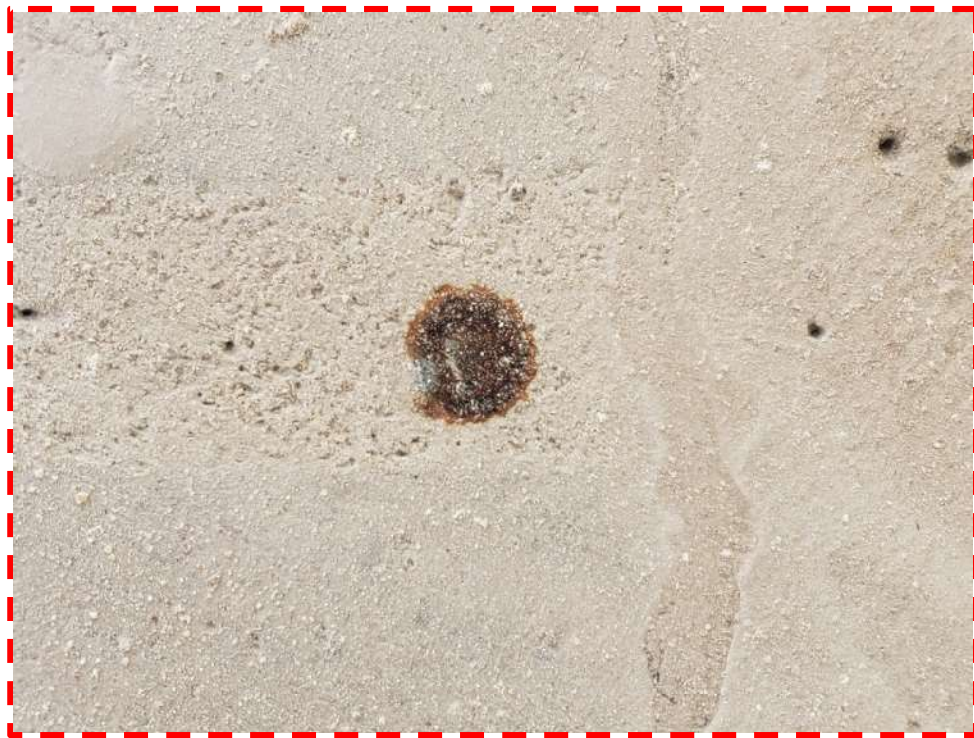
*Photo #127: Close-up view of rusted brick wire (west elevation, stairwell, 8/30/23).*

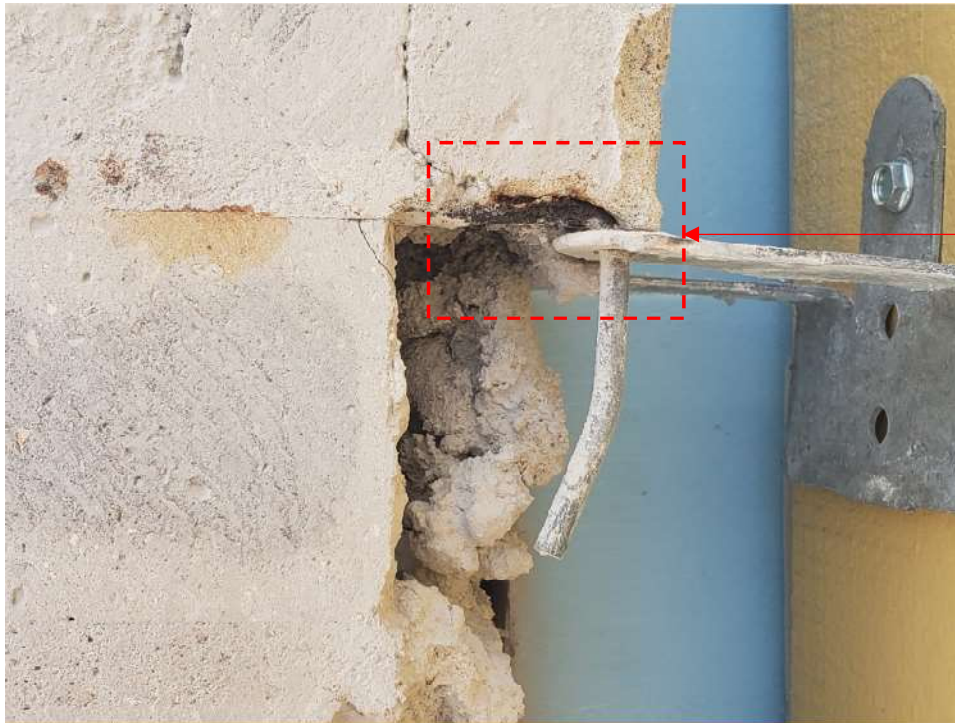
*Photo #128: View of a rusted brick wire, but no indication of steel corrosion where not embedded in the mortar joint (west elevation, stairwell, 8/30/23).*

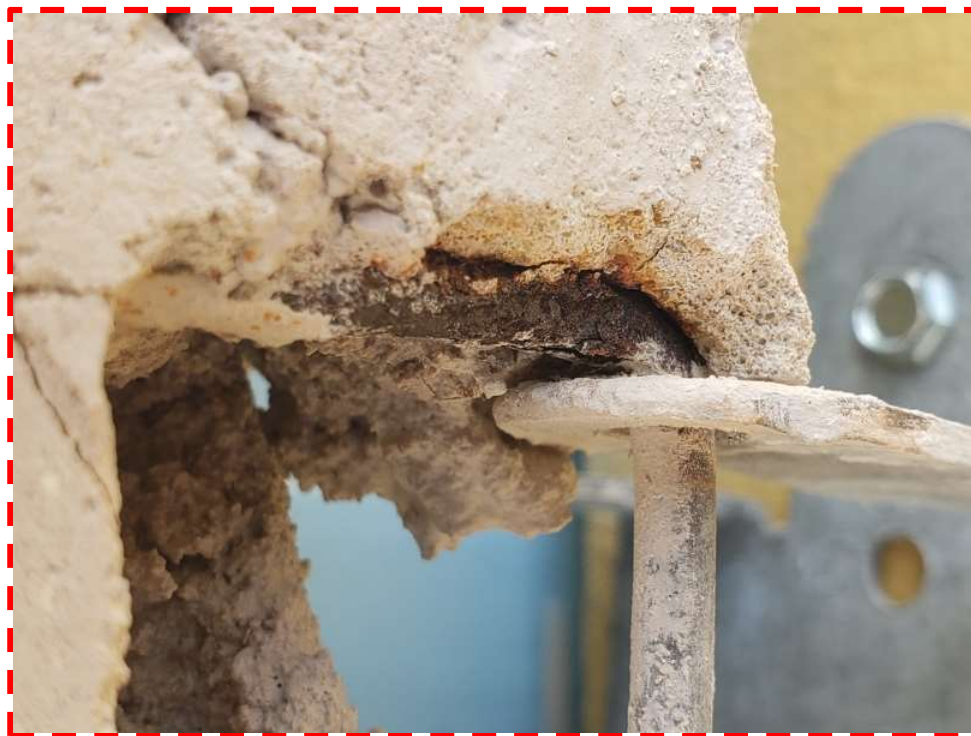
*Photo #129: Close-up view of rusted brick tie in direct contact with the mortar, but no indication of steel corrosion where not embedded in the mortar joint (west elevation, stairwell, 8/30/23).*
