Behind the Walls: The Silent Collapse of Structural Integrity

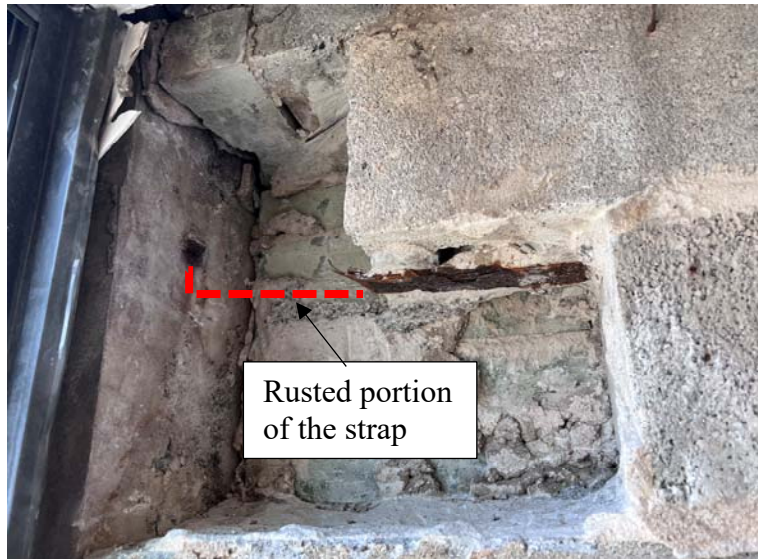
1. Sever corrosion of existing metal strap.

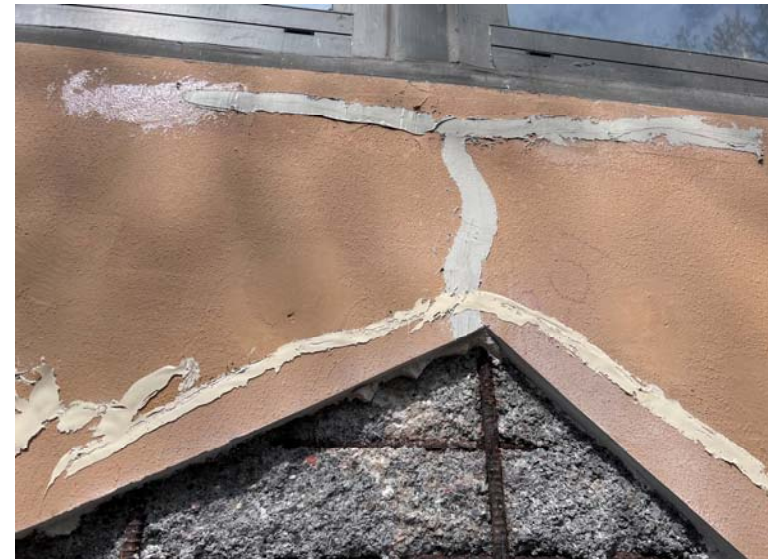
2. Previous maintenance repair to address the cracks on the precast panel. It is evident from pictures that rebar is severely corroded.

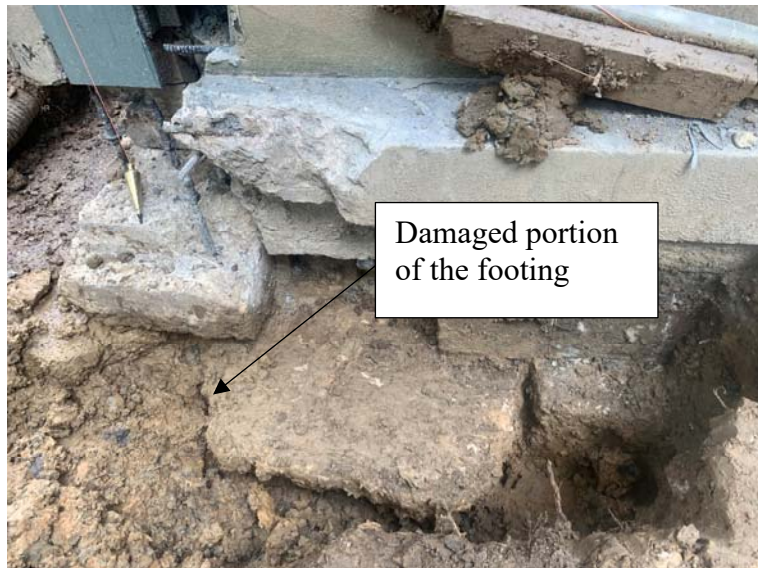
3. A portion of the footing is damaged due to poor soil condition and an inadequate water management system.

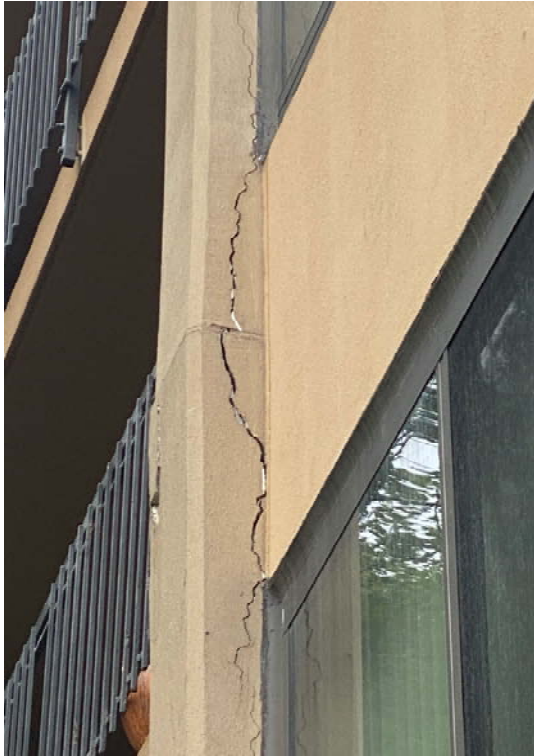
5. Concrete cracks in the precast column segments.

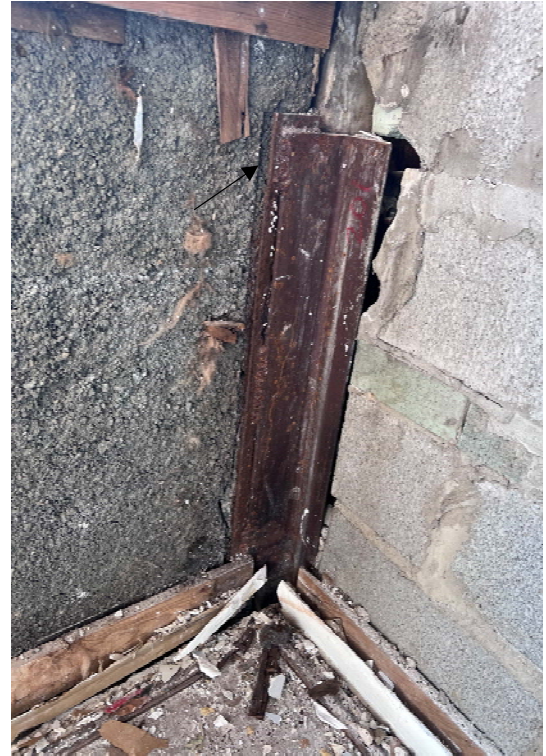
6. Disengagement of the mechanical embedment from the spandrel panel.

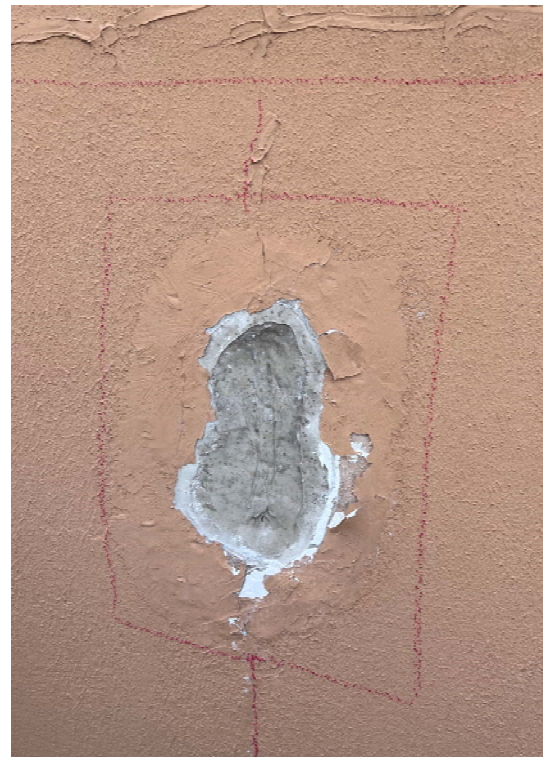
8. Another example of previous maintenance repair; the spall has been filled with sealant.

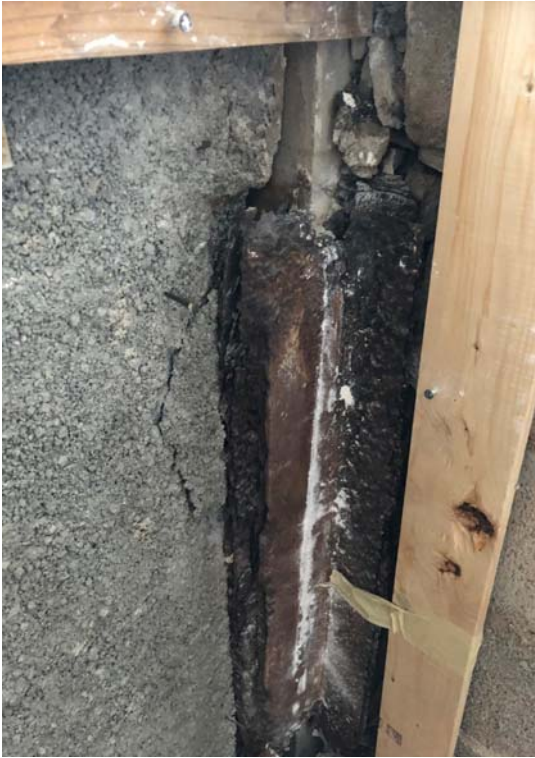
9. Severe corrosion of steel connections. Image from interior showing disengagement.

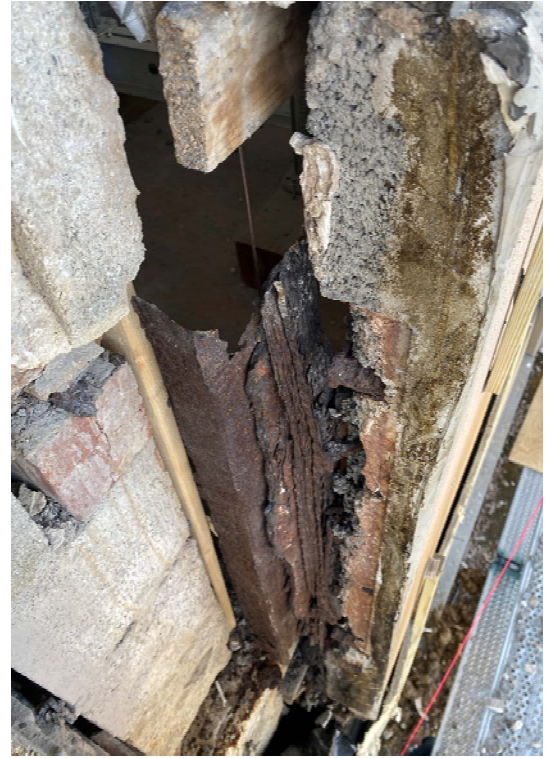
10. Severe corrosion of steel connections. Image taken from exterior after column was demolished.

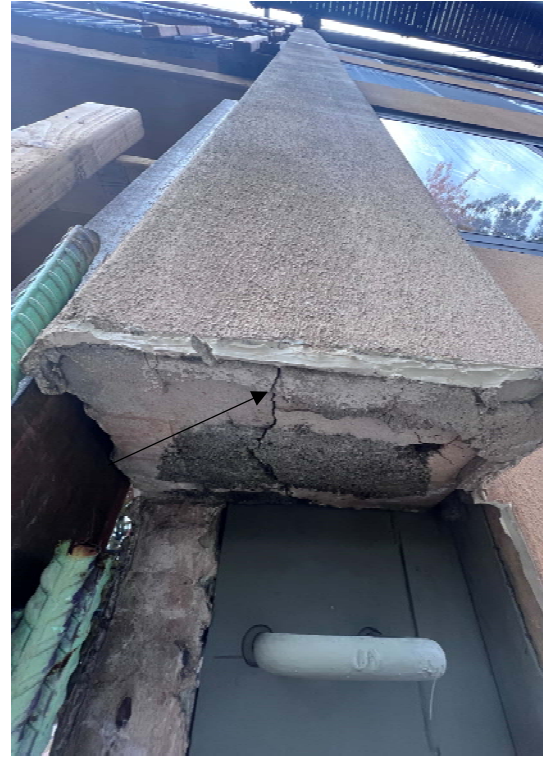
12. Cracks hidden by the coating.

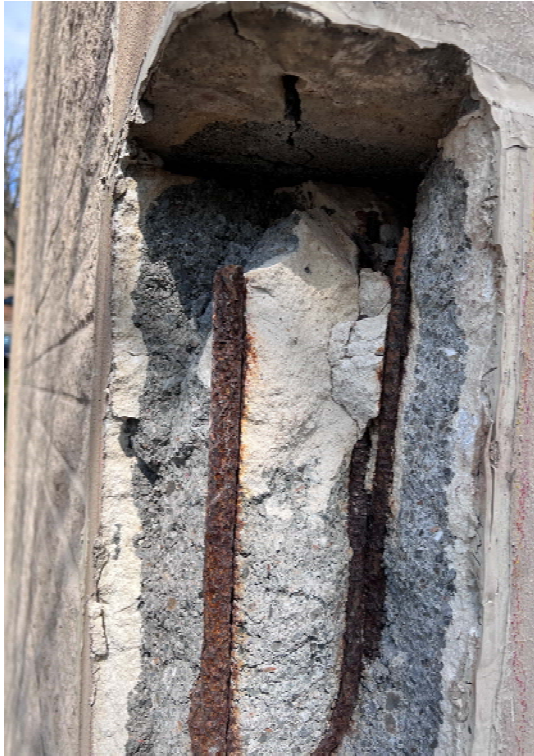
13. The concrete column profile and sever corrosion of rebars.
