THE ATRIUM

1079 COMMONWEALTH AVE BOSTON, MA

1 February 2024

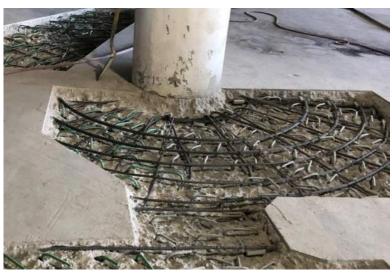
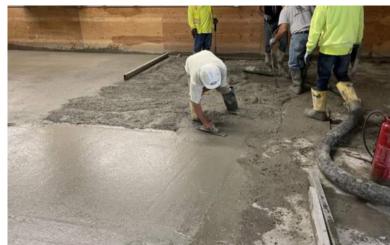
CORBEL AND COLUMN REPAIRS

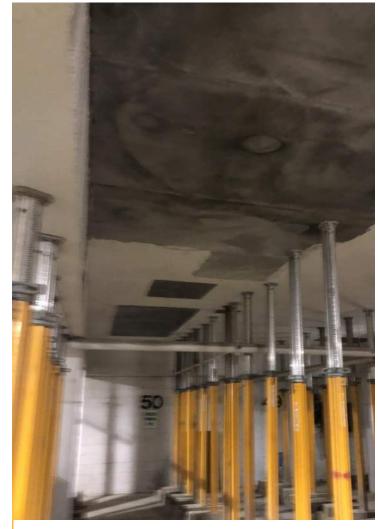
LARGE TOPSIDE NEG. MOMENT REPAIRS

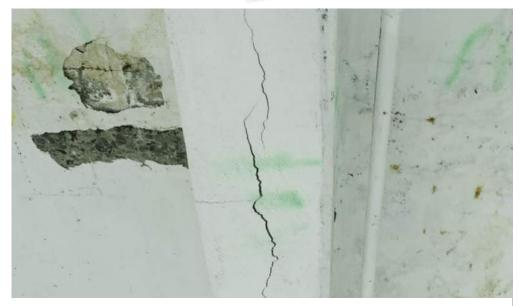
FULL-DEPTH SLAB REPAIRS

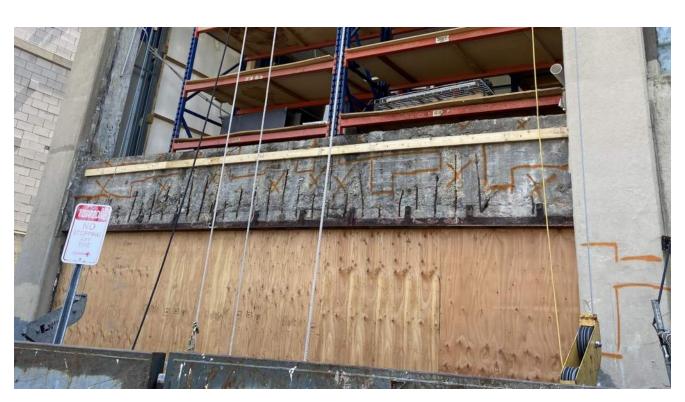
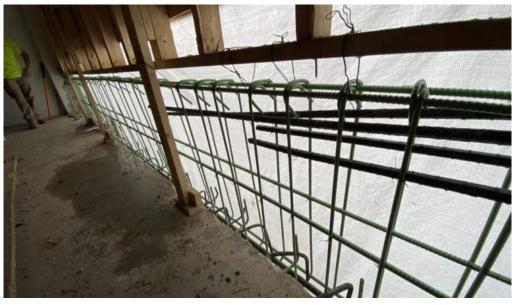
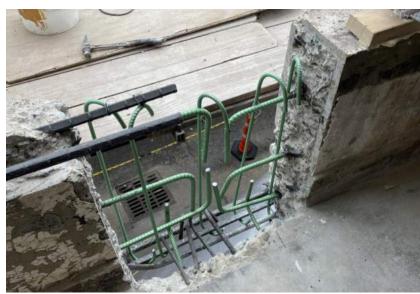
Unique Repair Conditions – Beam Repairs

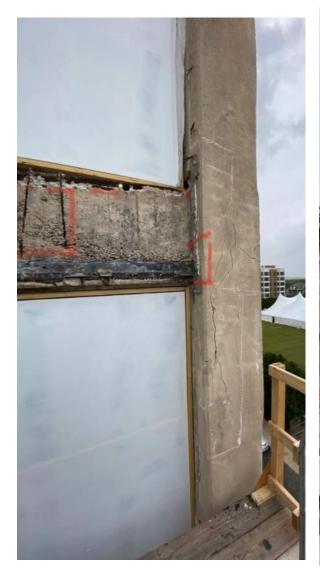
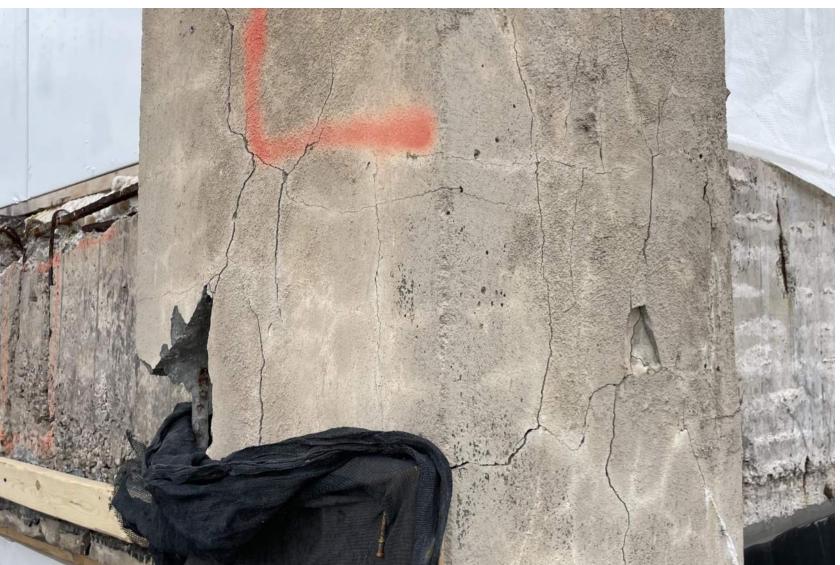
Unique Repair Conditions – Corner Column

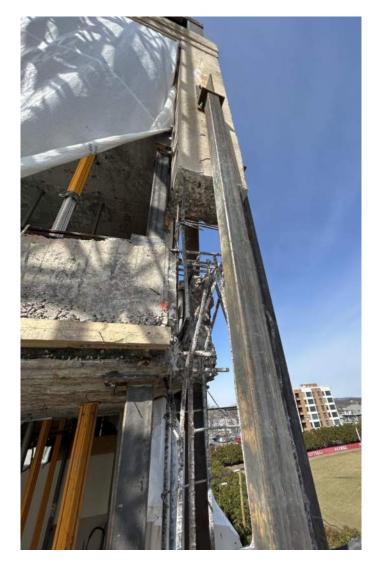
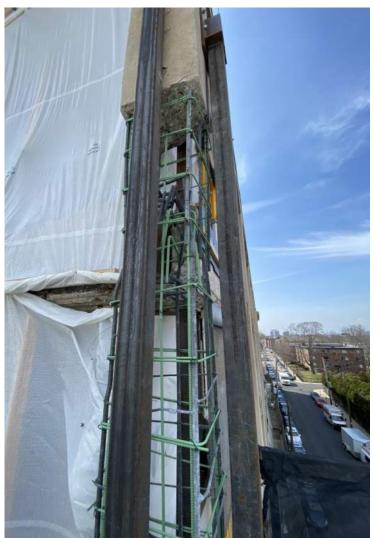
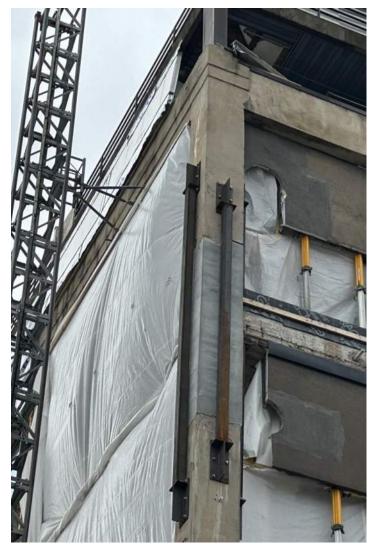
Unique Repair Conditions – Corner Column
