*Table #2: Summary of the project glass samples that were included in the evaluation.*

## II. Common Glass Evaluation Techniques

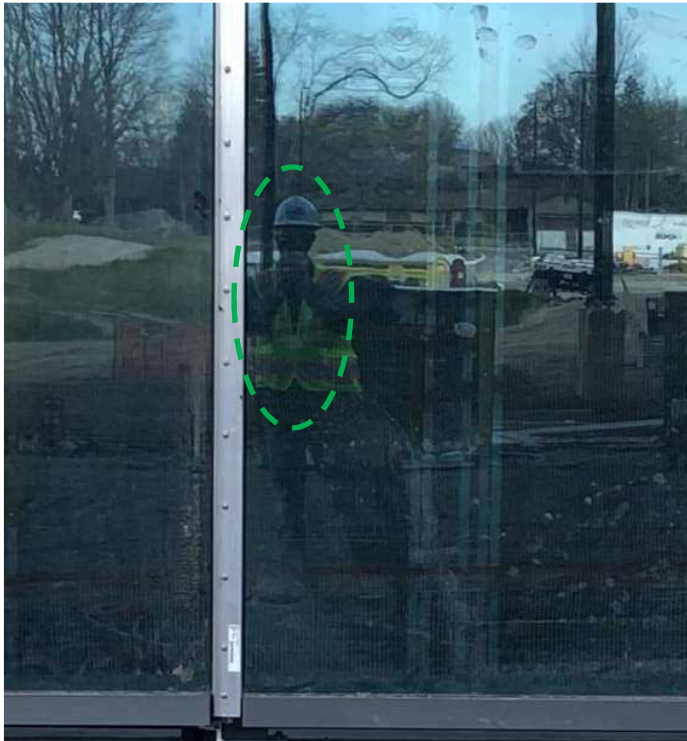
*Photo #1: Non-distorted reflected image of a person at the project site.*

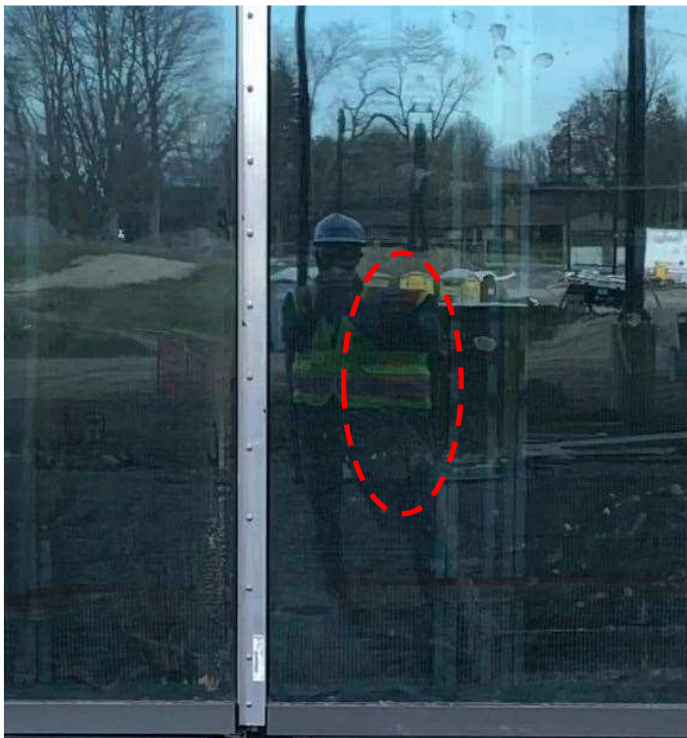
*Photo #2: Distorted reflected image of a person after moving slightly towards the right.*

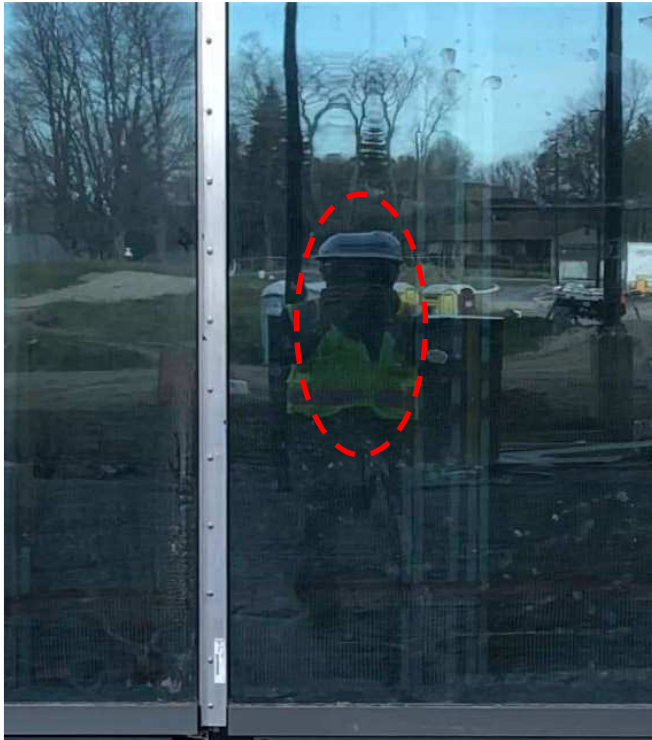
*Photo #3: Distorted reflected image of a person after moving slightly further towards the right.*

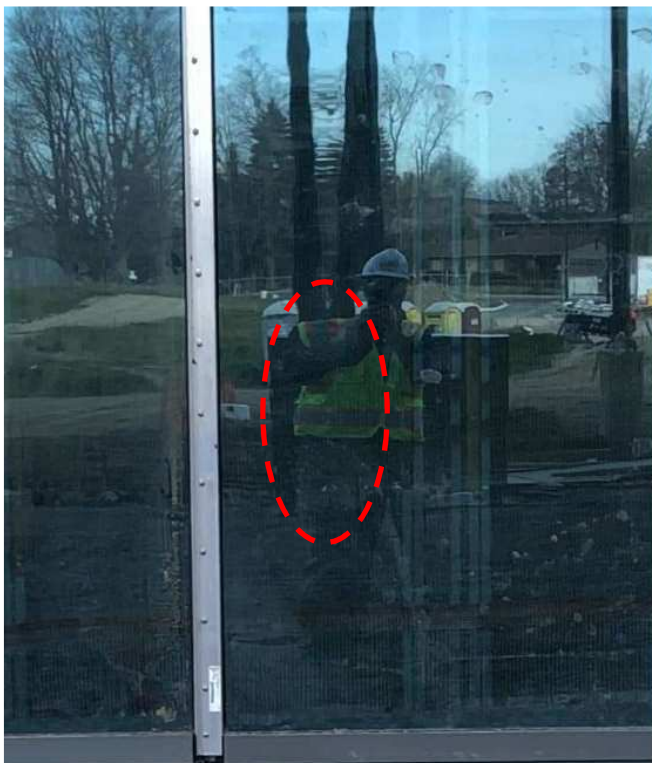
*Photo #4: Distorted reflected image of a person after moving slightly further towards the right.*

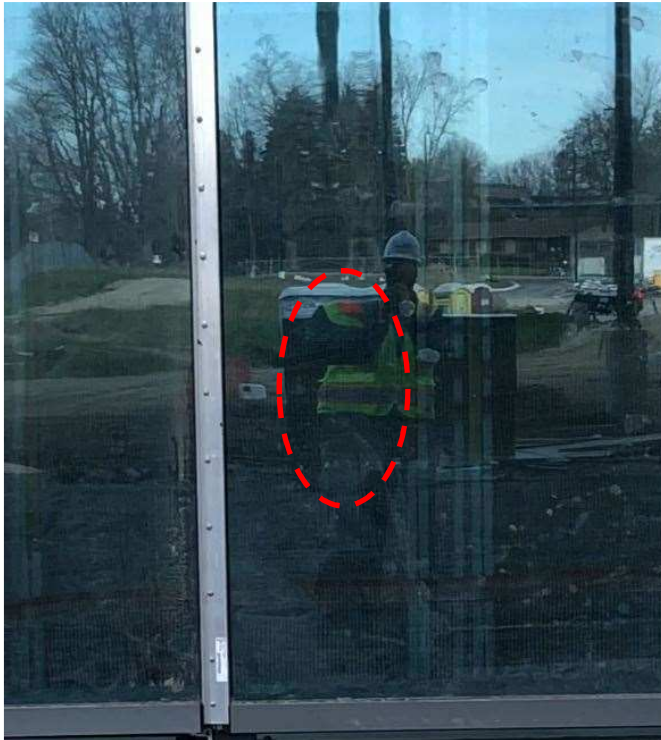
*Photo #5: Distorted reflected image of a person after moving slightly further towards the right.*

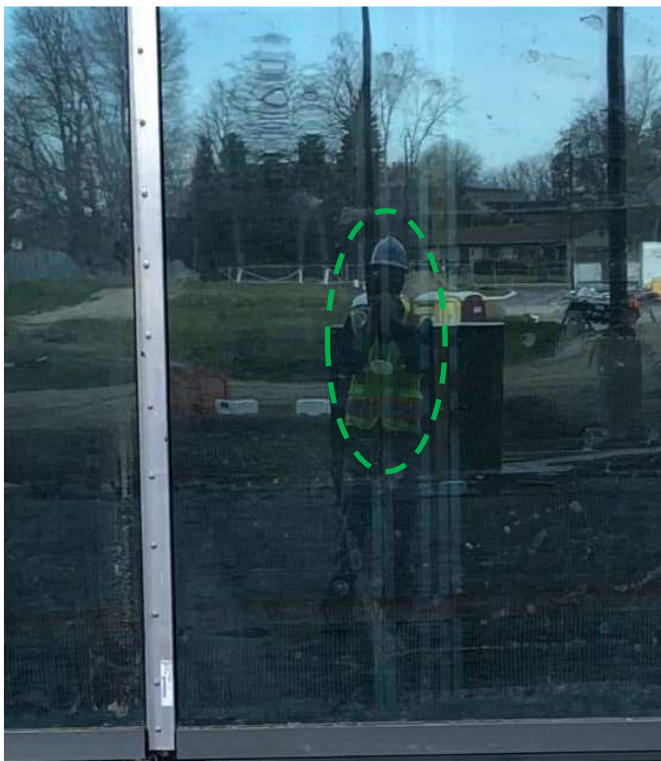
*Photo #6: Non-distorted reflected image of a person after moving slightly further towards the right.*

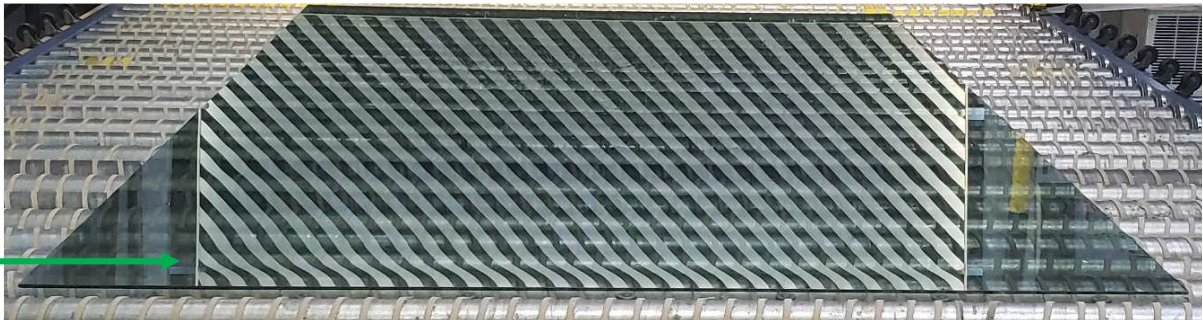
*Photo #18: Zebra board visual evaluation of the baseline control glass sample for group 4.  
Edge kink was observed, which is to be expected in heat-treated glass.*

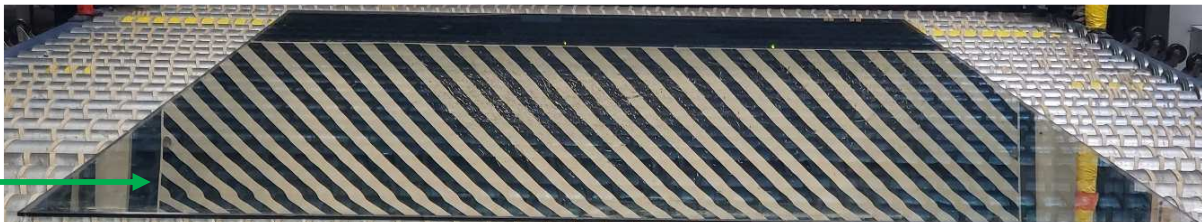
*Photo #19: Zebra board visual comparison evaluation of project glass sample D07 in Group 4.  
Edge kink was observed, which is to be expected in heat-treated glass.*

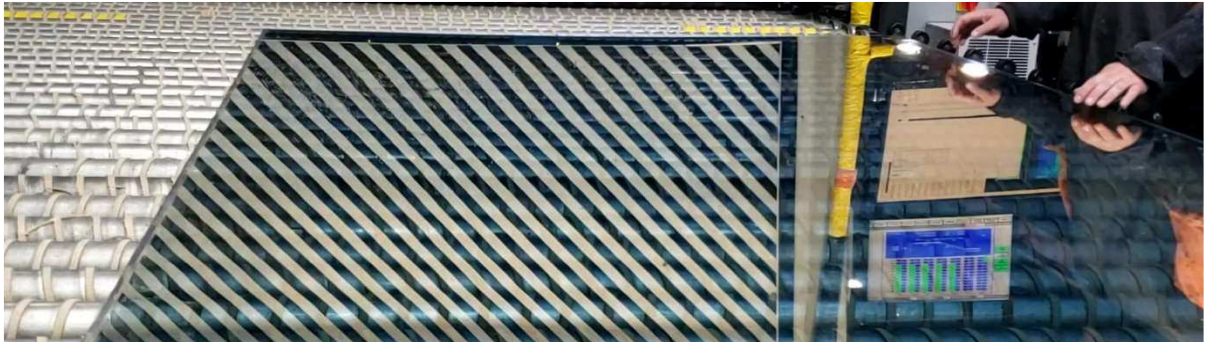
Photo #20: Vertical distortion not observed in project glass sample D07 as viewed in direction of travel through oven.

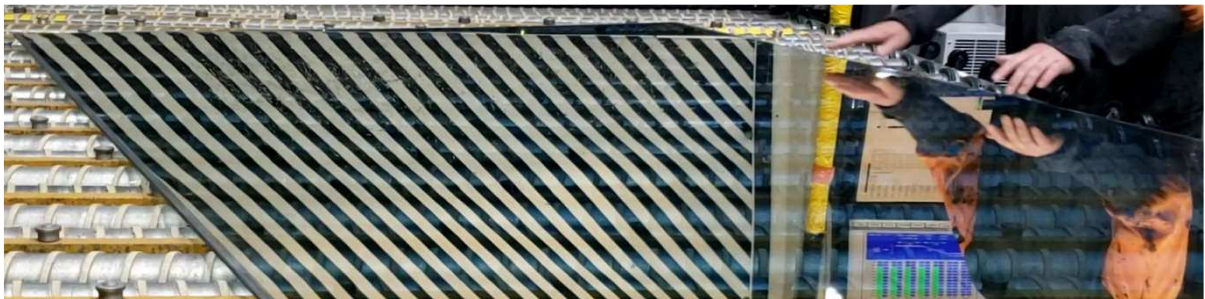
Photo #21: Vertical distortion not observed in project glass sample D07 when glass was slightly rotated counterclockwise.

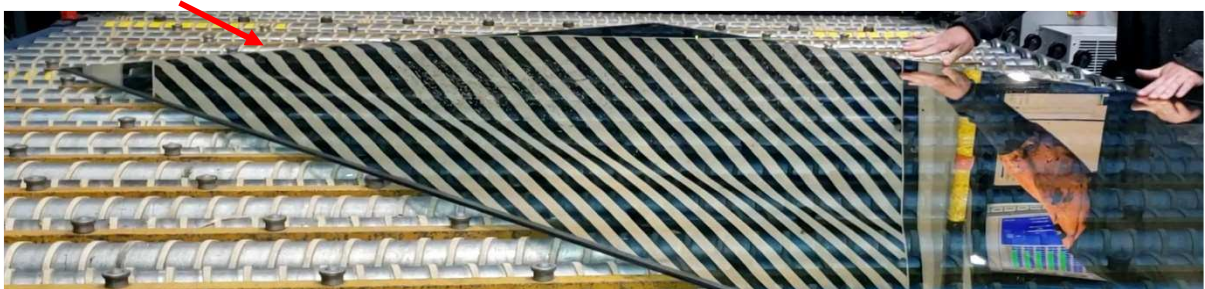
Photo #22: Localized vertical distortion starts to appear in project glass sample D07 after further rotation of the glass.

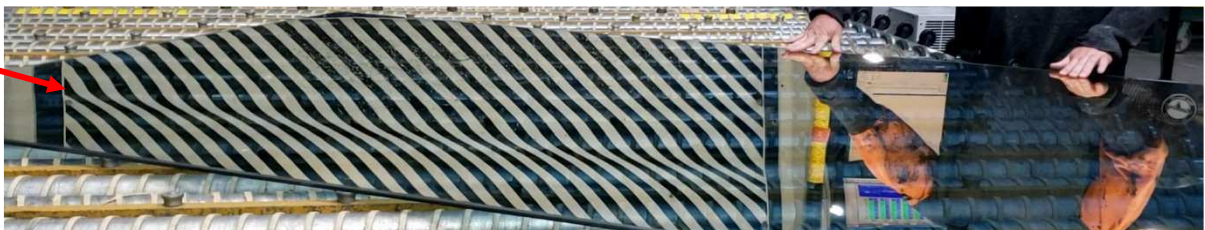
Photo #23: Localized vertical distortion is more pronounced in project glass sample D07 after further rotation of the glass.

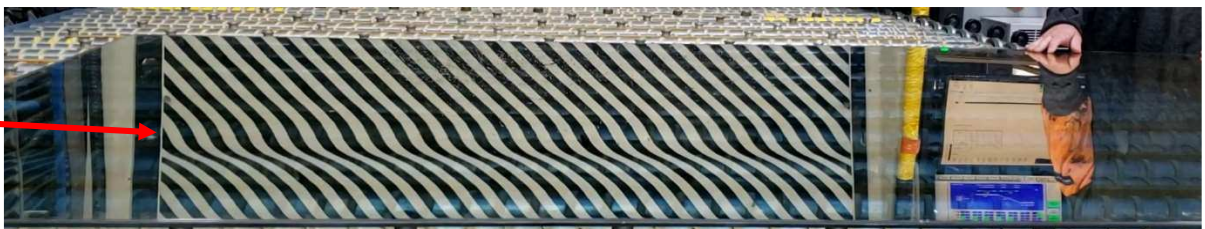
Photo #24: Localized vertical distortion was confirmed in project glass sample D07 after rotating it counterclockwise 90°.

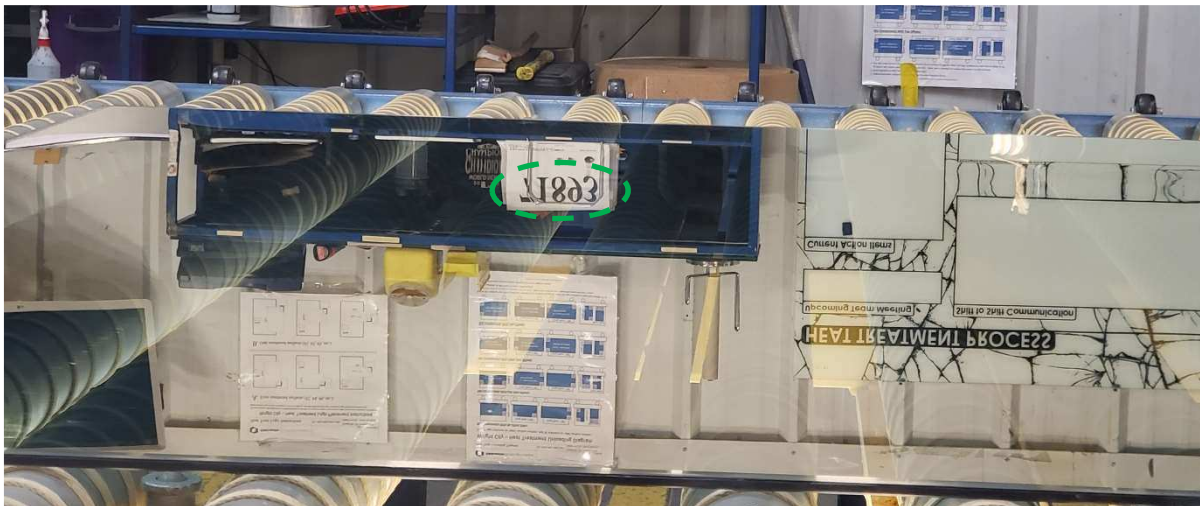
Photo #34: Side view of a reflected image (adjacent to the localized vertical distortion) on project glass sample A19.

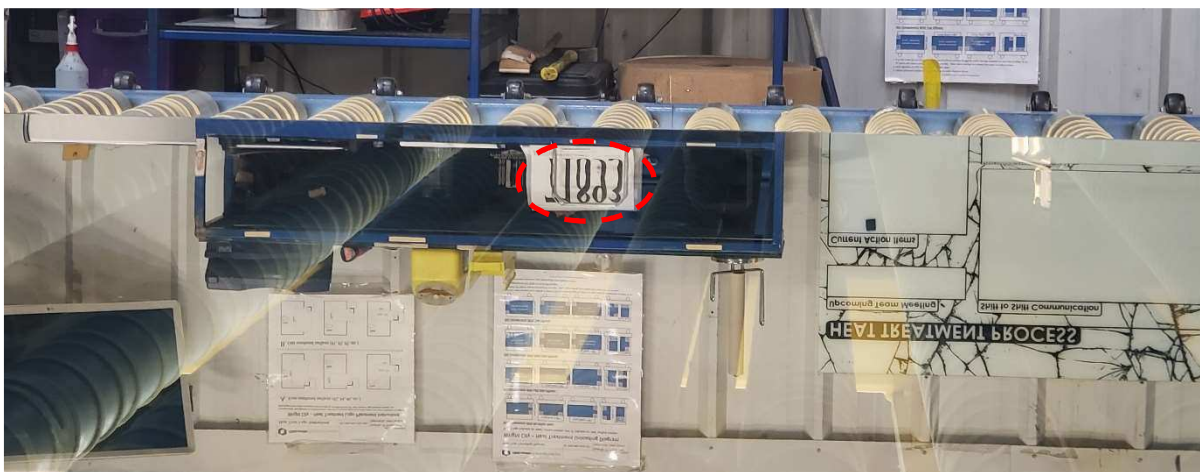
Photo #35: Side view of a distorted reflected image (at the localized vertical distortion) on project glass sample A19.

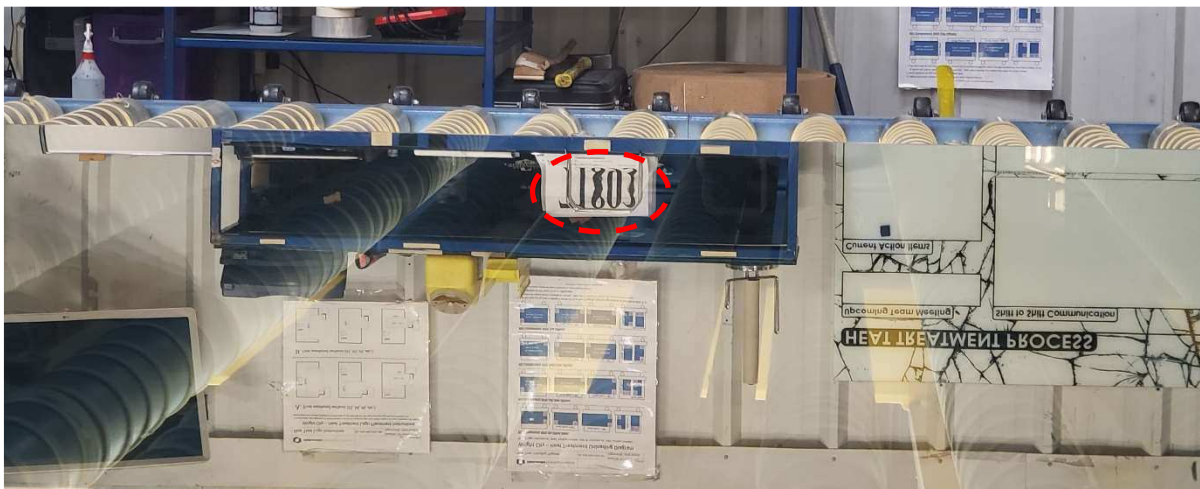
Photo #36: Side view of a distorted reflected image (at the localized vertical distortion) on project glass sample A19.

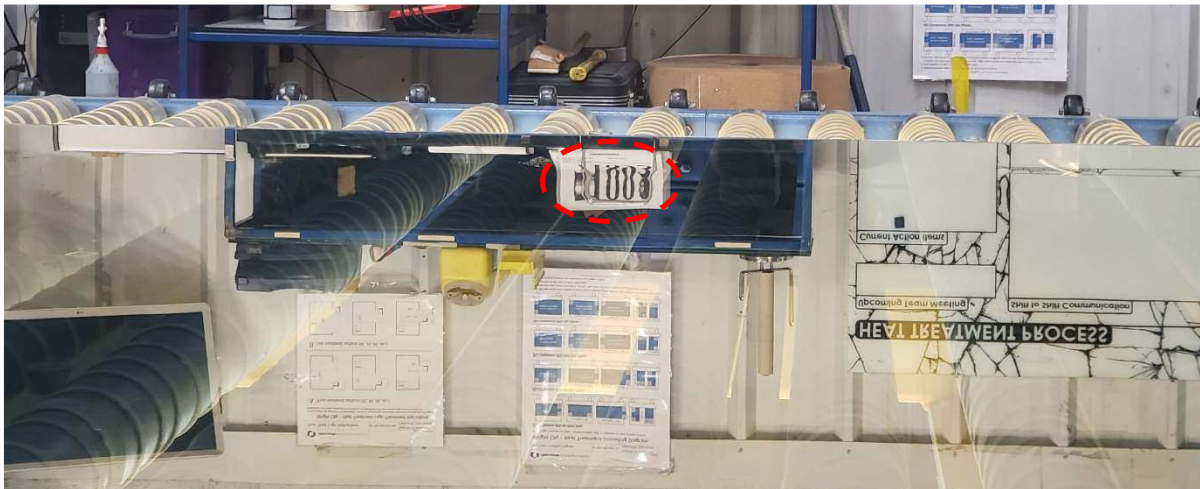
Photo #37: Side view of a distorted reflected image (at the localized vertical distortion) on project glass sample A19.

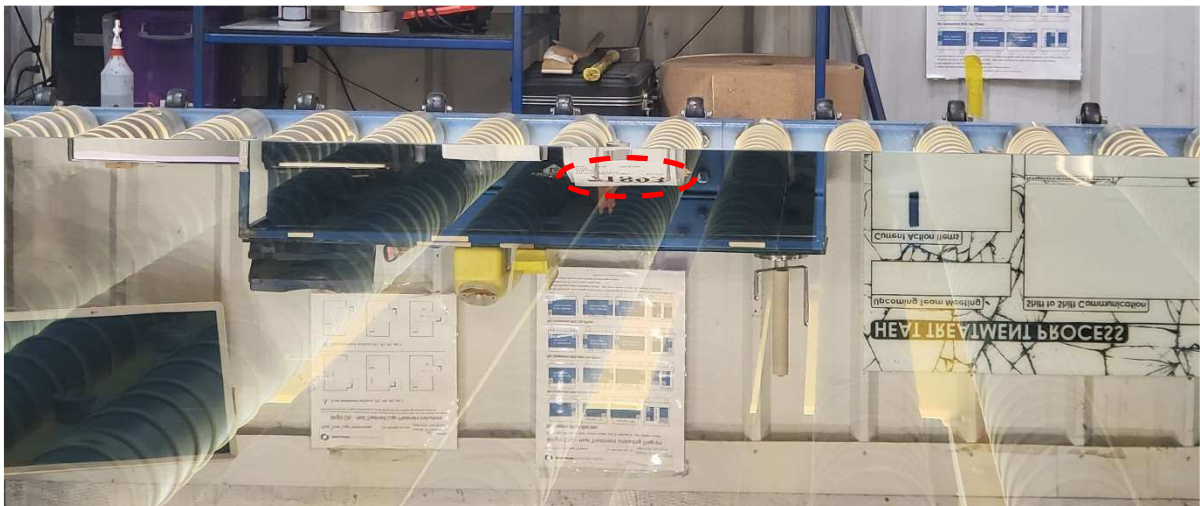
Photo #38: Side view of a distorted reflected image (at the localized vertical distortion) on project glass sample A19.

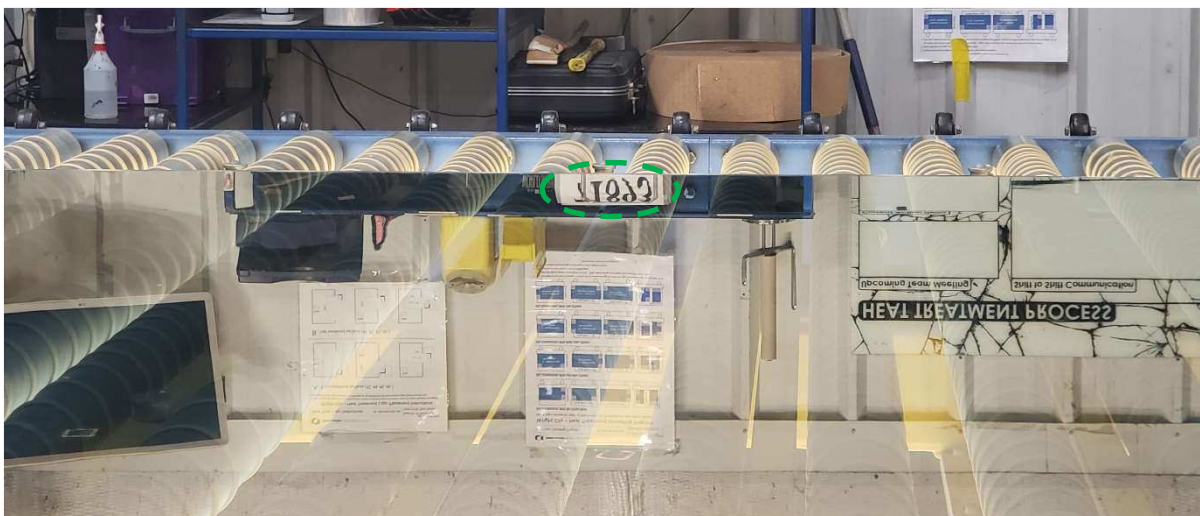
Photo #39: Side view of a reflected image (adjacent to the localized vertical distortion) on project glass sample A19.

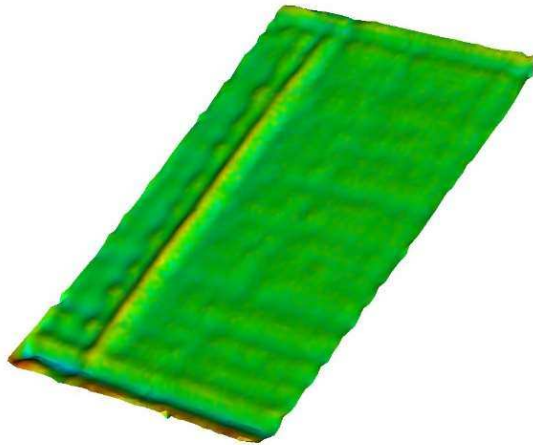
*Figure #6: 3D scan of project glass sample A13 in Group 1 shows localized vertical distortion.*

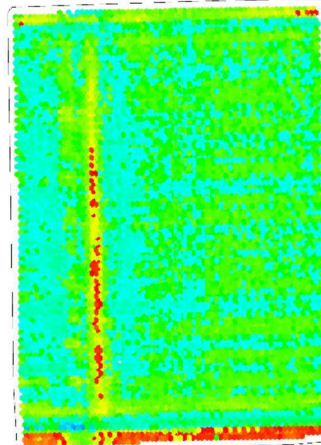
*Figure #7: 2D scan of project glass sample A13 in Group 1 shows localized vertical distortion.*

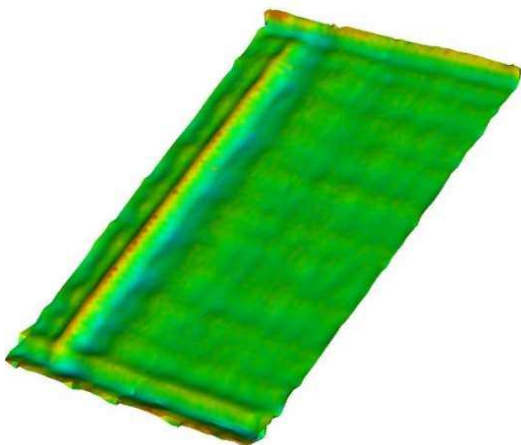
*Figure #8: 3D scan of project glass sample A17 in Group 1 shows localized vertical distortion.*

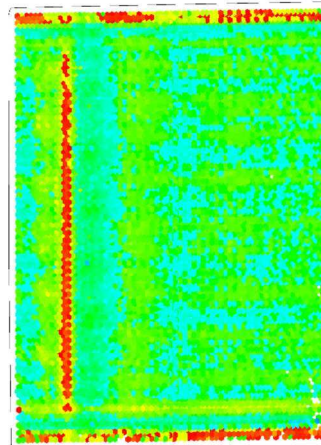
*Figure #9: 2D scan of project glass sample A17 in Group 1 shows localized vertical distortion.*

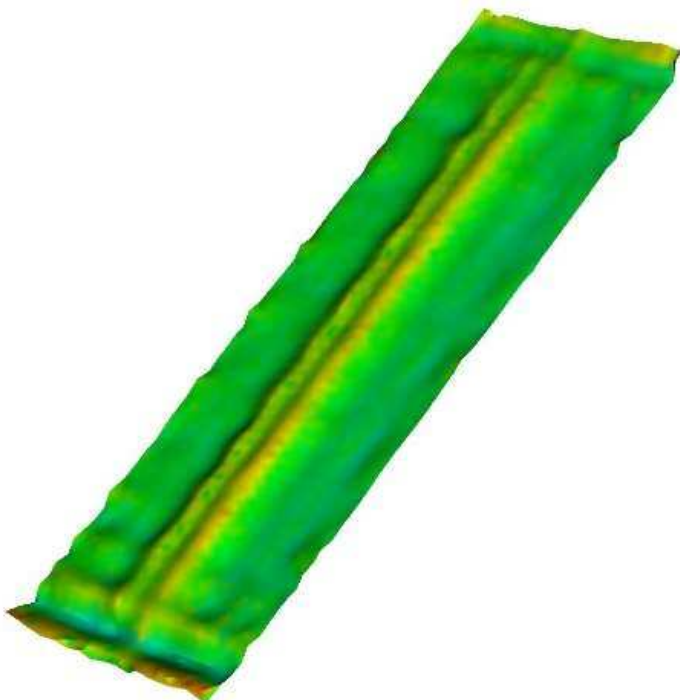
*Figure #16: 3D scan of project glass sample A30 in Group 2 shows localized vertical distortion.*

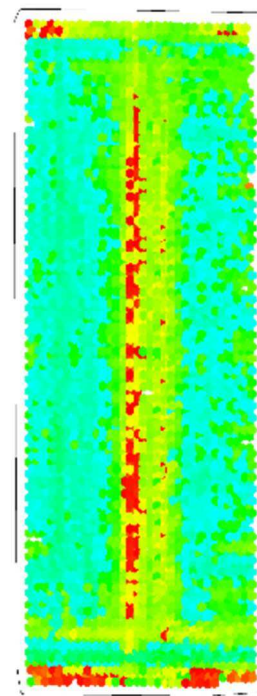
*Figure #17: 2D scan of project glass sample A30 in Group 2 shows localized vertical distortion.*

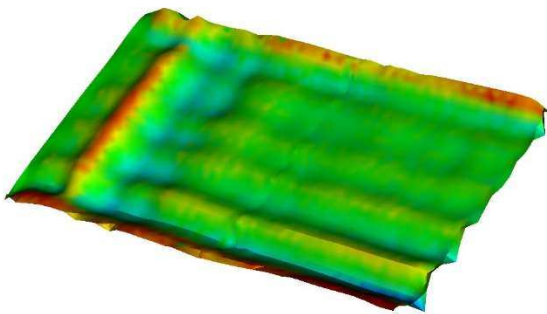
*Figure #22: 3D scan of project glass sample B13 in Group 3 shows localized vertical distortion.*

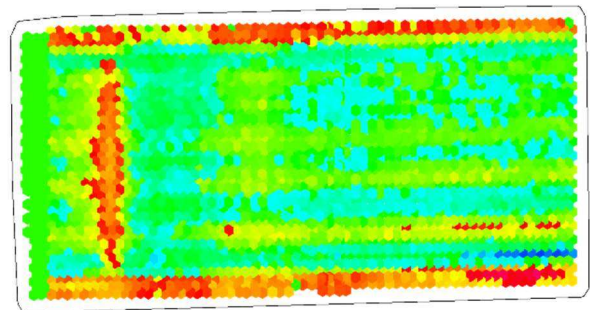
*Figure #23: 2D scan of project glass sample B13 in Group 3 shows localized vertical distortion.*

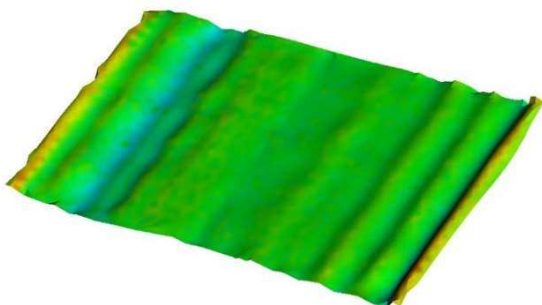
*Figure #24: 3D scan of project glass sample B17 in Group 3 shows a vertical roll wave pattern.*

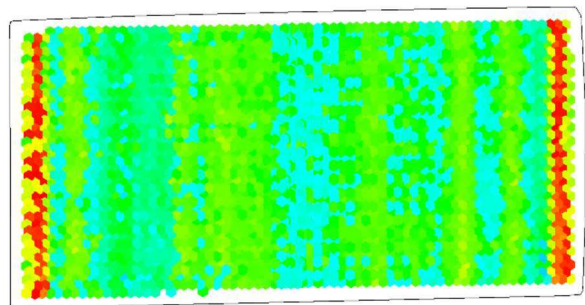
*Figure #25: 2D scan of project glass sample B17 in Group 3 shows a vertical roll wave pattern.*

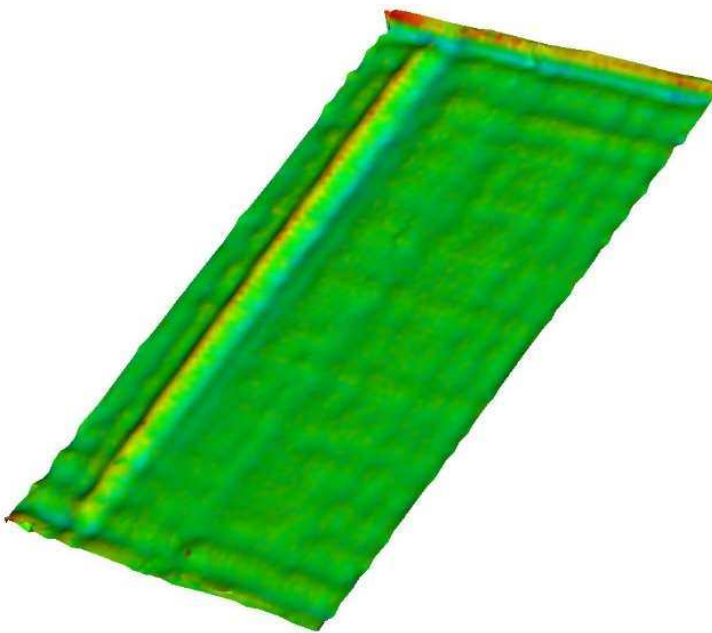
*Figure #28: 3D scan of project glass sample D07 in Group 4 shows localized vertical distortion.*

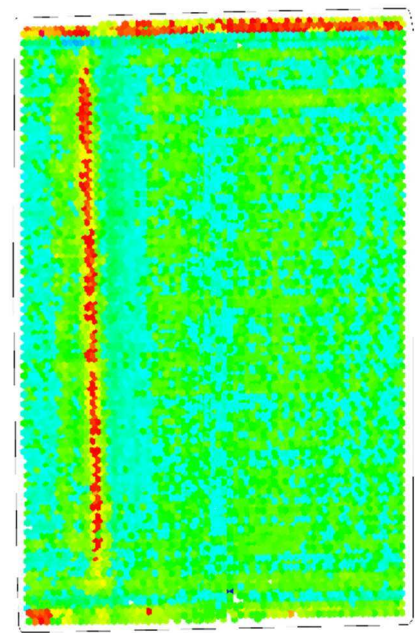
*Figure #29: 2D scan of project glass sample D07 in Group 4 shows localized vertical distortion.*
