Mold in Building Constructions in the Nordic Countries – With Emphasis on Roofs

Erik Brandt
Danish Building Research Institute (SBI)
Tommy Bunch-Nielsen
Danish Roofing Advisory Board (TOR)

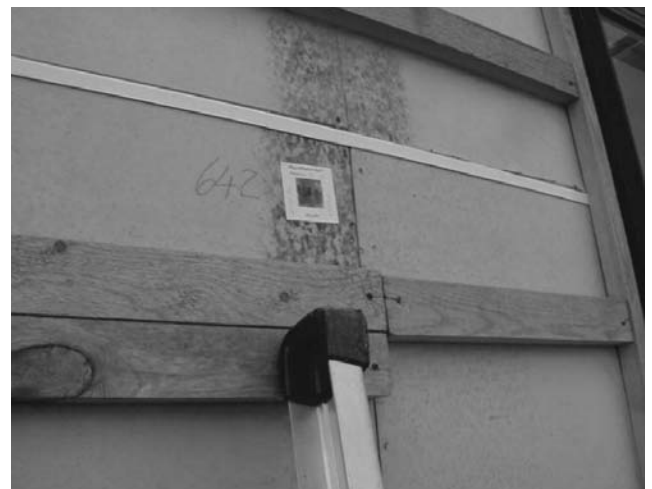
Figure 1 – Example of a ventilated façade with mold growth on the wind barrier (made by gypsum boards). Often mold growth in façades is due to water penetrating behind the cladding without being drained out (fast enough).

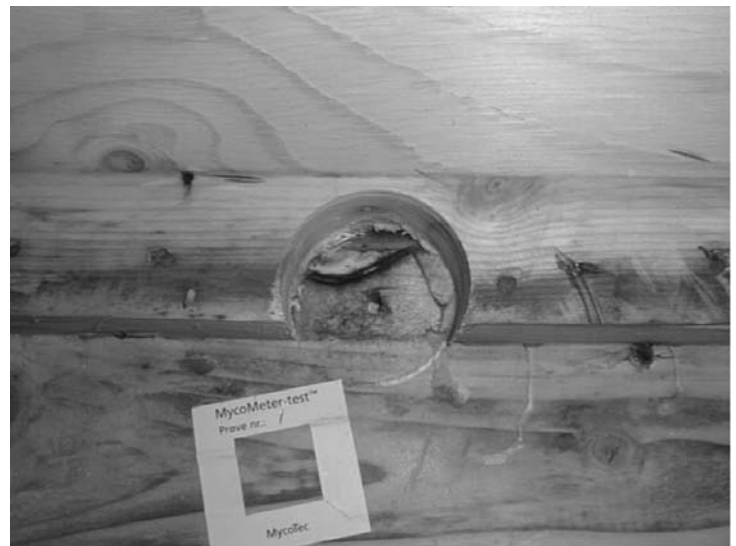
Figure 3 – Roof element in a new school with massive mold growth. The roof elements are prefabricated and meant to be sealed immediately after assembling. Lack of sealing, however, leads to penetration of water and eventually mold growth. The renovation included opening of the prefabricated elements, removal of insulation, and cleaning of the wooden surfaces in the elements. Afterwards, the elements were restored with new insulation and vapor barrier.

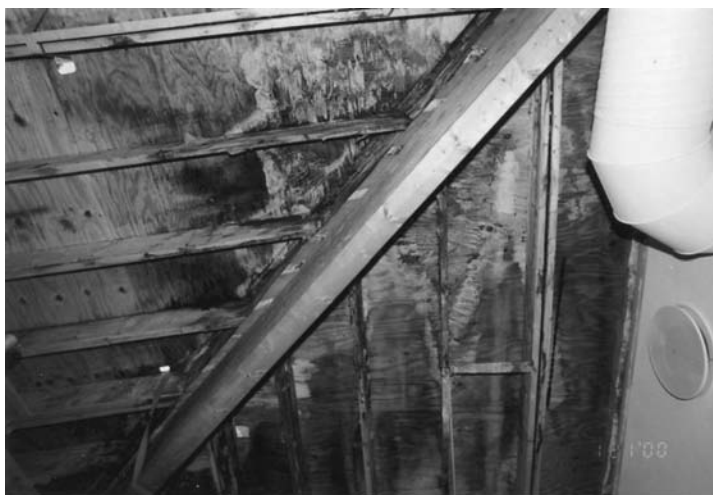
Figure 4 – Mold growth and deterioration of plywood in a sloped roof made from wood-based elements assembled in situ. Due to leaks in the interior joints between elements in the corners - and consequently also leaks in the vapor barrier – humid air has penetrated into the construction, where it condensates on the cold surfaces above the insulation.

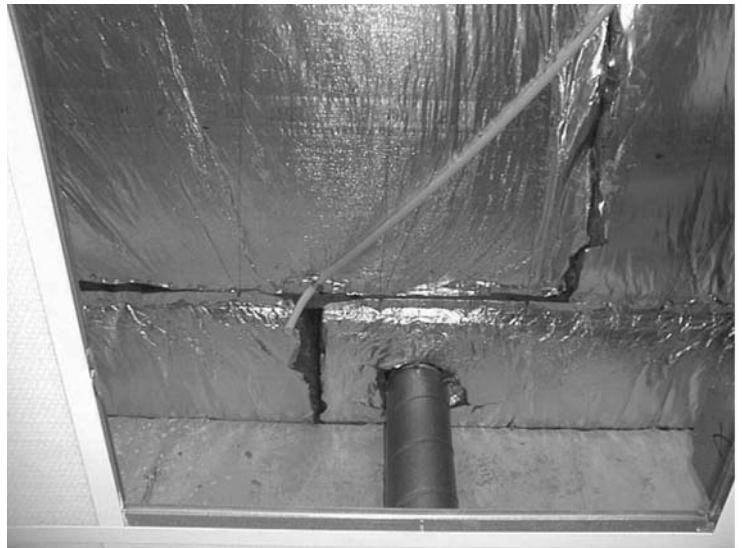
Figure 5 – Vapor barrier with leaks at joints and pipe penetration in a school. The entire school was built in the same way. The consequence was that there was massive mold growth in all roofs and that a major renovation was necessary to remove the mold.

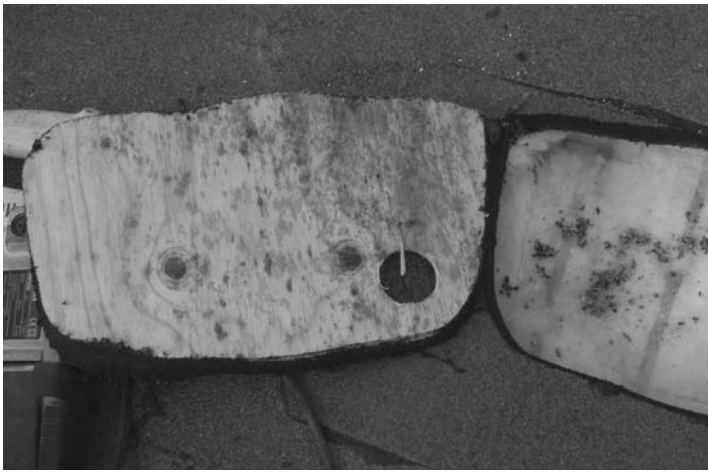
Figure 6 – Mold on plywood in roof element with Hygrodiode. This roof element was in the shade from a higher part of the building and consequently was not heated sufficiently to force the moisture down to the inner surface.

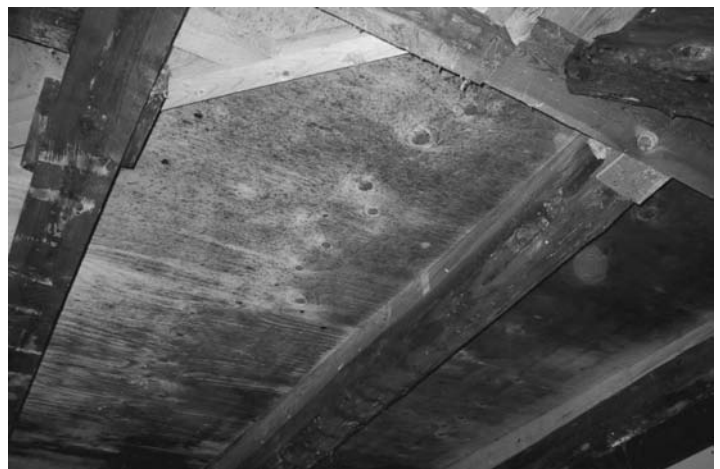
Figure 7 – Mold growth on plywood substrate for roofing felt in a ventilated roof due to sub-cooling caused by radiation to the sky. Plywood is more vulnerable to mold growth than boards, probably due to the treatment during production.
