ROOF-TOP REAL ESTATE IN A WIRELESS WORLD

BY DONALD KILPATRICK

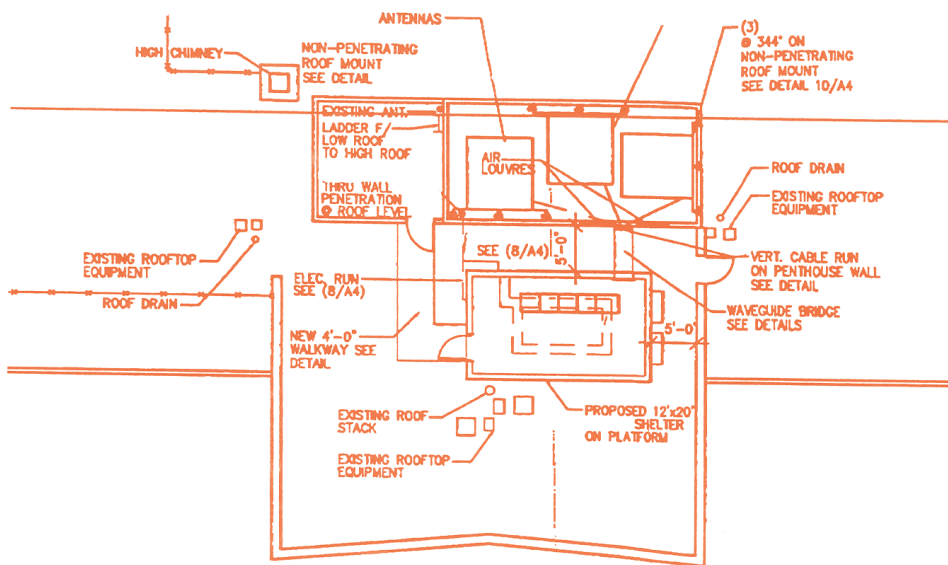
Figure 1: Both the existing and new penthouses were centered in a bay approximately 50' x 50', with rooftop penetrations limited to several PRV (Powered Roof Ventilators) and one interior roof drain.

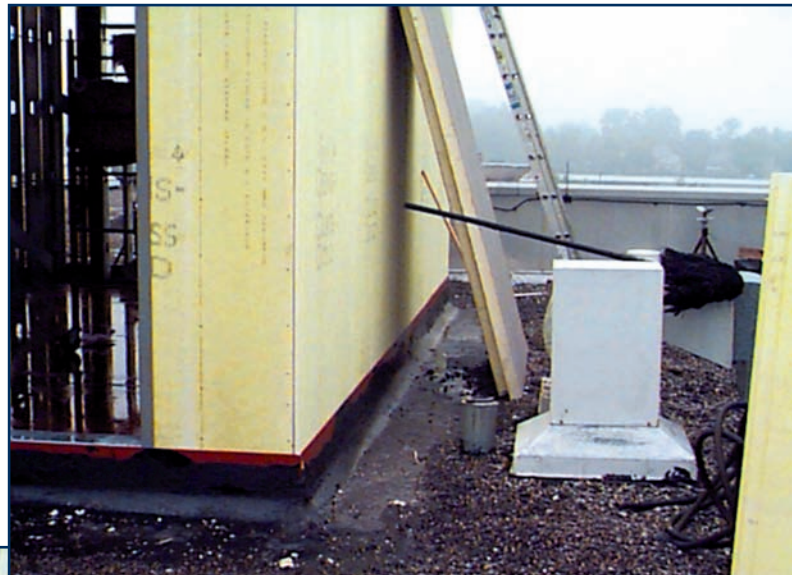
Right: Flashing of existing roof to steel curb.

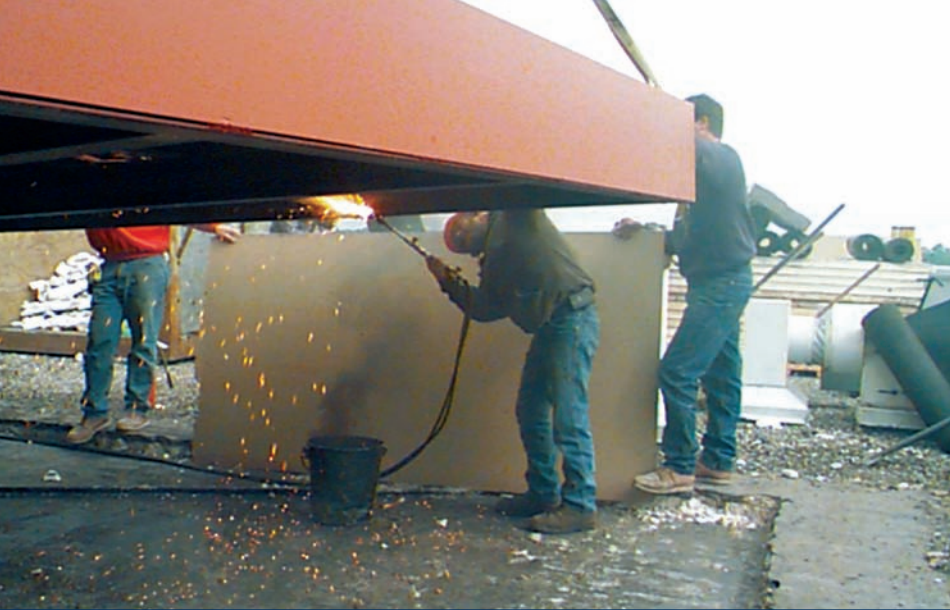
Small fire contained in bucket.

structural steel frame fabricated as the base for the penthouse addition. Notches were cut in the I-beam to accommodate the run of conduit across the involved roof area. The ensuing small fire had minimal impact on what would prove to be an eventful day.
