A PROPOSAL FOR UNIFORMLY ASSESSING HAIL DAMAGE TO ROOFS

BY LYLE D. HOGAN, FRCI, PE

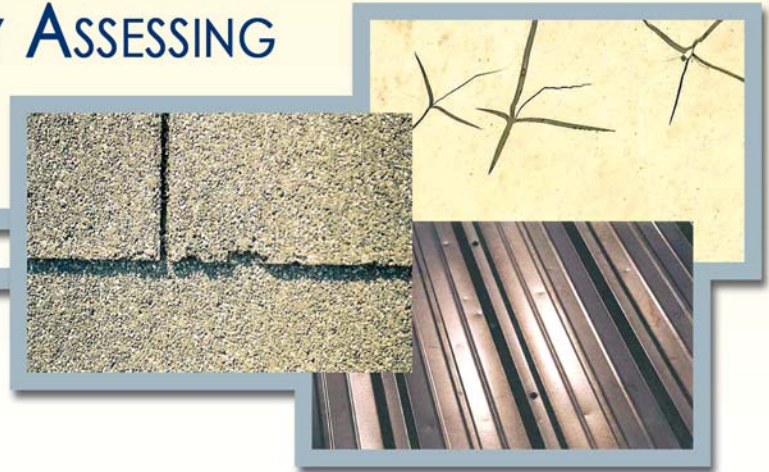
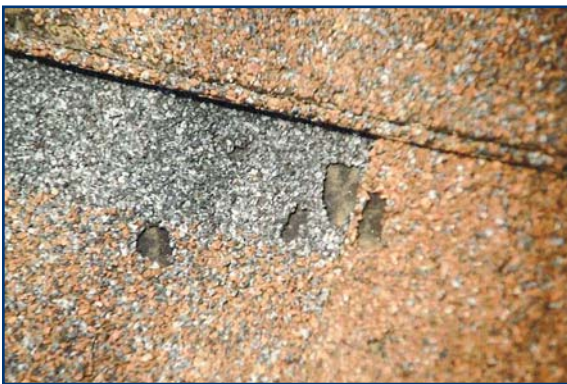
Figure 1 – Hailstone pockmarking is the loss of ceramic granules and the asphalt top coating. Where this has occurred, the shingle has been compromised, especially if the glass reinforcement is exposed.

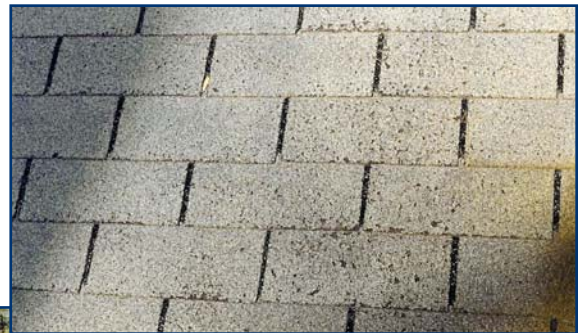
Figure 2 – “Rash blistering” is particularly likely when substandard attic ventilation is afforded. The tiny blisters can rupture under even very light contact, leaving the appearance of small pockmarks.

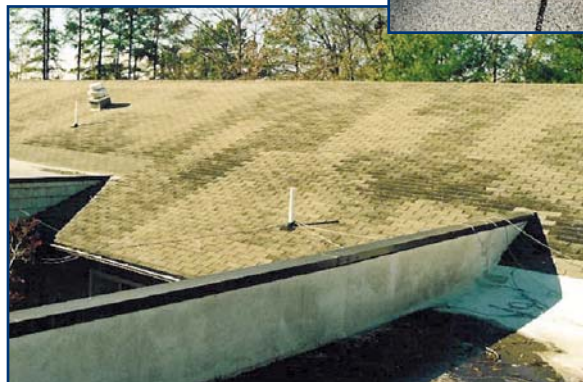
Figure 3 – Lot-to-lot variation in a shingle product.

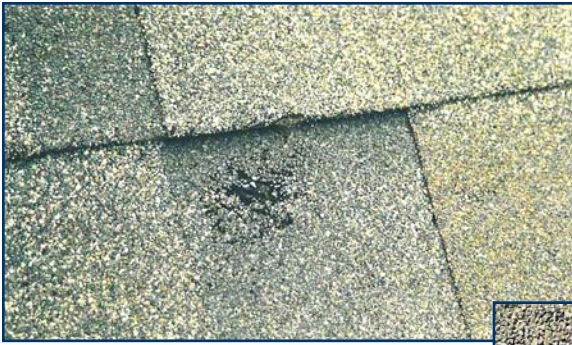
Figure 4 – “Bruising” of the protective granules but no loss of the coating asphalt. Surface temperature at the time of hail has considerable influence on damage susceptibility.

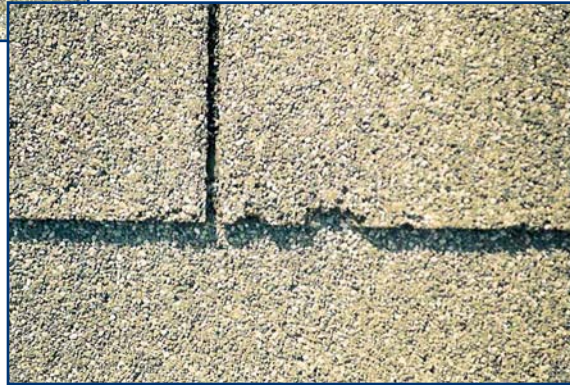
Figure 5 – Chipping of shingles edges (only) with no evidence whatsoever of ordinary pockmarking.

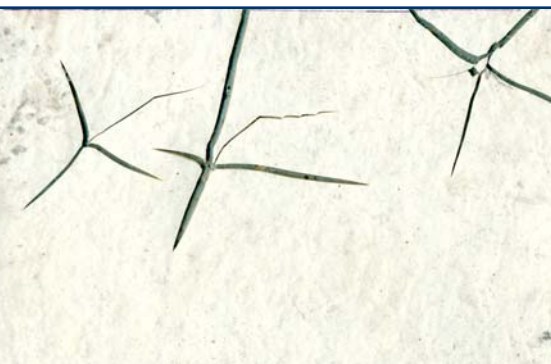
Figure 8 – Star-type breaches resulted when first-generation PVC membranes were subjected to hail.

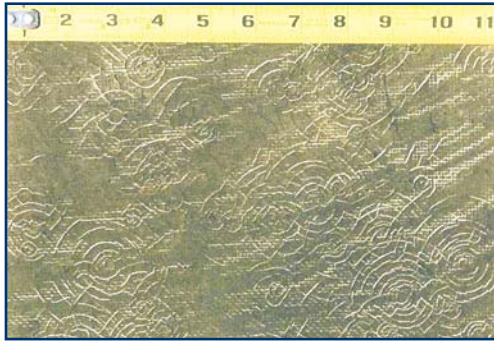
Figure 10 – a hailstorm ravaged this 1989 membrane while the older 1988 phase (same membrane vendor) was virtually unaffected. The loss should not have occurred and represents substandard product.

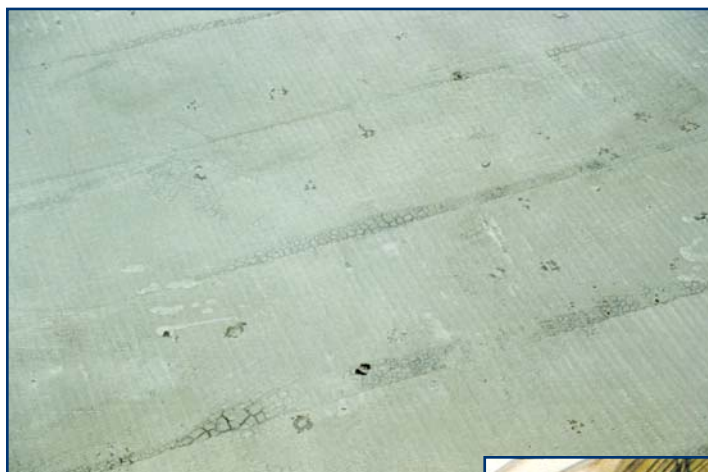
Figure 11 – Roof coating can be compromised by hail exposure, even when the felt plies remain intact.

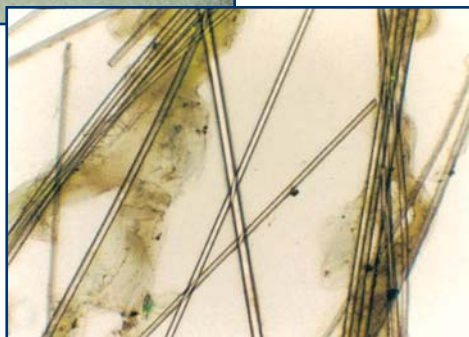
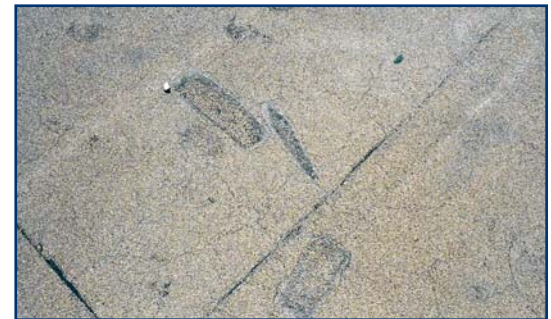
Figure 13 – Granule-surfaced modified bitumen has been reworked with a hot trowel and loose granules for cosmetic purposes. The markings are not from hail.

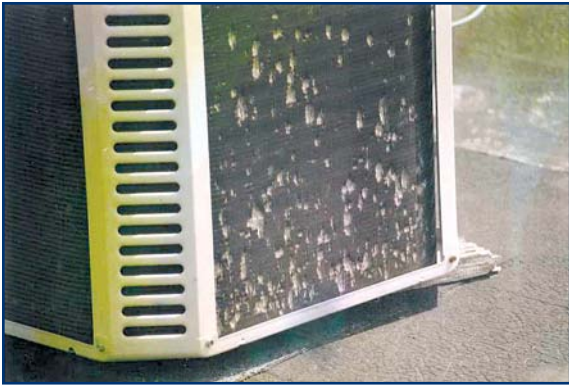
Figure 14 – Deformed cooling fins on HVAC units are the sure signature of hail exposure.

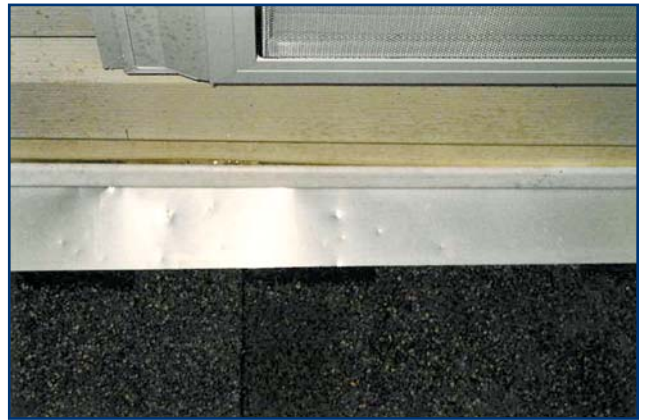
Figure 15 – Light-gauge metal flashings can be helpful in evaluating the severity of hail exposure.
