DYNAMIC BUFFER ZONE STRATEGY FOR RENOVATION OF THE I.K. BARBER LEARNING CENTRE

LESLIE PEER, PHD, PENG, BEP

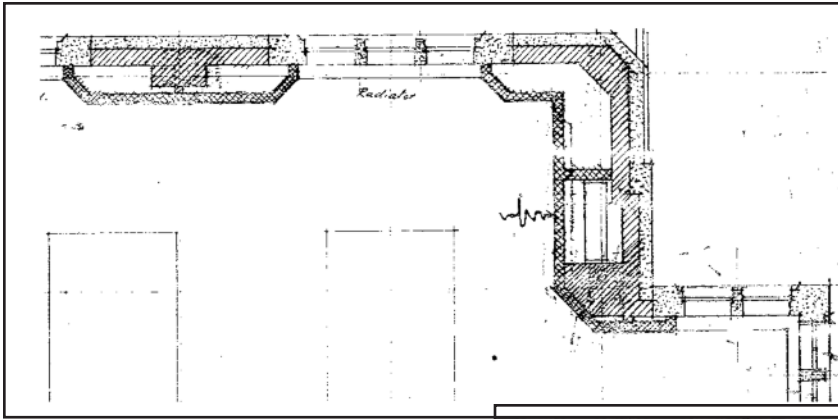
Figure 3 – Extract from original drawing showing granite (1) and brick masonry composite wall (2), wall cavity (3), interior clay tile wall (4), window (5), and brick or concrete pilasters (6).

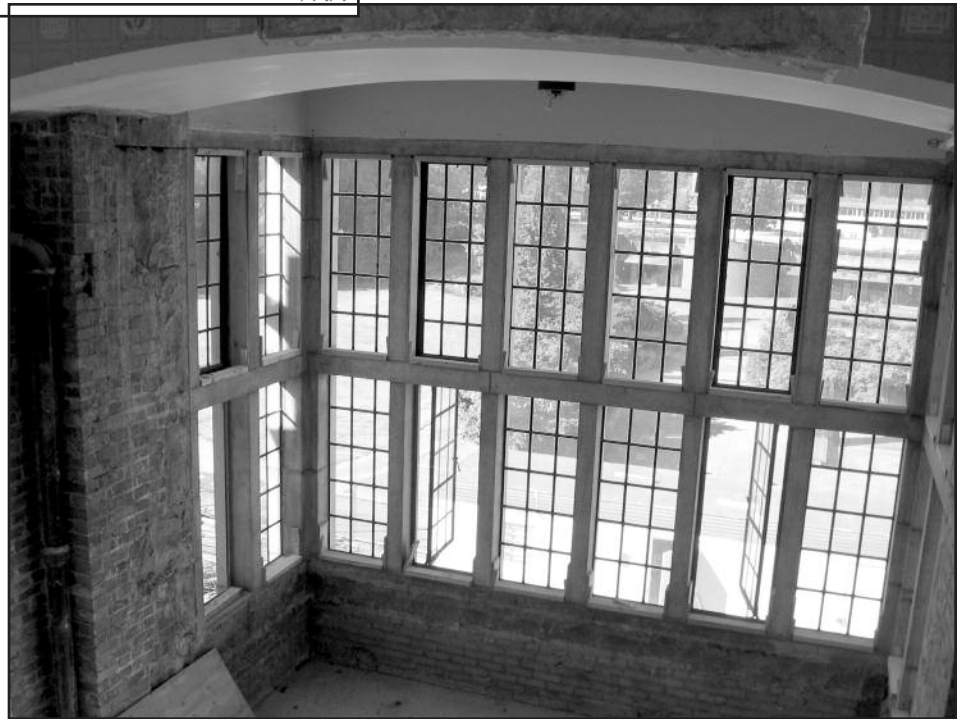
Figure 4 – Original steel-framed windows in set-in granite mullions.

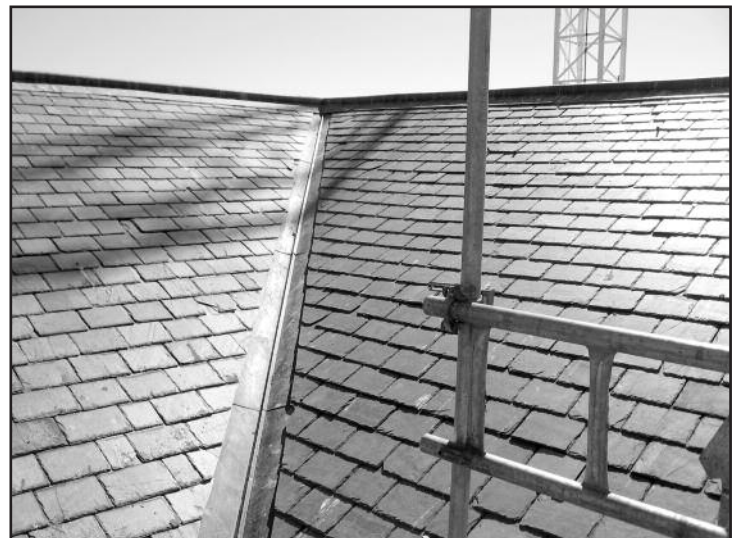
Figure 5 – Slate roofing on main hall restored c. 2000.

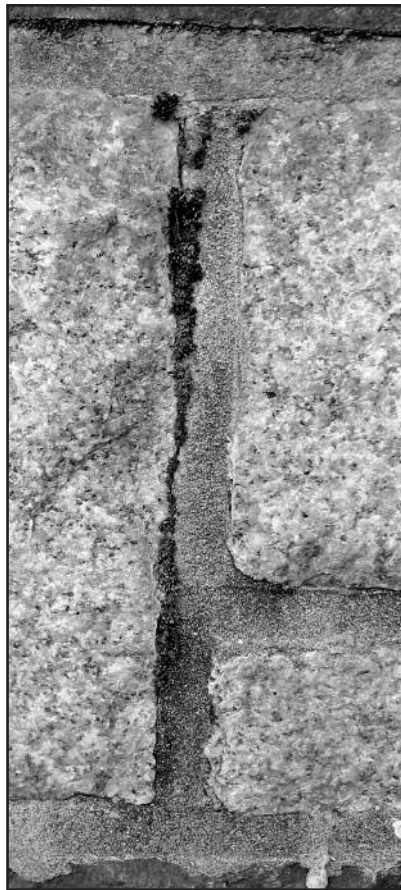
Figure 8 - Typical crack in granite masonry head joint. Presence of moss in the joint indicates persistent water presence in otherwise tight mortar joints.

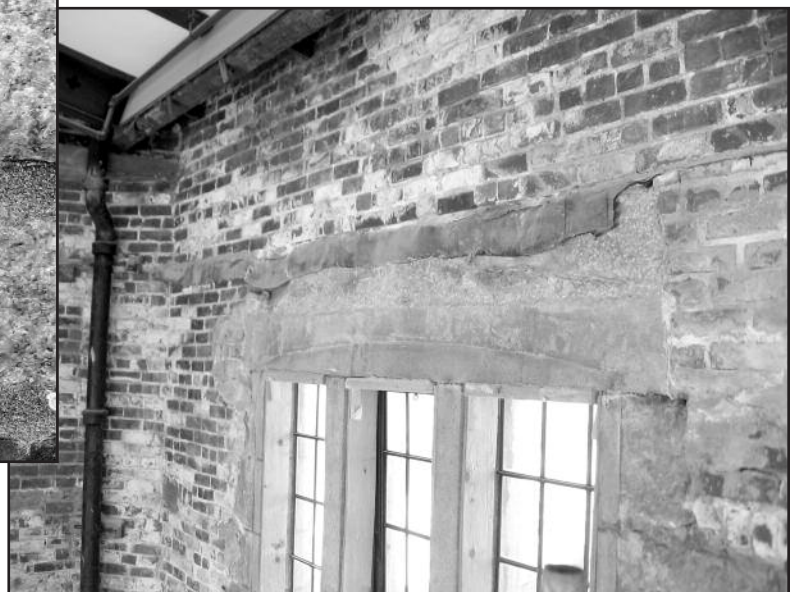
Figure 9 - Efflorescence on interior face of wall showing location of long-term evaporation of water from the brick.

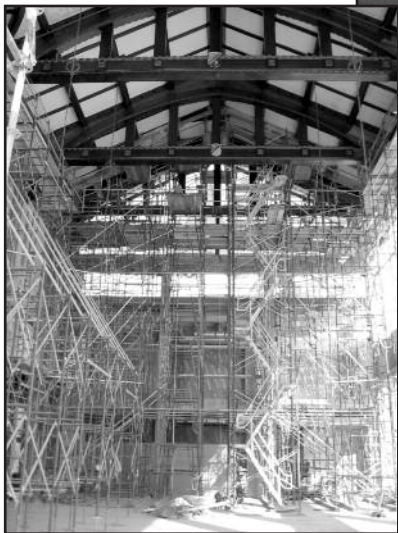
Figure 10 – Main hall with scaffolding to support trusses while end-bearing timber is replaced where rotted from contact with masonry.

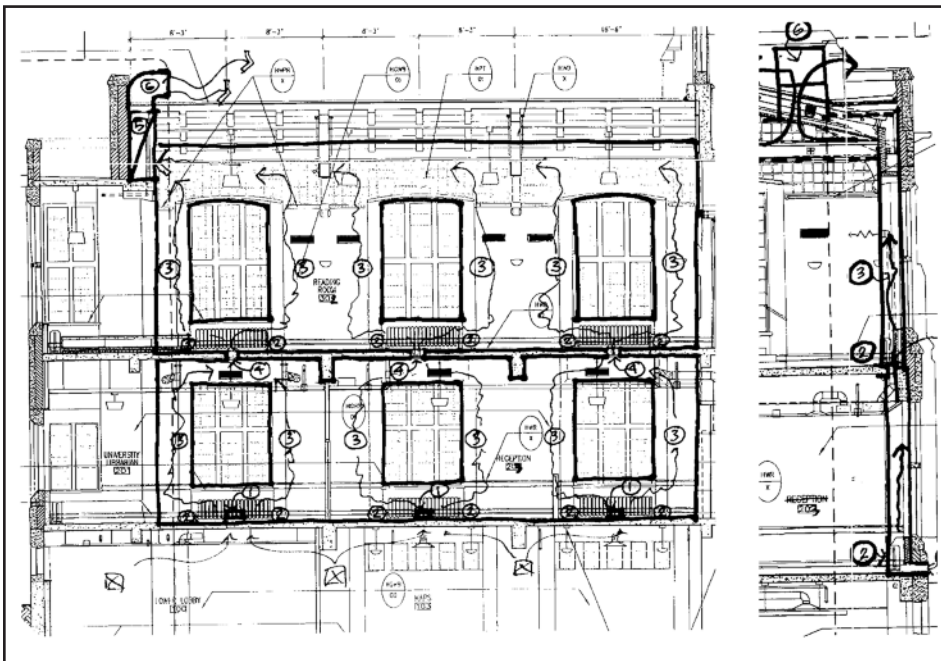
Figure 13 -Elevation of DBZ showing air intakes (1), convection paths (3), reused ventilation shaft (5), and sheet metal hood (6).
