Testing Building Envelopes with Infrared Thermography; Delivering the “Big Picture”

By Peter Brooks

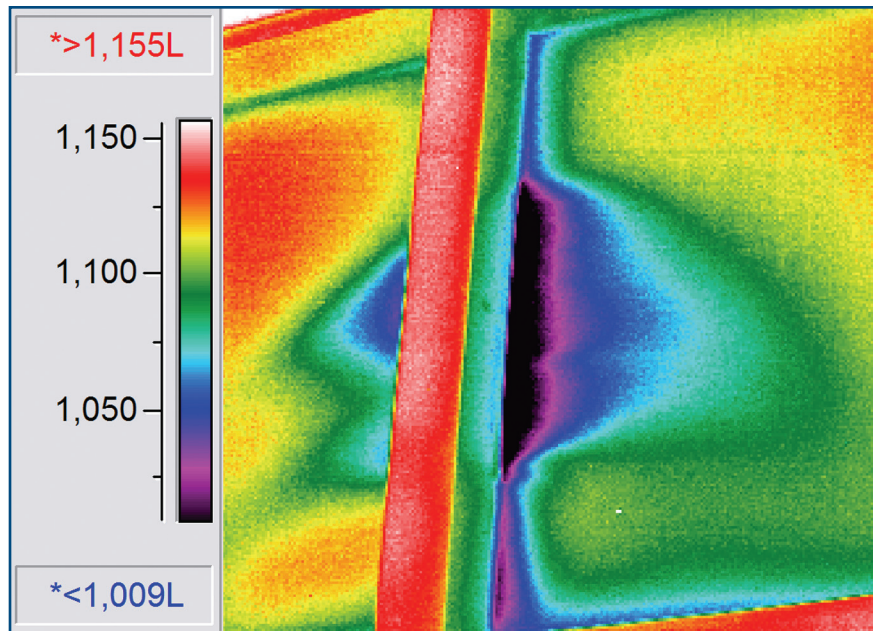
Buildings that are too warm or too cold can substantially reduce employee efficiency and occupant comfort. Recently, a large office building in New York that was constructed with insulated metal panels was tested with an infrared camera. While the metal panels themselves were performing well, gaskets between panels and between the panels and window glazing allowed so much air transference that, on windy days, it was impossible to maintain the building’s temperature at a comfortable level. Infrared testing revealed that the building was suffering from significant “stack effect” issues, with warm air escaping near the top of the building while cold air was infiltrating at the lower levels. *Thermogram 1* illustrates substantial cold air infiltration through leaky gaskets in the insulated metal panel system. *Thermogram 2* was taken of the outside of the building near the top and documents a typical area of substantial warm air exfiltration.

Thermogram 1 – Cold air infiltration due to gasket failure can seriously affect occupant comfort.

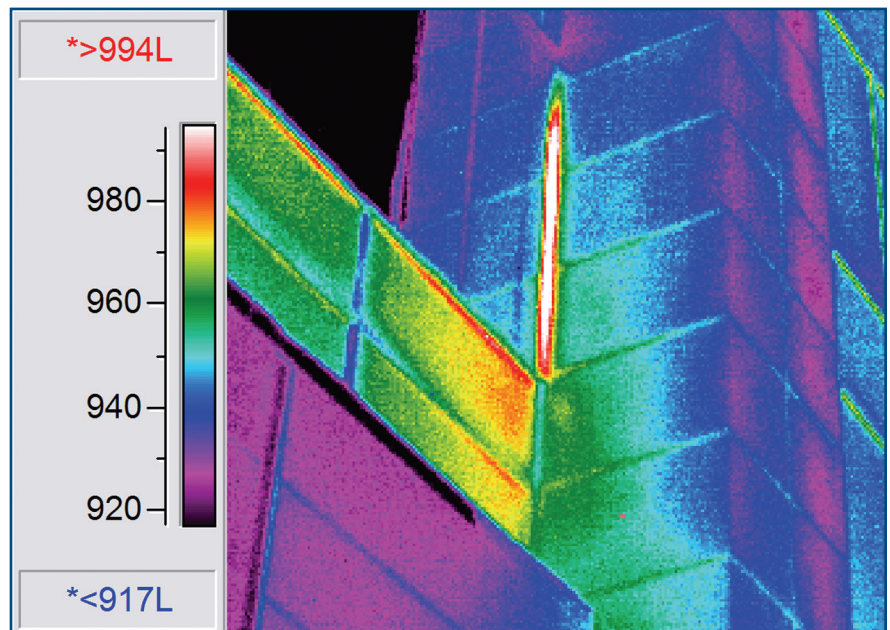
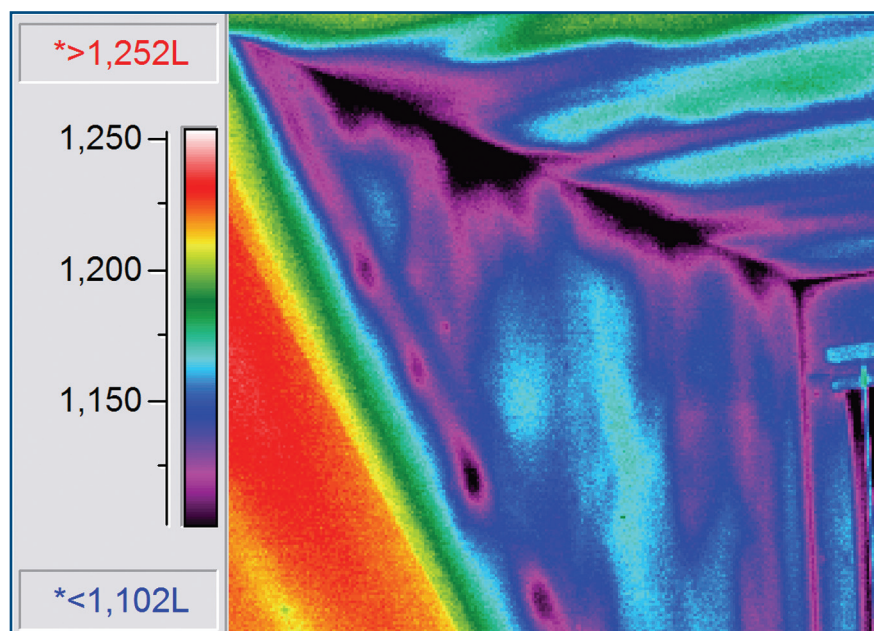
Below: Thermogram 2 – “Stack effect” is exacerbated by significant warm air exfiltration near the top of the building.

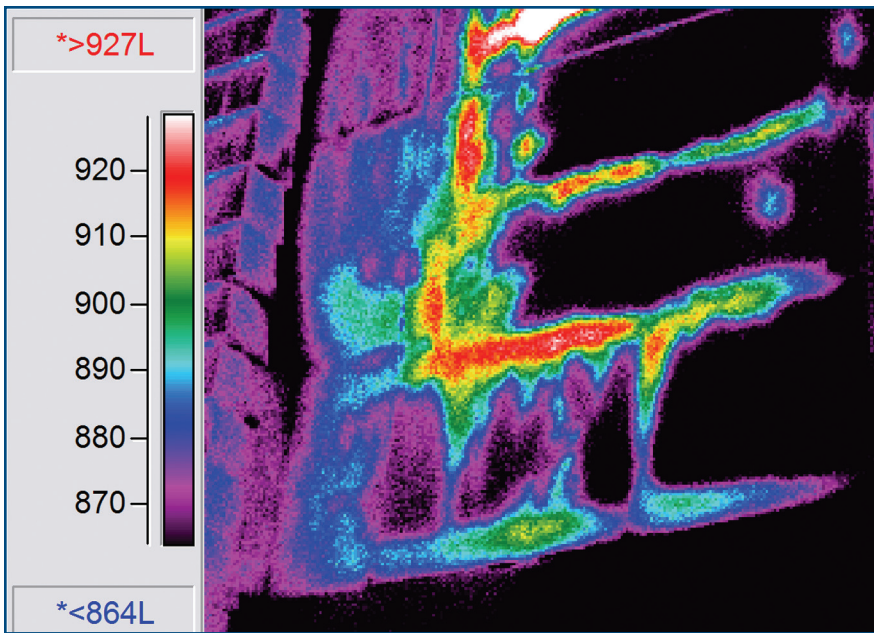
Thermogram 3 – Substantial conduction losses were creating very cold temperatures on the interior of this newly renovated dormer.

Thermogram 3 depicts an office dormer wall and ceiling. In the lower left-hand corner of the thermogram a section of the pitched roof where the insulation is performing well can be seen. The wall and ceiling of the dormer are extremely cold due to poorly installed insulation and an inadequate exterior air barrier. The institution used the findings of the thermographic testing to guide an intensive effort to correct the detected problems.

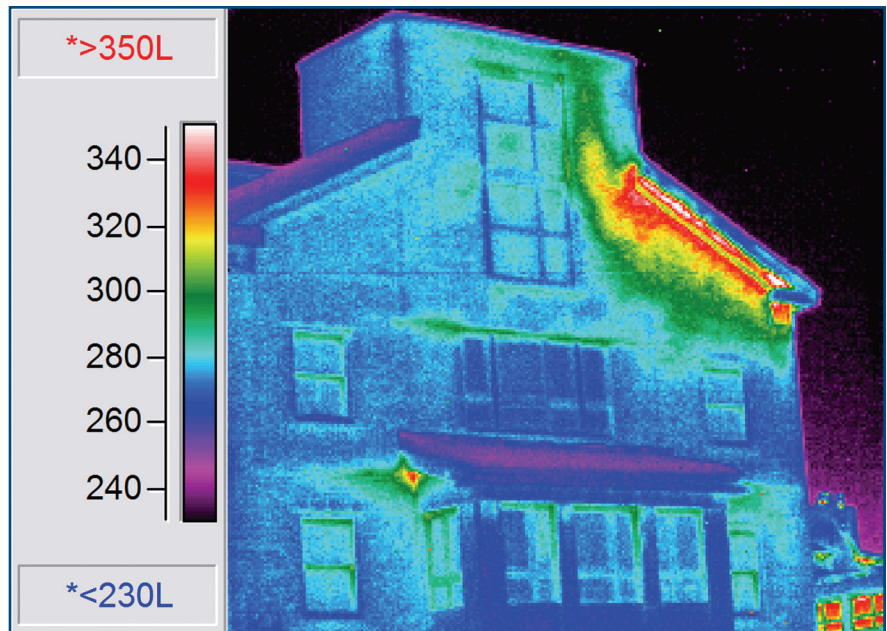
windows. Substantial differences in performance between two roof rakes are documented in *Thermogram 7*. In all, over 50 significant problem areas were identified.

Thermogram 7 - Thermographic evaluations of new construction often reveal significant building envelope problems.
