RECOGNITION

AND

REPAIR

OF HAIL-RELATED DAMAGE ON CEDAR SHAKES AND SHINGLES

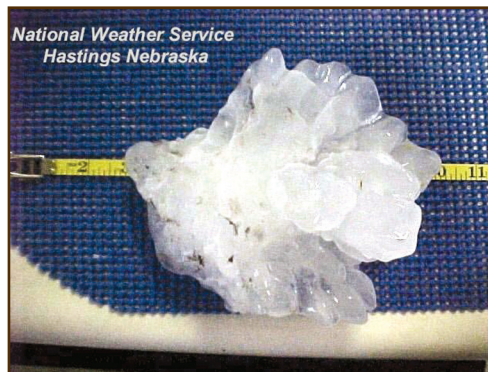
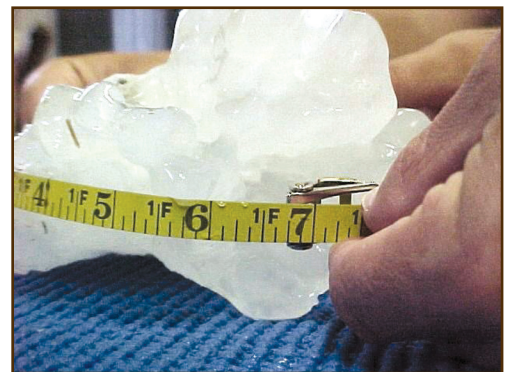
The largest hailstone ever confirmed by the National Weather Service measured 7 inches in diameter and 18.75 inches in circumference and fell in Aurora, Nebraska, in 2003³ (see *Photos 1A and 1B*).

Photos 1A and 1B – Pictures of the record-breaking Aurora, Nebraska, hailstone. Since the hailstone struck a house roof in its descent and partially broke, an accurate weight of the hailstone was not possible. Property damage from the storm was estimated at \$500,000, with \$1 million in crop damage across Hamilton County, Nebraska (NCDC 2003). Large hail left craters in the ground up to 14.0 inches (35.56 cm) in diameter and 3.0 inches (7.62 cm) deep. National Weather Service photo.

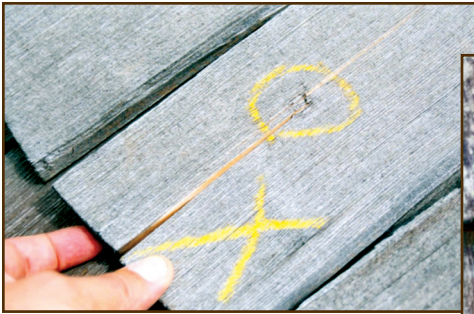
Photo 2A – Hail impact split.

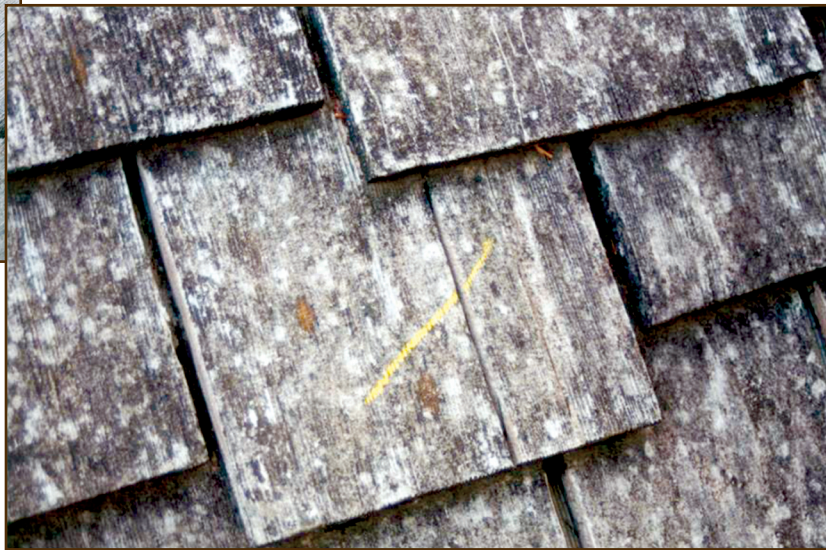
Photo 2B – Weathering split and small hail impact marks.

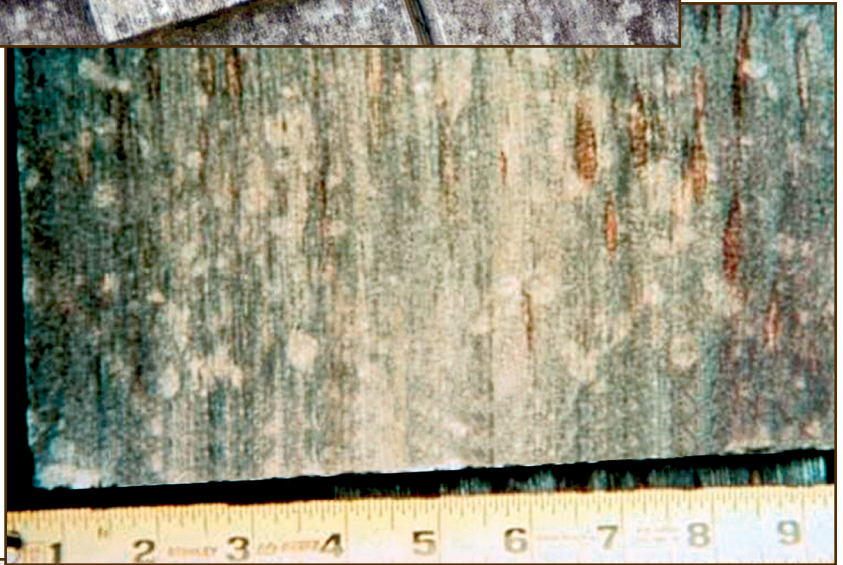
Photo 2C – Many small hail impact marks, but no splits in shingle.

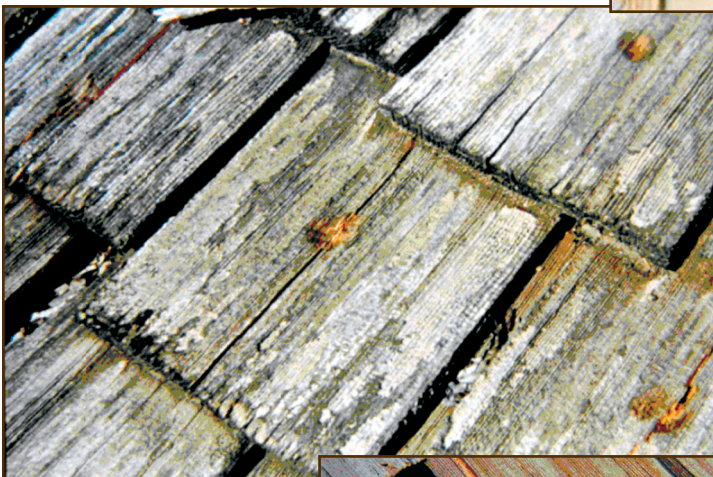
Photo 3A – Intentional ballpeen hammer damage (note regular pattern).

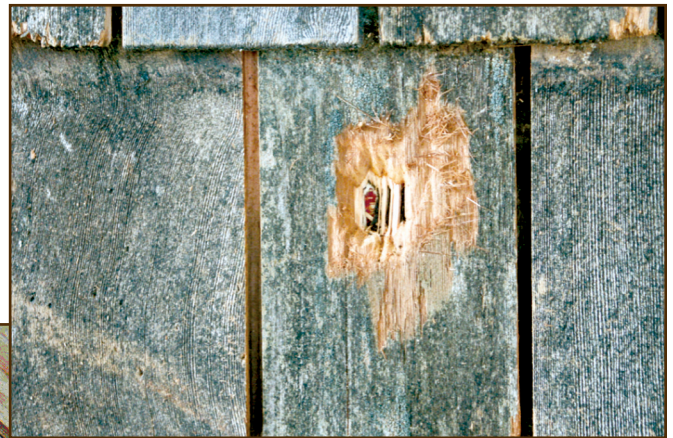
Photo 3C – Actual pressure-washing damage. This type of damage is typically caused by inexperienced equipment users. Contact CSSB for care and maintenance of cedar shingles and shakes.

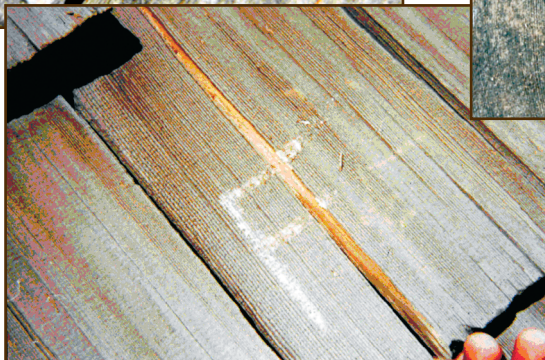
Photo 3B – Footfall split damage (note no denting and new cedar color).

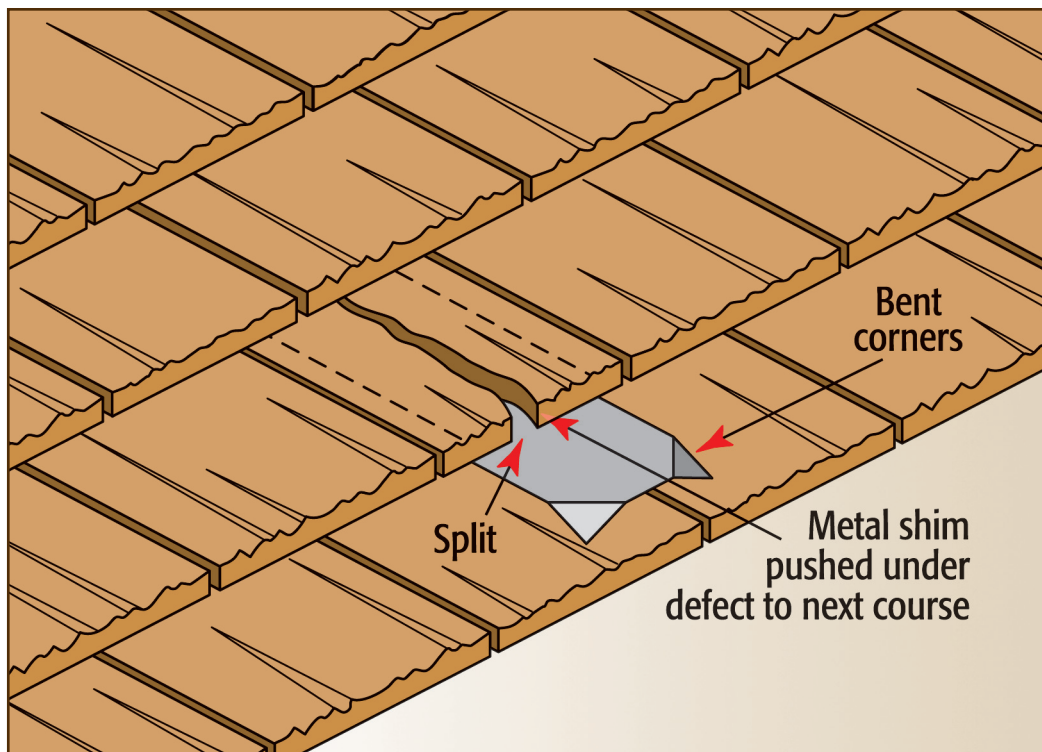
Figure 5 – In general, no more than 25 hail impact splits per 100 square feet should exist if shimming is to be used. Otherwise, consider using new shakes or shingles or replace the entire roof.

Shimming can be used to repair the odd shake or shingle, filling in a split piece from below. However, for purposes of both roofing system integrity and cosmetic appearance, no more than 20 percent of a roof area

should be shimmed (Figure 5). If this 20-percent limit is reached, one should consider repairing the area with new shakes or shingles or a complete reroof job, depending upon the circumstances and level of damage.
