PREMATURE METAL ROOF DECK CORROSION:

Difficult to Detect and Diagnose

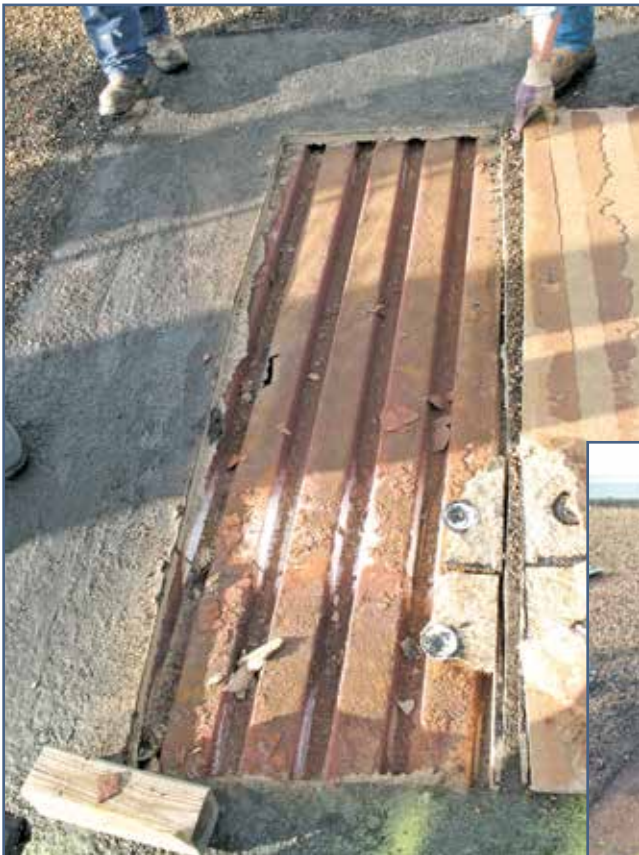
Figure 1 – Roofing membrane and insulation board removed to expose metal decking. Note corrosion occurs at both “peaks” and “valleys” of metal decking.

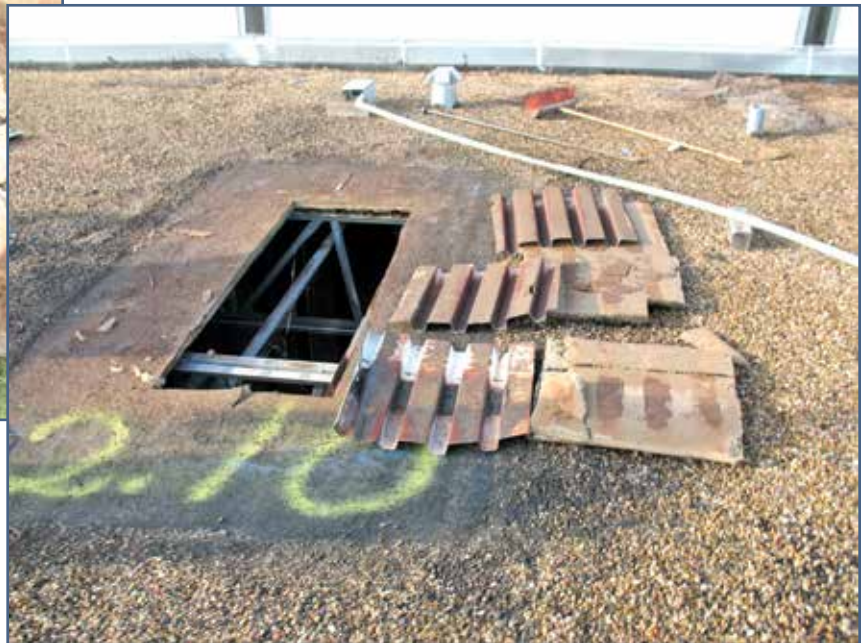
Figure 2 – Metal deck samples with corresponding section of fiberboard insulation.

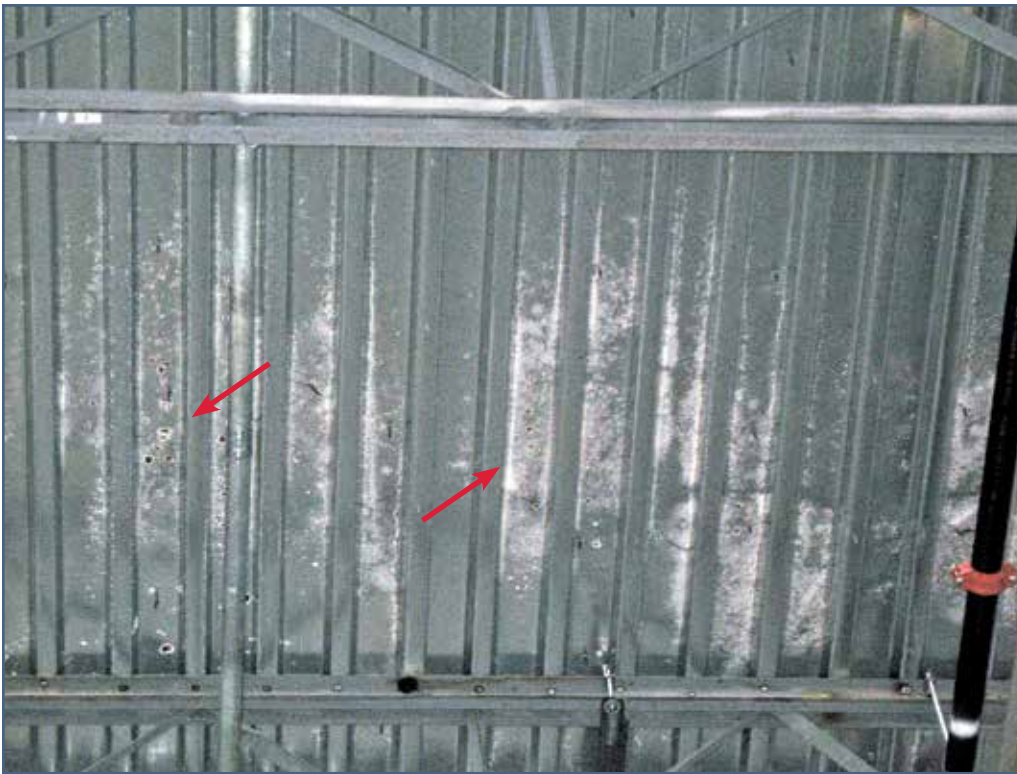
Figure 3 – Small red rust spots (left arrow) and white rust (right arrow) developing on bottom side of roof deck.

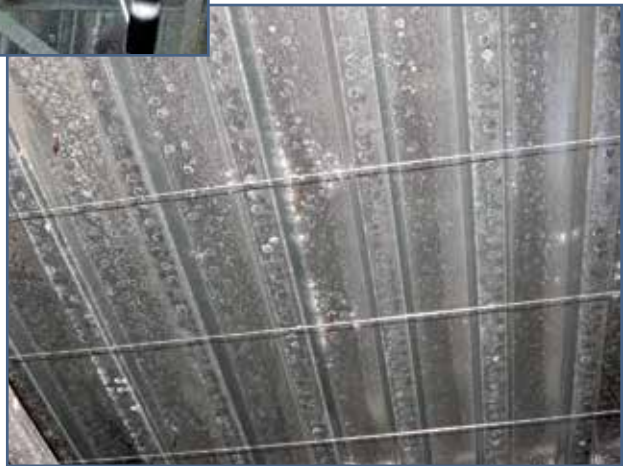
Figure 4 – White rust starting on bottom side of roof deck looks like deposits from water droplets.

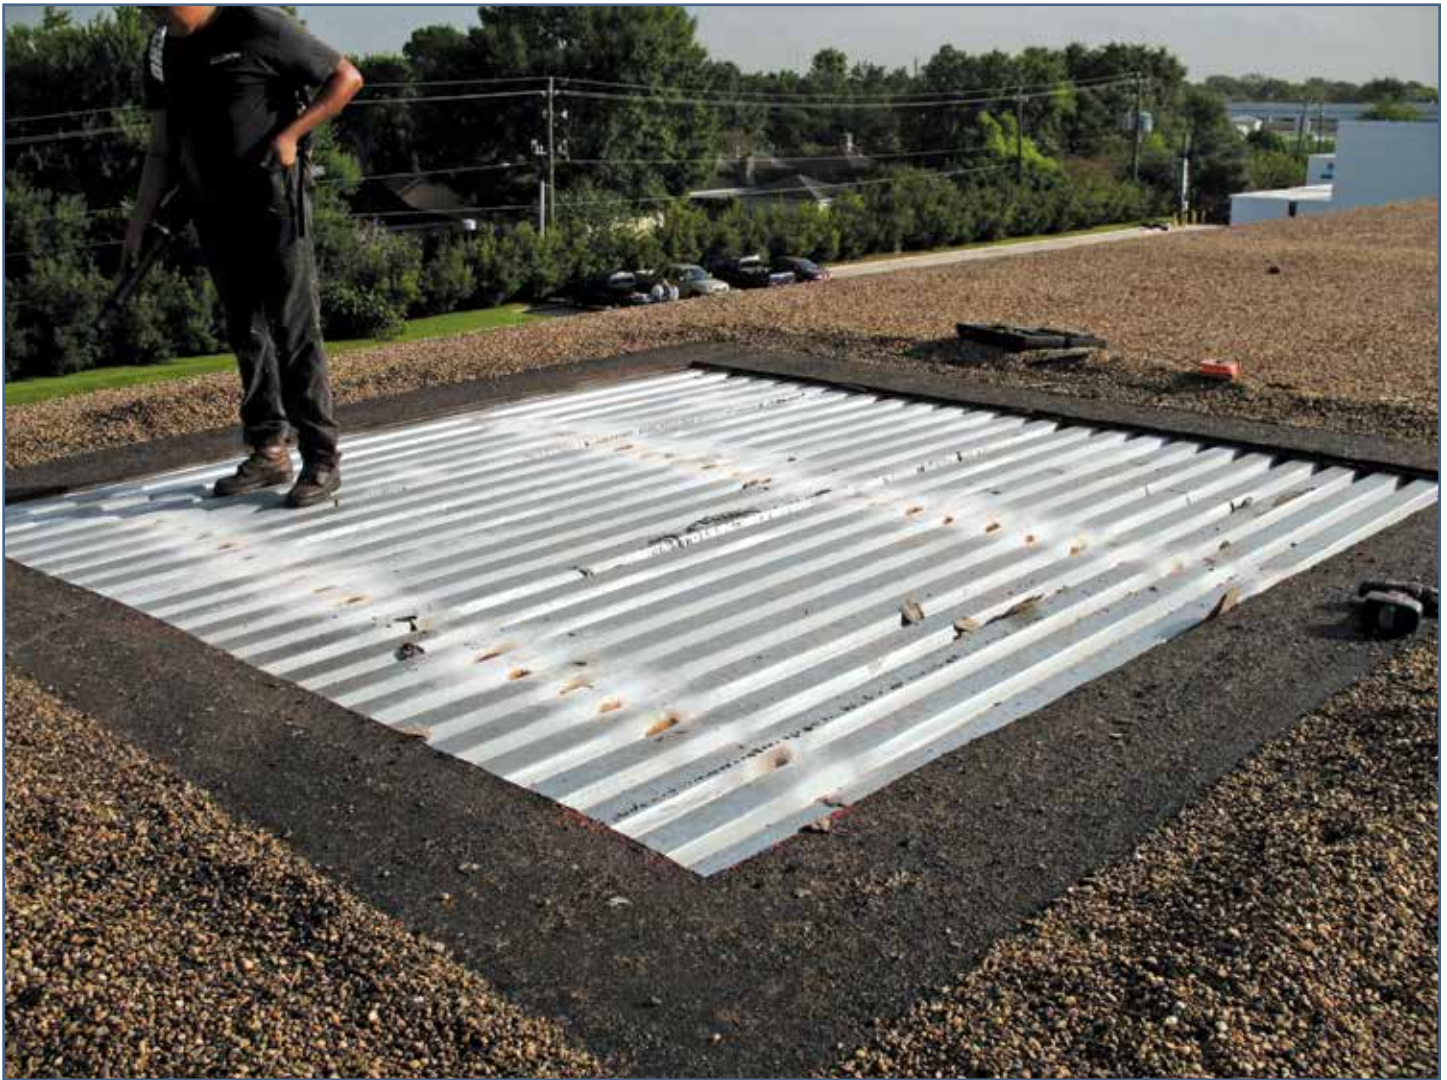
Figure 5 – Lines of white rust on top of metal deck at spot welds.

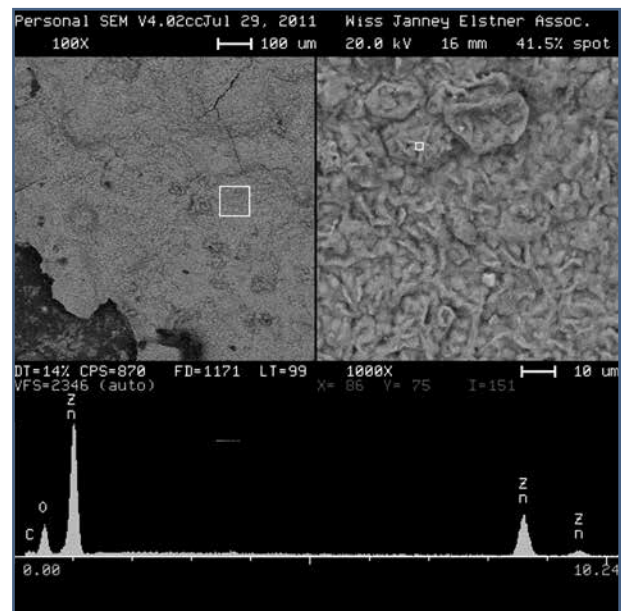
Figure 6 – SEM/EDS analysis of corroded galvanized steel roof deck. Note that the analysis found the presence of zinc, oxygen, and carbon only.

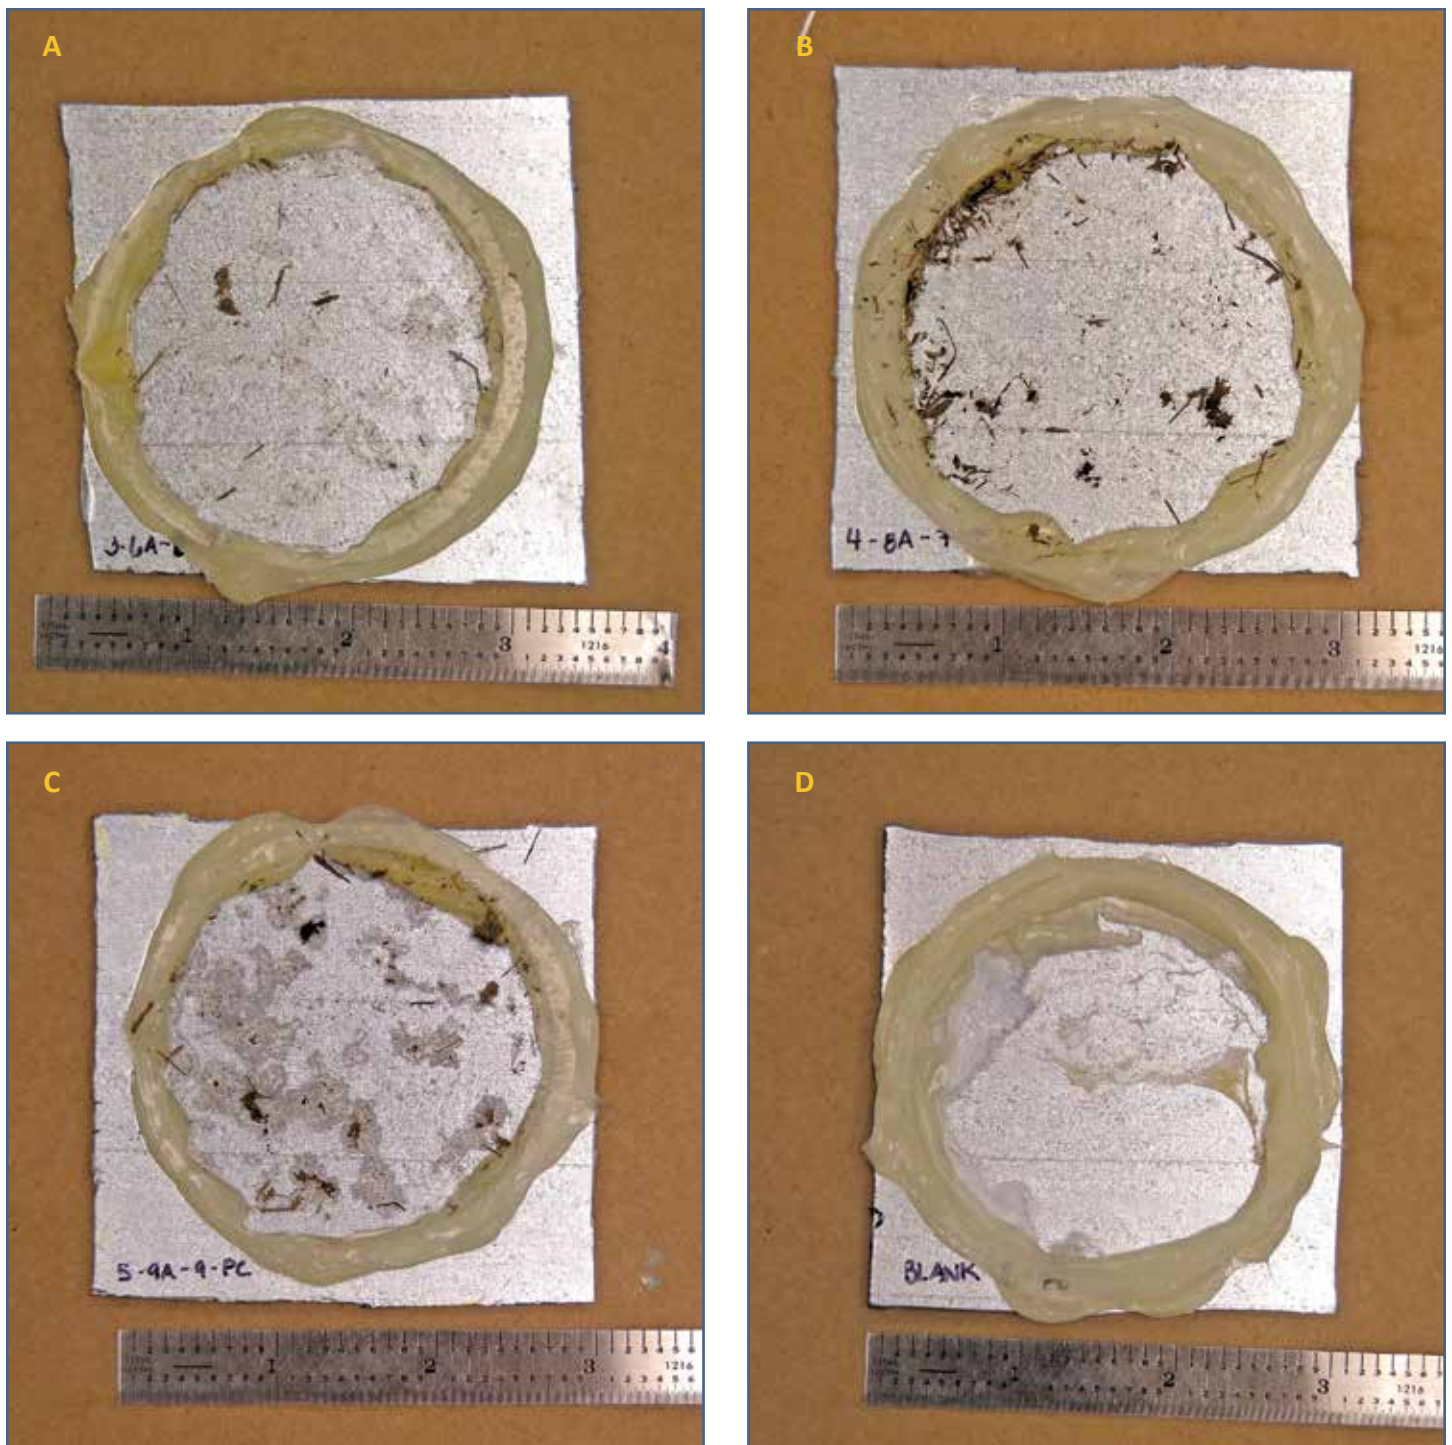
Figure 7 – Physical contact exposure test samples after eight days of exposure at 160°F to different moistened insulation samples. Levels of water-soluble anions detected on a separate portion of the insulation samples used for exposure tests were as follows: A) 16,000 mg acetate/kg insulation, <1 mg formate/kg insulation, 1,080 mg chloride/kg insulation, 314 mg nitrate/kg insulation, and 405 mg sulfate/kg insulation; B) 1,400 mg acetate/kg insulation, 420 mg formate/kg insulation, 160 mg chloride/kg insulation, <1 mg nitrate/kg insulation, and 105 mg sulfate/kg insulation; C) 5,800 mg acetate/kg insulation, 590 mg formate/kg insulation, 499 mg chloride/kg insulation, <1 mg nitrate/kg insulation, and 206 mg sulfate/kg insulation; and D) no insulation used for blank test.

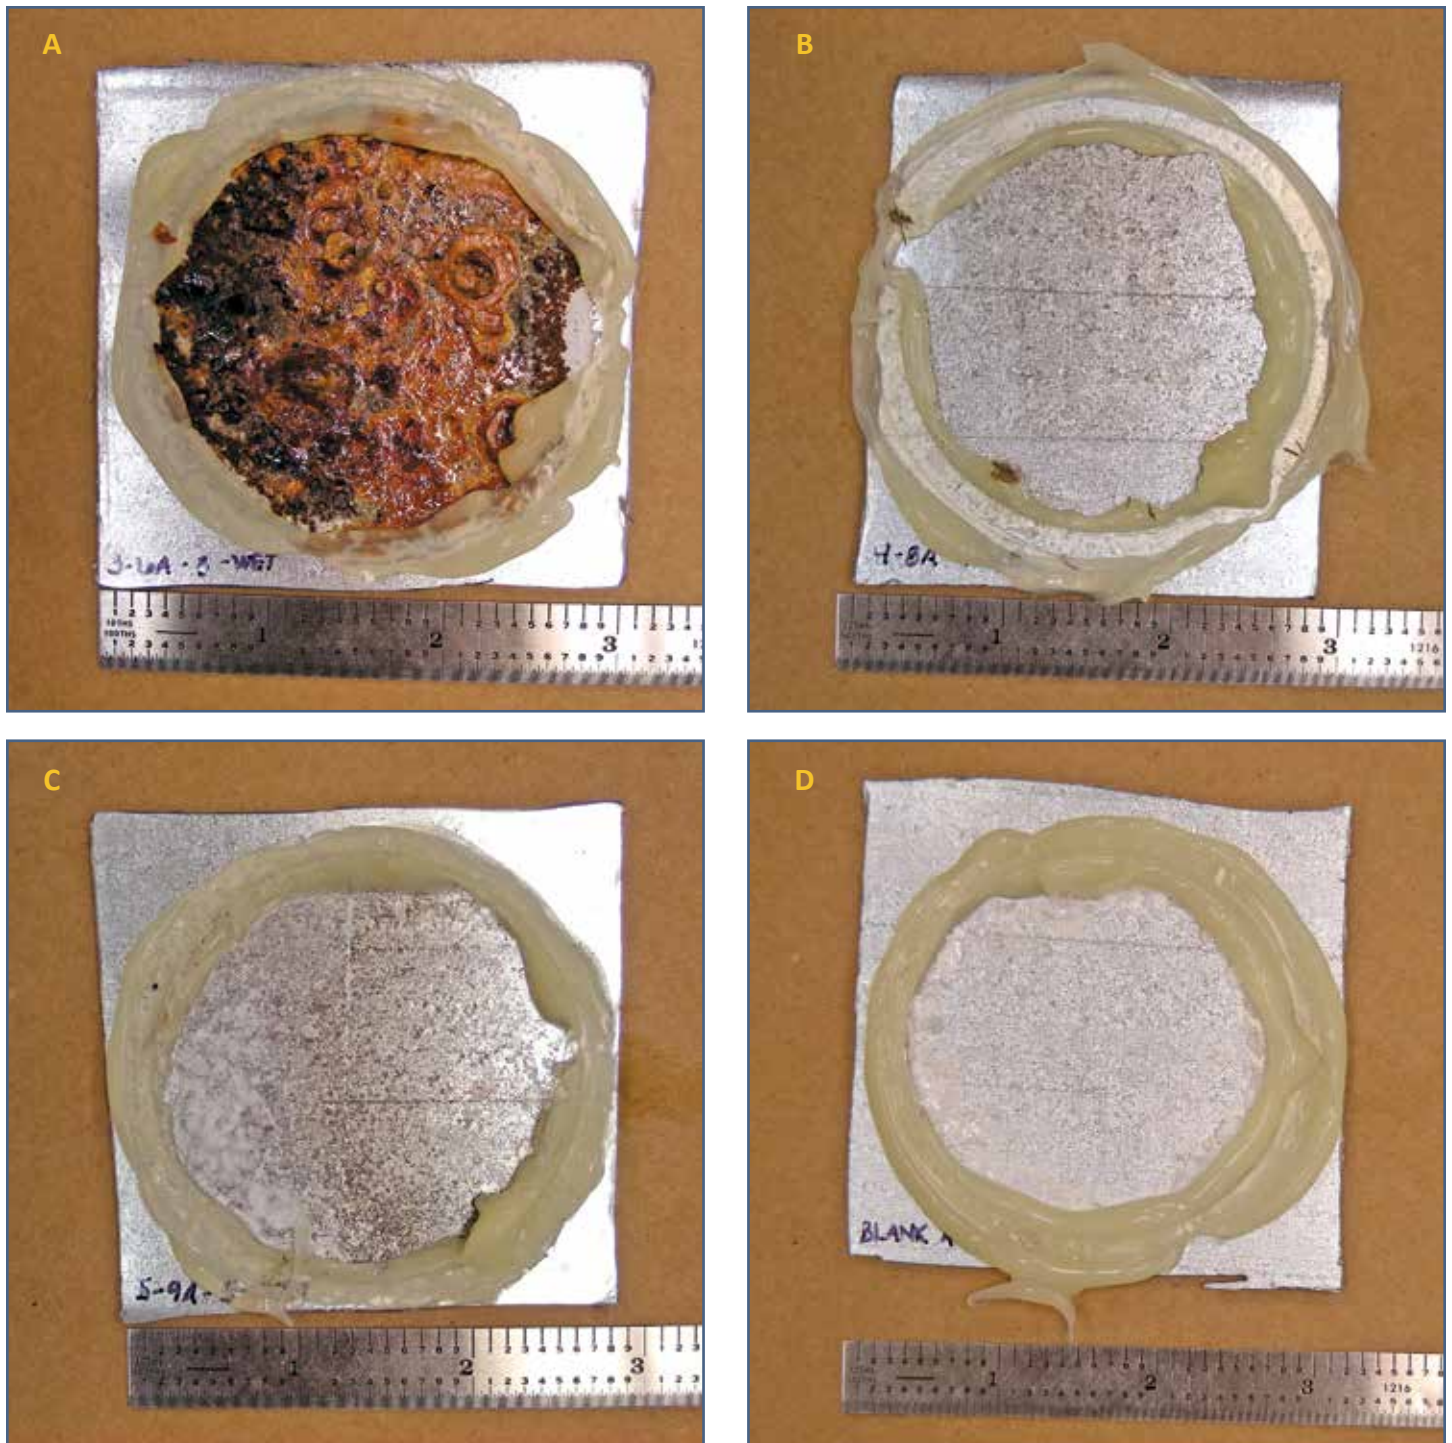
Figure 8 – Vapor phase exposure test samples after eight days of exposure at 160°F to different moistened insulation samples. Levels of volatile acetic and formic acids detected on a separate portion of the insulation samples used for exposure tests were as follows: A) 5,980 mg/kg insulation, B) <1 mg/kg insulation, C) 2,850 mg/kg insulation, and D) no insulation used for blank test.

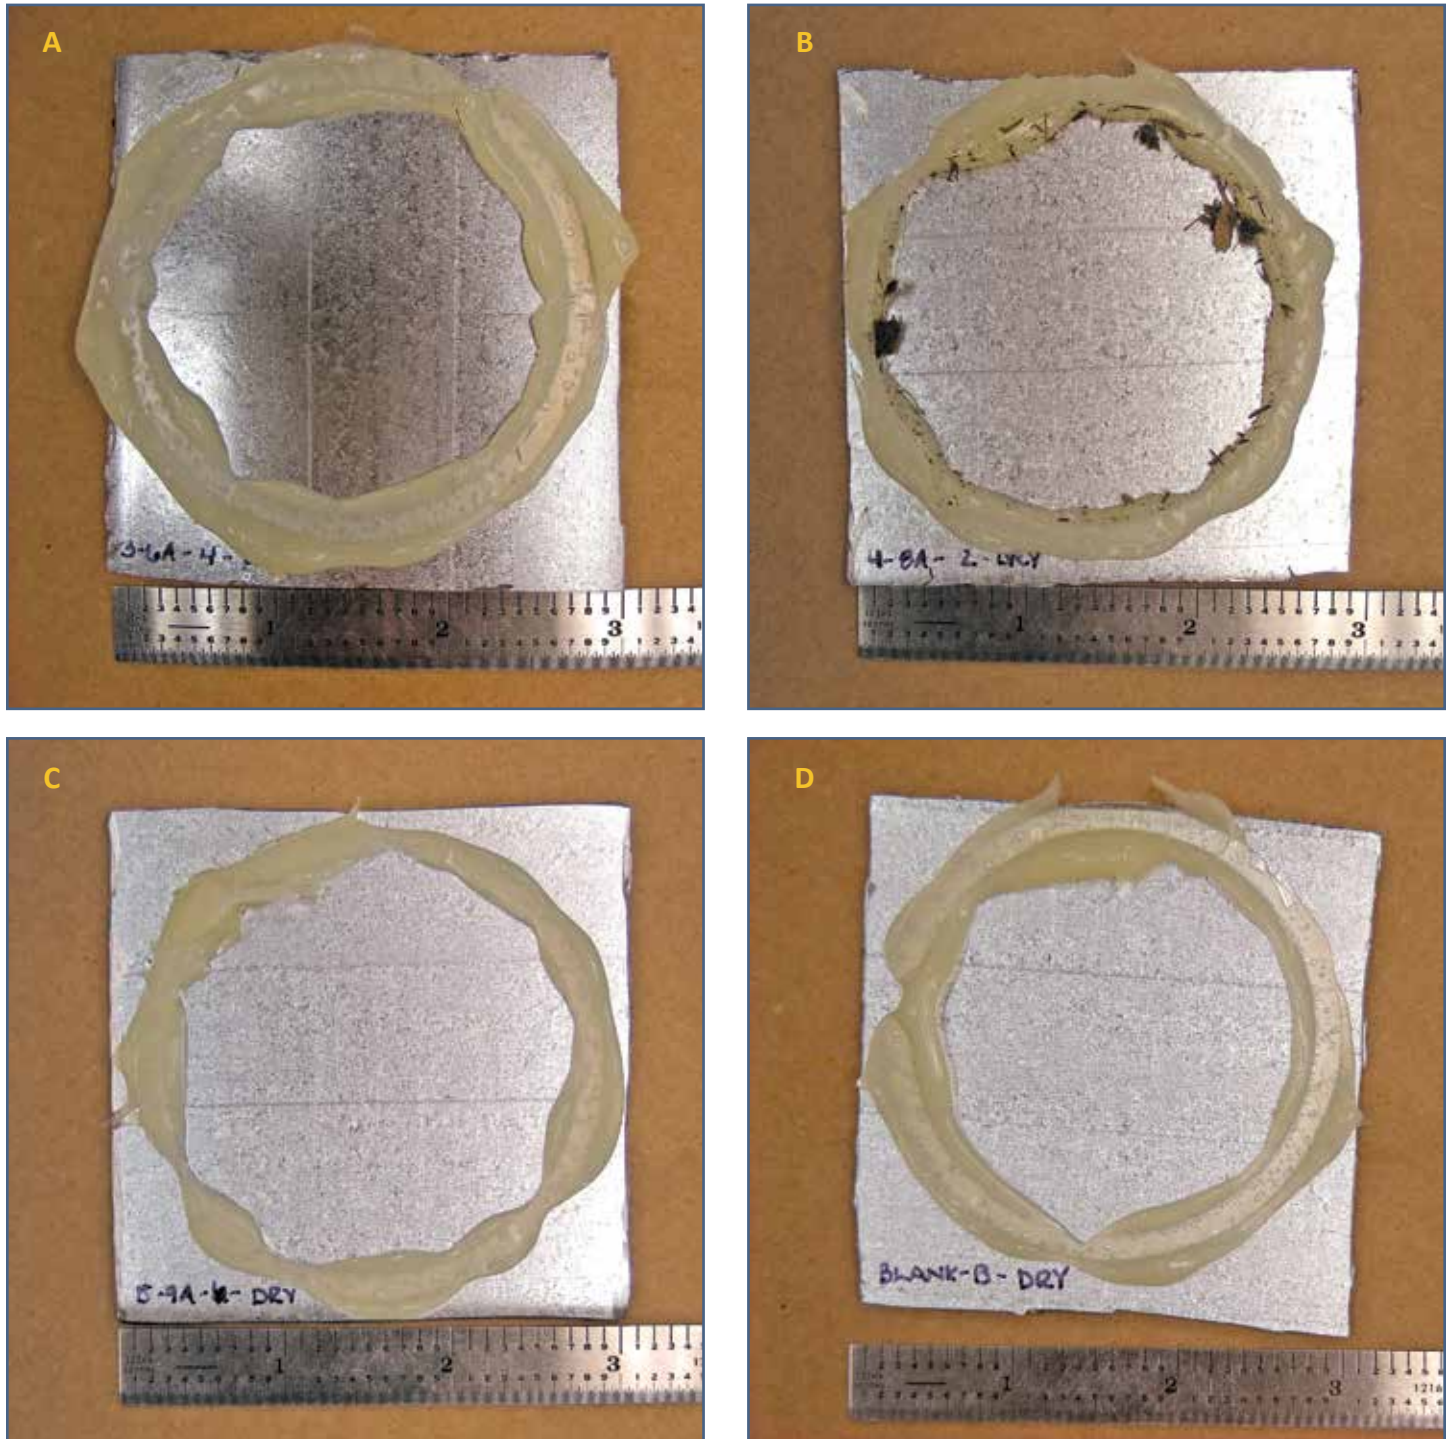
Figure 9 – Vapor phase exposure test sample after eight days' exposure at 160°F to oven-dried insulation. The sample in 9D was exposed to laboratory air only. The other samples were exposed to different insulation samples.

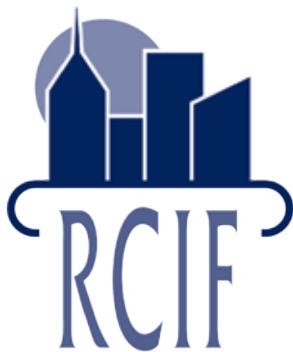
RCI Foundation – United States

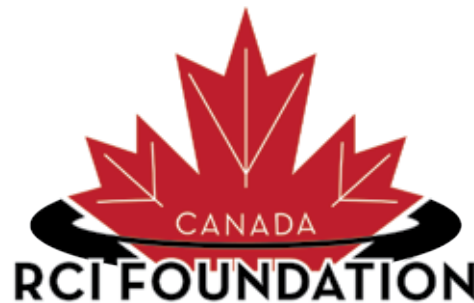
RCI Foundation – Canada
