PROCEEDINGS

RCI INTERNATIONAL CONVENTION AND TRADE SHOW

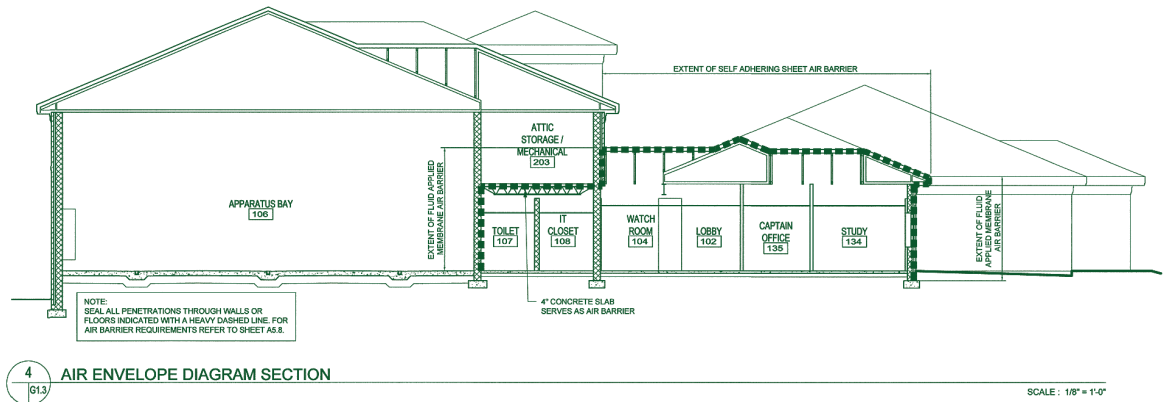
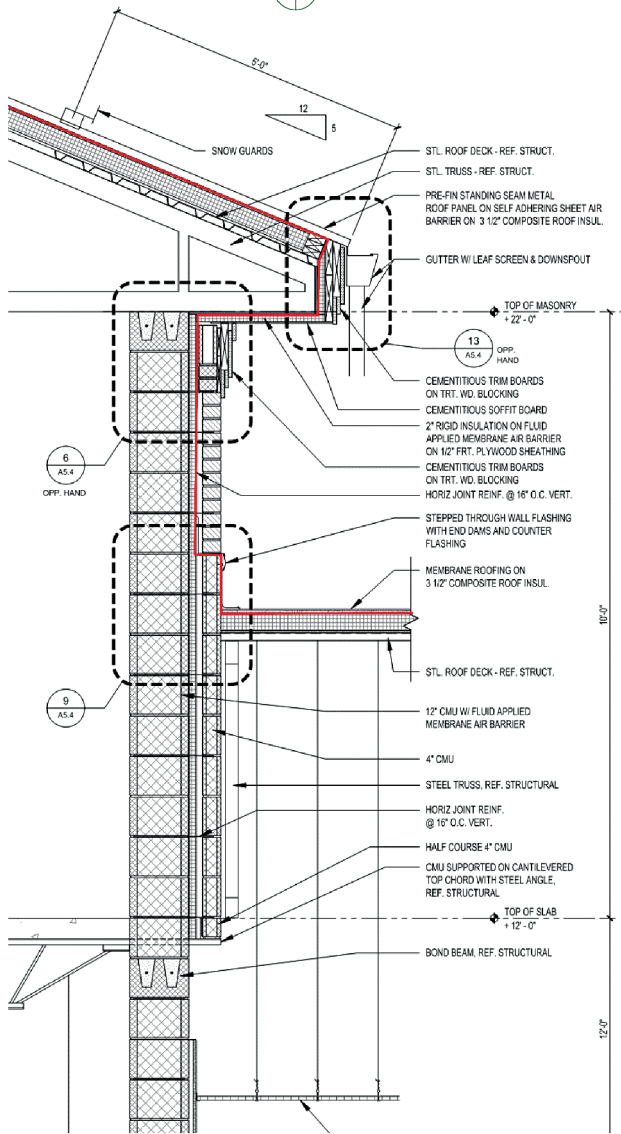
Figure 4 – Fire Station A. View of the demising wall between the conditioned and unconditioned spaces and location of the air barrier as designed.

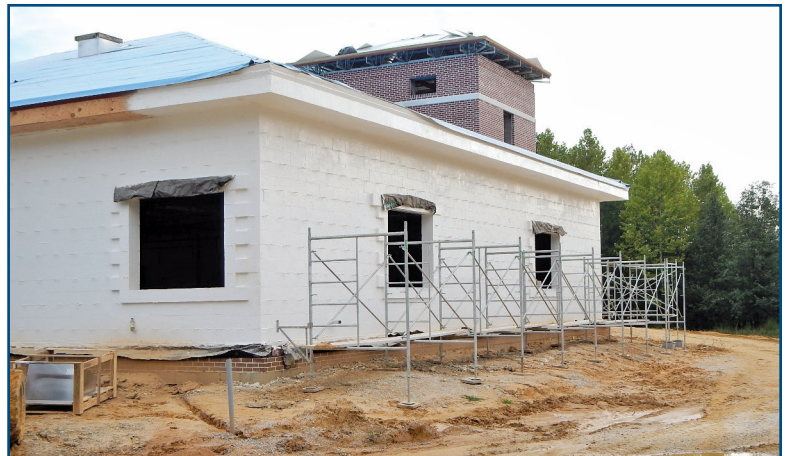
polyisocyanurate/OSB rigid board roof insulation. The standing-seam metal roofing system's concealed fasteners were screw-fastened directly through the air barrier to the composite insulation.

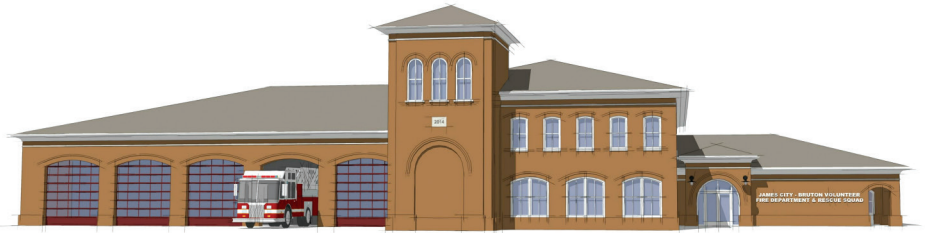
Figure 6 – Fire Station B. Architect's rendering of the project.

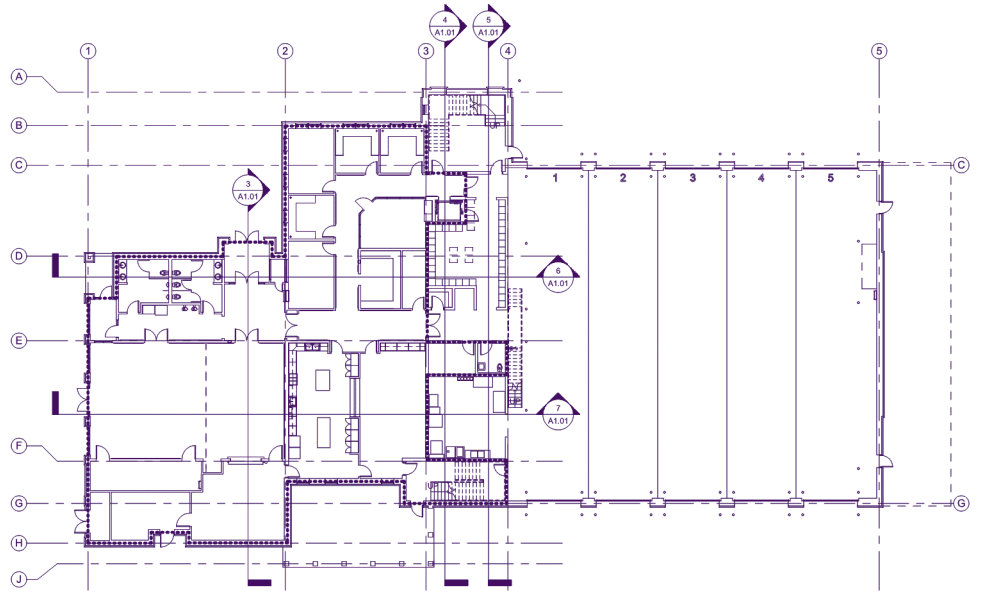
1 1ST FLOOR PLAN - AIR BARRIER
1/16" = 1'-0"

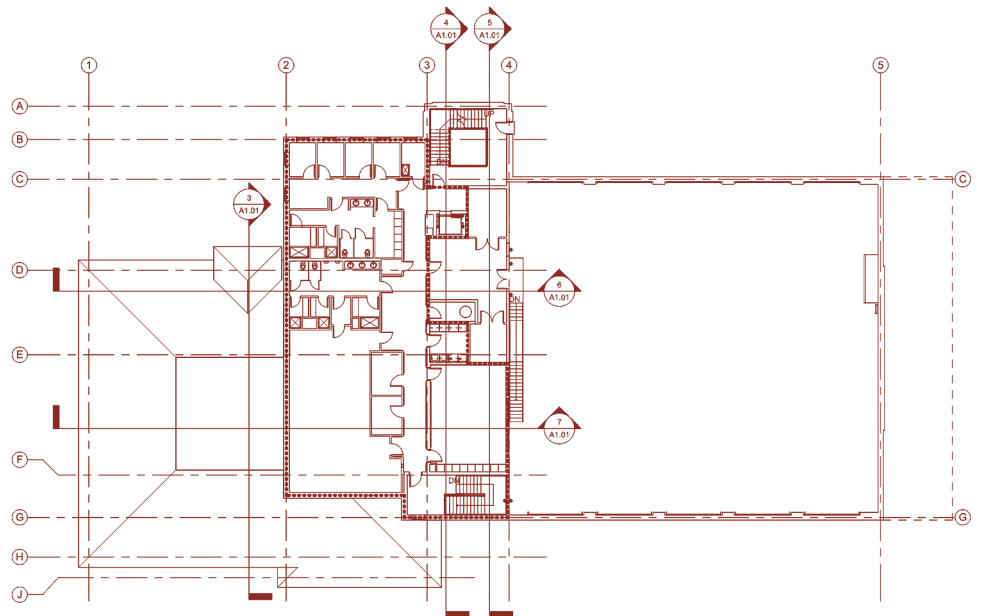
2 2ND FLOOR PLAN - AIR BARRIER
1/16" = 1'-0"

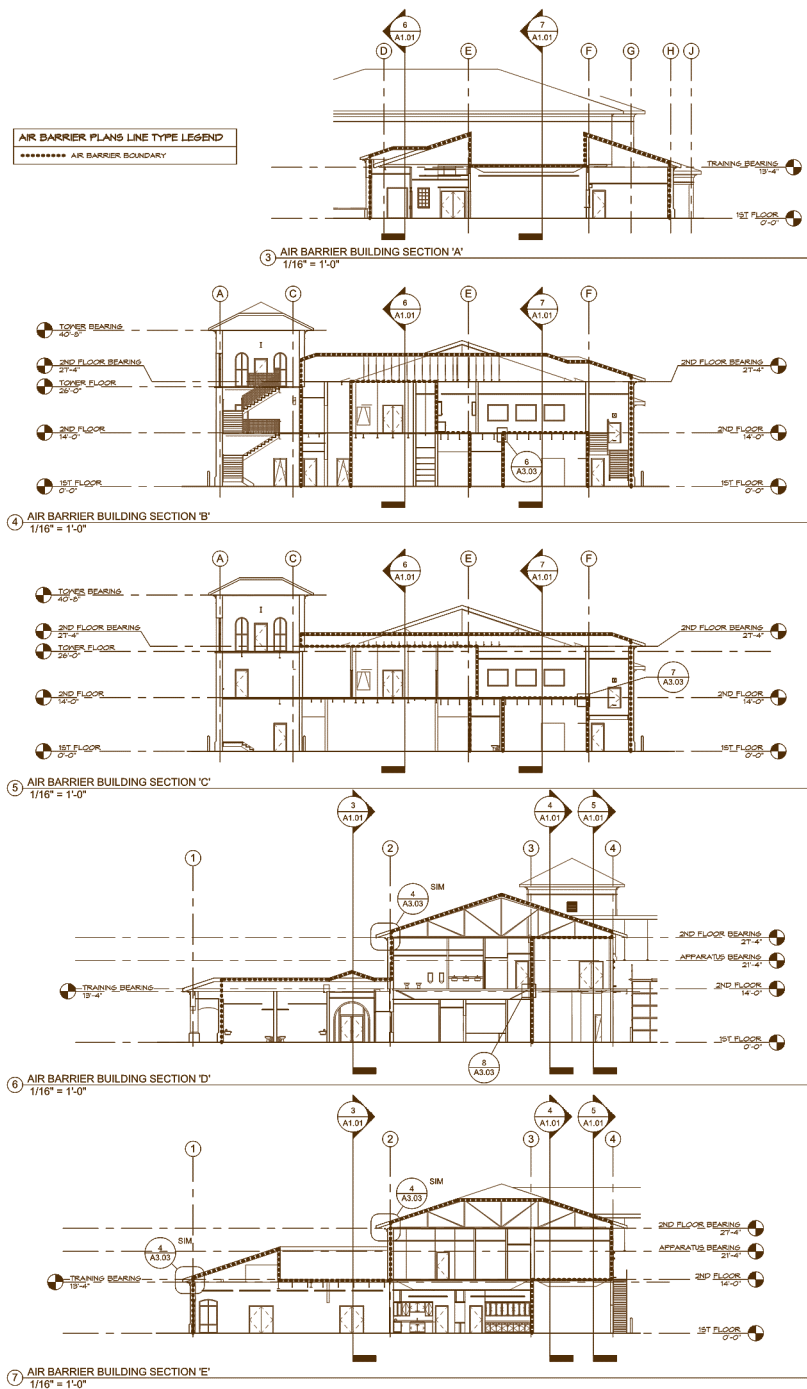
Figure 9 – Fire Station B. Architect’s “Air Barrier Building Sections” depicting the complex interaction between the air barrier systems between the occupied and unoccupied spaces.

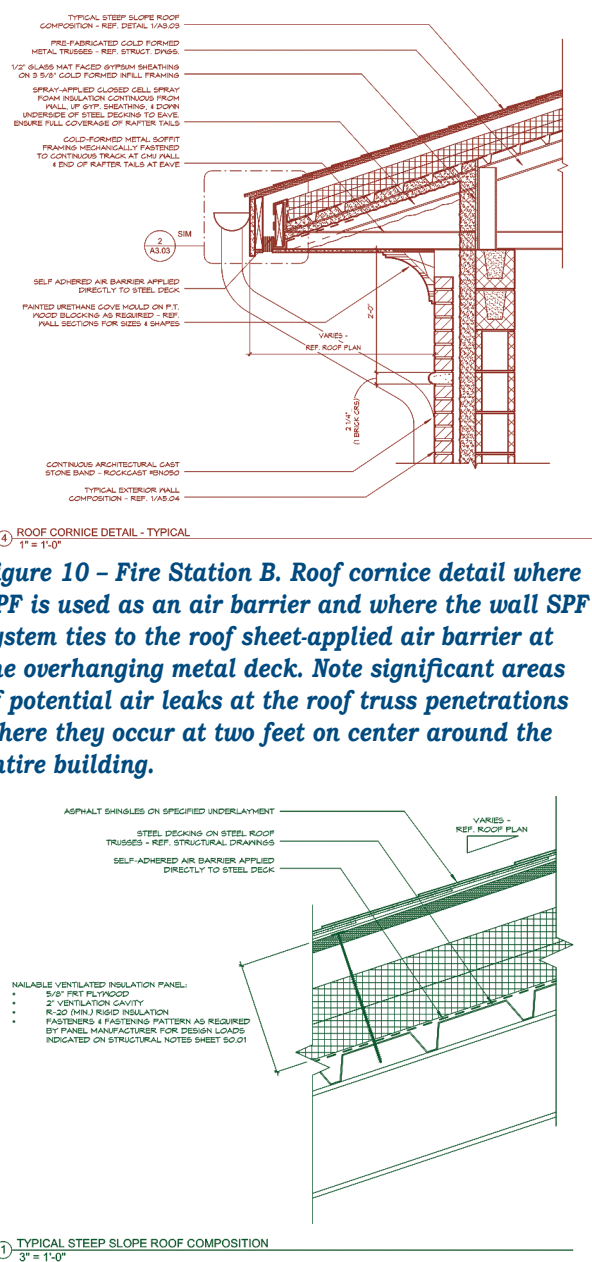
Figure 10 – Fire Station B. Roof cornice detail where SPF is used as an air barrier and where the wall SPF system ties to the roof sheet-applied air barrier at the overhanging metal deck. Note significant areas of potential air leaks at the roof truss penetrations where they occur at two feet on center around the entire building.

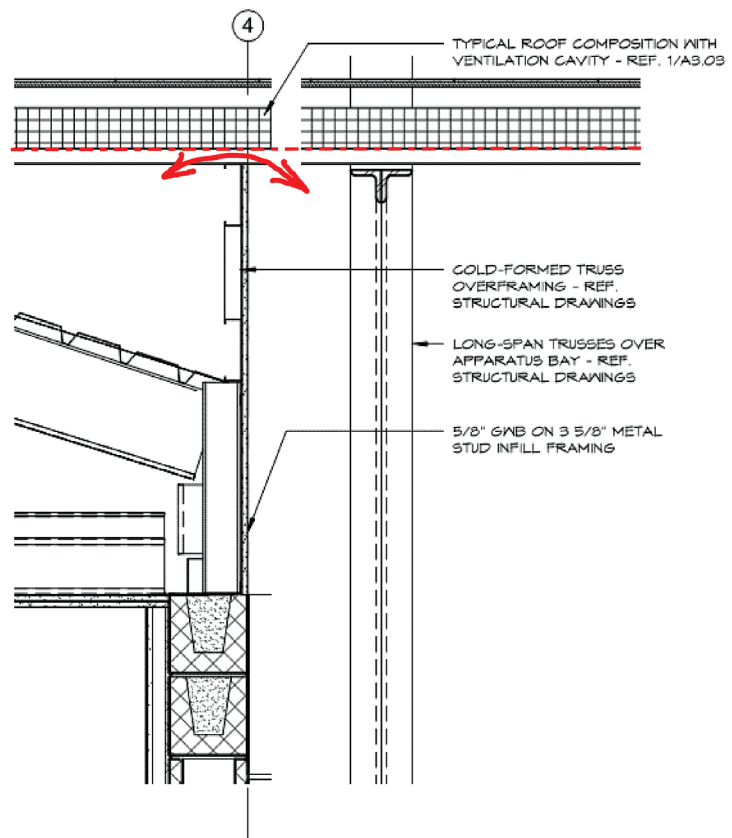
④ ROOF/CEILING FIRE RESISTANCE CONTINUITY AT APPARATUS BAY OVERFRAME
1" = 1'-0"

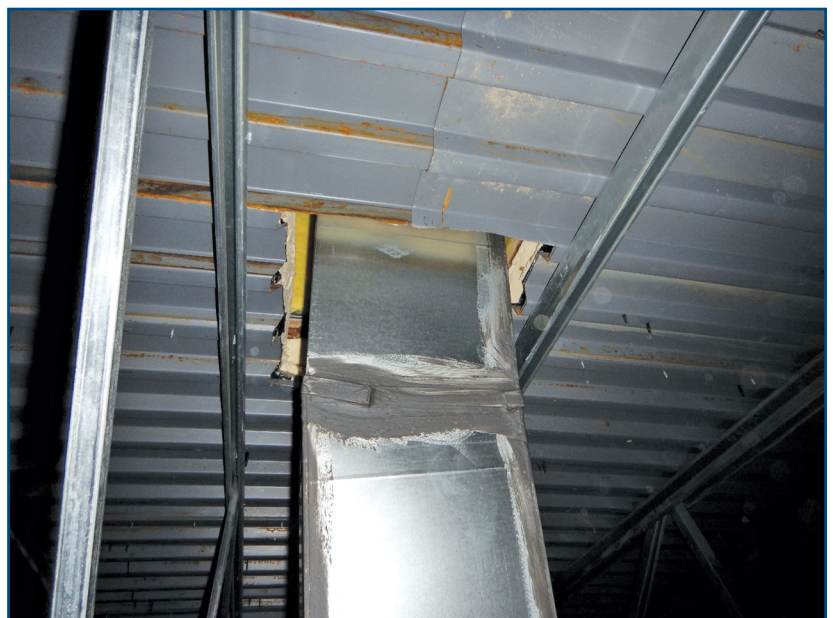
Figure 13 – Fire Station B. View of typical roof deck penetration for a duct where the roof deck penetration must be sealed on the top side of the deck to prevent air infiltration/exfiltration via the compact ventilated roof assembly.

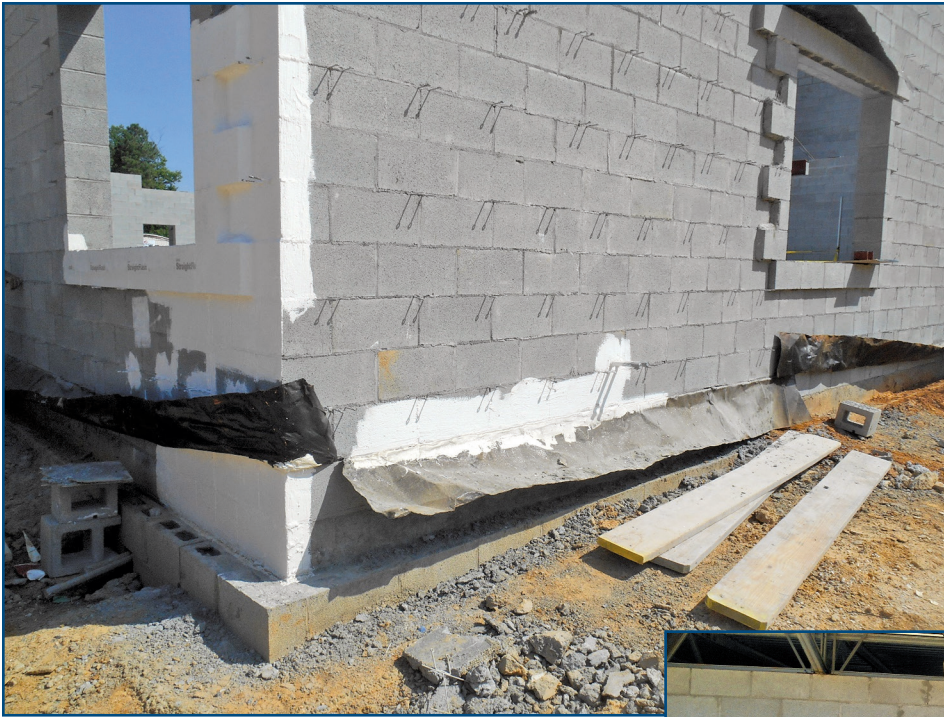
Figure 14 – Fire Station A. View of ongoing preparation work of the liquid-applied air barrier above and below the through-wall flashing tying it into the foundation wall, rough openings, and through-wall flashing.

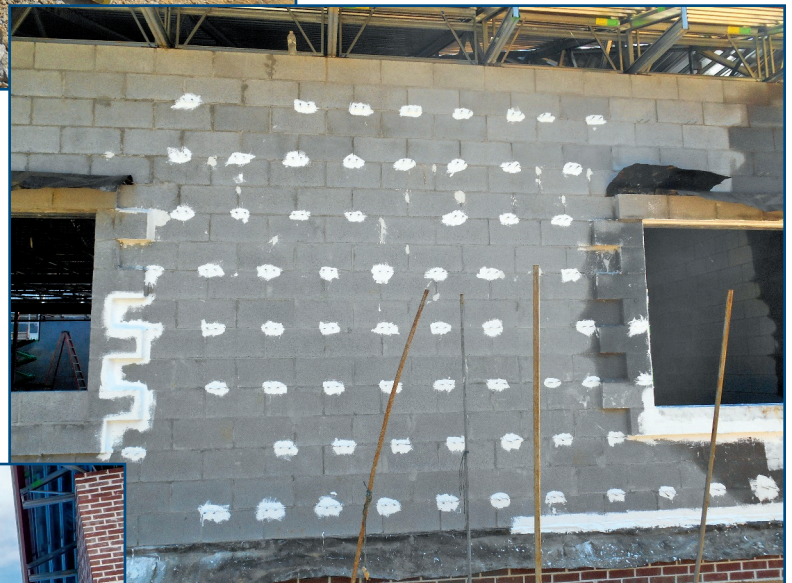
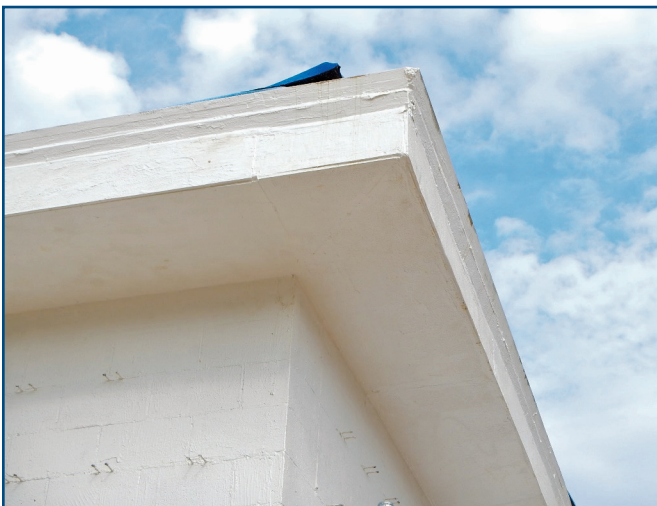
Figure 16 – Fire Station A. Closeup view of the liquid-applied air barrier creating airtight assembly at the roof soffit.

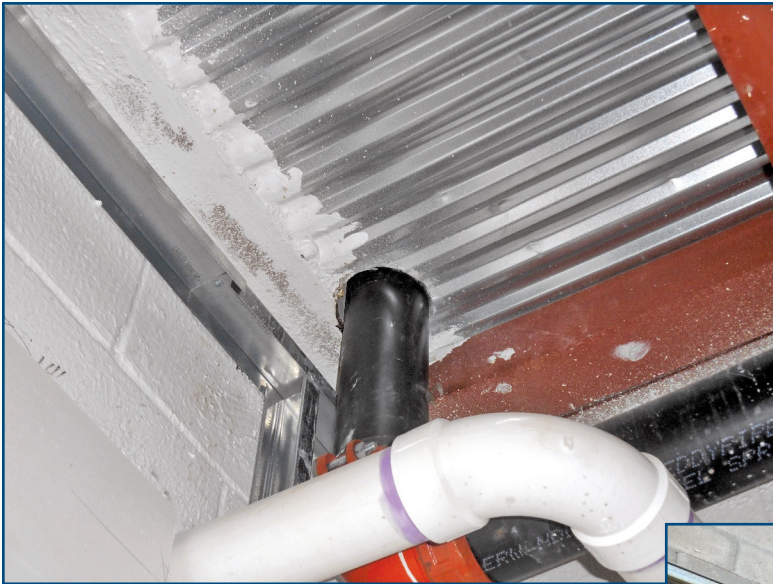
Figure 18 – Fire Station A. Typical view of air sealing efforts internal to the building, separating conditioned spaces from unconditioned spaces at roof-floor intersection.

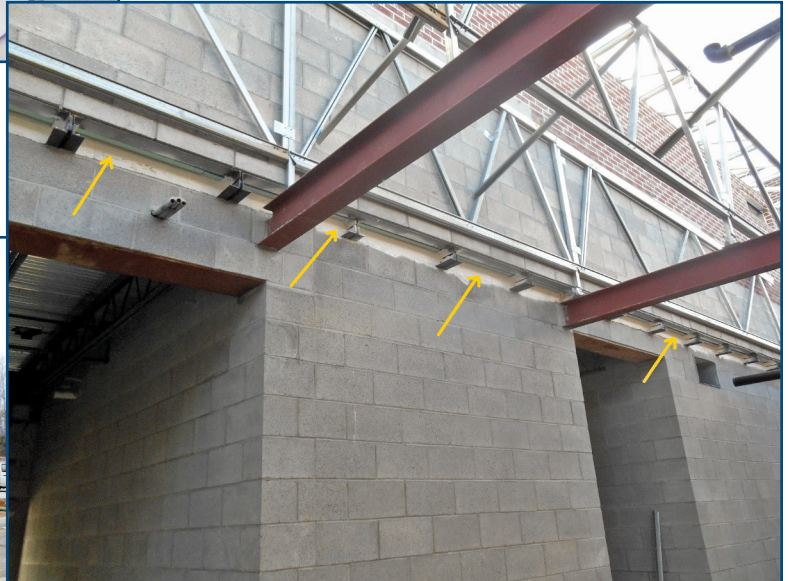
Figure 20 – Fire Station A. View of nearly completed occupied portion of the building where the exterior walls and roof line comprise the air barrier line.

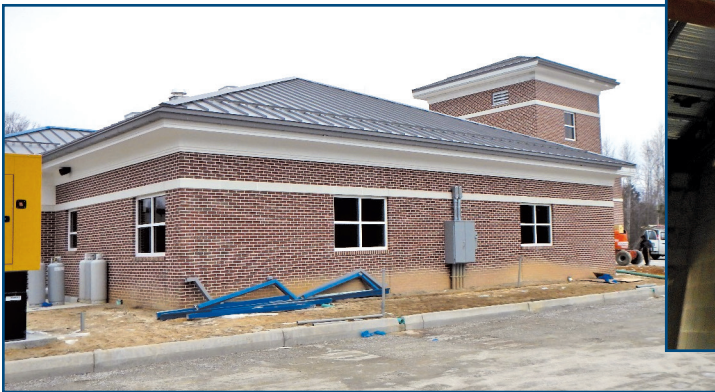
brick veneer cladding on the demising wall between the apparatus bays and the rest of the building contained a wide-open masonry cavity. This cavity was open to the above-ceiling space on the first floor (Figure 19). Outside air could easily find its way from the masonry cavities on the front and rear elevations or at through-wall step flashing locations and work its way to the building’s interior; or alternately, interior conditioned air could leak out through the masonry cavity via exfiltration. Regular air barrier audits during construction picked up on this condition, which was easily corrected by sealing the bottom of the open masonry cavity where it was exposed in the ceiling space. See Figure 20.

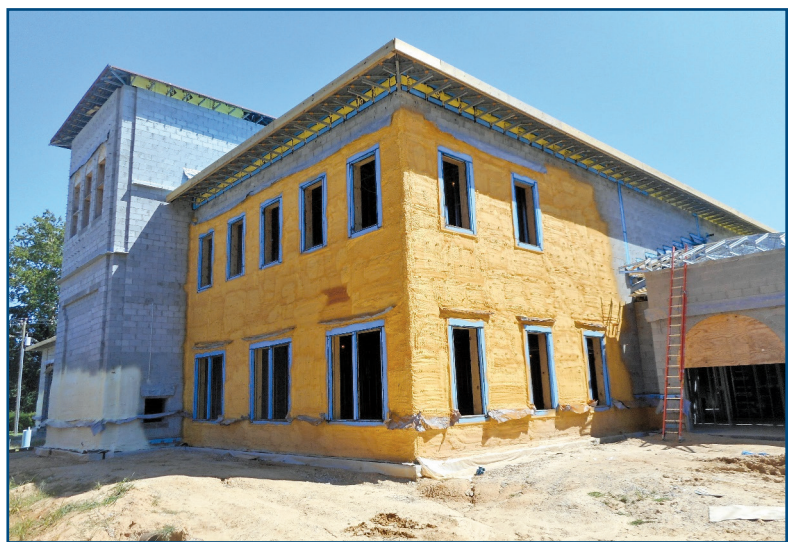
Figure 21 – Fire Station B. View of SPF air barrier over CMU backup wall. Note areas of detailing around windows and other penetrations.

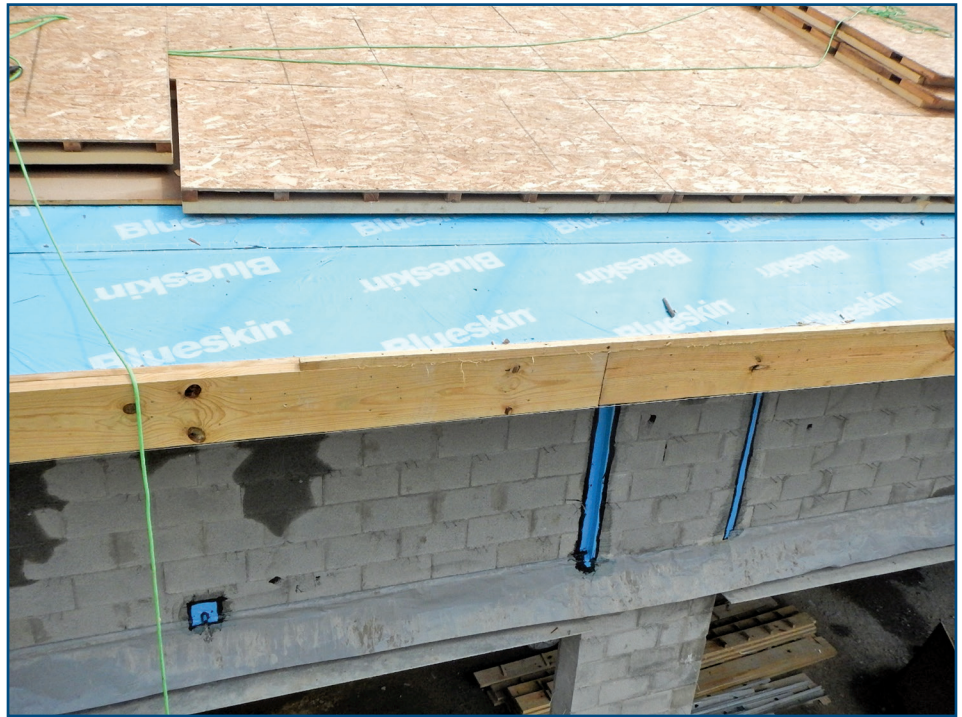
Figure 24 – Fire Station B. View of installed vapor/air barrier on the roof deck prior to installation of the compact ventilated roof system insulation and roof sheathing.
