BACKGROUND

- Insect-resistant
- Rot-resistant
- Fire-resistant
- Less expensive than traditional wood siding
- Resembles real wood

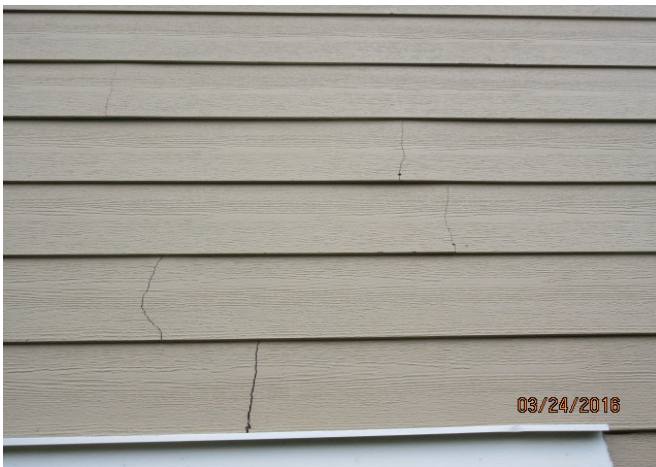
Figure 1 – Cracks in fiber-cement siding.

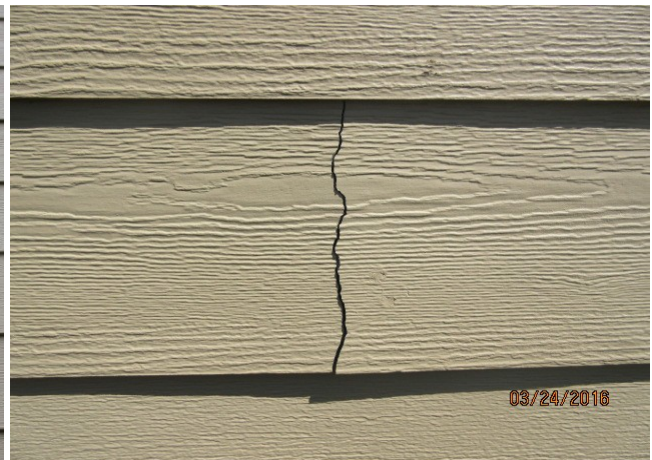
Figure 2 – Close-up view of crack in fiber-cement siding.

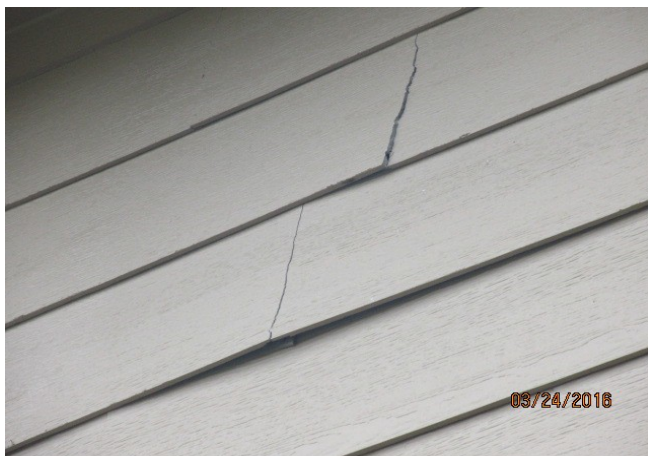
Figure 3 – Cracks and “warping” in fiber-cement siding.

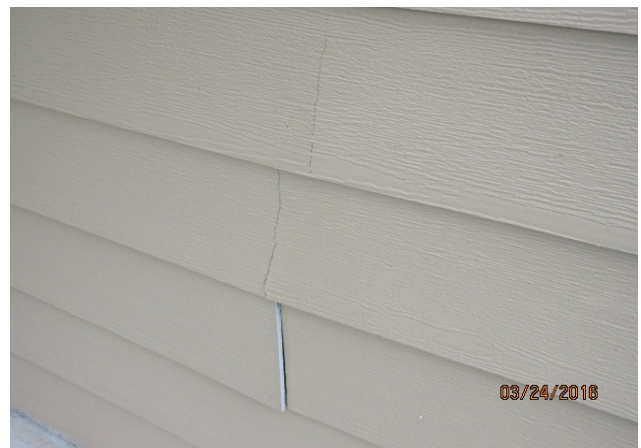
Figure 4 – Cracks and “warping” (open joint) in fiber-cement siding.

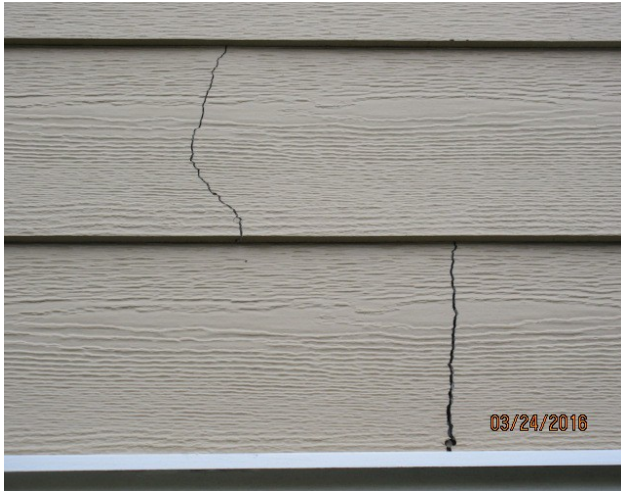
Figure 5 – Close-up view of cracks in fiber-cement siding.

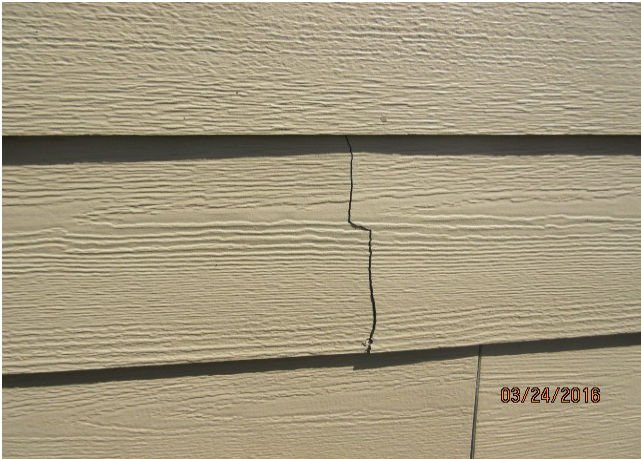
Figure 6 – Close-up view of cracks in fiber-cement siding.

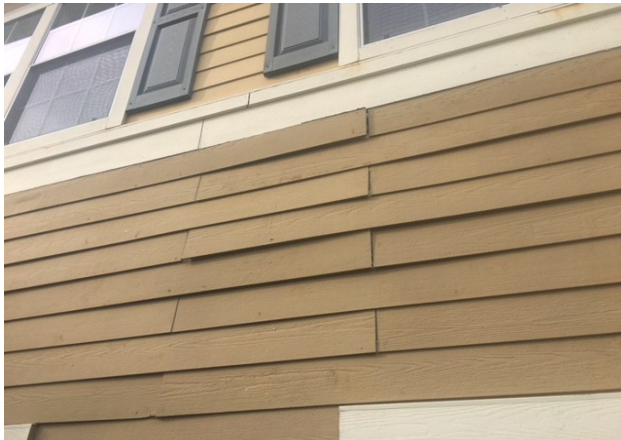
Figure 7 – Warped fiber-cement siding panels and opened butt joints between panels.

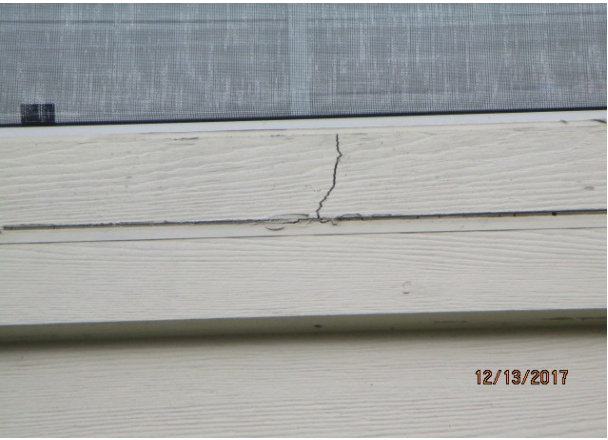
Figure 8 – Crack in fiber-cement trim.

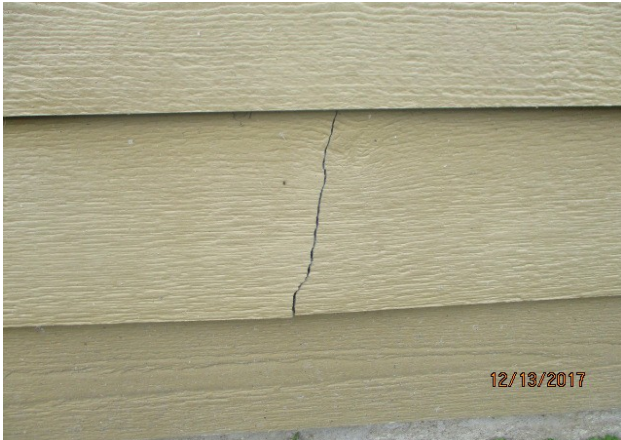
Figure 9 – Close-up view of crack in fiber-cement siding.

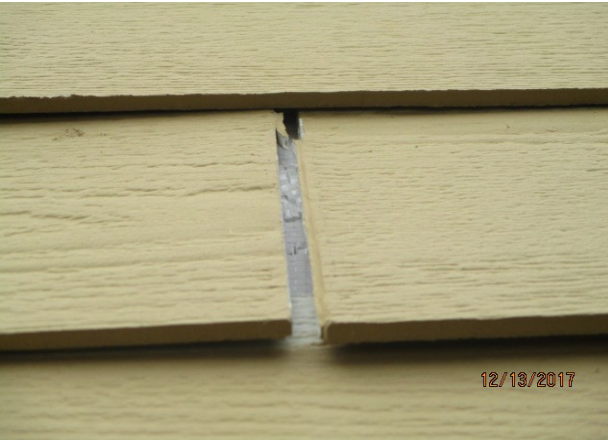
Figure 10 – Close-up view of open butt joint in fiber-cement siding.
