# 30<sup>th</sup> RCI International Convention and Trade Show

## STUCCO DETAILING FOR BUILDINGS WITH UNIQUE GEOMETRY

# STUCCO DETAILING FOR BUILDINGS WITH UNIQUE GEOMETRY

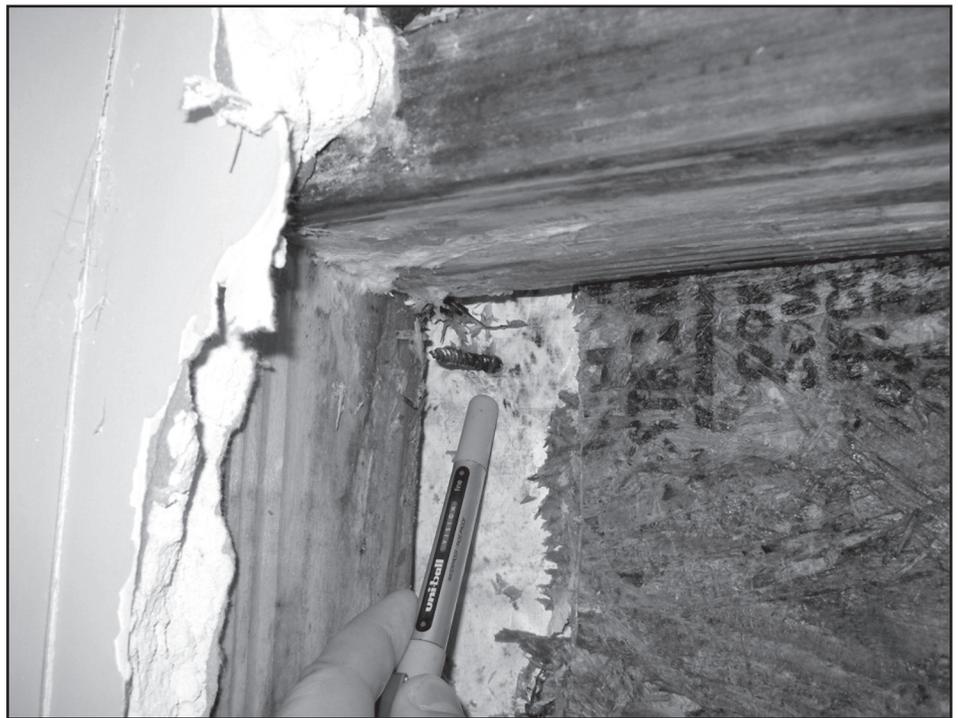
*Figure 1 – Water leakage at screw installed through sheathing (with sheathing removed for clarity).*

When installing attachments for metal plaster bases to wood framing members or to metal framing members, ASTM C1063, Sections 7.10.2.5; and 7.10.3.3 require the fasteners to be installed into the framing member such that the fasteners pass through the lath, but do not deform the rib. Section 7.10.2.2 states that 6d nails, 1-in. roofing nails, or 1-in. wire staples shall be installed flush with the lath and into the wood-framing member. Although some sheathing materials can provide adequate capacity to resist required lateral loads, water infiltration often results when fasteners are not installed in the framing members. During leakage investigations, the authors have frequently witnessed water leakage through the exterior wall system at locations where fasteners are attached only to the exterior sheathing and not the framing members (*Figure 1*).

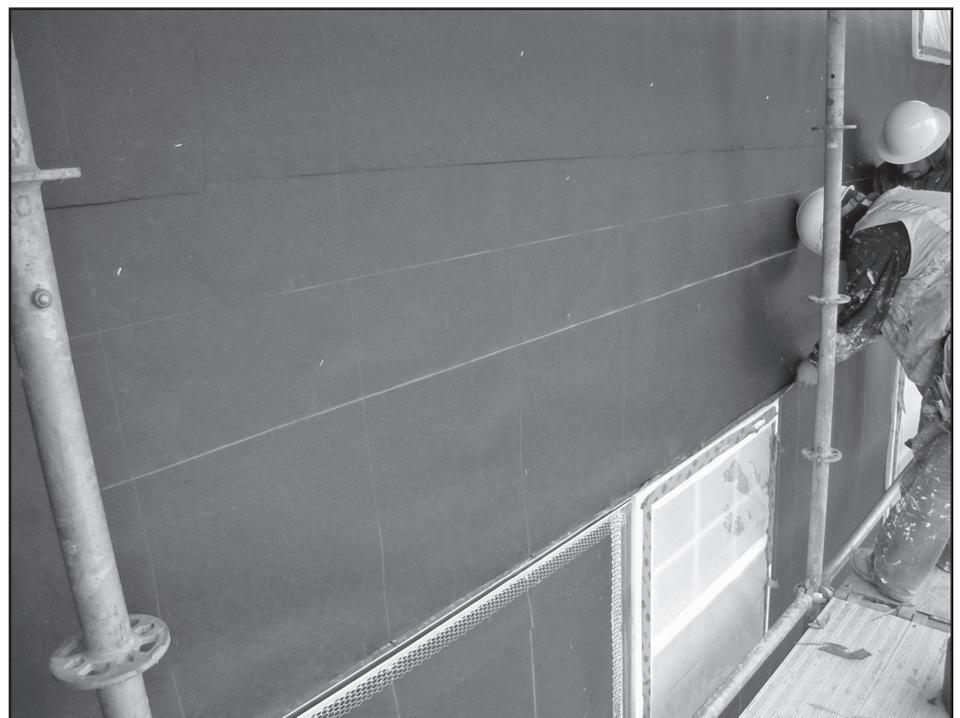
**Figure 3 – View of chalk lines illustrating locations of studs and floor slab.**

that chalk lines can be placed to highlight their locations (*Figure 3*). If an anchor misses a stud during the installation of the lath, the anchor should be removed; the lath and weather barrier should be cut to expose the unsealed penetration in the sheathing so that it can be sealed. Once the penetration in the sheathing is sealed, the WRB should be repaired and the lath should be retied.

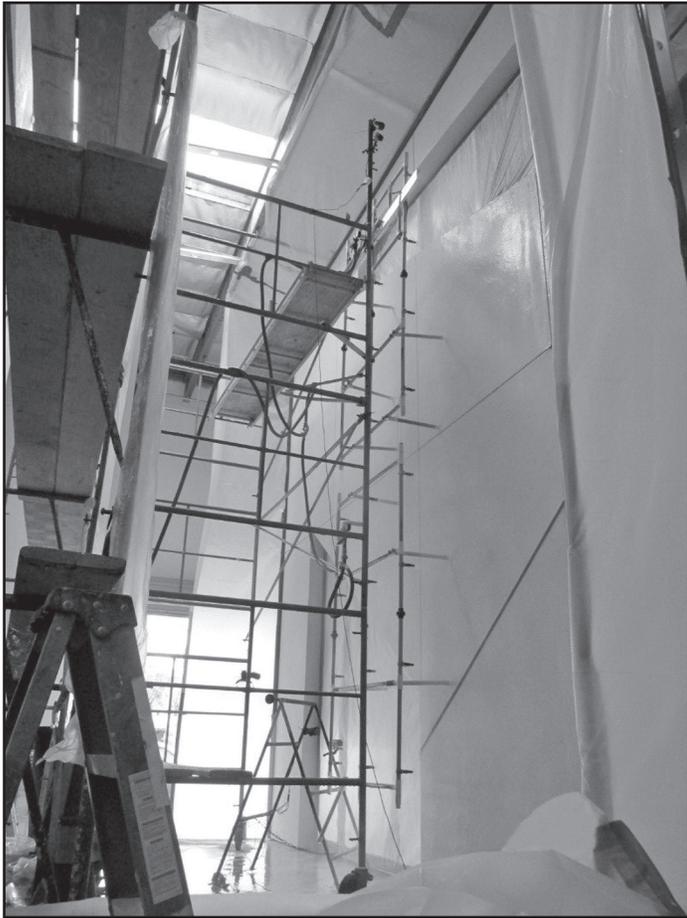
**Figure 8 – Water testing of laboratory mock-up.**

Water testing was performed on the mock-up in the laboratory using the procedures outlined in ASTM E2128, including the use of the calibrated spray rack, but without a pressure differential between interior and exterior conditions (*Figure 8*).
