33RD RCI INTERNATIONAL CONVENTION AND TRADE SHOW

WATERPROOFING AND INTEGRATION OF EXPOSED AIR HANDLING UNIT (AHU) CLADDING WITH THE BUILDING ENVELOPE

SIMPSON GUMPERTZ & HEGER INC.

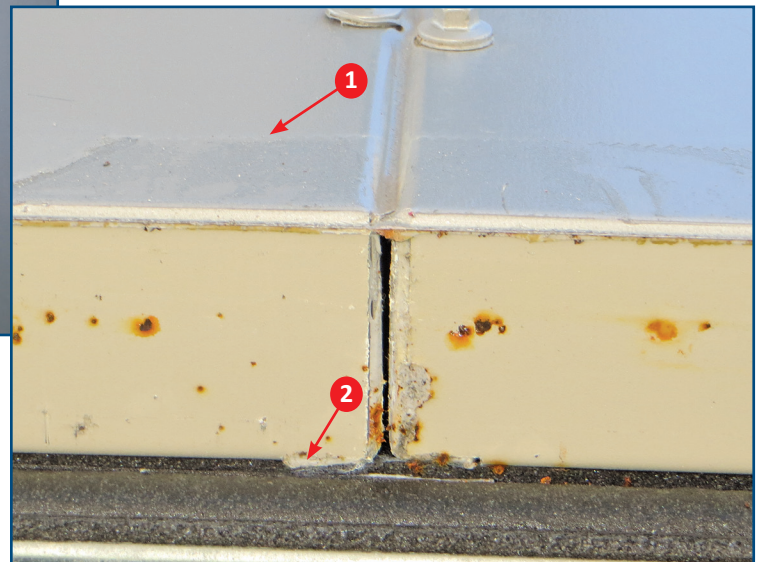
The industry standard for minimum sealant bond line and sealant joint width is 6 mm. As you can see in *Figure 2*, the joint width does not meet this requirement. The sealant joint shown in *Figure 2* acting as the primary weather seal would

Figure 2 – Sealant joint (1) between metal wall panels and foam gasket (2).

not be acceptable on the building envelope and should not be acceptable on an AHU that is now acting as a component of the building envelope. On many AHUs, this is just a bulk water diverting seal. However, at this size, the joint does not have the same performance as a joint designed per industry standards. In the above case, the wall panel returns are break metal with the edges butted together. The joint does not incorporate welded corners. Interior fillet sealants are installed at the factory. To speed construction, the wall panels are also fastened to the unit in the factory. This makes portions of the primary weather seal unavailable for field verification. Wall panel construction and similar joints are common across the industry. When identifying paths of water intrusion, the wall panel construction can be a common component of the path.

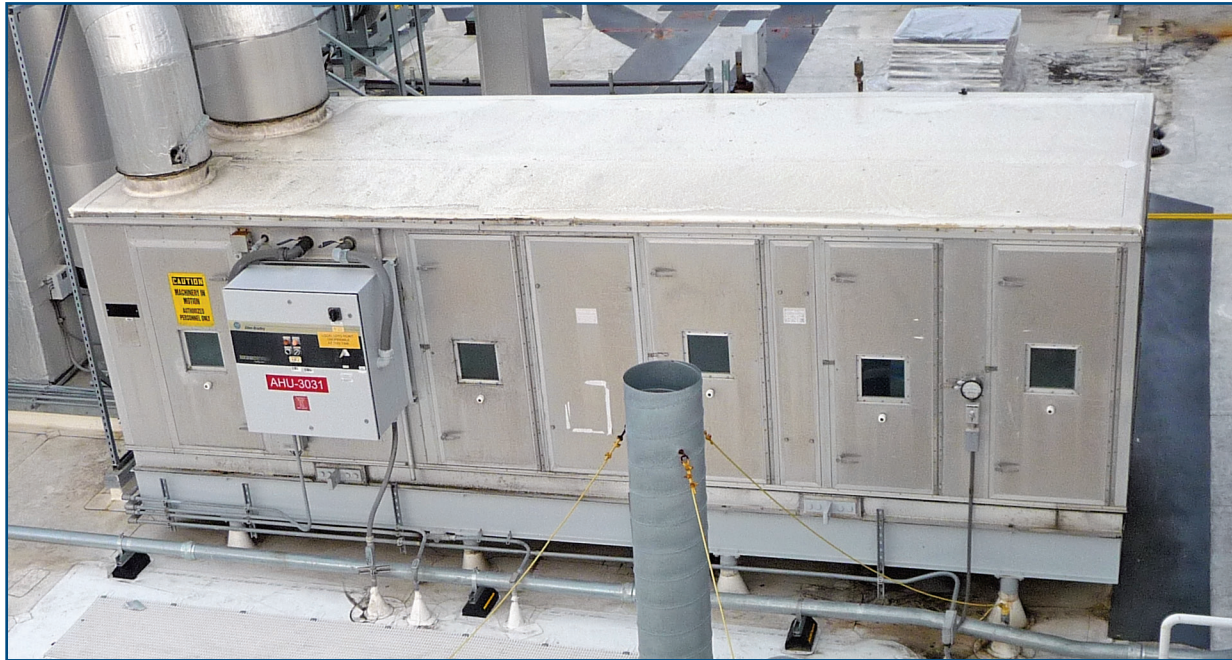
**Figure 4 –
AHU mounted
on posts.**

**Figure 5 –
Close-up of
unit mounted
on posts.**

As shown in *Figures 4 and 5*, with the unit mounted on posts, the contractor can install the roof membrane under the AHU. In this way, the only discontinuities introduced in the building envelope are the posts and any potential ductwork under the unit. Depending on where the AHU exhaust and supply ducting are routed, any duct openings that occur below the AHU will still require curbs; however, the overall discontinuity created by the AHU is reduced. In our review of five projects, the surface area of these discontinuities can be as little as 5% of the typical footprint plan area of the unit. Installing the unit on posts as shown in *Figure 5* effectively removes the rooftop AHU from the building envelope. The AHU becomes an isolated piece of rooftop equipment whose function as equipment will continue to have an effect on the building, but its impact on the building envelope is reduced. In addition to reducing the impact of the AHU on the building envelope by extending the building envelope continuously under the AHU, the ponding and roof slope cricketing is avoided because water can flow directly under the units. Complete reroofing does require the space below the unit to be tall enough to facilitate construction. These tangible benefits to the building do come with some drawbacks. The cost of posts is often higher than the cost of curbs. Additionally, the installation of the posts can take longer than the installation of curbs.

As an alternative to the conventional AHU installation on curbs, the AHU’s envelope can be isolated from the building envelope by mounting the unit on cantilevered steel columns acting as support posts.

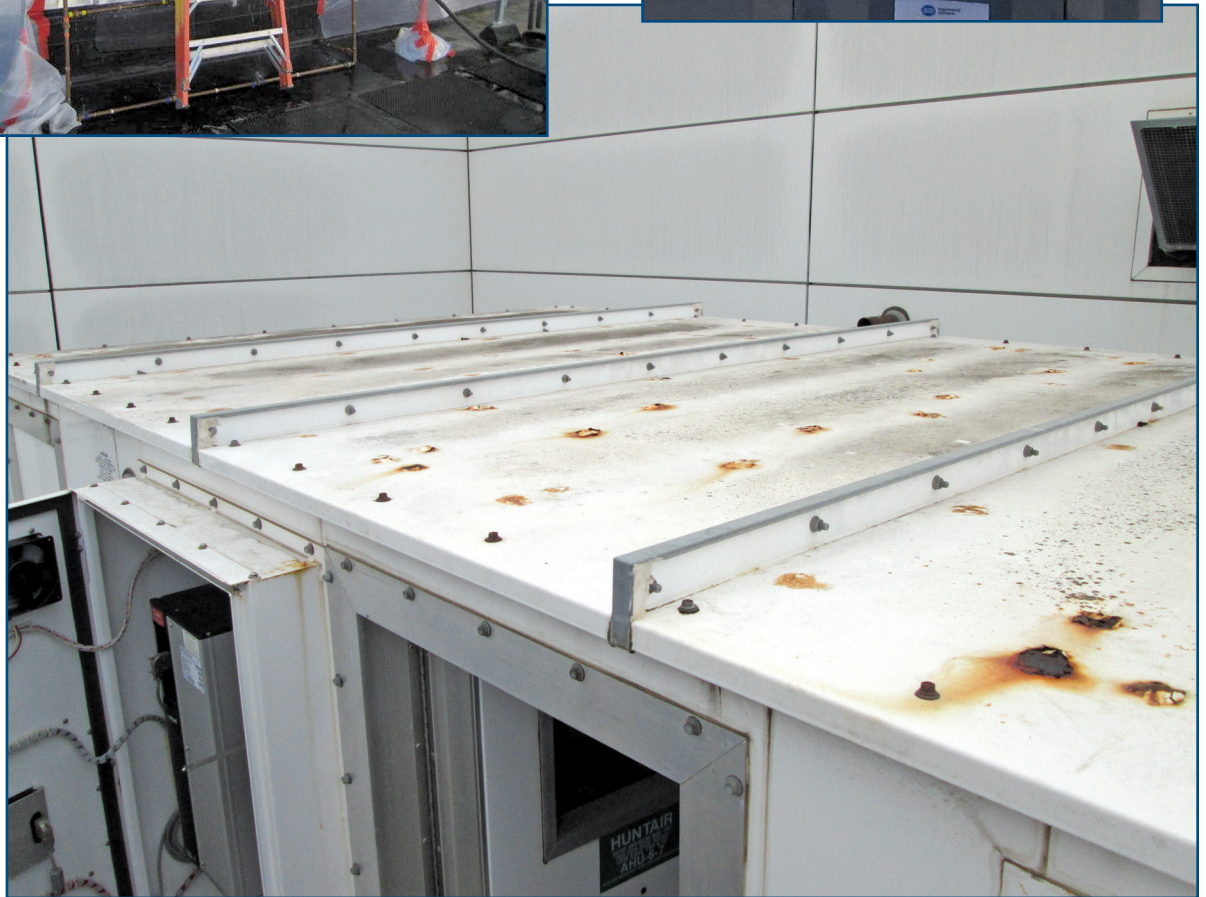
As shown in *Figure 9*, this rooftop AHU showed significant corrosion on top of the standing seam metal roof. The combination of water ponding and a marine environment were the primary sources of corrosion. However, other units on the same building, exposed to a similar environment and of a similar vintage, did not exhibit this corrosion. This was primarily an anti-corrosion coating failure, and the repair was to re-coat the standing seam metal roof.

Figure 9 – Coating failure on metal roof.

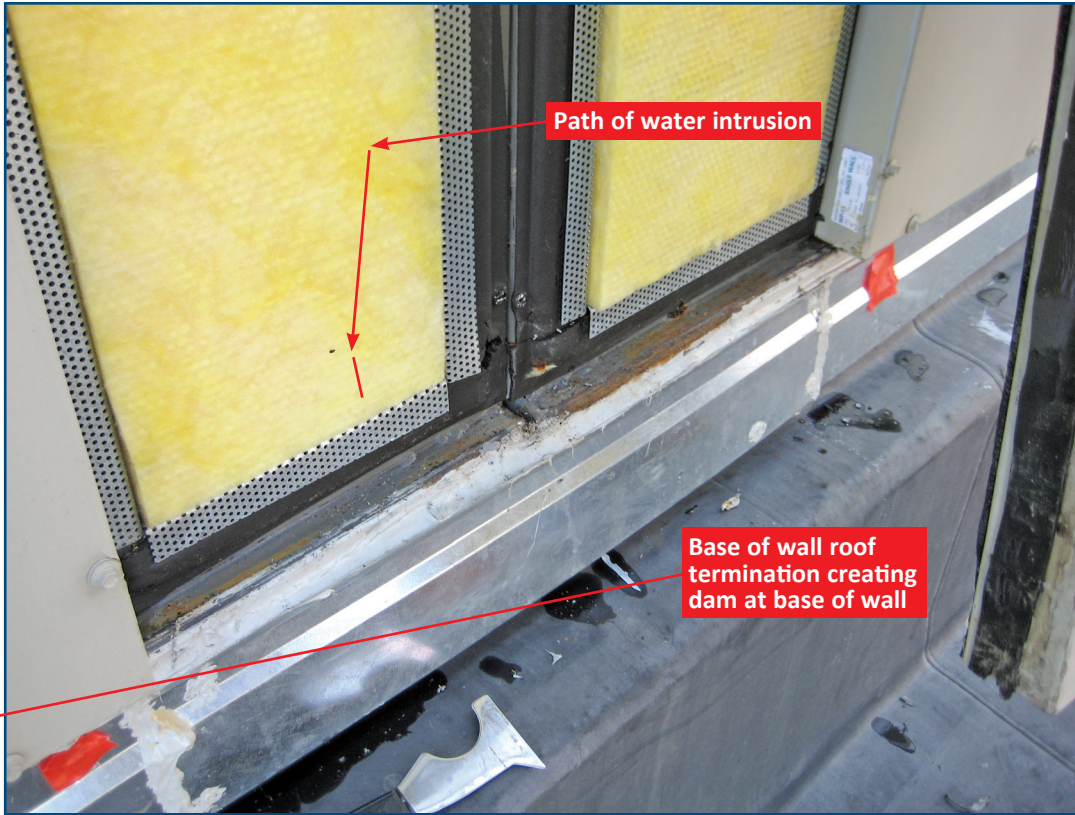
Doors, and Curtain Wall by Uniform or Cyclic Static Air Pressure, to subject different sections of the AHU to sustained water spray. After each test, the wall panels were removed to check for water intrusion (Figure 10). Figure 10 also shows the condition where two wall panels from different AHU sections come together at the demount line. Above the stainless steel counterflashing, you can see the gap between the units. The exterior wall panels are designed to

seal at the black gasket. This makes the area outboard of the gasket the wet zone. Water draining down the panel joint is directed into the joint at the demount line and thus into the building. See the arrow in Figure 10. In addition to water leakage at some of the demount lines, the original roofing system terminated onto the base of the exterior AHU wall panels. These panels are not barrier wall panels that are

Figure 10 - Wall panels removed after water test.
