31ST RCI INTERNATIONAL CONVENTION AND TRADE SHOW

CURTAIN WALL LABORATORY MOCK-UP TESTING: THE WHO, WHAT, WHEN, WHY, AND HOW

AMY M. PEEVEY, REWC, RRO, PE

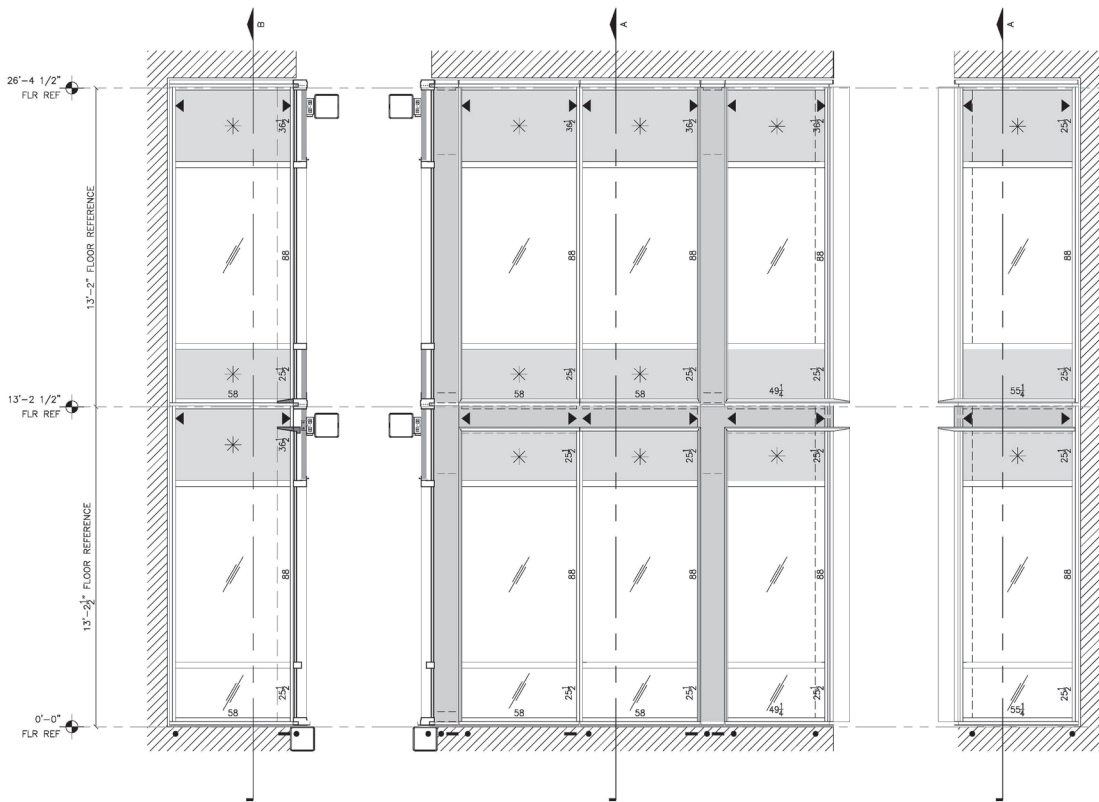
Figure 1A – Mock-up elevation for a Class-A office building in The Woodlands, Texas.

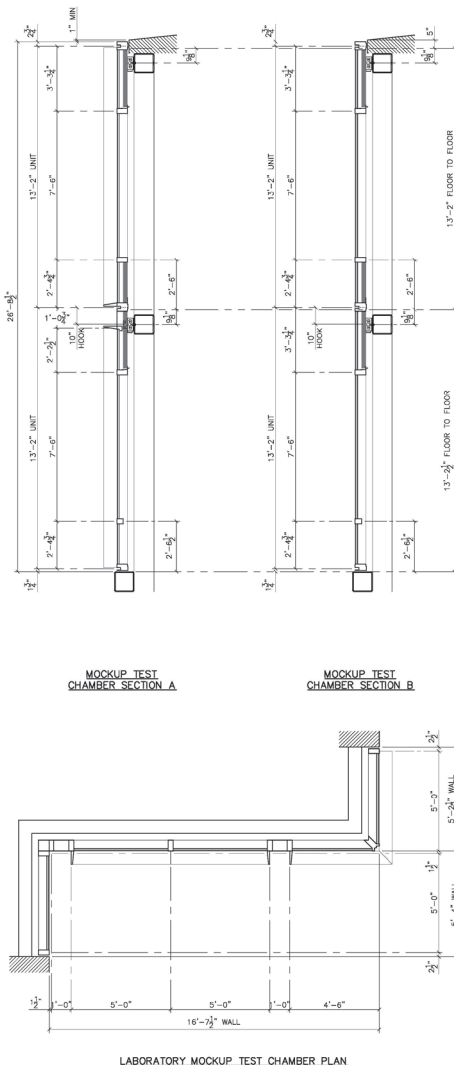
Figure 1B – Mock-up sections for a Class-A office building in The Woodlands, Texas.

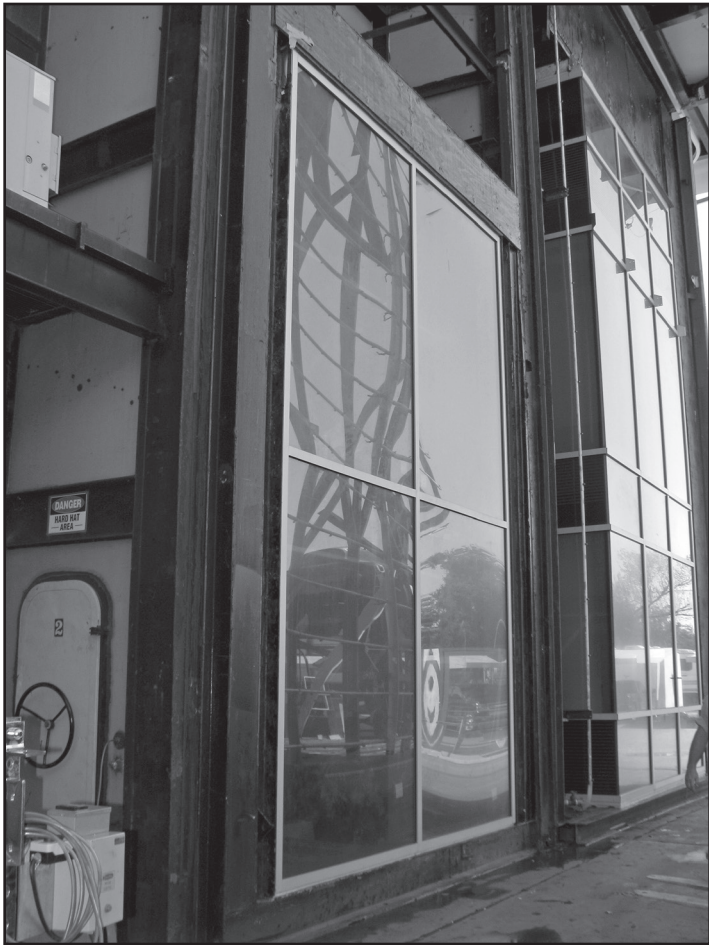
Figure 2 – Stick-framed curtain wall mock-up.

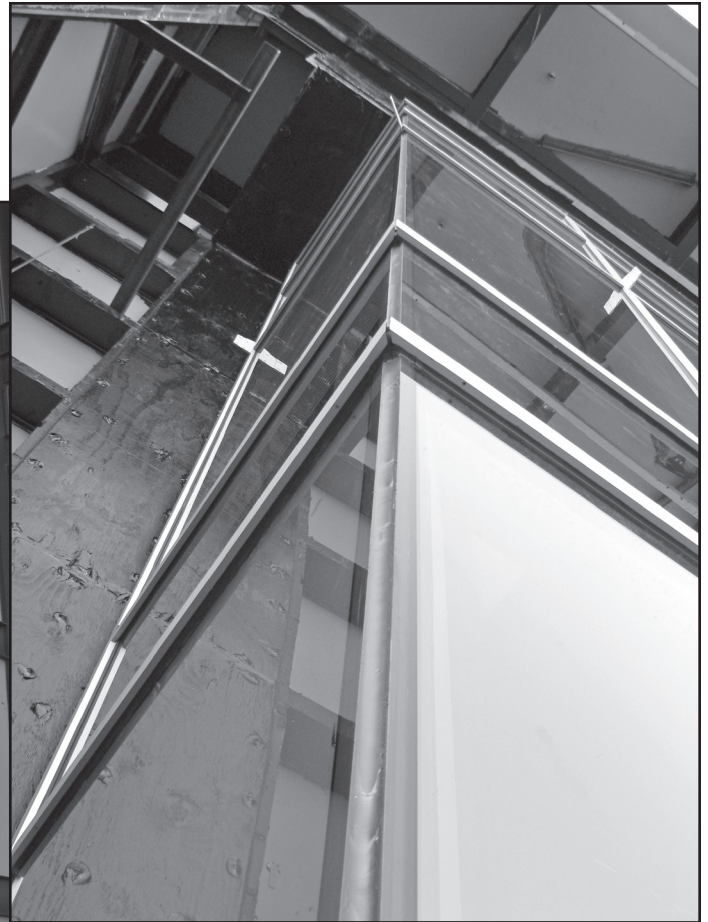
Figure 3 – Unitized curtain wall mock-up.

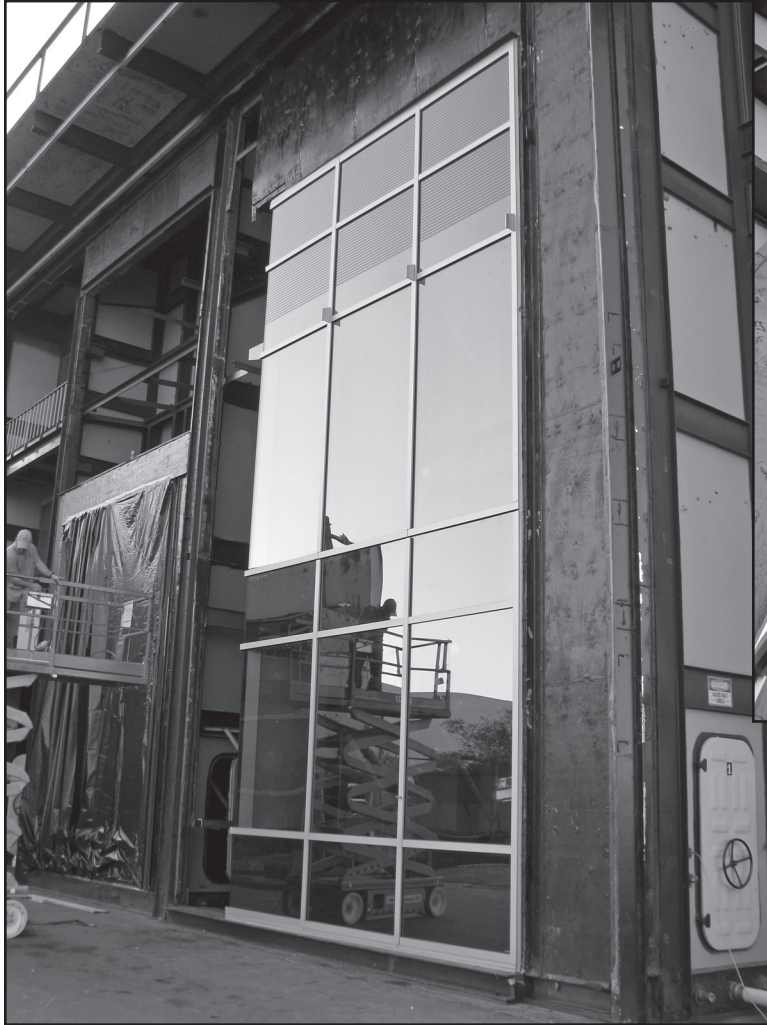
Figure 4 – Outside corner of unitized curtain wall mock-up.

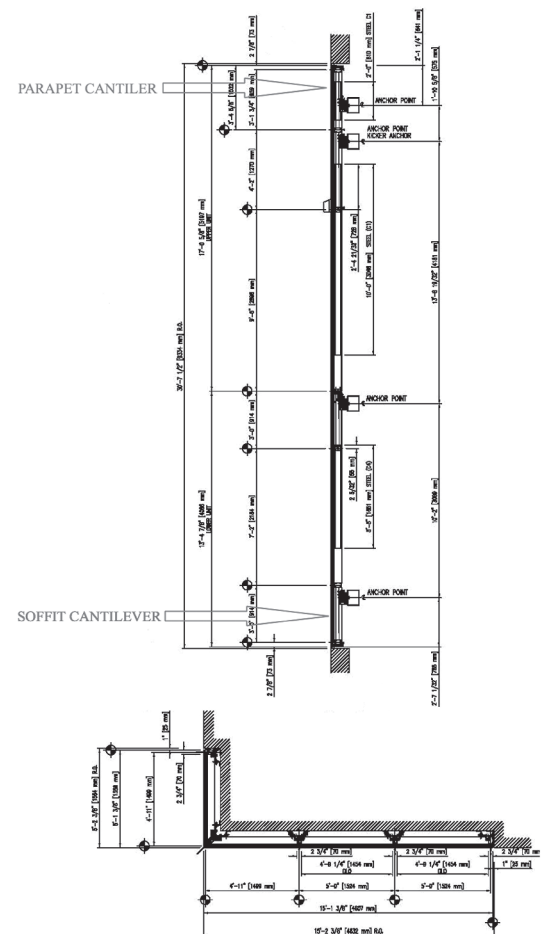
Figure 5 – Section through unitized mock-up.

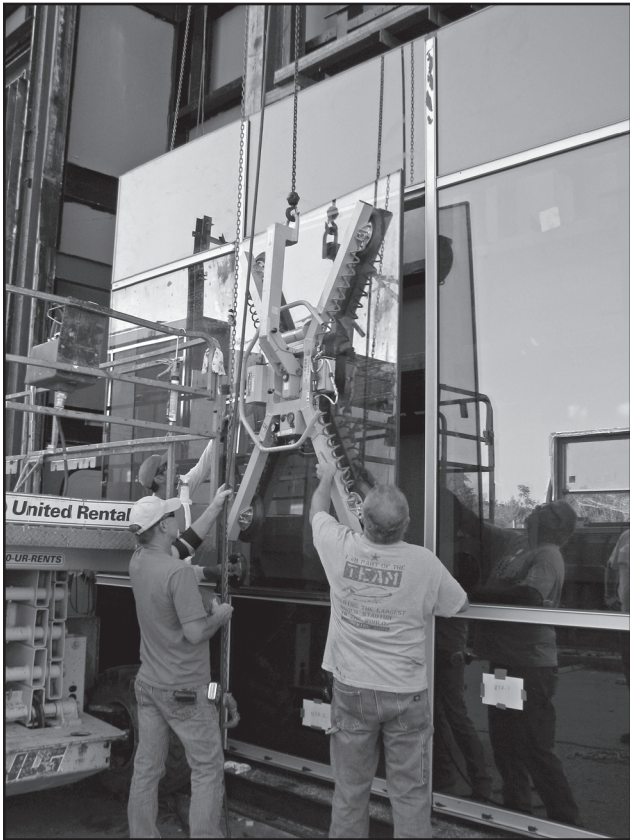
Figure 6 – Reglazing of unitized mock-up.

The consultant required that one of the insulated glass units (IGUs) be deglazed and reglazed within the unitized mock-up specimen (*Figure 6*) to confirm the performance of the custom system’s reglaze procedure. During the deglazing and reglazing process, it was determined that the reglaze procedure was inadequate because it omitted ripping of the pressure plate to allow clearance for the IGU installation, and also because it required additional joinery and zone plug sealant repairs as a result of deglazing. The consultant, installer, and manufacturer worked together to create a new reglaze procedure that accurately reflected the reglaze requirements to ensure that replacement of units would still meet the project requirements.

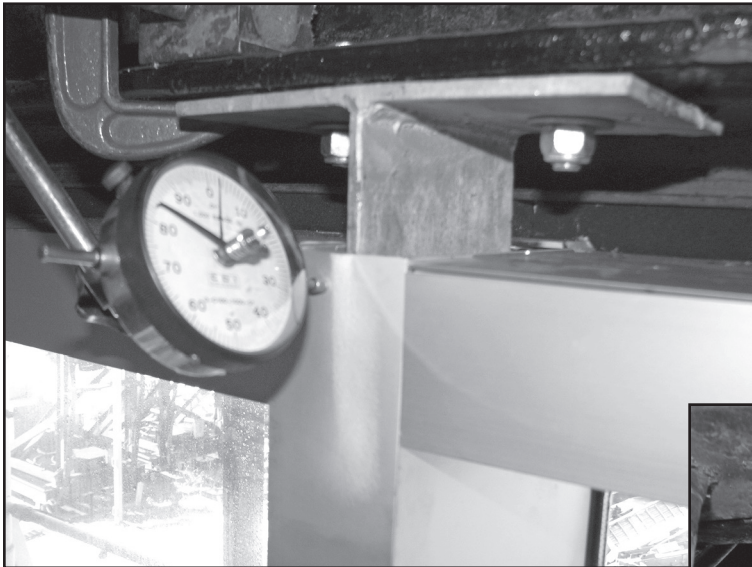
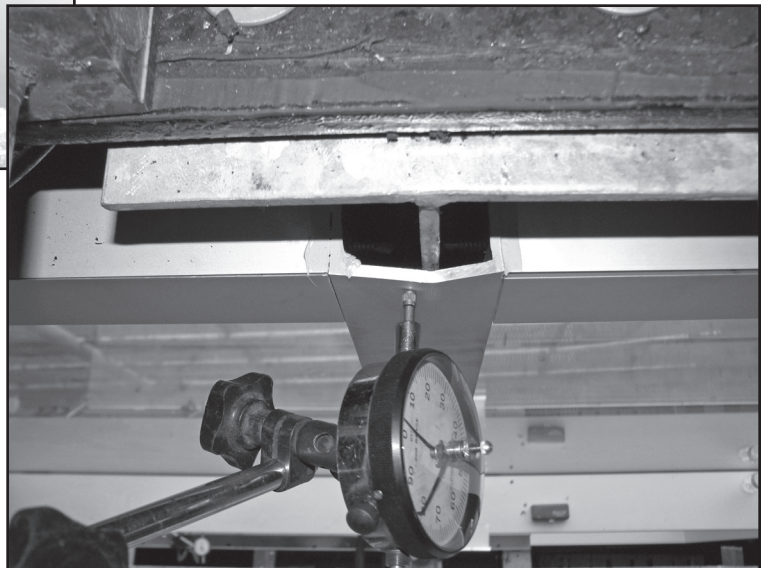
Figure 7 – Structural failure at mullion connection of stick-framed curtain wall.

Figure 8 – Structural failure at mullion connection of stick-framed curtain wall.

For the stick-framed curtain wall, it was determined that the single-trunk “T” mullion anchors resulted in excessive bearing pressure on the aluminum mullion interior wall, resulting in deformation of the mullion. The anchors were replaced with standard two-trunk “T” brackets to distribute the bearing between the anchors and the mullions so that it did not exceed the allowable aluminum-bearing strength. Once the structural issues were mitigated, static water testing was performed and water intrusion was observed. The water intrusion was subsequently repaired, and the specimen was able to pass the remainder of the testing, meeting the specified performance requirements.

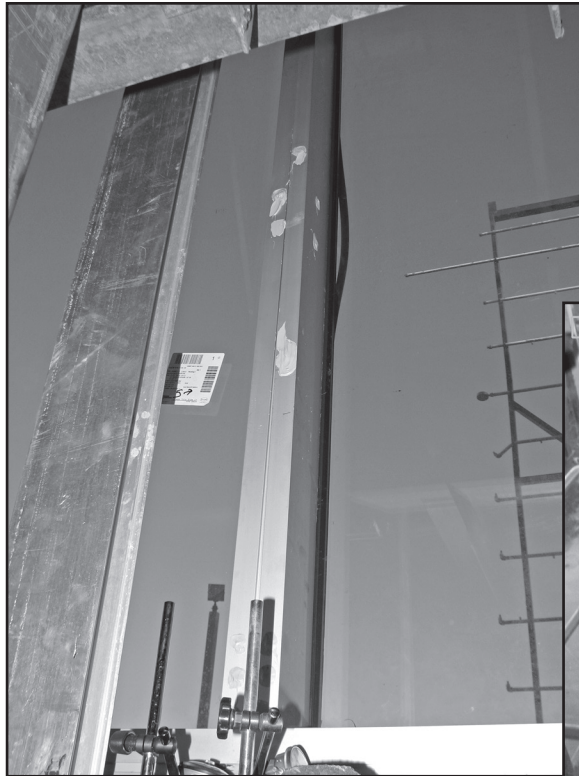
Figure 9 – Partial deglazing of vision unit due to excessive deflection of two-piece mullion for unitized curtain wall.

egated design. This was of particular concern, as not only was the curtain wall experiencing excessive deflection that was partially deglazing units and causing rolling of the intermediate two-piece mullions, but the engineer's assumptions for structural modeling of the curtain wall system did not appear to be accurate. As a result, the custom unitized curtain wall design was in question.

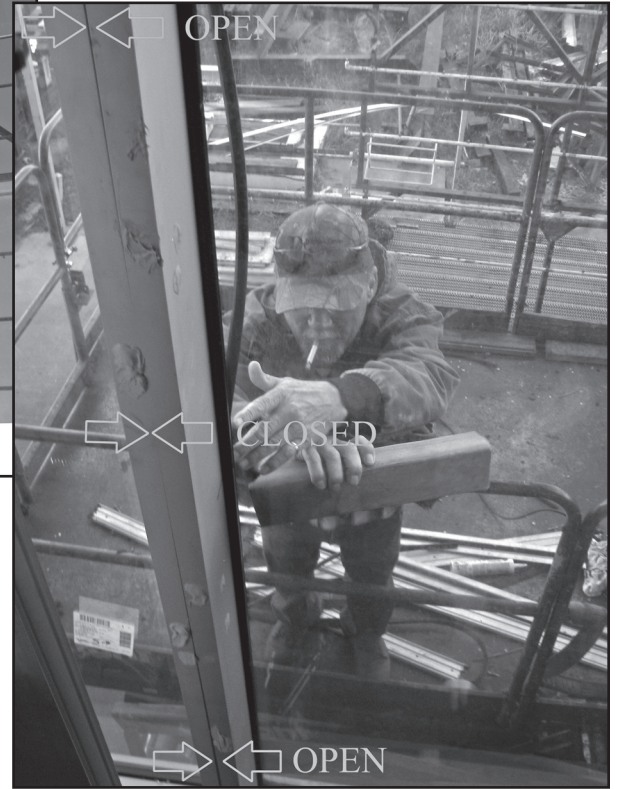
Figure 10 – Rolling of two-piece intermediate mullions and partial deglazing of IGU following negative-pressure structural testing.

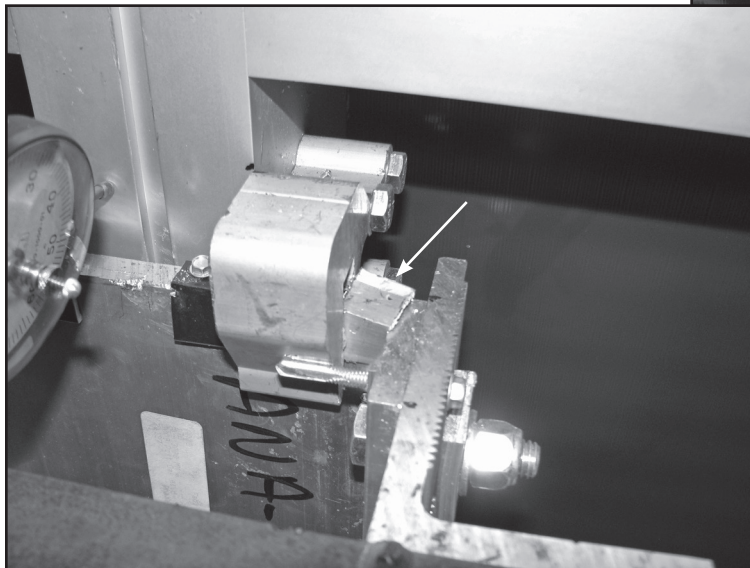
Figure 11 – Shim added at unitized curtain wall anchor bracket assembly.

Initially, rotation of the anchor clips was suspected as the cause of the abnormal behavior. However, adjustments to the anchors did not mitigate the excessive deflections during subsequent retesting, and displacement at the anchors was observed (Figures 11 and 12). In addition, the unitized curtain wall was disassembled so that steel reinforcing could be incorporated. However, additional retesting continued to result in excessive deflections of the intermediate mullions, which continued even after the maximum amount of reinforcing was incorporated at the intermediate mullion conditions.

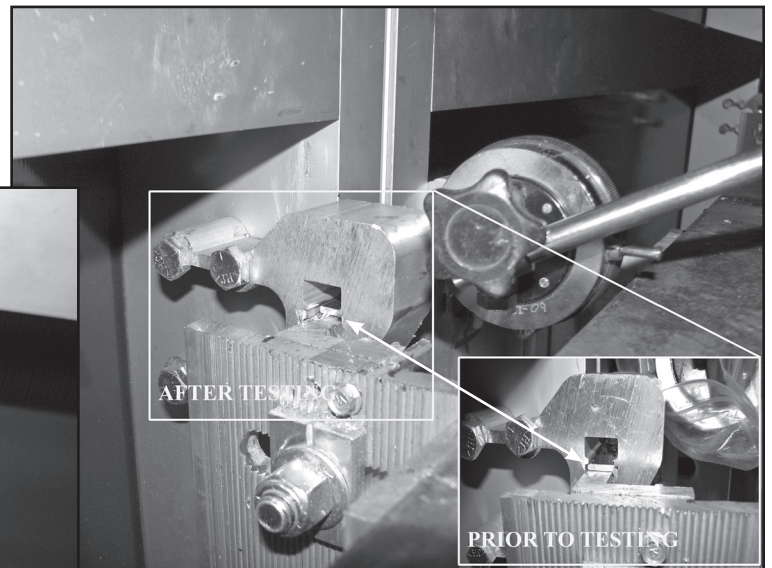
Figure 12 – Displaced shim following structural testing at negative pressure.

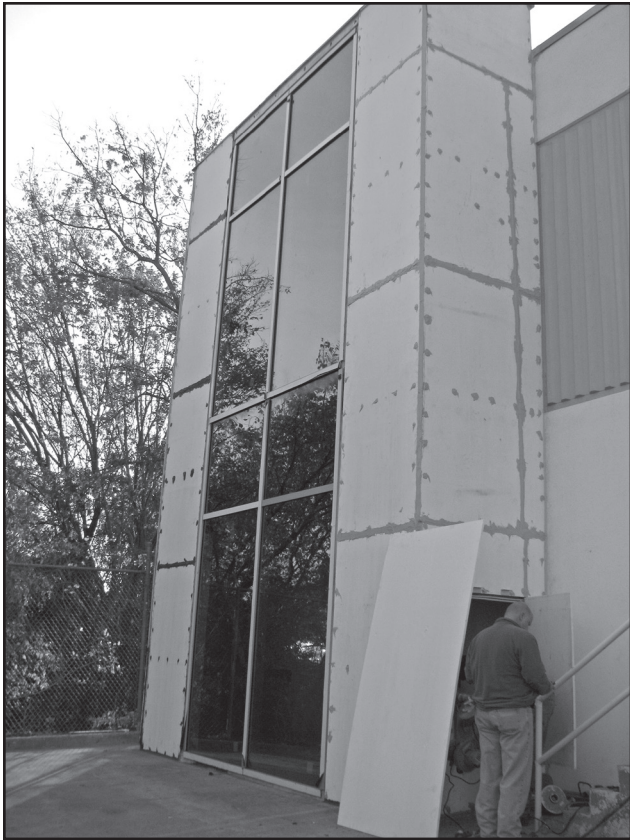
Figure 13 – Two-story unitized mock-up of typical floor spans.

Following the mock-up testing, it was determined that the mock-up configuration with two cantilevered conditions at each end with only an intermediate twin-span condition was not representative of any condition of the actual project. While the deflections of the fully reinforced intermediate mullions at the taller upper floors adjacent to the parapet condition still exceeded the requirements, it was determined that the mock-up configuration resulted in significantly higher deflections than representative for the project and that the fully reinforced mullions at the upper floors was acceptable.

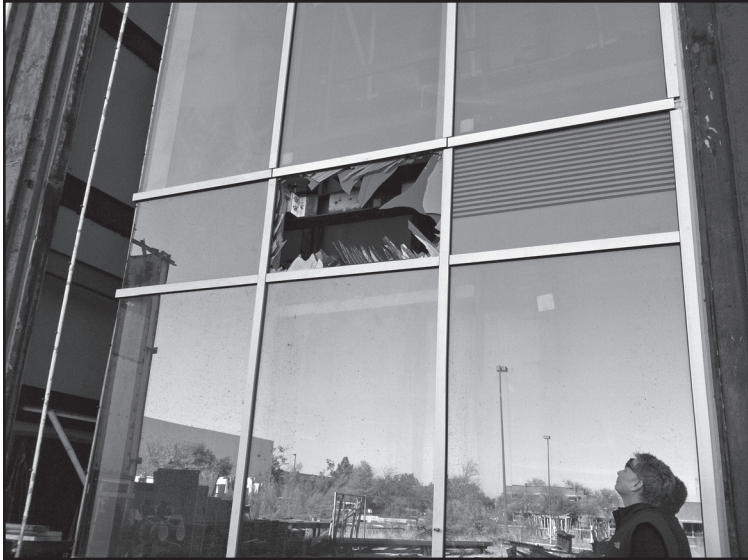
Figure 14 – Glazing breakage during 150% negative structural load testing.

Meanwhile, additional testing of the original unitized mock-up was performed with modified anchors and maximum reinforcement of the intermediate mullions. This testing yielded breakage of the glazing when tested at 150% negative structural load (Figure 14). The failure was attributed to displacement of the horizontal stack assembly (Figure 15).

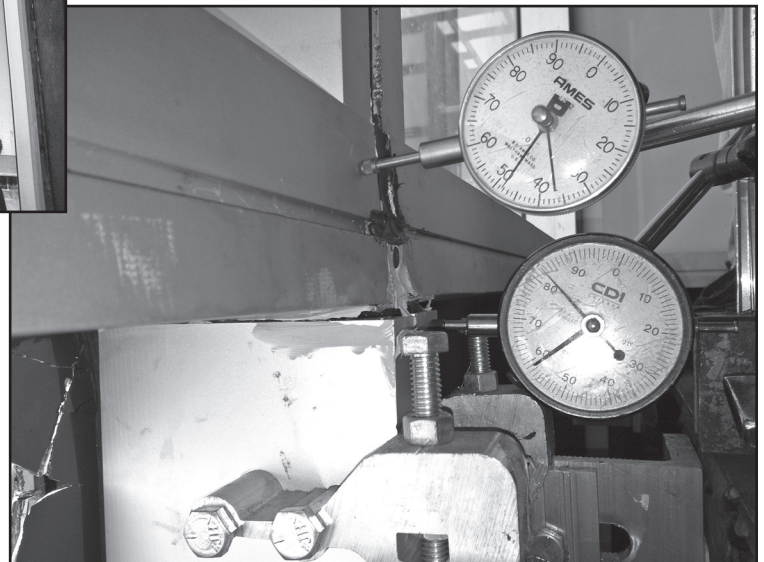
Figure 15 – Displaced unitized curtain wall horizontal stack assembly.

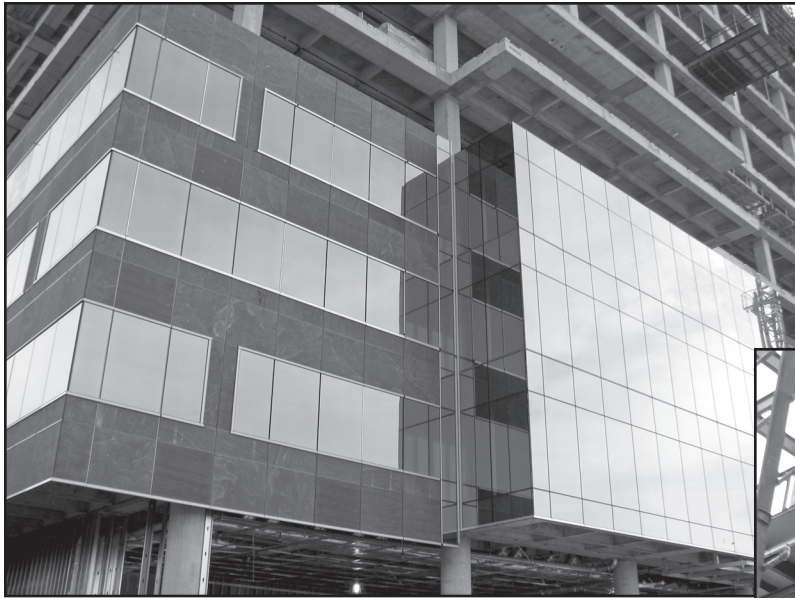
Figure 16 – Case Study #2—a 12-story commercial office building.

In 2014, a 12-story, high-rise, concrete-framed Class-A office building located in Houston, Texas, was constructed with the exterior walls consisting of aluminum-framed glass curtain wall (Figure 16). As with Case Study #1, the owner/developer negotiated a contract price with a curtain wall installer for a "custom" unitized curtain wall system at a significant savings without the involvement of a building envelope consultant on the project. The custom system was to be designed by the installer to meet the project requirements, including the incorporation of glazed granite panels within the unitized system. This time, consideration for a preconstruction laboratory mock-up was included within the installer's scope and the project schedule.

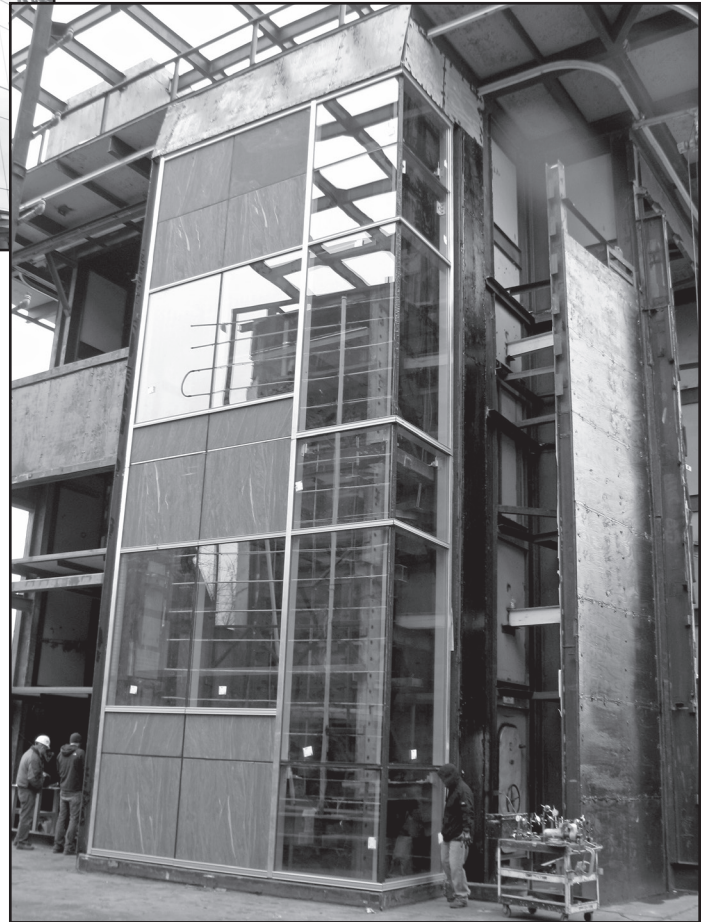
Figure 17 – Unitized mock-up of Case Study #2.

It was determined that the mock-up configuration would be two stories in height and three units wide, with a single-unit outside corner return (Figure 17). The preconstruction laboratory test scope included air infiltration, water infiltration (dynamic and static), and structural testing of the unitized curtain wall specimen, as well as testing of the window washer stabilization anchorage. Specifically, the testing sequence was as follows: static water testing, dynamic water testing, structural testing at +100%, static water testing, structural testing at +150%, and window-washer stabilization anchor testing.

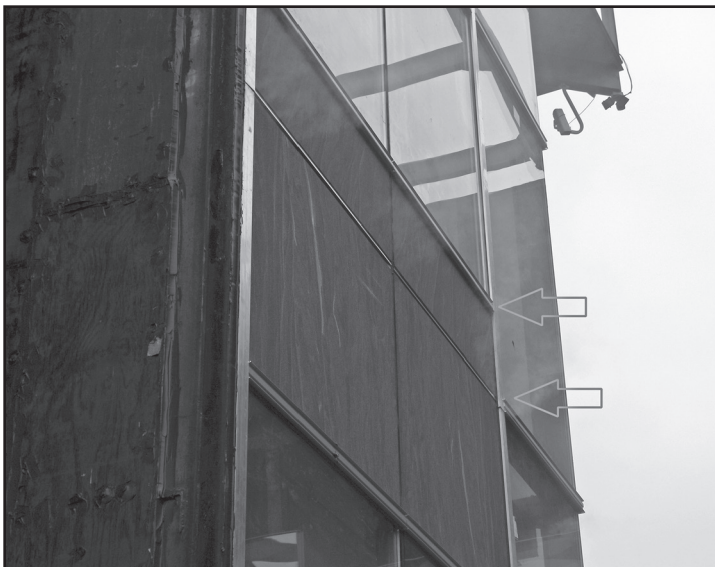
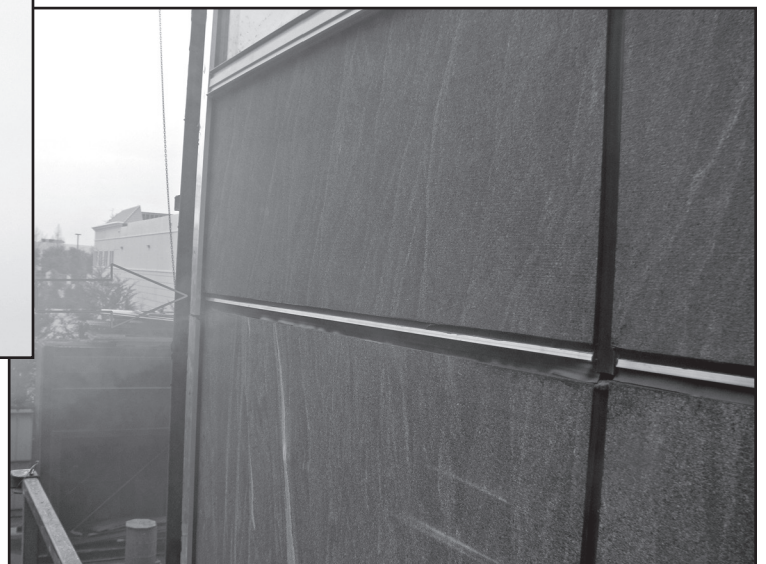
Figure 18 – Air exfiltration observed with smoke bomb and pressurized chamber.

Figure 19 – Air exfiltration observed with smoke bomb and pressurized chamber.

Additionally, the source of the air leakage was investigated with a smoke pen and a smoke bomb while negatively pressurizing the chamber (Figures 18 and 19). Air infiltration was observed at each mullion head, stack joint, and sill condition. Specifically, it was determined that air was passing up and over the stack joint vertical receiver (aka “chicken head”) inside the overlying hollow two-piece mullions. Additionally, the mullion end caps were not of sufficient depth to encapsulate the back of the glazing pocket, allowing air infiltration at each end of the unit mullions.

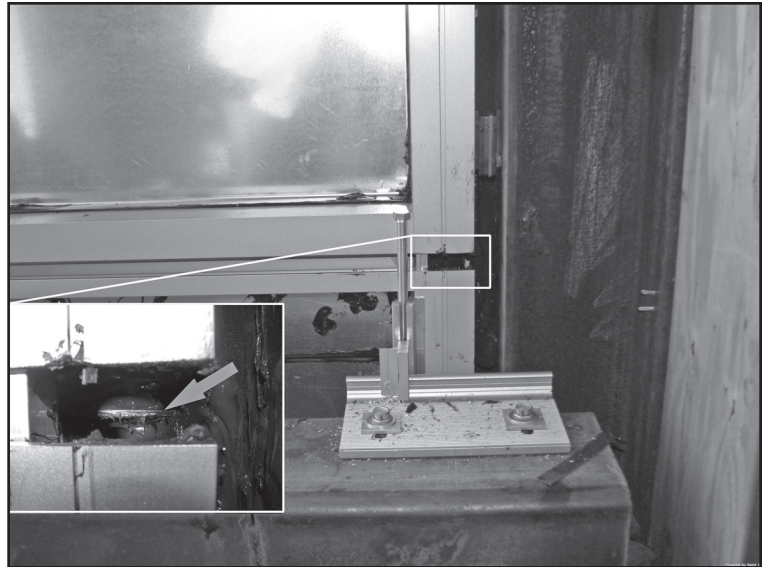
Figure 20 – Extended mullion end cap.

Repairs were made to the test specimen, which included the installation of deeper mullion end caps (Figures 20 and 21) at the head and sill of each mullion, as well as the installation of sealant at the interior pocket at the stack joint condition within each mullion (Figures 22A and 22B). Testing was repeated, and the system met the air infiltration and water penetration performance requirements, as well as the structural requirements.

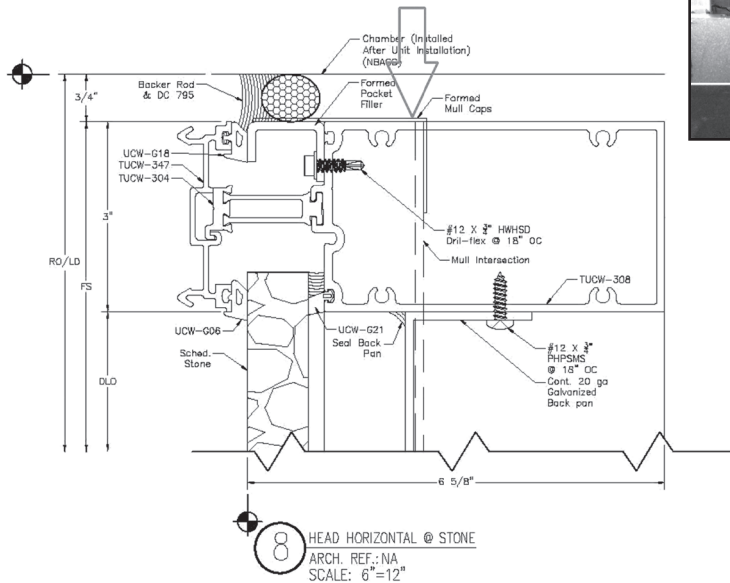
Figure 21 – Section at extended mullion end cap.

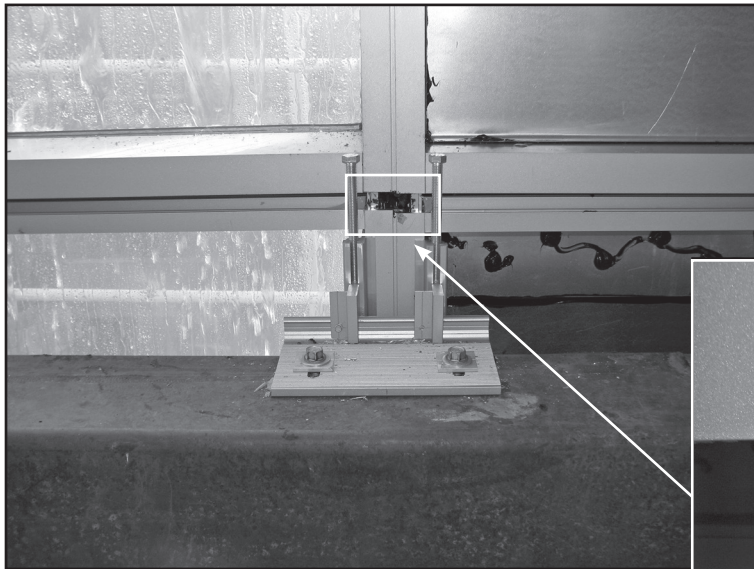
Figure 22A – Additional seal at hollow two-piece mullion stack joint condition.

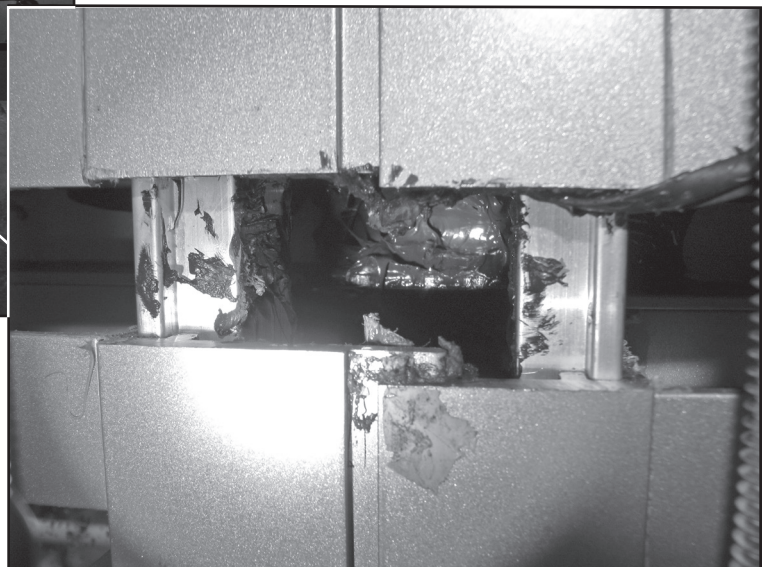
Figure 22B – Close-up of additional seal at hollow two-piece mullion stack joint condition.

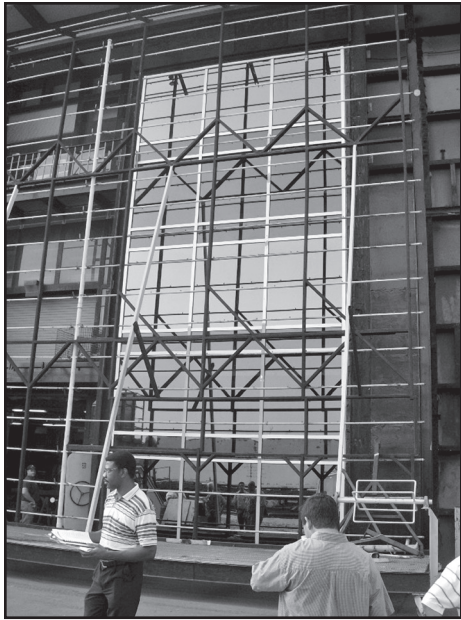
Figure 23 – Stick-framed mock-up of Case Study #3.

It was determined that the mock-up configuration would be two stories in height and three units wide (Figure 23). The preconstruction laboratory test scope included air infiltration, water infiltration (dynamic and static), and structural testing of the curtain wall specimen, as well as testing of the window-washer stabilization anchors. Specifically, the testing sequence was as follows: static water testing, dynamic water testing, structural testing at +100%, static water testing, structural testing at +150%, and window-washer stabilization anchor testing.

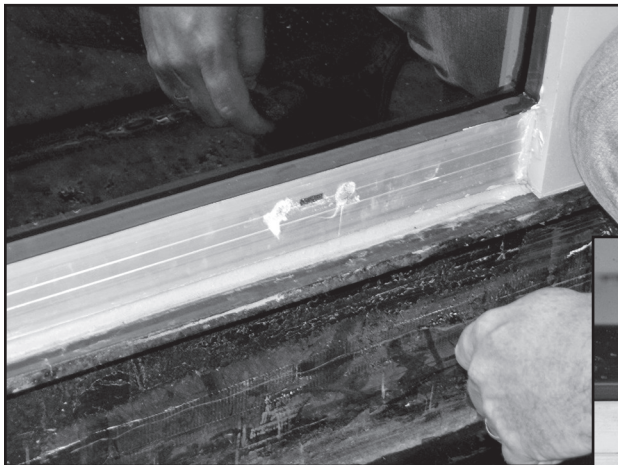
Figure 26 – Rectangular weepholes at base sill track.

Another source was determined to be weep holes that were modified in size and profile from that indicated in the shop drawings along the sill condition. Rectangular slotted weeps, in lieu of circular weeps, were observed (Figures 26 and 27). These weeps allowed more water into the system than could be managed and evac-

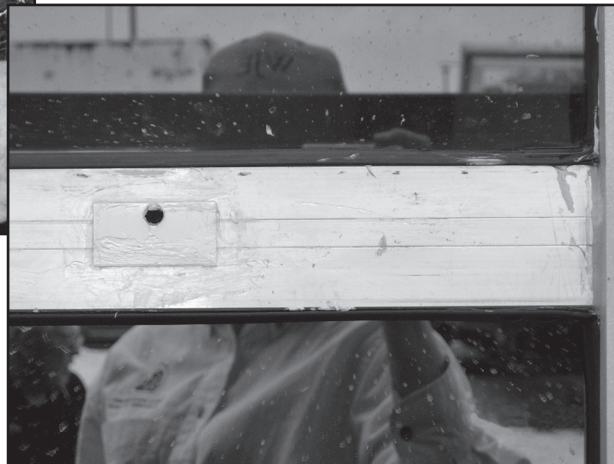
Figure 27 – Modified weepholes at other intermediate horizontal mullions.

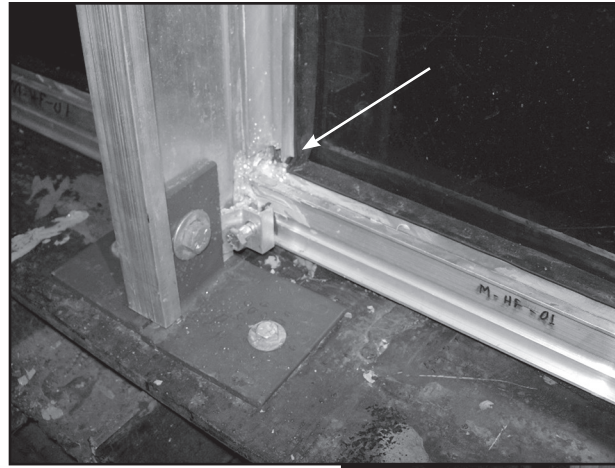
Figure 24 – Prematurely terminated interior glazing stop.

A large source of water intrusion was the premature termination of the interior glazing stops (Figure 24) or discontinuity of the glazing stops at curtain wall mullion anchor locations (Figure 25). The glazing stops were replaced with continuous glazing stops that terminated within ¼ inch of the glazing corner conditions.

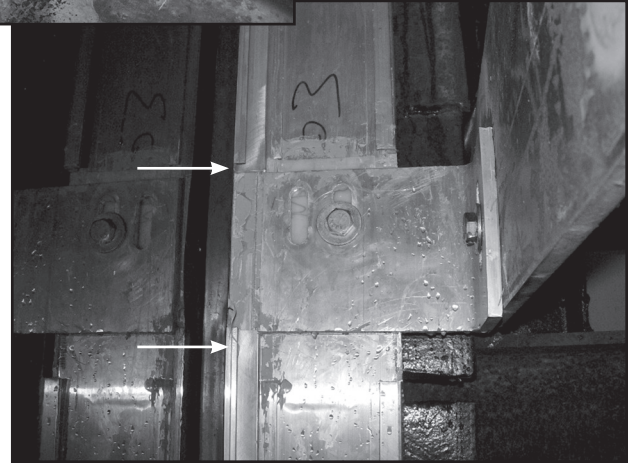
Figure 25 – Discontinuous interior glazing stop at mullion anchor.

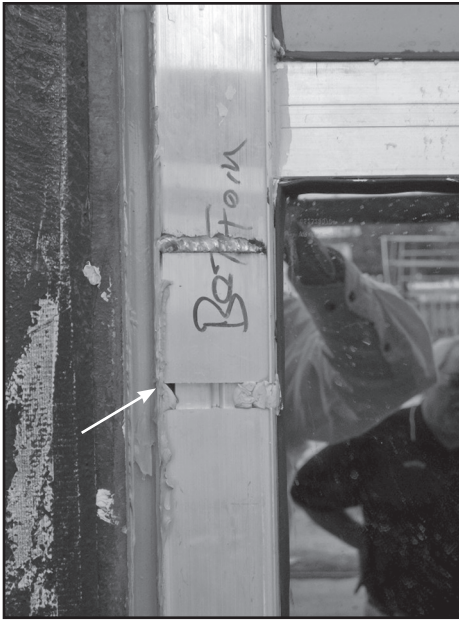
Figure 28 – Alignment plate at the face of the splice joint prohibiting proper field sealant installation.

Finally, the alignment plate at the mullion splice along the face of the left mullion prohibited proper field adhesion of the splice sealant (Figure 28). Therefore, the field installation procedure was modified so that the alignment plates were removed during installation to permit adequate field-sealant installation. The alignment plates were then reinstalled with cap-sealed fasteners.
